Release Notification and Corrective Action

Name of Company	McElvain Oil & Gas Properties, Inc.	Contact	E. Reed Fischer
Address	1050-17 th St, Ste. 1800 Denver, Colorado 80265	Telephone No.	(303) 893-0933
Facility Name	McElvain # 5	Facility Type	Tank Battery

SPCC PLAN
 Facility Layout & Surface Drainage
 Date of Inspection: 1-22-2008

Facility Description
 McElvain Lease Well No.5
 # NMNM 0245247
 SW SW, Sec. 25, T18S, R33E
 Lea County, New Mexico

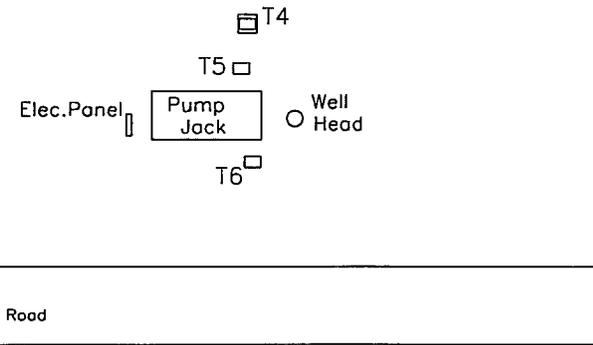
Note:
T-4, 5 & 6 are 55 Gal Drums.
T4 has 38"x62"x9" plastic
secondary containment.
T5 & T6 are not being used.

Note:
To meet SPCC Plan requirements the following
repairs or changes need to be made:
-Tanks T5 & T6 need to be removed from
the site.
