**Release Notification and Corrective Action**

TABLE 2  
**Summary of Excavation Soil Sample Analytical Results**  
**DEVON MORTON SOLID STATE #1 (1PR 1931)**

**Executive Summary  
Devon Energy Corporation  
Morton Solid State # 1  
Spill Remediation Report**

### **Morton Solid State # 1**

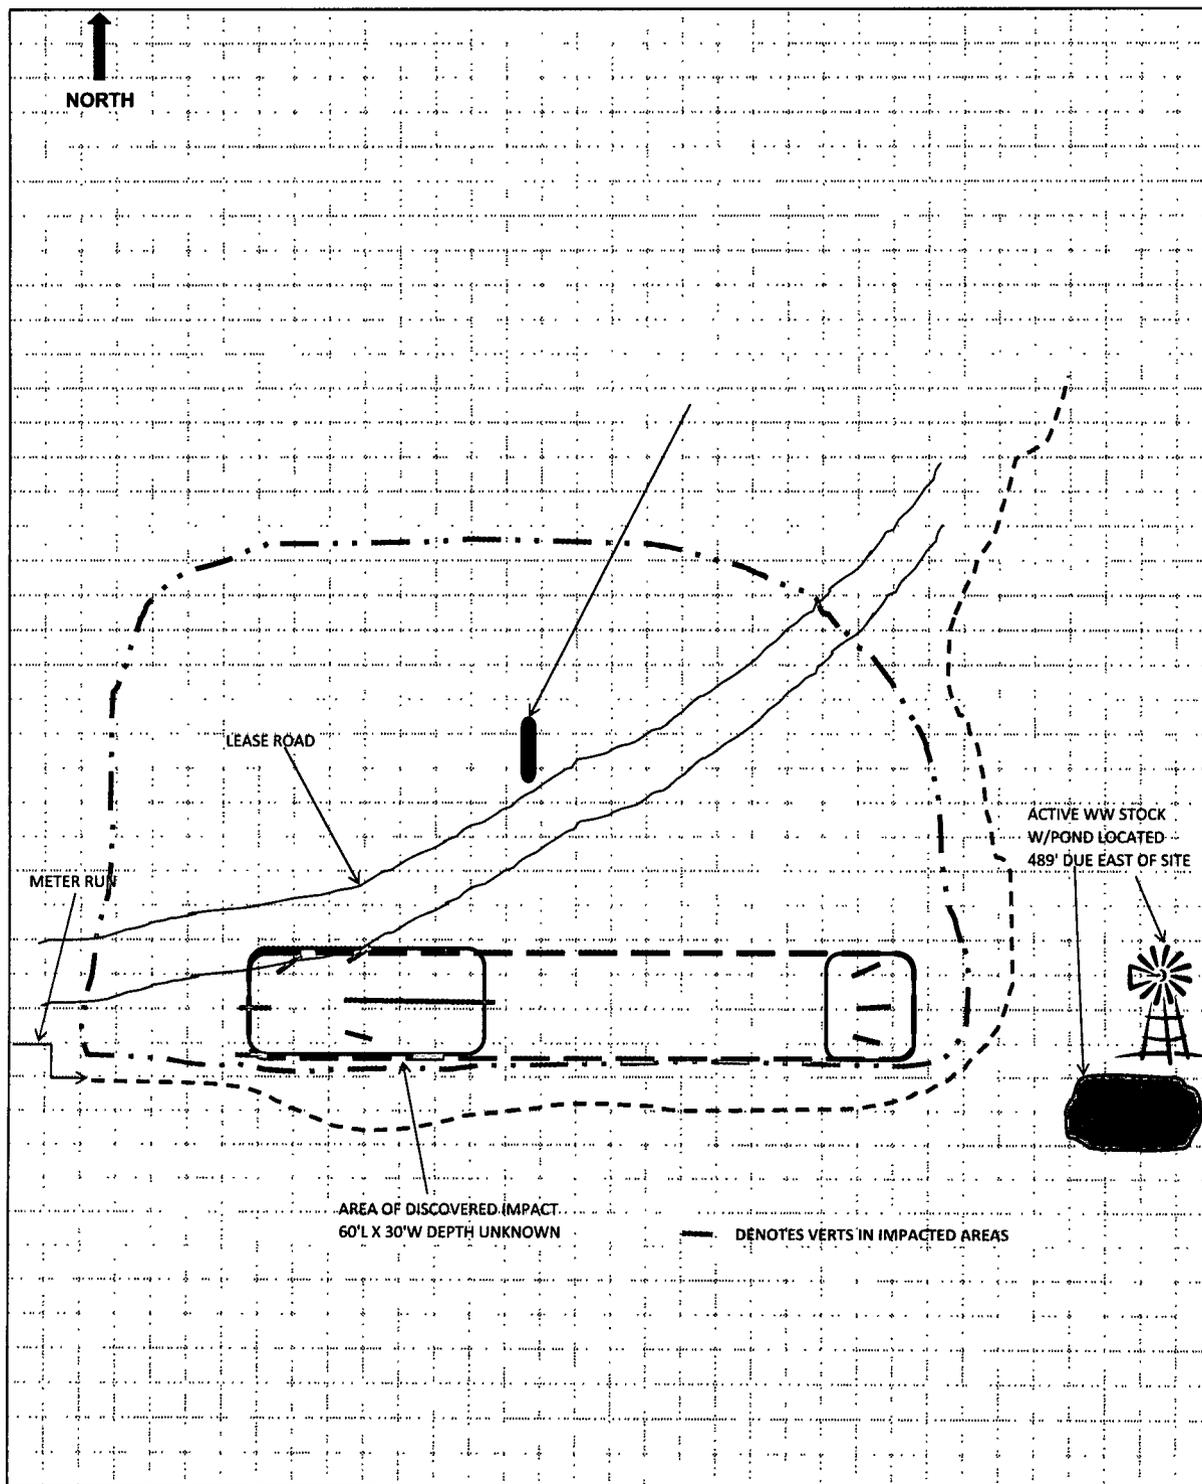
# INITIAL SITE ASSESMENT

DEPTH TO GW: 67' NOTE: ACTIVE WATER WELL FOR STOCK 489' DUE EAST OF LOCATION.
