**GW - 243**

RE. GW-243, House Compressor Project

Southern Union Gas Services  
House Compressor Station  
GW-243

## GW-243, Permit Conditions Inspections

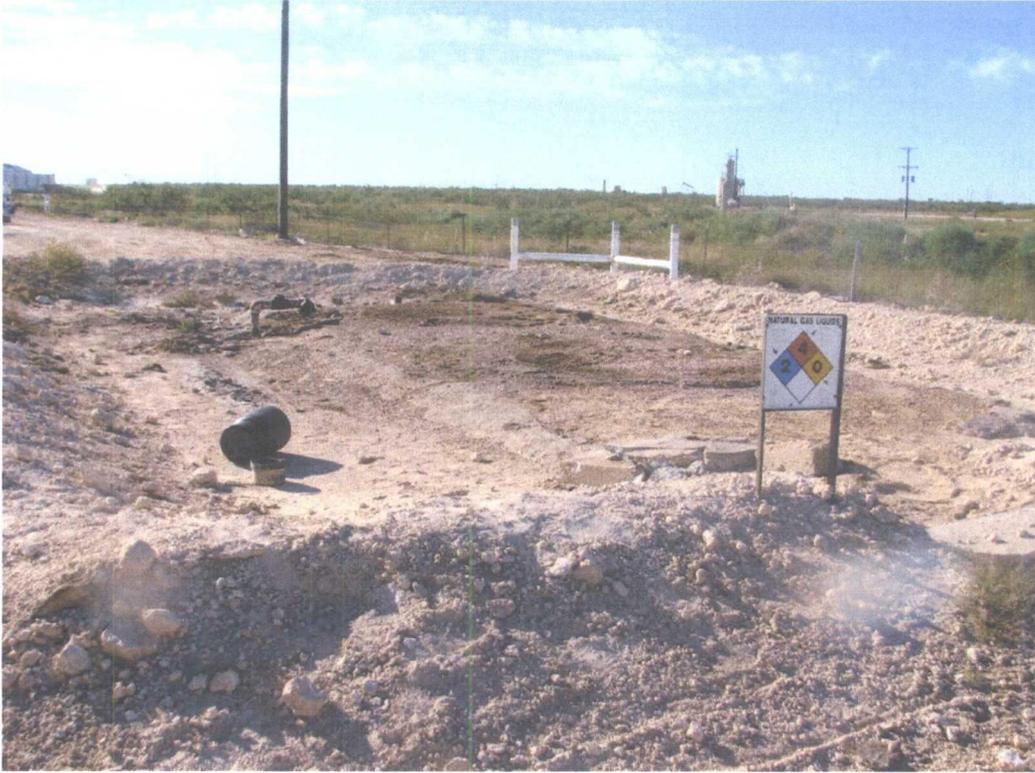
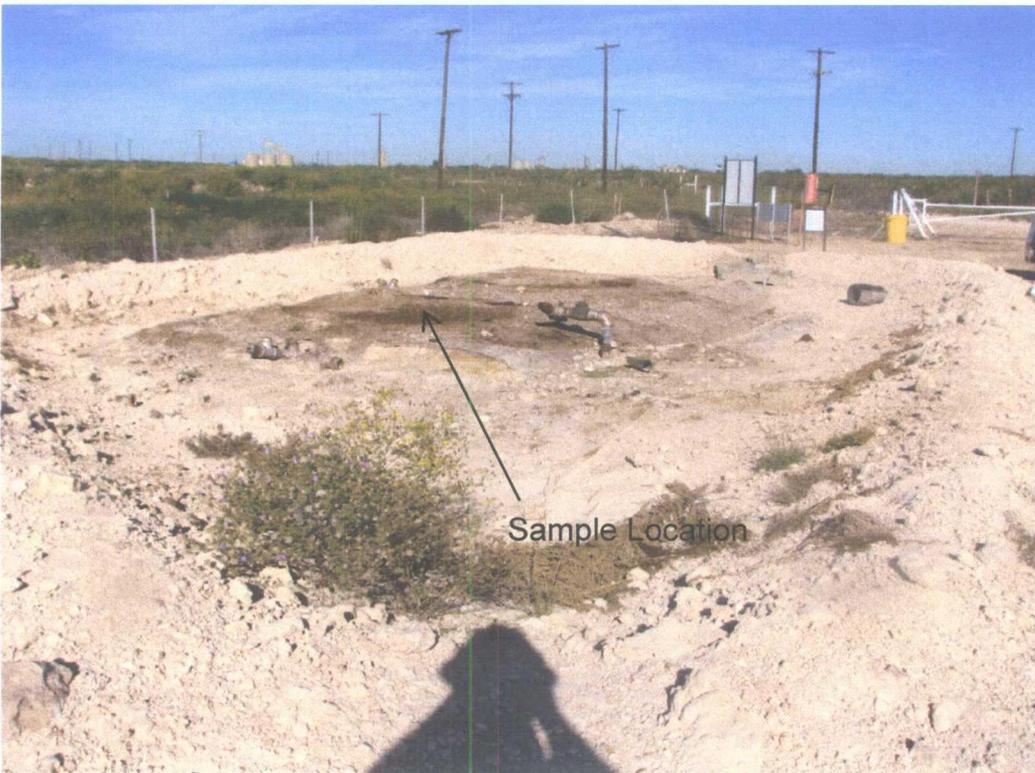
The area was sketched photographed and sampled on 10/9/08. *Reference SUGS Photos #1 & #2*

Old Tank Location 10/9/08

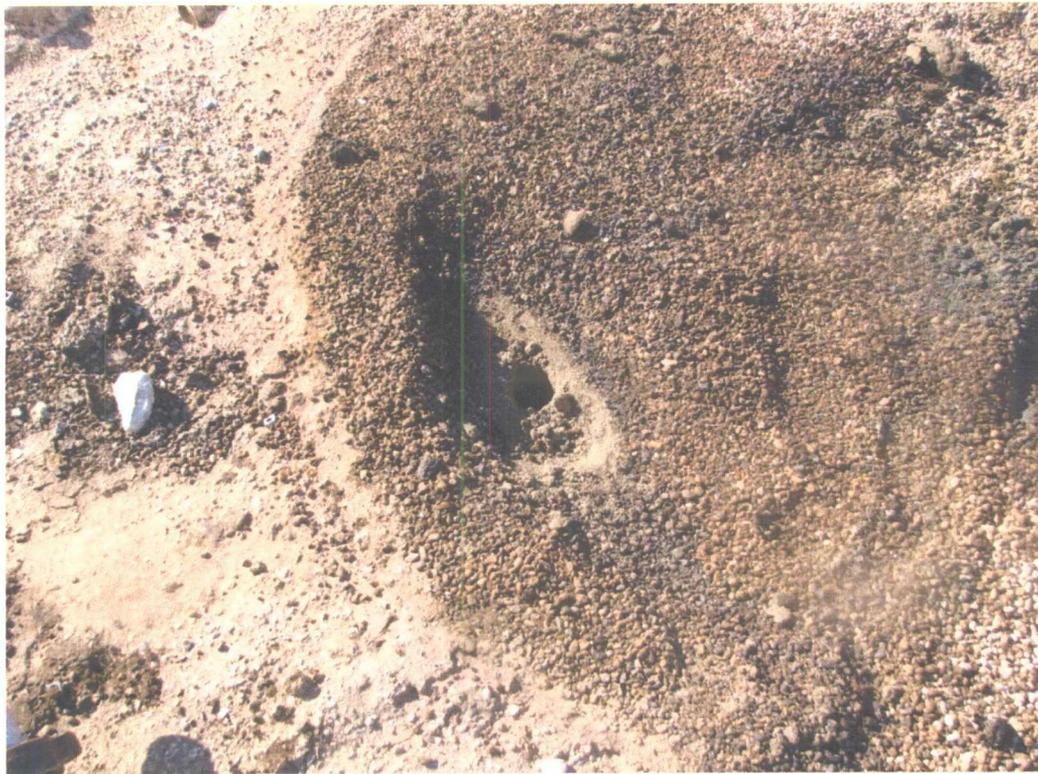
Photo SUGS #3

The area under the south tank indicated that it may have been leaking. A hand auger was used to sample to a depth of approximately 3 ft. below the ground surface, further vertical delineation could not be achieved with the auger. *Reference SUGS Photos #3*

Close up of Sample Location  
South Tank Location

We will schedule an air rotary rig to delineate the tank site; hopefully this will be done by 11/15/08. *Tank removal verified, still open due to leak in south tank. (X)*

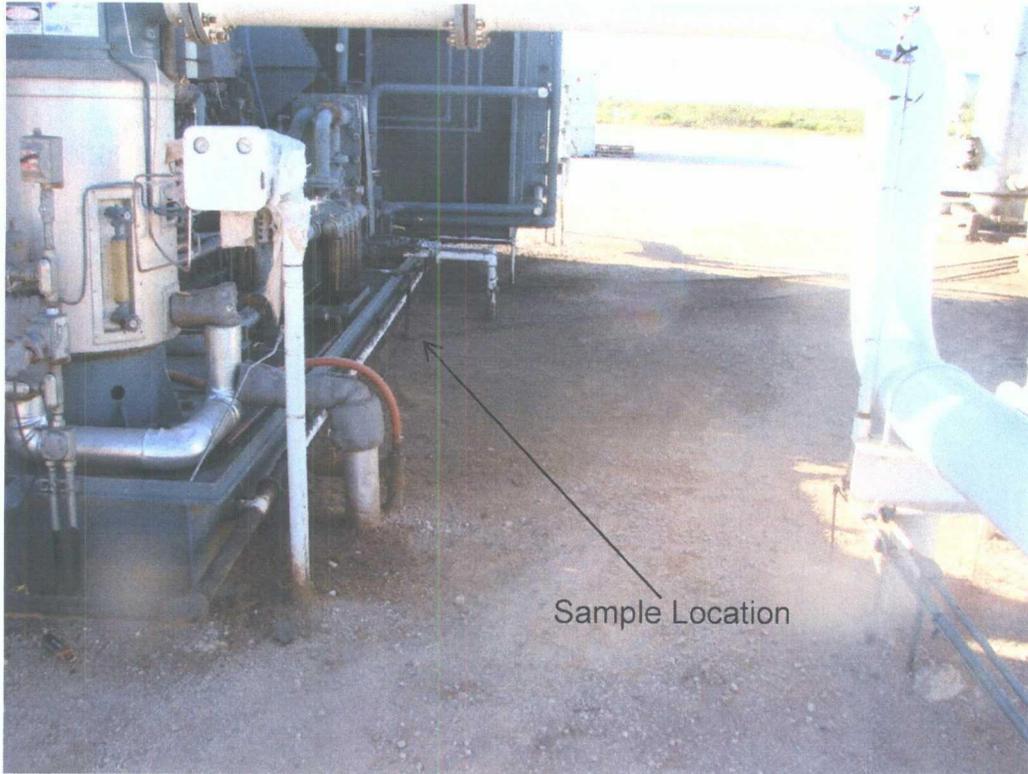
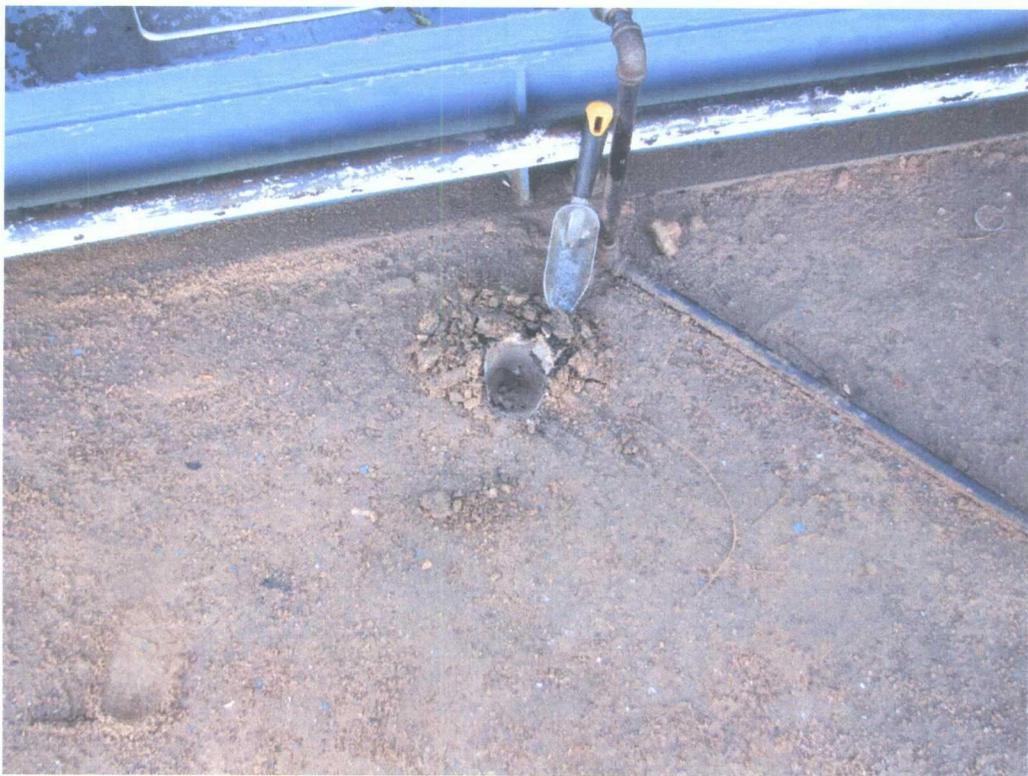
An area just west of the furthest East compressor was sampled on 10/9/08. Since the release was more than likely lube oil a waste characteristic sample will be ran before the area will be remediated.

Sample Location at East Unit

The soil will be analyzed for TCLP metals, RCI, TCLP BTEX, and TPH 8015 Extended.

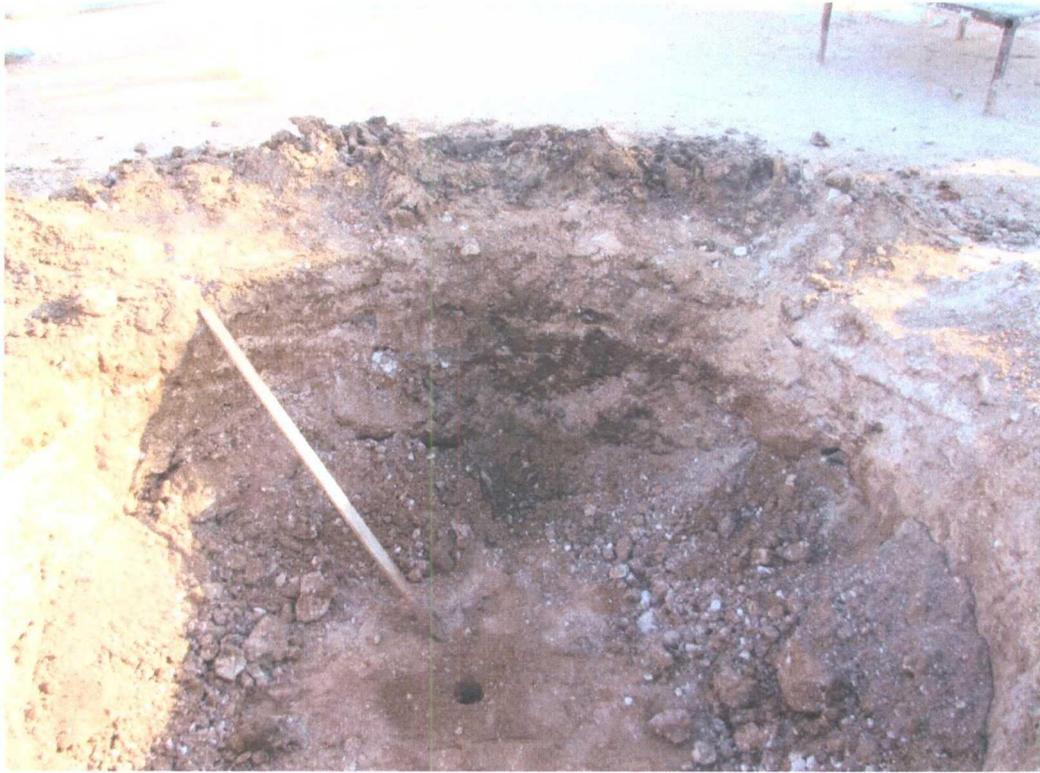
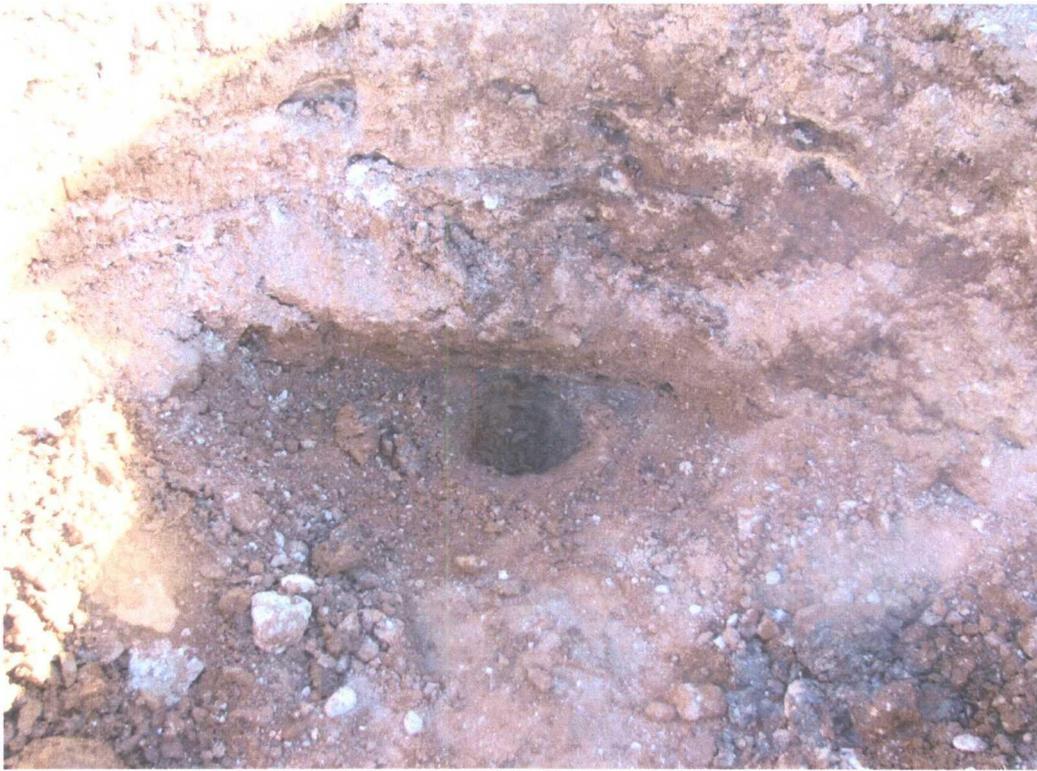
It does appear that the sump had run over prior to removal based on the contamination discovered on the north east side of the sump location.

On 10/9/08 soil samples were taken from the center of the sump location in the bottom of the hole and at a depth of approximately 1 ft. below the surface. Samples were also collected from the northeast side of the hole 1 ft. below the surface, 30 inches below the surface and 38 inches below the surface. *Reference Photos #6 & #7*

Sample Location Former Sump Location

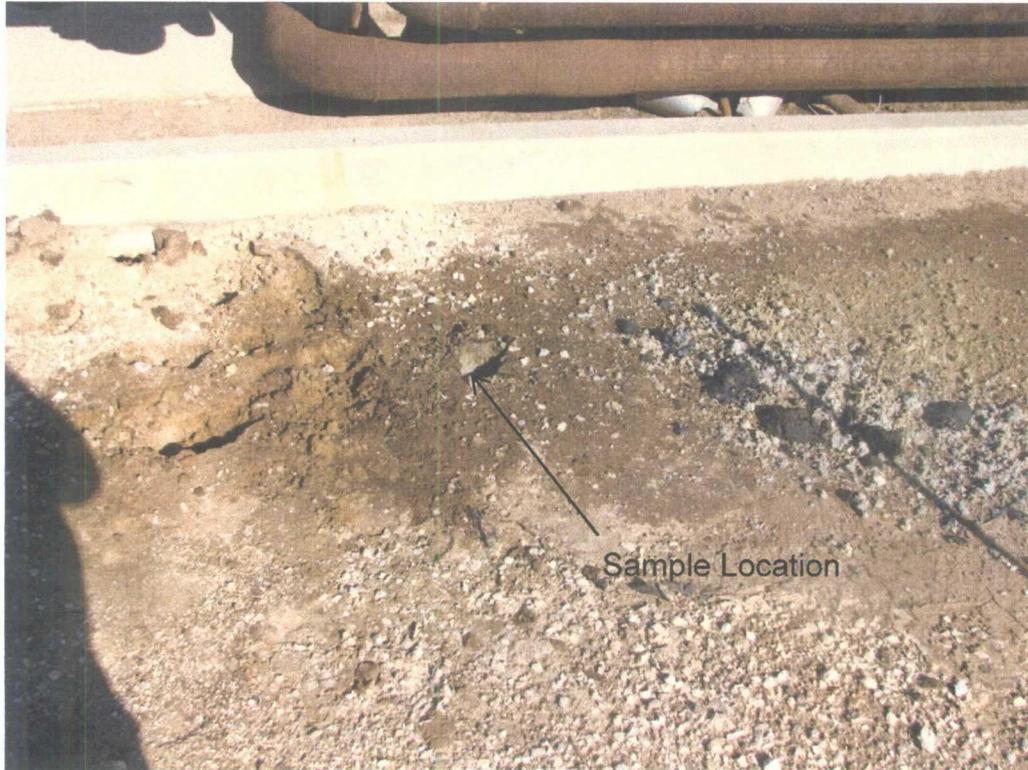
Photo SUGS #8

Soil samples were collected from the South side of the engine skid on 10/9/08 these will be analyzed for waste characteristics. **Reference Photo SUGS #8**

Sample Location Old Cooper Bessemer Engine

The engine, compressor and building will be demolished and hauled to a metal reclaimer. All of the concrete will be cleaned prior to being busted up for hauling to the Lea County Landfill.

Once all of the compressor components, piping and concrete have been removed the soil will be remediated using the NMOCD guidelines.

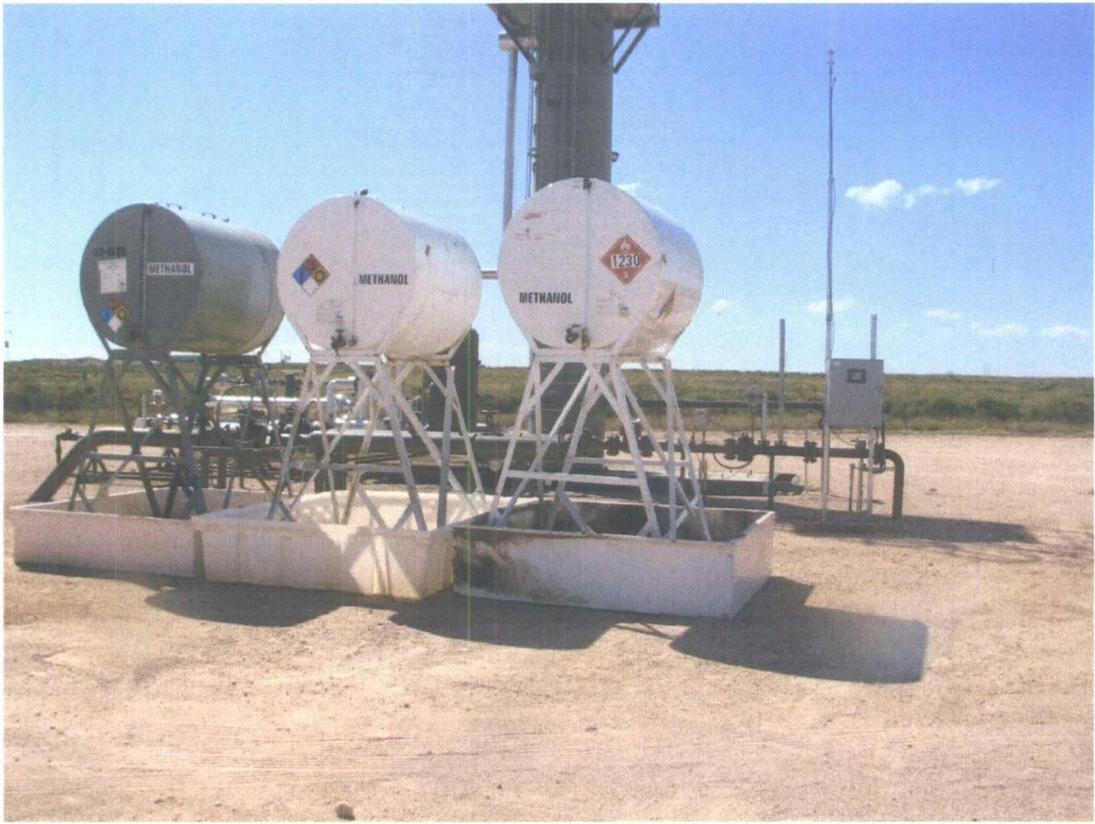
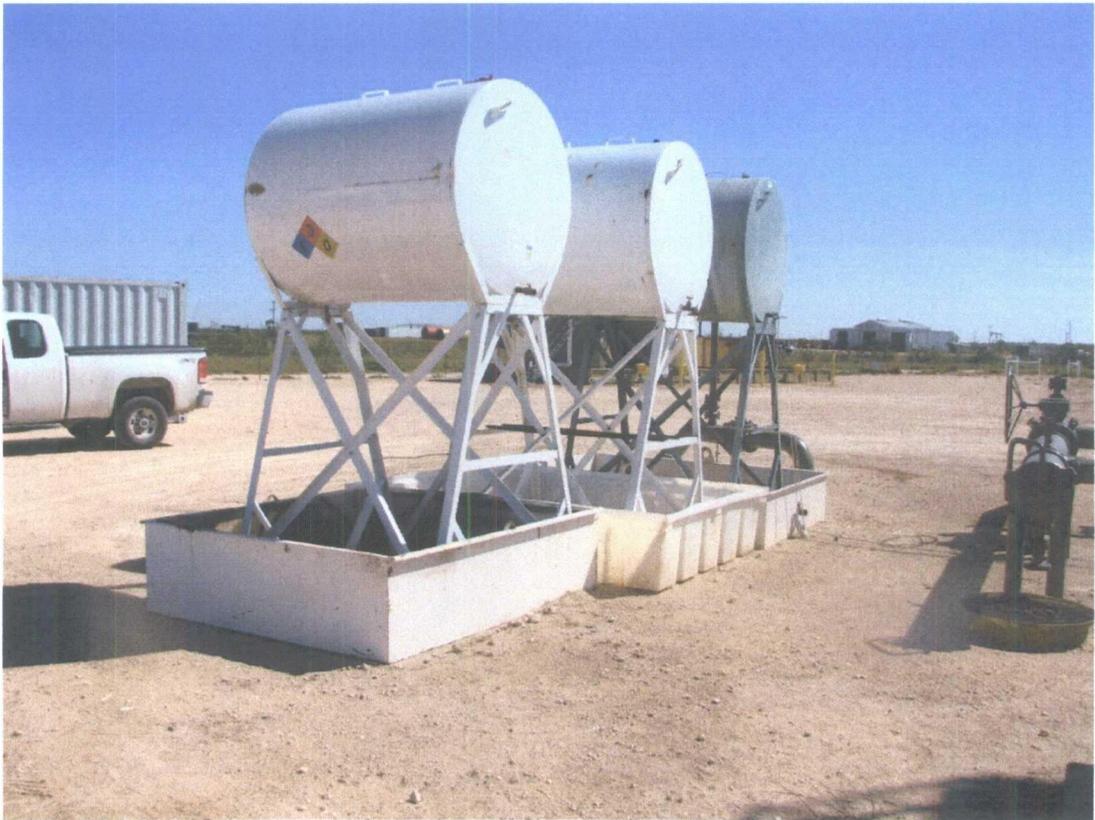
Photos Taken 10/10/08  
After containment was installed

The vendor has verified that containment will be delivered on 10/10/08. Photos will be taken to verify this action. *Still open until photo received. (X)*
