**Release Notification and Corrective Action**

Name of Company Occidental Permian Limited Partnership	Contact Steven M. Bishop
Address 1017 West Stanolind Road, Hobbs, N.M. 88240	Telephone No. (575) 397-8251
Facility Name South Hobbs Unit Injection System #53	Facility Type Production

RE: Remediation Plan  
South Hobbs Unit 8" Injection Trunk line  
from Central T/B to Injection Building #7  
SHU #53 Closest Injector API No 30-025-07612  
UL 'L' and 'M', Sec. 4, T-19-S, R-38-E

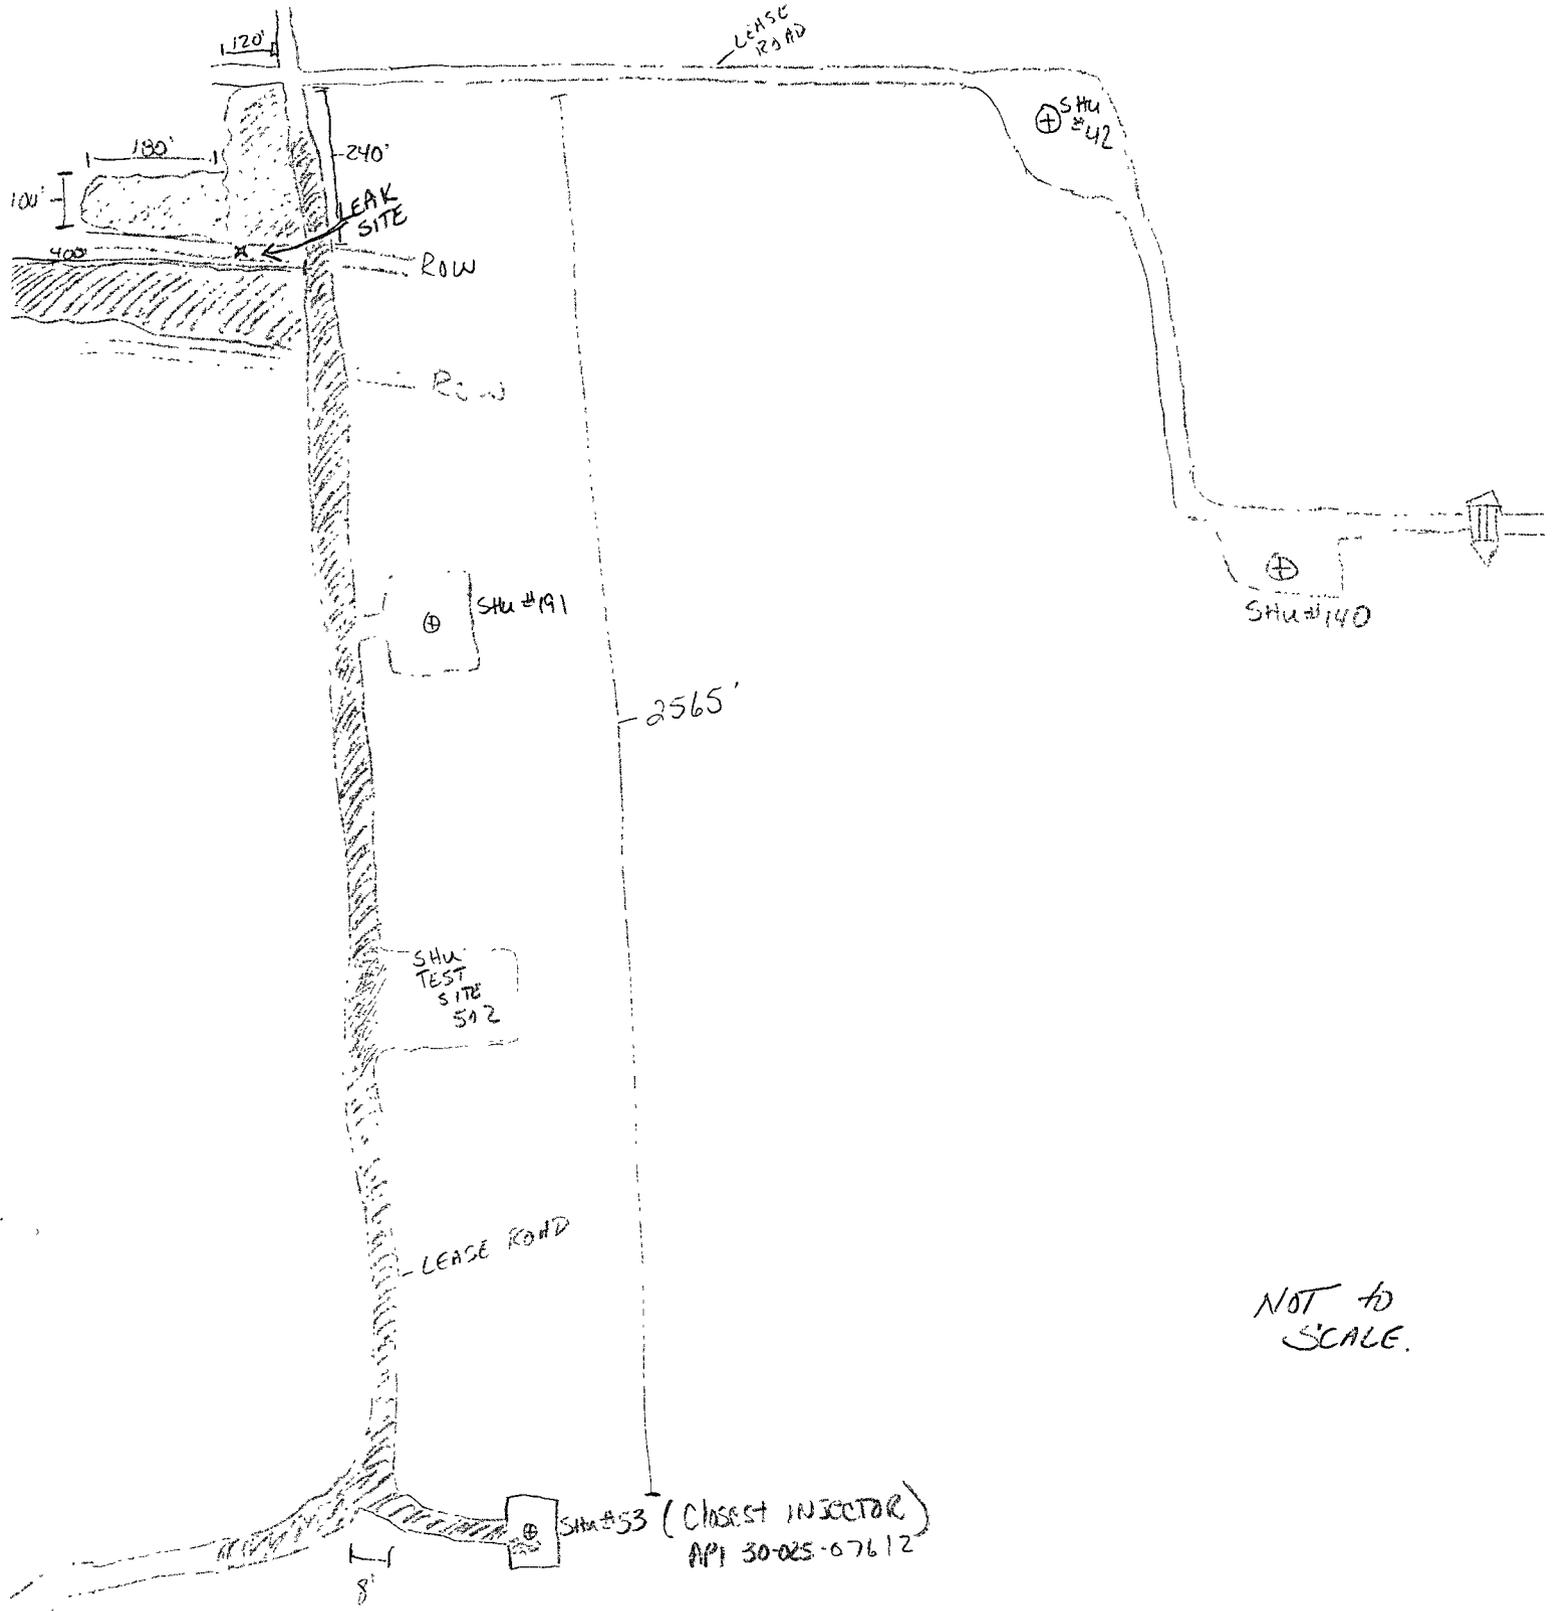
# SPILL MAP

11/03/2008 8" Fiberglass, H-Pump 7 LINE, 50 PSI, 12,000 bbls/day RATE  
LEAK DISCOVERED 2:30PM, ESTIMATED 300-400 Bbls Prod. Water  
LEAK SITE UL 'L' SEC. 4, T-19-S, R-38-E - N 32° 41' 16.90" - W 103° 09' 40.90"  
LEAK RAN SOUTH INTO UL 'M', SEC 4, T-19-S, R-38-E - MALCOLM COOMBS, LANDOWNER
