Release Notification and Corrective Action

## Corrective Action Plan

Torch Energy Services, Inc.  
Cooper Jal Unit Satellite No. 2 Battery  
Sec. 24 -T24S-R36E  
Lea County New Mexico

October 7, 2008

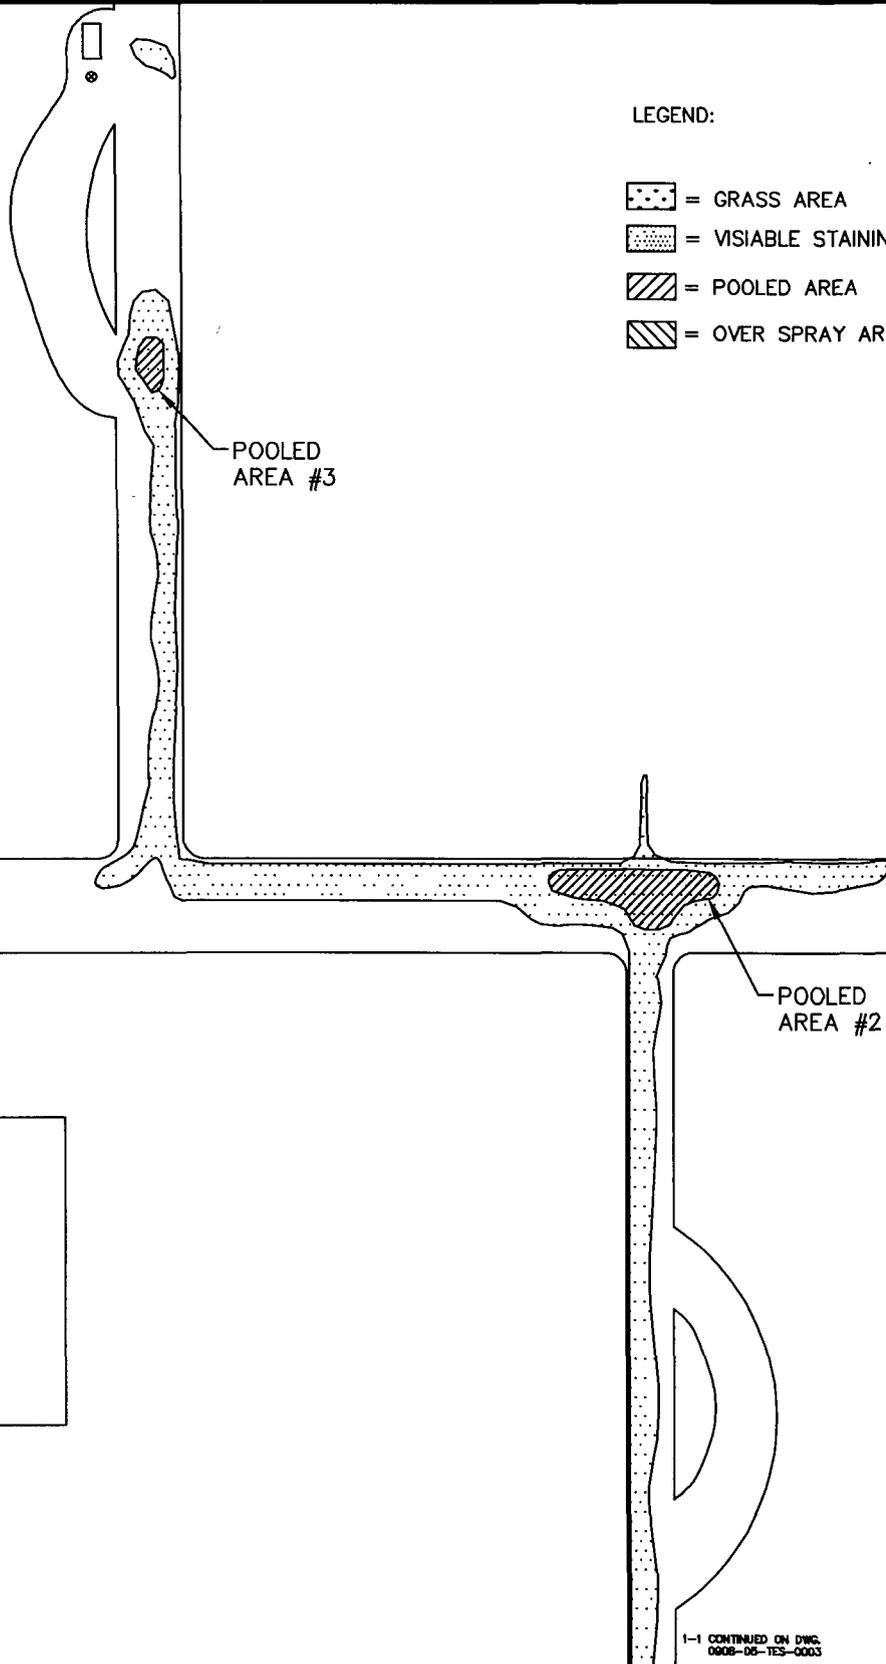
DATE:	DRAWING APPROVAL				
9/08	SIGNATURE	DATE		SIGNATURE	DATE
DRAWN BY:	JJL	9/21/08	CHECKED BY:	DC	9/08
DWG. NO.	0908-05-TES-0002				0

POOLED  
AREA #3

POOLED  
AREA #2

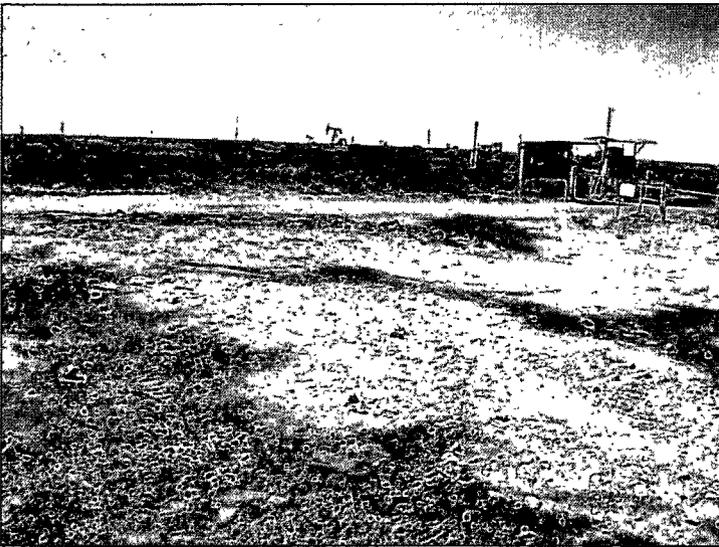
Pooled area #1  
Photo ID- 007

On September 9, 2008 at approximately 0500, a failure of redundant back-up systems caused a temporary production holding tank to over flow causing produced water and hydrocarbon to migrate down gradient from the initial site resulting in pooling in three locations. All pooled areas were contained on the operators road locations and adjacent to the tank battery. This release was reported by Randy McNally of Torch to the NMOCD immediately upon discovery and the initial Form C-141 was submitted to the NMOCD on September 17, 2008 (signed by Larry Johnson of the NMOCD on September 22, 2008). Corrective actions were initiated to recover free standing fluid from the pooling areas by vacuum truck.

It is our plan to remediate this site by removing contaminated soils in the three (3) main areas where pooling occurred. We will have a third party environmental firm perform on-site analysis of the walls and bottoms of the excavated areas to confirm contamination levels of less than five thousand (5,000) ppm total petroleum hydrocarbons and two hundred-fifty (250) ppm chlorides before backfilling the excavated areas with fresh caliche. One (1) sample will be gathered from each of the pooled areas and submitted to a lab for confirmation that the clean-up has met the standards set forth by the NMOCD.

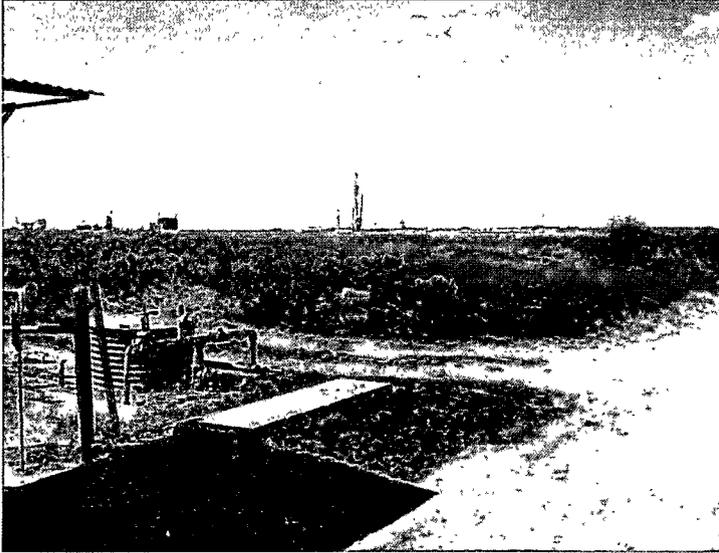
over spray Area  
Photo ID- 013
