Release Notification and Corrective Action

| Facility Name | WEST DOLLARHIDE DRINKARD UNIT | Facility Type | OIL & GAS PRODUCTION |

RE: Remediation Proposal  
Chevron USA – WDDU #51  
UL-H (SE ¼ of the NE ¼) Section 31, T 24 S, R 38 E  
Latitude: 32° 10' 29.07"N; Longitude: 103° 05' 31.64"W  
API #30-025-12279  
NMOCD 1RP #1179; EPI Ref. #200108

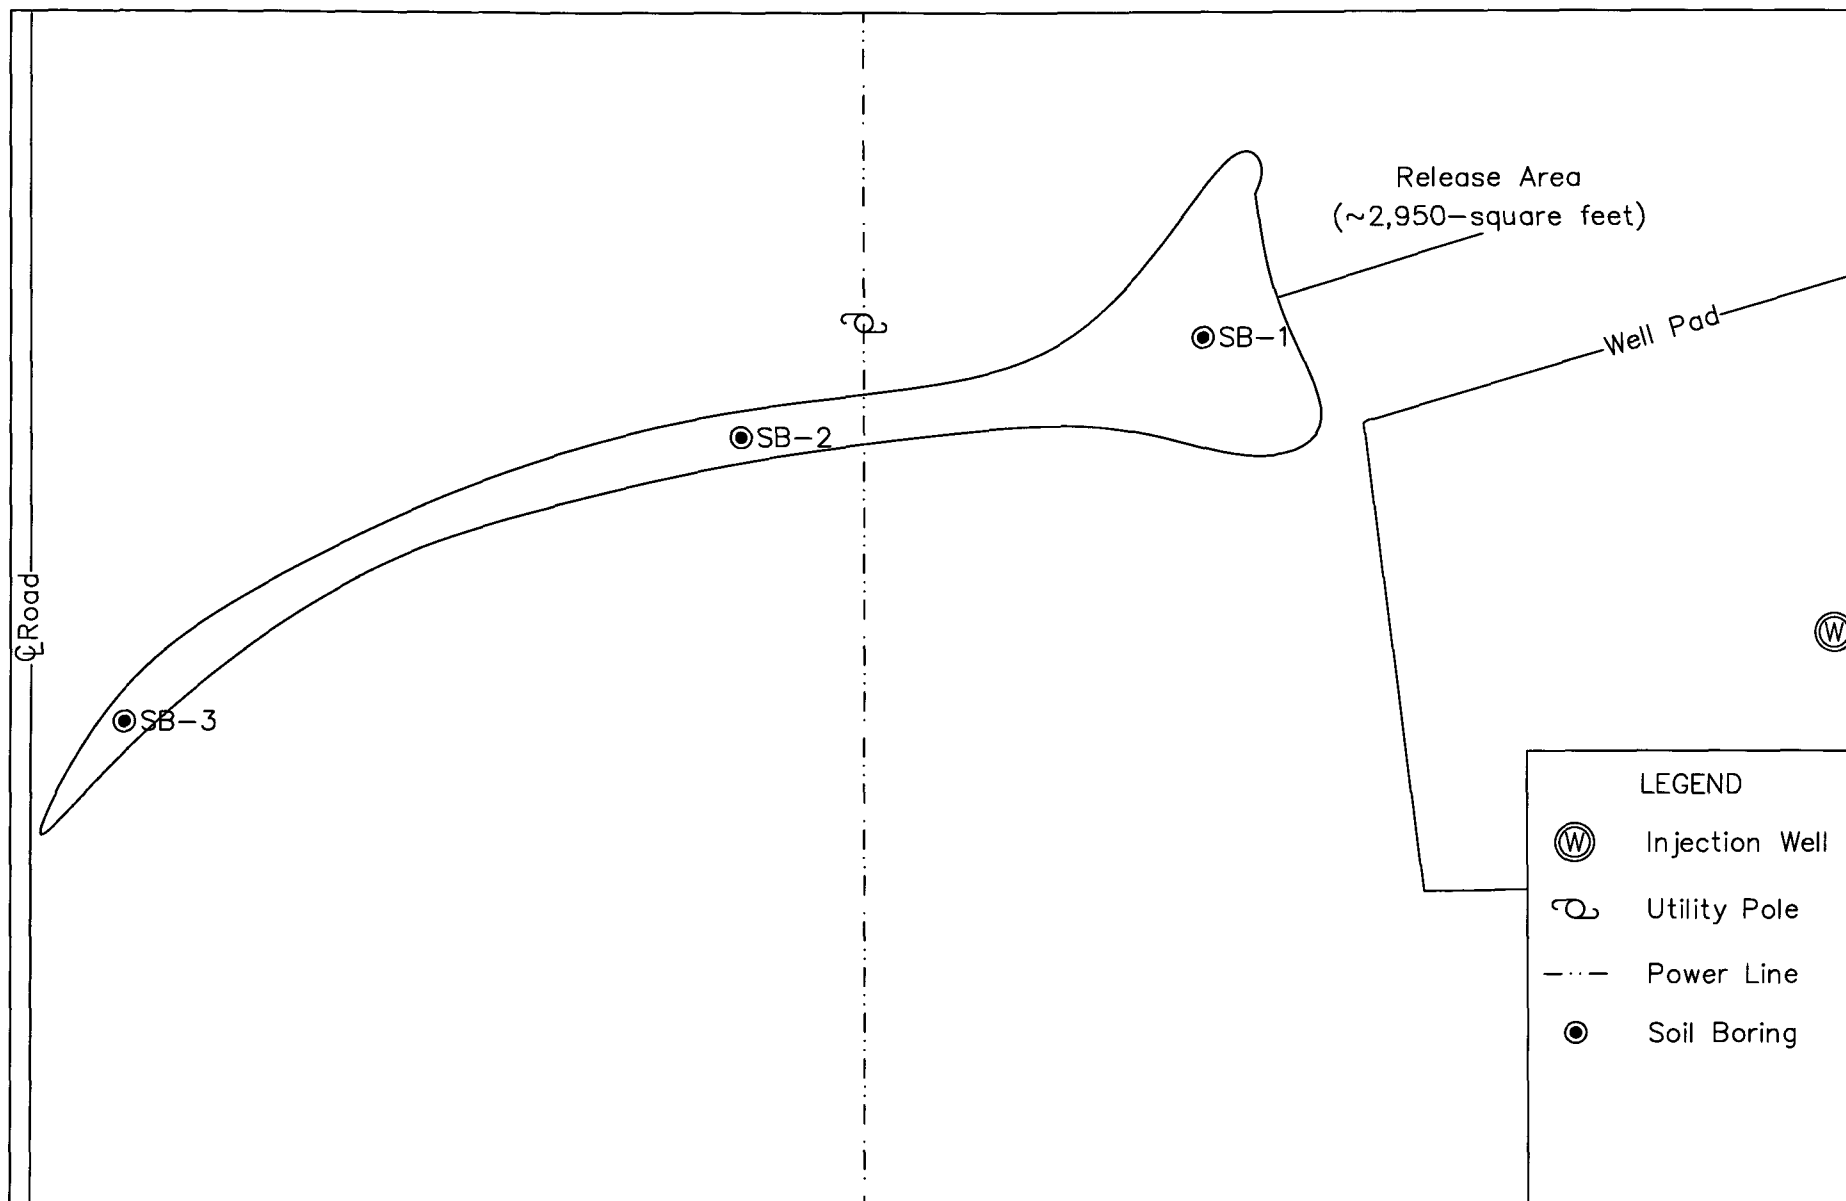
Figure 5  
Soil Boring Map  
Chevron Corporation  
WDDU #51

Internal corrosion of a steel injection flow line resulted in the release of approximately twenty (20) barrels (bbls) of produced water. Vacuum trucks were dispatched to the site and recovered approximately eighteen (18) bbls of produced water. The line remained out of service until bad sections were replaced and hydro-tested to ensure pipe line integrity. RWI Construction excavated and removed approximately twenty-four (24) cubic yards of contaminated soil on November 1, 2006. Contaminated soil was transported to Lea Land Farm for disposal. On January 18, 2007 EPI performed assessment, GPS survey and photographed the site. EPI advanced three (3) soil borings from January 26 through 29, 2007 across the release area to delineate vertical extents of impacted soil (reference *Table 2*).

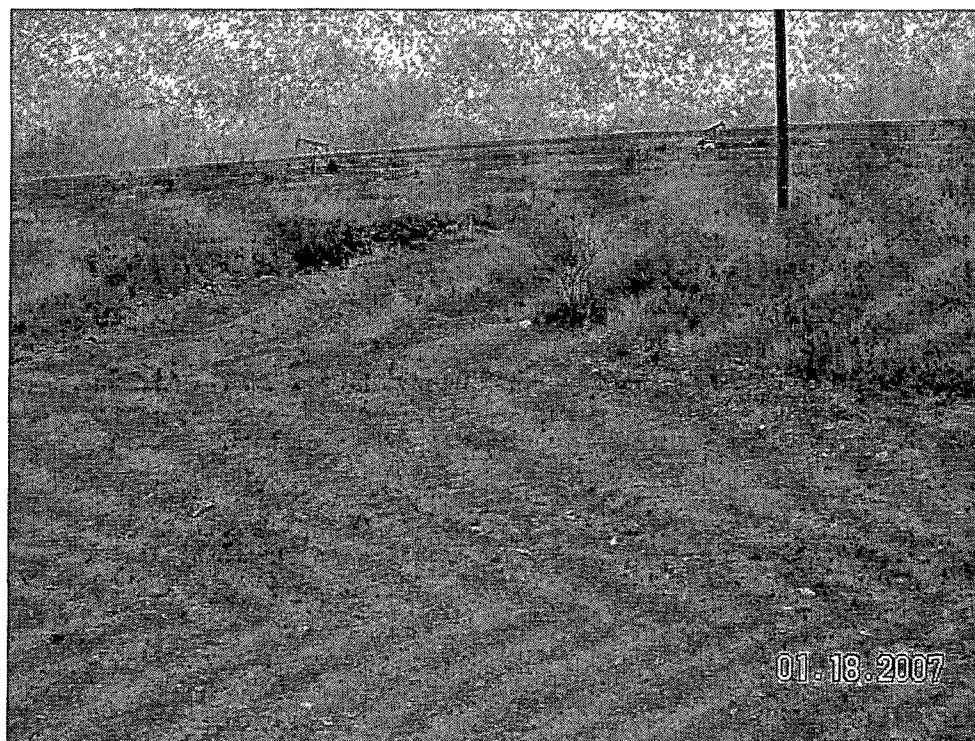
Photograph No. 2 – Looking westerly across release area

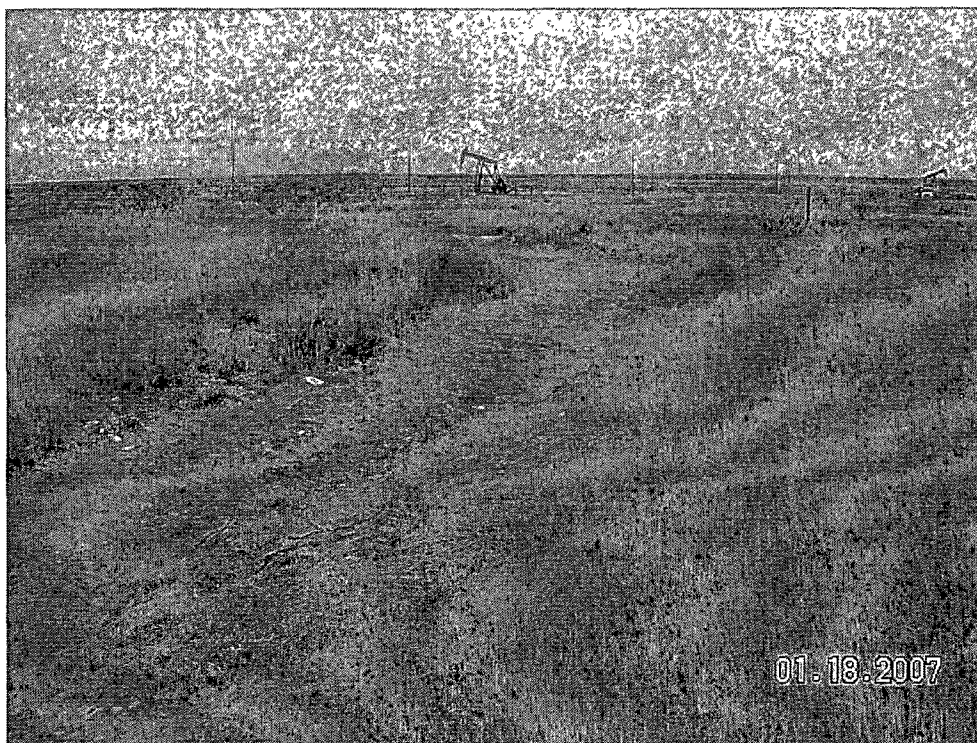
Photograph No. 3 – Looking westerly across release area

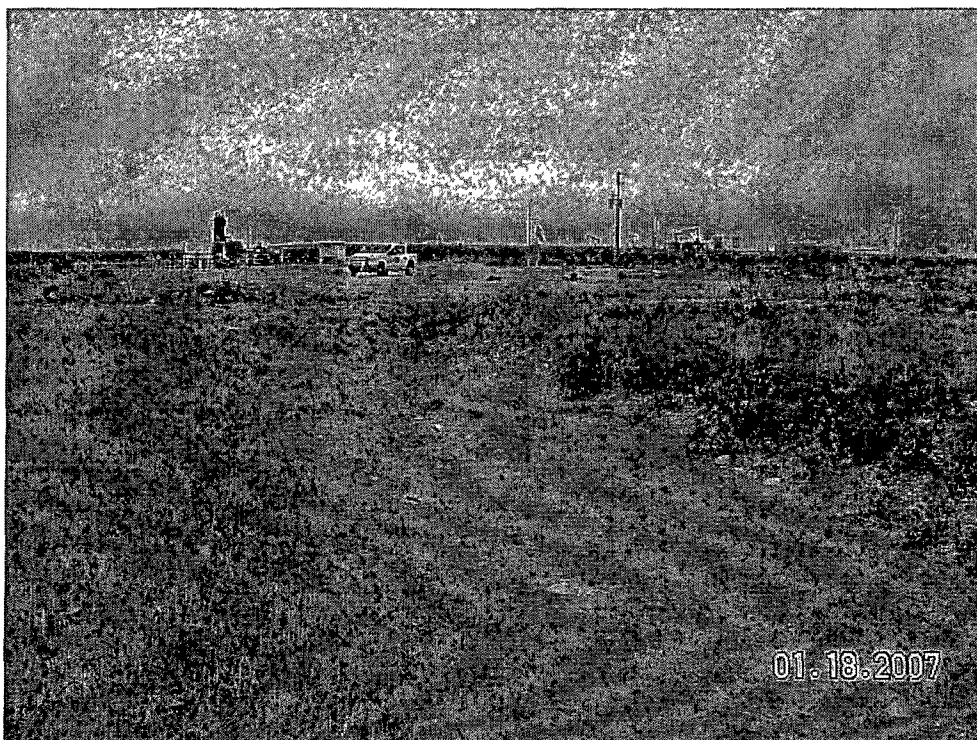
Photograph No. 4 – Looking easterly across release area toward injection well
