From: Bratcher, Mike, EMNRD
Sent: Tuesday, May 05, 2009 11:56 AM
To: 'Vernon Black'
Subject: RE: Sterling Silver #33

Sterling Silver 33 Fed #4

TO: Sherry Bonham
NM OCD District II
REFERENCE: Remediation Work Plan

OPERATOR: OXY USA
LOCATION: Sterling Silver 33 Fed #4
API: 30-015-27519
LEGALS: UL E, Sec 33, T23S, R31E
GPS: N32 15.770 W103 47.453
DEPTH to GROUND WATER: >100'

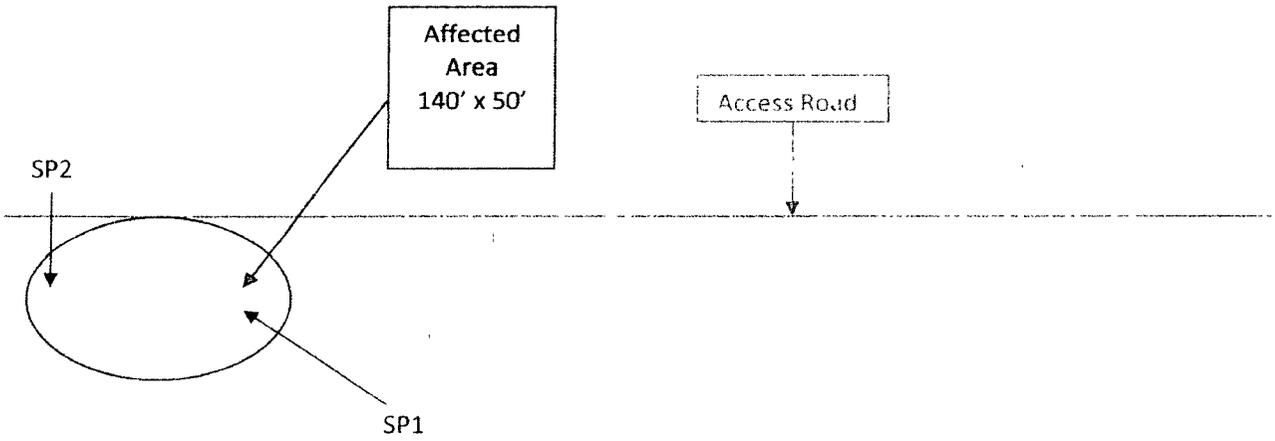
General Site Characteristics: The affected area is the result of a flow line release. The terrain is relatively flat containing native vegetation. The soil is sandy and is considered unsaturated contaminated soil by OCD definition. The affected area is approximately 140' x 50'. It is bordered on the north and west by lease roads. There are no known water wells or surface bodies of water within 1000' of this location.

Work Plan Proposal: Delineation at sample point 1 (SP1) was accomplished with a drill rig using a hollow stem auger with a split spoon. Delineation results at SP1 indicate that the contamination (chlorides) reached a depth of 50'. Delineation at sample point 2 (SP2) was conducted using hand tools with lab results indication the depth of contamination only reached 1' below ground surface (BGS).

The work plan, as submitted, is not approved. The area labeled SP1 shows chloride levels in the five-digit range (greater than 10,000 mg/kg) down to 34' bgs. OCD will require removal of as much of the material exhibiting the elevated chloride levels as is practicable. A liner may be required at that time, dependent upon the volume of impacted materials removed.

Due to the depth of groundwater exceeding 100' and knowing the depth of contamination, my work plan proposal for the area of SP1 is to remove 4' of the contaminated soil, line the area with a 20mil synthetic liner, and backfill with like material. I feel through the use of the synthetic liner, further penetration of the chlorides will be prevented thus the ground water will not be impacted.

Due to shallow contamination and low chloride levels in the area of SP2, we propose to remove the 1' of contaminated material and backfill with like material.
