**Release Notification and Corrective Action**

Name of Company Occidental Permian Limited Partnership	Contact Steven M. Bishop
Address 1017 West Stanolind Road, Hobbs, N.M. 88240	Telephone No. (575) 397-8251
Facility Name South Hobbs Unit Injection System	Facility Type Production

Describe Cause of Problem and Remedial Action Taken.\* An 8" fiberglass injection trunk line from South Hobbs Unit Central T/B to South Hobbs Unit Injection Building #7 was struck by a backhoe shortly after the line was repaired. Isolated the trunk line by shutting valves at both ends. South Hobbs Unit #53 is the closest injector and the API number for this well was used for this report.

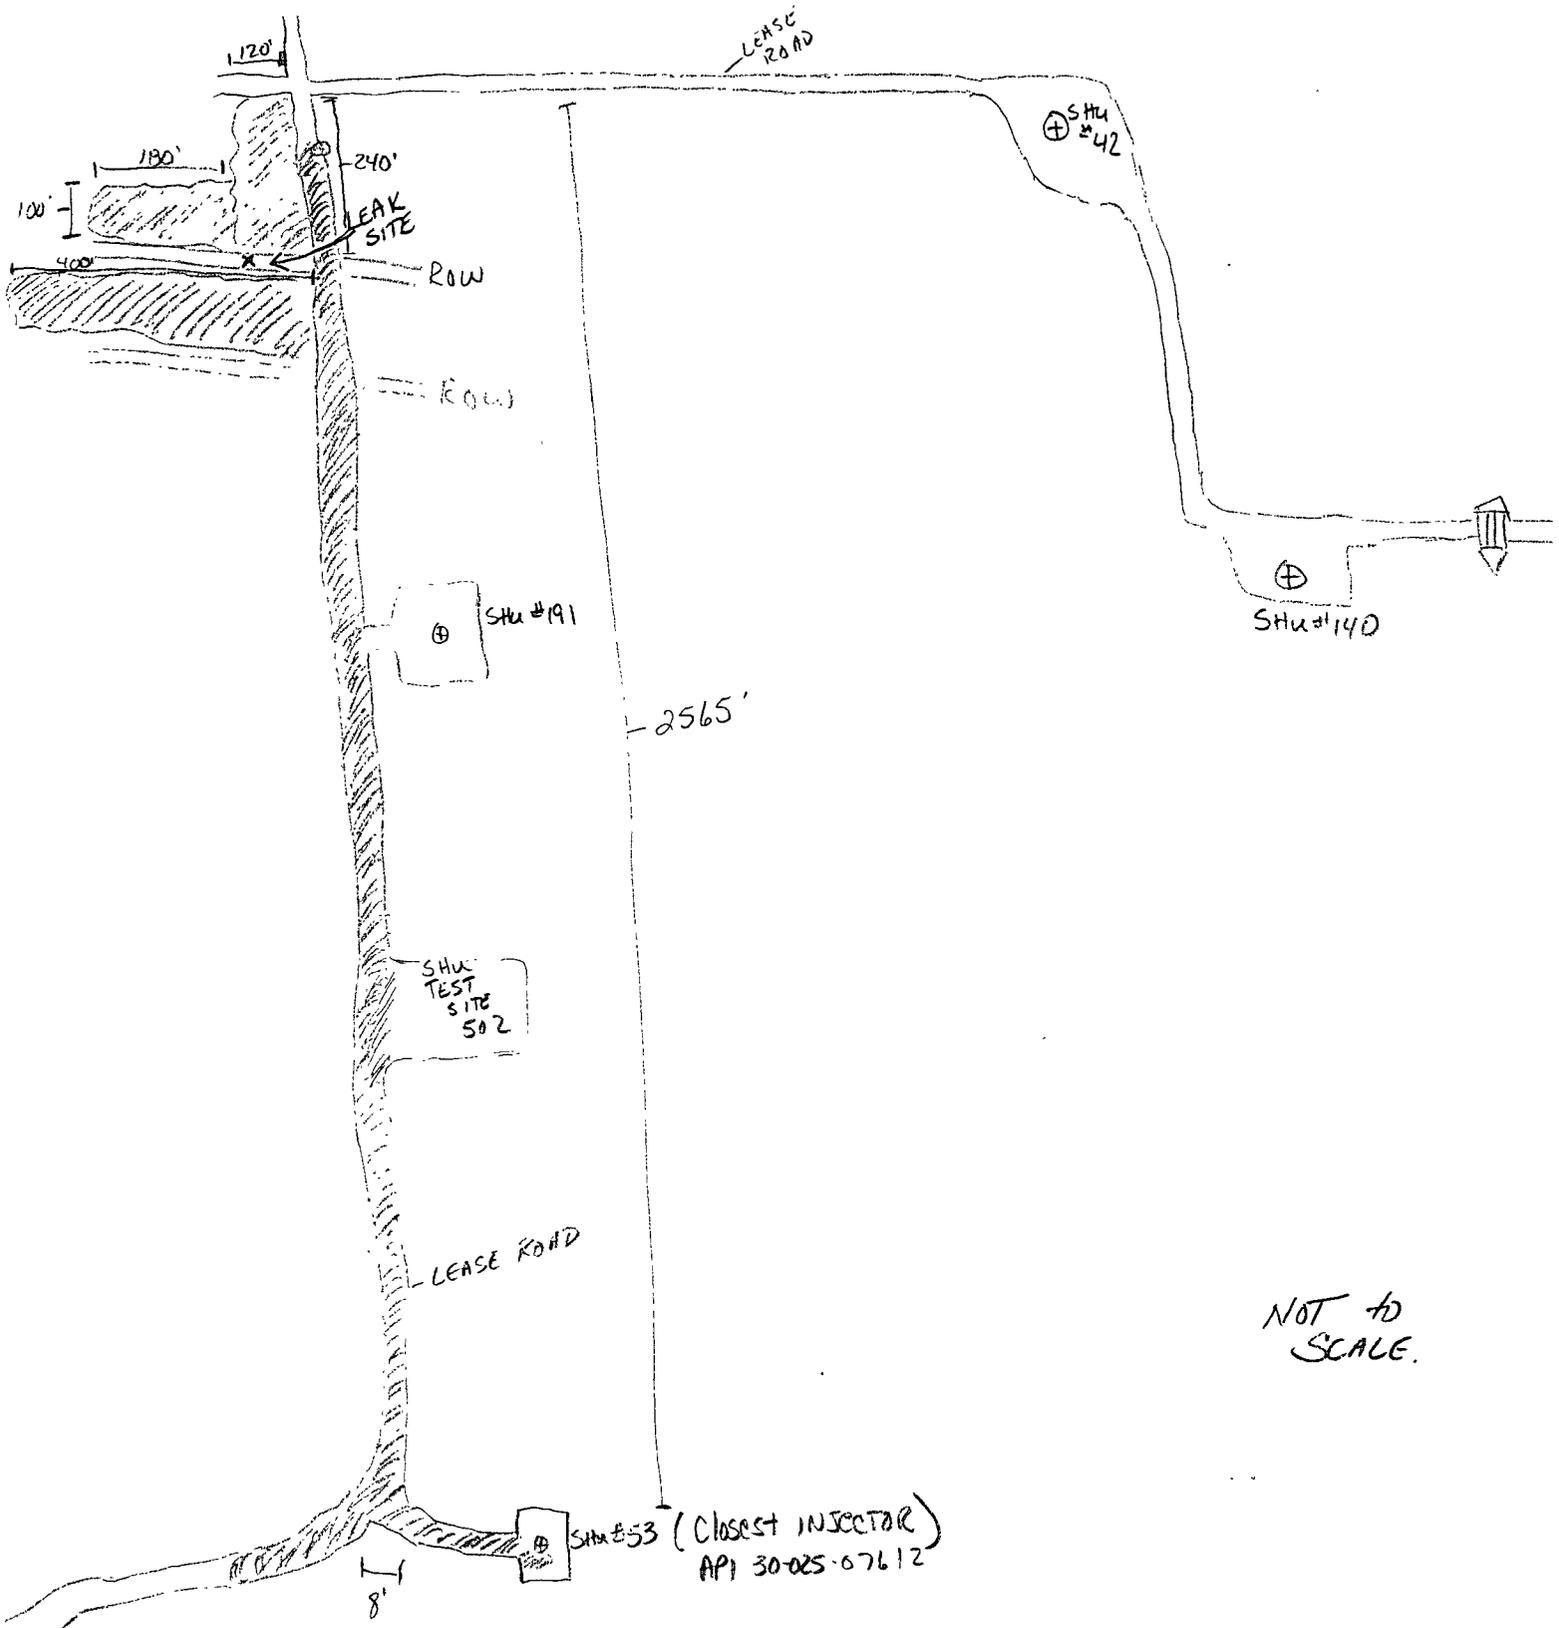
# SPILL MAP

11/03/2008 8" Fiberglass, H-Pump 7 LINE, 50 PSI, 12,000 bbls/day RATE  
LEAK DISCOVERED 2:30 PM, ESTIMATED 300-400 Bbls Prod. Water  
LEAK SITE UL 'L' SEC. 4, T-19-S, R-38-E - N 32° 41' 16.90" - W 103° 09' 40.90"  
LEAK RAN SOUTH INTO UL 'M' SEC 4, T-19-S, R-38-E - MALCOLM COOMBE'S, LANDOWNER

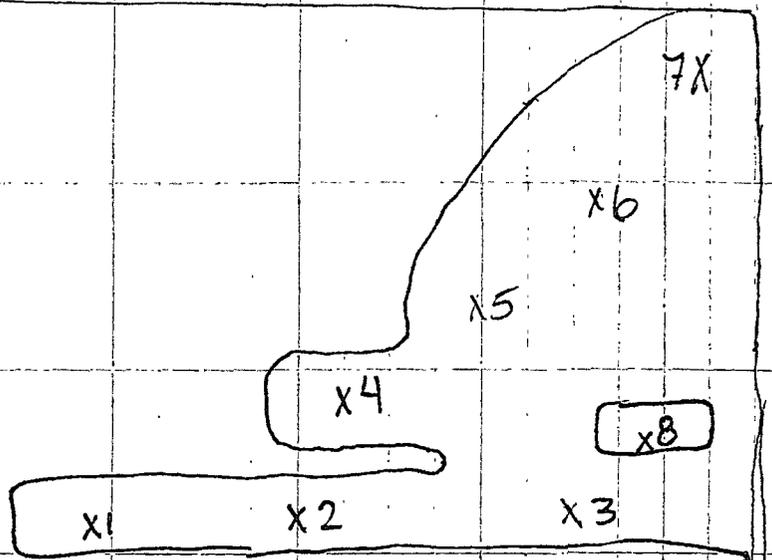
Sample point map

SP	TIME
SP 1	8:30
SP 2	8:40
SP 3	8:50
SP 4	9:00
SP 5	9:05
SP 6	9:10
SP 7	9:15
SP 8 taken from bottom of hole	9:20 5' depth
SP 9 1' depth	9:30
