GW - 344

Re:*Inspection Report – GW-344
Versado Gas Processors LLC
Eunice South Compressor Station
Lea County, New Mexico*

Subject: Notice of Violation

OCD Inspection: Targa, Eunice South C.S., GW - 344

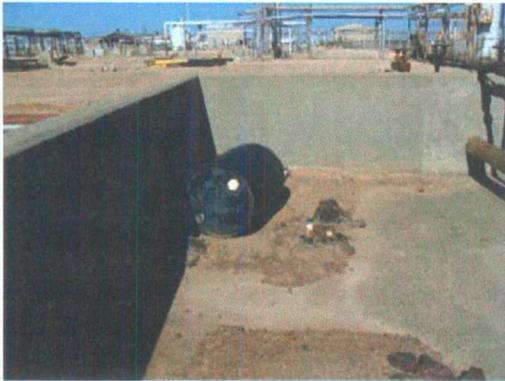
- 1. Photo 1-5, and 12 – The secondary containment are full of debris and sediments. One berm is deteriorated. Excess materials in these containments reduce the 133% volume needed to sustain the large volume.***

1. **Photo 1 – 5 & 12:** The secondary containments are full of debris and sediments. One berm is deteriorated. Excess materials in these containments reduce the 133% volume needed to sustain the largest volume. Targa shall clean out and properly maintain these secondary containments. Reference *Condition 9* of the permit for details.

Photo 1: Debris in secondary containment.

Photo 1. As communicated during the inspection this secondary containment and the equipment within it was taken out of service in 2000 when the processing plant was shutdown. This equipment is being demolished and removed.

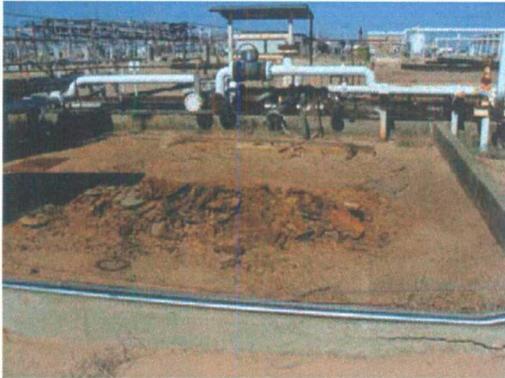
Photo 2: Waste in secondary containment.

Photo 2-5. These concrete pads are not intended to be secondary containment. The equipment in this area is pressure vessels and piping. There are no storage tanks. Targa has cleaned the concrete areas of debris and blow sand.

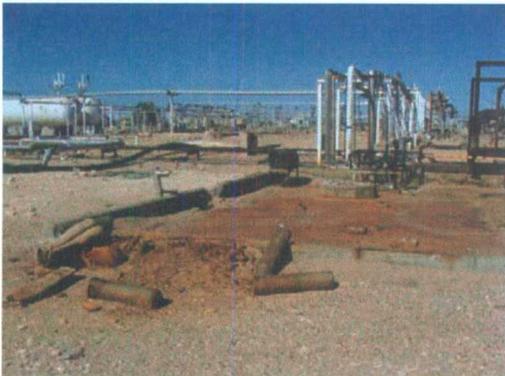
Photo 3: Used filters near secondary containment.

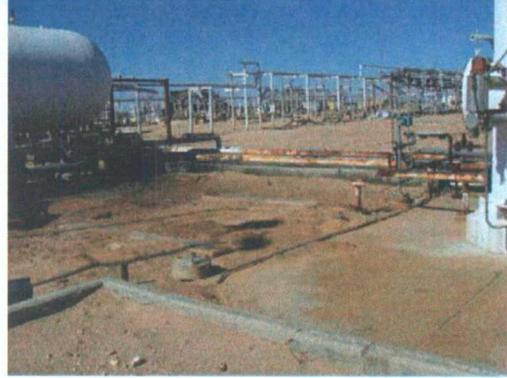
Photo 4: Sediment in secondary containment.

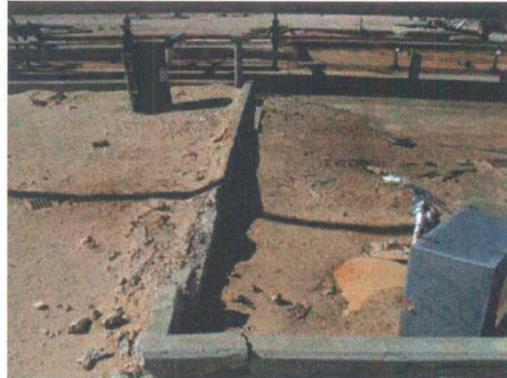
Photo 5: Breached secondary containment wall.

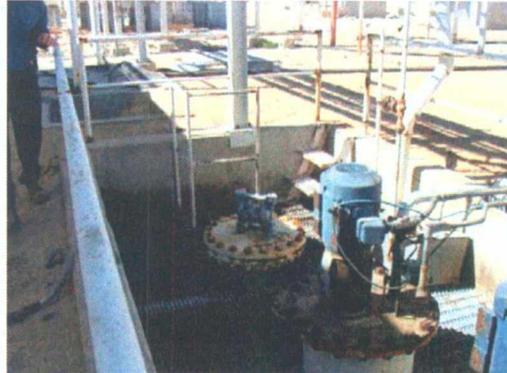
- 2. Photo 6-8 – The secondary containment for the below grade tanks must be cleaned out and inspected or leaks. This containment should be kept clean at all times other than for its intended use of catching fluids. A few cracks were noted on the outer edge of the cement berm. A secondary containment is meant to catch fluids and not to hold them indefinitely. At the time of the inspection, Targa was not able to determine the integrity of the secondary containment. Targa shall clean, inspect, and prove integrity of the containment and properly maintain the below grade tank. OCD does not consider this to be a sump.***

2. **Photo 6 – 8:** The secondary containment for the below-grade tank must be cleaned out and inspected for leaks. This containment should be kept clean at all times other than for its intended use of catching fluids. A few cracks were noted on the outer edge of the cement berm. A secondary containment is meant to catch fluids and not to hold them indefinitely. At the time of inspection Targa was not able to determine the integrity of the secondary containment. Targa shall clean, inspect and prove integrity of the containment and properly maintain the below grade tank. Targa shall submit the latest hydrostatic test report for all drain lines to this below grade tank. OCD does not consider this to be a sump.

Photo 6: Large below grade tank located within the gas plant boundaries, east of the compressor station.

This below grade tank's containment was visually inspected and did not show any signs of cracking other than that along the top edge of the cement as seen in photo #8. Targa plans to remove this tank from service in its current location and will be moved to a new location to replace the two sumps on the West side of the plant near the engines.

A closure plan will be submitted for the removal of this tank.

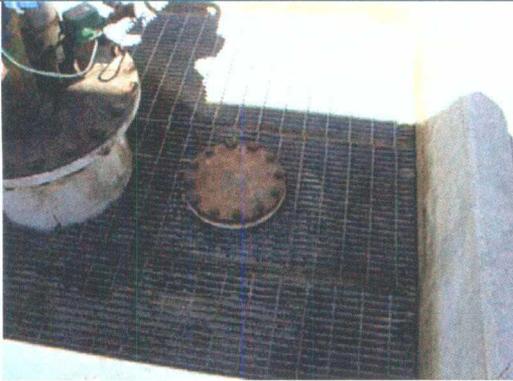
Photo 7: BGT with residuals in secondary containment area.

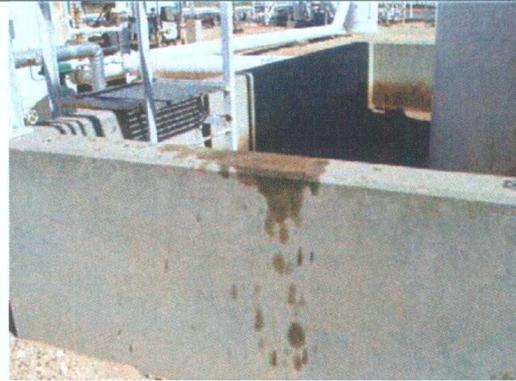
- 4. Photo 10 & 11 – A leaking conduit was noted. Targa shall ensure that such scenarios are addressed in a timely manner and any discharges on the ground be properly cleaned up.***

4. **Photo 10 & 11:** A leaking conduit was noted. Targa shall ensure that such scenarios are addressed in a timely manner and any discharges on to the ground be properly cleaned up.

Photo 10: Leaking on to berm wall.

The piping was stained from a previous leak. The piping has been cleaned and will be monitored.

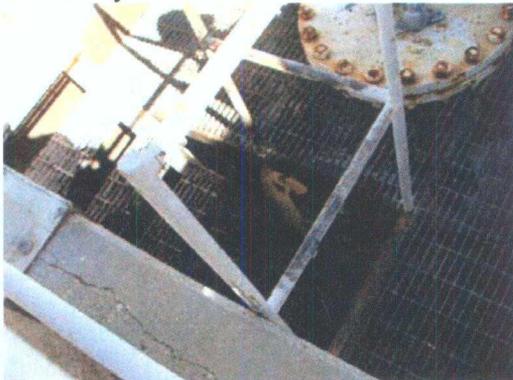
Photo 8: BGT with cracked containment.

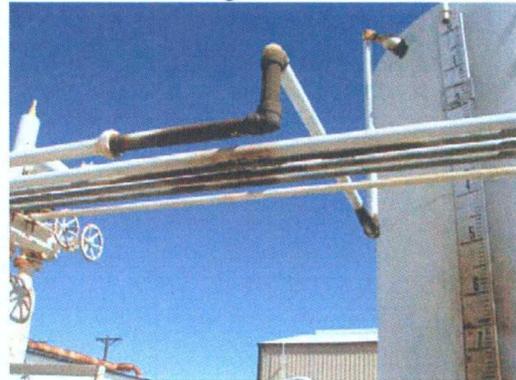
Photo 11: Source of leak ID in Photo 10.

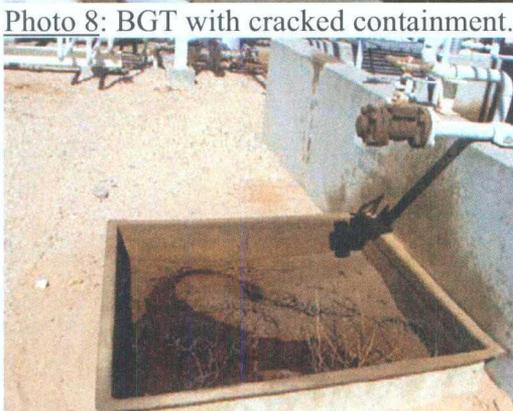
- 3. Photo 9 – Catch pan needs to be cleaned and properly maintained. Targa shall ensure that all catch pans are properly maintained and that no fluids are left standing for greater than 72 hours.***

3. **Photo 9:** Catch pan needs to be cleaned and properly maintained. Targa shall ensure that all catch pans are properly maintained and that no fluids are left standing greater than 72 hours. Reference *Condition 14* of your permit for details.

Photo 9: Drip pan with sediments.

The blow sand and debris in the catch pan has been removed. Targa employees have been instructed to monitor and remove liquids from containment areas within 72 hours.

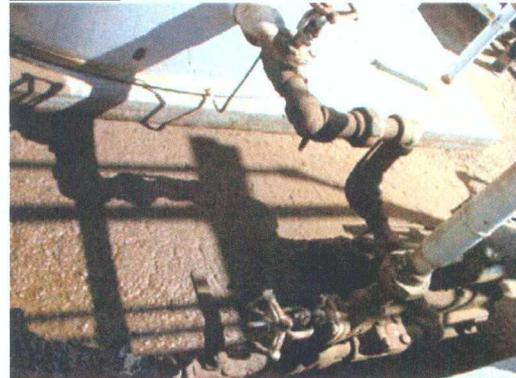
Photo 12: Sediment and hydrocarbon staining in secondary containment area.

Photo 12. This area is within the secondary containment around a lubricating oil storage tank. Blow sand continually accumulates in these areas. The area has been cleaned and the containment visually inspected for integrity.

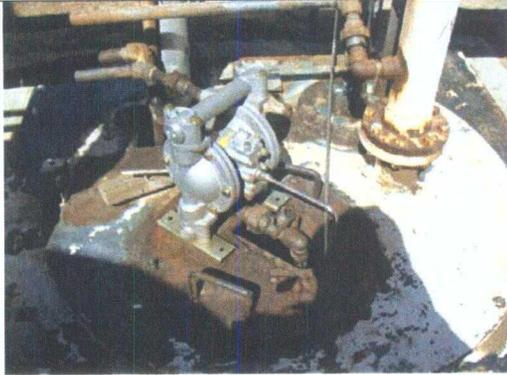
5. ***Photo 13-26 – Two below grade tanks located between the compressor buildings appear to have their contents discharged on the ground. At the time of inspection there were several indications of new soil dispersed over contaminated soil areas, in particular photo 16-18. The covering of contaminated areas is not remediating the problem, but only increasing the waste volume. Targa shall immediately clean up all contamination around the below grade tanks. Targa shall cease the practice of covering contaminated areas with clean soil. Targa shall investigate the cause of the discharge from the below grade tanks and place measures to prevent such future discharges.***

5. **Photo 13 – 26:** Two below-grade tanks located between the compressor buildings appear to have their contents discharged on to the ground. At the time of inspection there were several indications of new soil dispersed over contaminated soil areas, in particular photos 16 – 18. The covering of contaminated areas is not remediating the problem, but only increasing the waste volume. Targa shall immediately clean up all contamination around the below grade tanks. Targa shall cease the practice of covering contaminated areas with clean soil. Targa shall investigate the cause of the discharge from the below grade tanks and place measures to prevent such future discharges.

Photo 13: BGT located between compressor buildings.

The contaminated soil around these sumps is being removed by hand digging. The majority of the soil has been removed but the process has been slow due to the areas under the pipe racks. The soil will be tested and further removal will be done as necessary to meet OCD guidelines. Targa plans to remove these two sumps and replace with the below ground tank discussed in item #2.

A closure plan will be submitted for the removal of these two sumps.

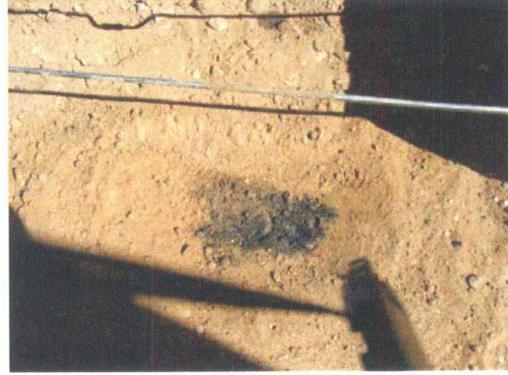
Photo 16: New soil with exposed contamination.

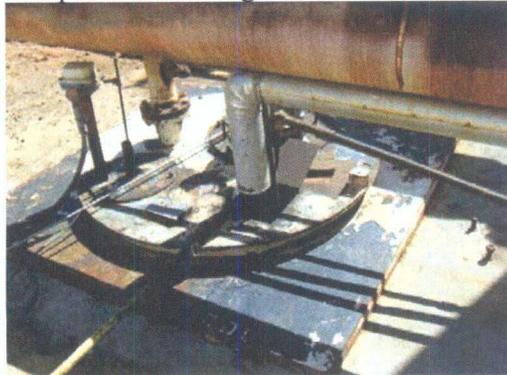
Photo 14: Another BGT located between compressor buildings.

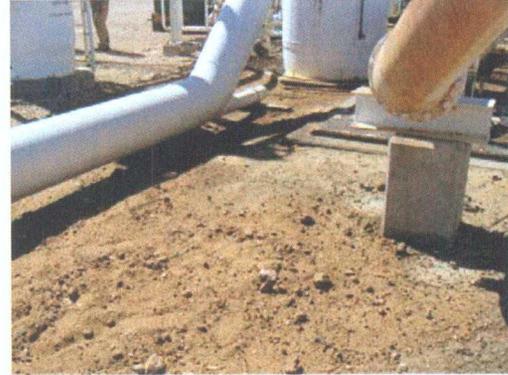
Photo 17: New soil around BGT area.

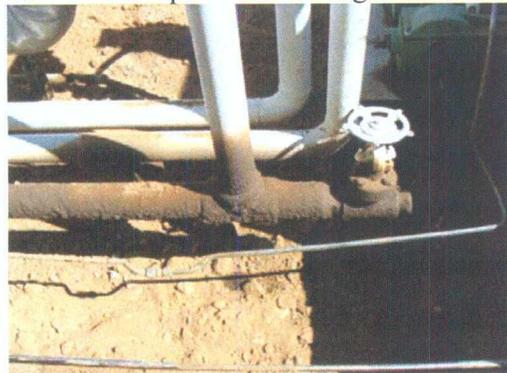
Photo 15: New soil around leaked conduits near BGT's.

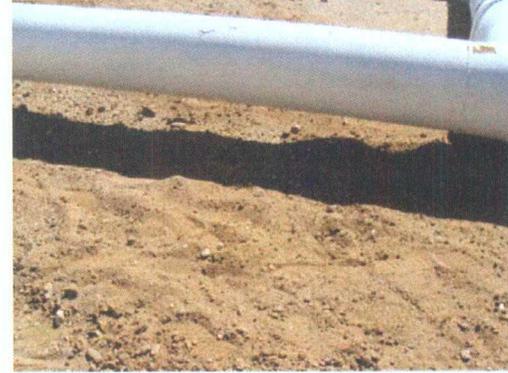
Photo 18: New soil.

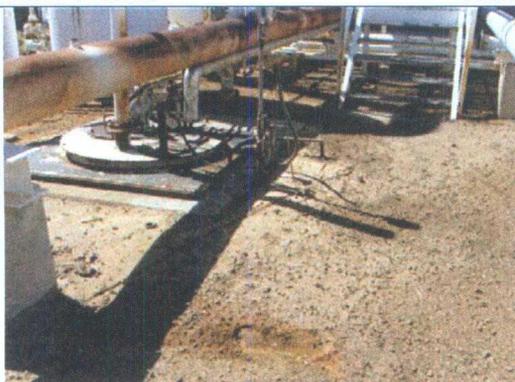
Photo 19: Contaminated soil.

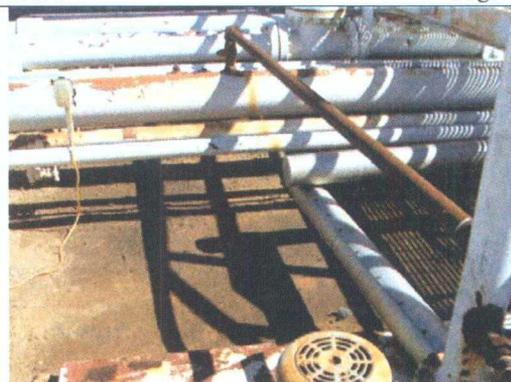
Photo 22: Contaminated soil.

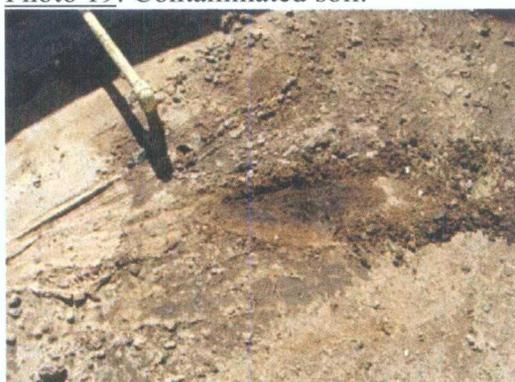
Photo 20: Close up of contaminated soil.

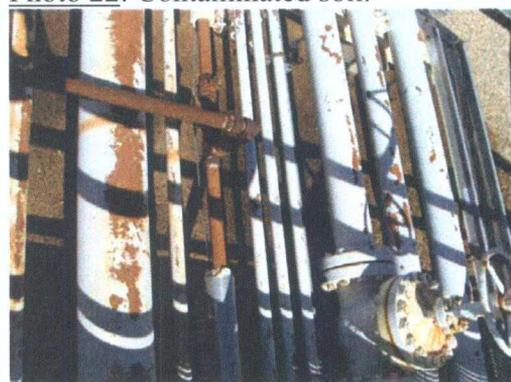
Photo 23: Contaminated soil.

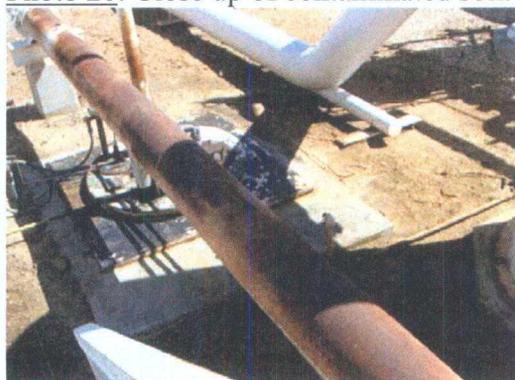
Photo 21: BGT with new soil and contaminated soil around.

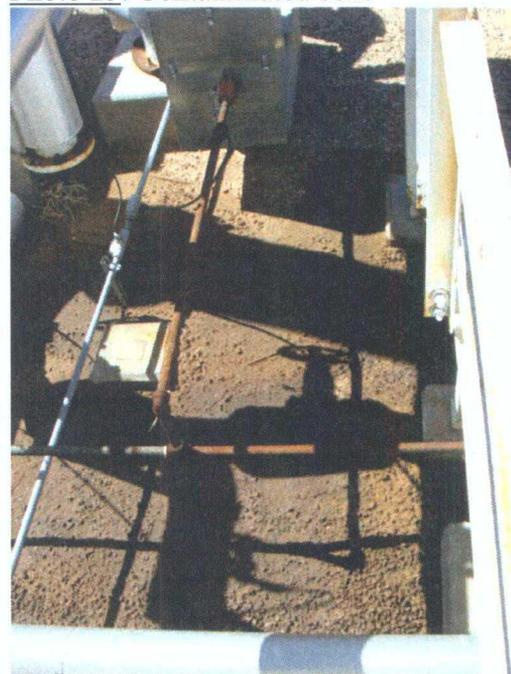
Photo 24: Contaminated soil.

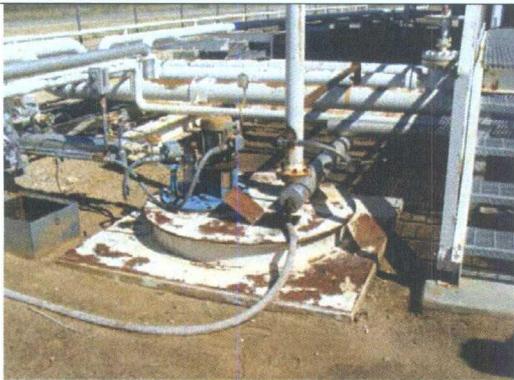
Photo 25: Contaminated soil around BGT.

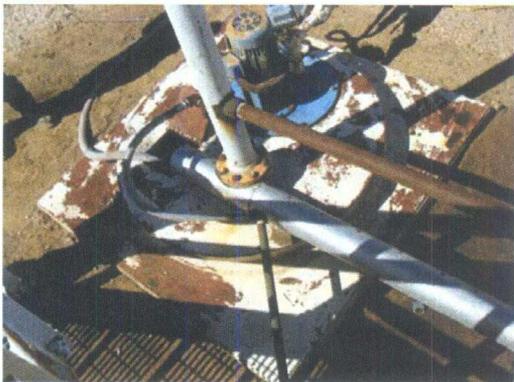
Photo 26: Contaminated soil around BGT.

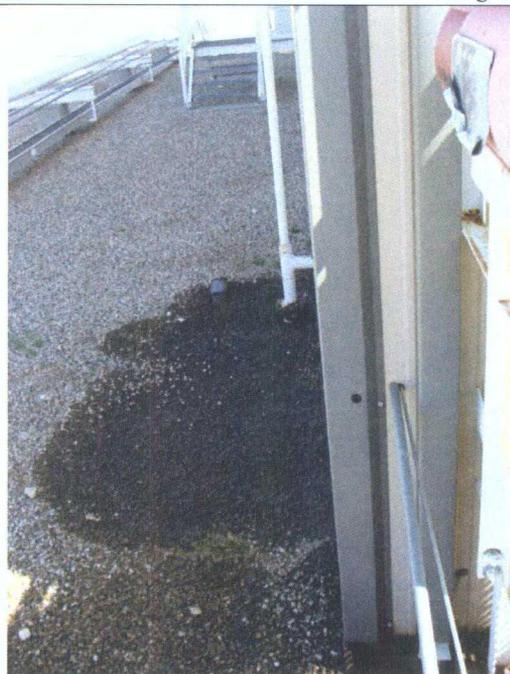
6. ***Photo 27 & 32-35 – The northern most compressor building has hydrocarbon leaking from the building on to the ground. Targa shall investigate the cause of these discharges and prevent it from reoccurring. Targa shall clean up and properly dispose of the soil contamination. It appears the building floor catch basin has overflowed. Targa shall clean out the basin of the two compressor buildings.***

6. **Photo 27 & 32 - 35:** The northern most compressor building has hydrocarbon leaking from the building on to the ground. Targa shall investigate the cause of these discharges and prevent it from reoccurring. Targa shall clean up and properly dispose of the soil contamination. It appears that the building floor catch basin has overflowed. Targa shall clean out the basin of the two compressor buildings.

Photo 27: Hydrocarbon fluids leaked from compressor building.

The soil behind the northern most compressor building has been removed. The floor basin below the engine room grating has been cleaned on the North engine room and is in progress on the South engine room. The drains in these buildings were installed on a level surface without a sloping grade to properly catch fluids. Targa is in the process of installing an angle iron retaining rail to prevent fluids from leaving the buildings.

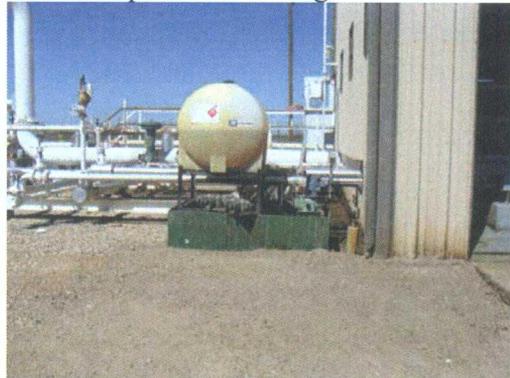
7. ***Photo 28-31 – There is evidence of clean soil being placed over contaminated areas. This is not an allowable practice and is a violation of the discharge permit.***

7. **Photo 28 – 31:** There is evidence of clean soil being placed over contaminated areas. This is not an allowable practice and is a violation of the discharge permit.

Photo 28: New soil located at entrance of compressor building.

7. **Targa is reminded that covering up contaminated soils is NOT ALLOWED. Doing so will result in WQCC penalties, 20.6.2.1219 PENALTIES ENFORCEMENT, COMPLIANCE ORDERS, PENALTIES, ASSURANCE OF DISCONTINUANCE. OCD will be waiting on the final results of the testing and removal of additional soils.**

The contaminated soil identified in these photos has been removed. The area will be tested and further removal will be done as necessary to meet OCD clean up guidelines. Employee training on DP has been completed (June 18) to ensure employees are aware of appropriate cleanup practices.

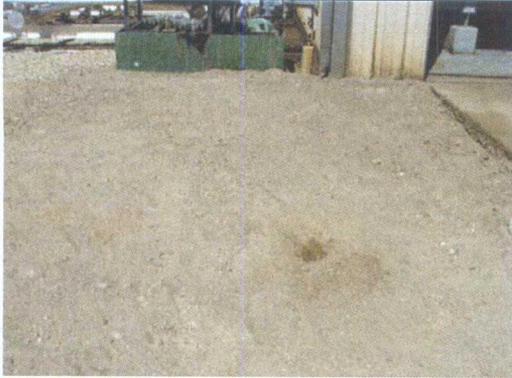
Photo 29: New soil near compressor building entrance exposed underlying contaminated soil.

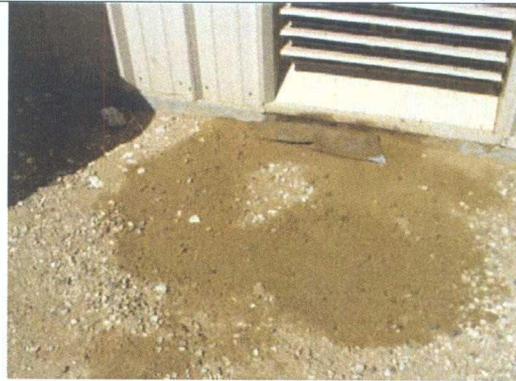
Photo 32: Contaminated soil near compressor building.

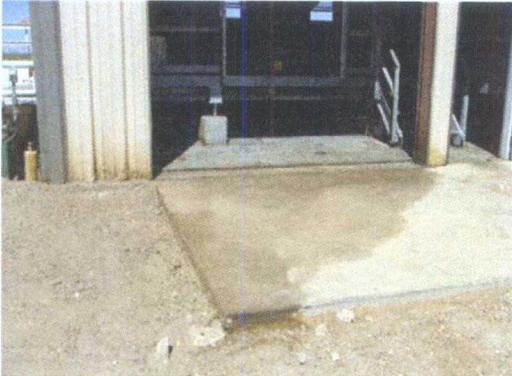
Photo 30: New soil near large door of compressor building.

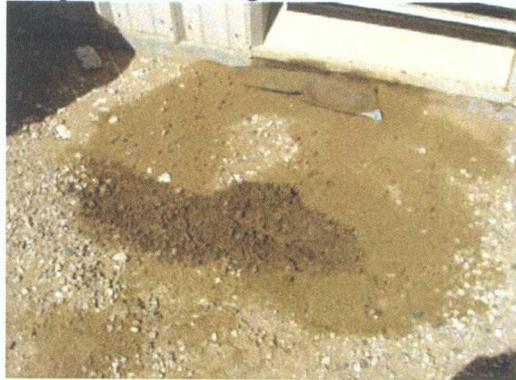
Photo 33: Exposed contaminated soil near compressor building.

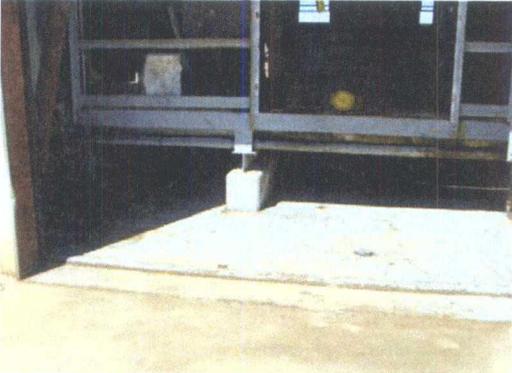
Photo 31: Cleaned area around compressor building location.

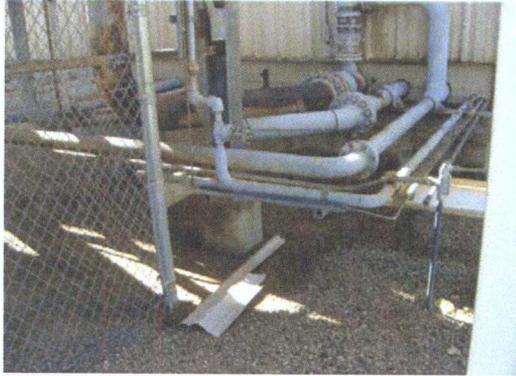
Photo 34: Contaminated soil near compressor building.

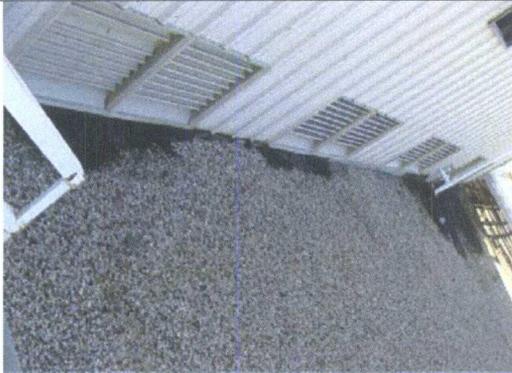
Photo 35: Hydrocarbon waste breaching the compressor building.

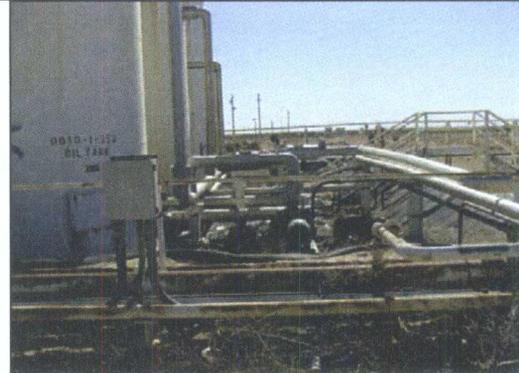
8. ***Photo 36-38 – OCD performed an inspection of this facility on January 31, 2006 and determined there was a housekeeping issue with these above ground storage tanks. These tanks were found to be in the same condition during this inspection as previously noted. Targa shall immediately clean out the secondary containment and inspect the integrity of the liner.***

8. **Photo 36 – 38:** OCD performed an inspection of this facility on January 31, 2006 and determined that there was a housekeeping issue with these above ground storage tanks. These tanks were found to be in the same condition during this inspection as previously noted. Targa shall immediate clean out the secondary containment and inspect the integrity of the liner.

Photo 38: ** These tanks were noted in a previous inspection, 01/31/06. **

The blow sand and debris has been removed from this area. Targa addressed this area after the previous inspection as noted but it continues to accumulate blow sand and tumble weeds as seen in these photos. The liner was visually inspected for rips, tears, or other integrity concerns and appears to be in good condition.

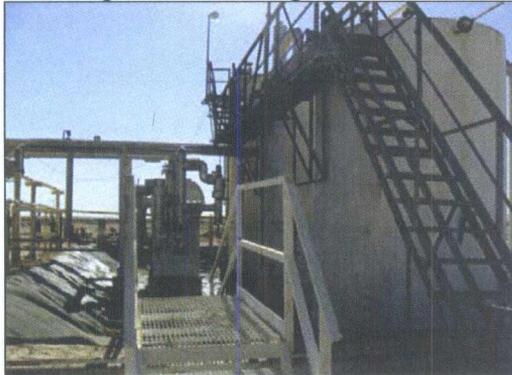
Photo 36: ** These tanks were noted in a previous inspection, 01/31/06. **

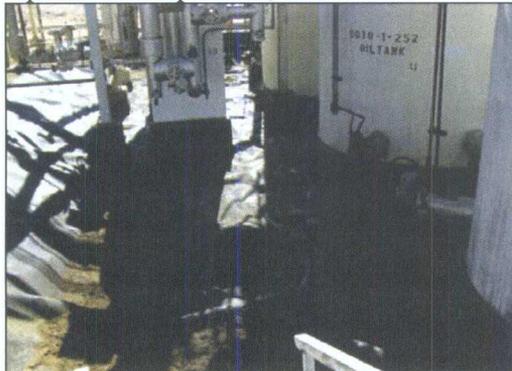
Photo 37: ** These tanks were noted in a previous inspection, 01/31/06. **
