# R. T. HICKS CONSULTANTS, LTD.

August 12, 2009

RE: Seven Produced Fluid Releases at sites operated by Marks and Garner Production Ltd, Company in Eddy County, NM as follows:

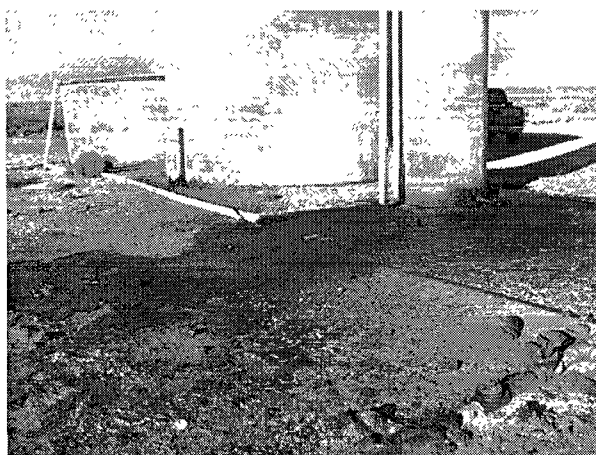
A release of heavy “tank bottom” oil occurred from a broken valve at the base of a large separator and extends approximately 30 feet down slope. We used a hand auger to obtain soil samples at depths of 0.5, 1.0, and 3.0 feet below the free liquid. Results of laboratory analyses on selected samples for benzene, toluene, ethylbenzene, xylenes; and gasoline, diesel, and oil range hydrocarbons as well as field screening and laboratory results are provided on the table below:

None of the hydrocarbon concentrations measured at the Levers Federal No. 7 site exceeds the 1993 NMOCD or 2006 NMED Guideline soil screening levels. The fact that the concentrations of regulated constituents do not exceed NMED Guidelines allows us to conclude that the impacted soil does not represent a threat to fresh water or public health. The recommended corrective action for this site is:

1. Remove out-of-service vessels or repair all leaks
2. Excavate the upper 6-inches of earth within the spill footprint
3. Mix the excavated spill material with 2-5 parts clean soil

4. Use this blended soil for the construction of firewalls around tank batteries (use now or stockpile on site for future use)
5. At abandonment of the site the surface will be restored according to the landowner's specifications

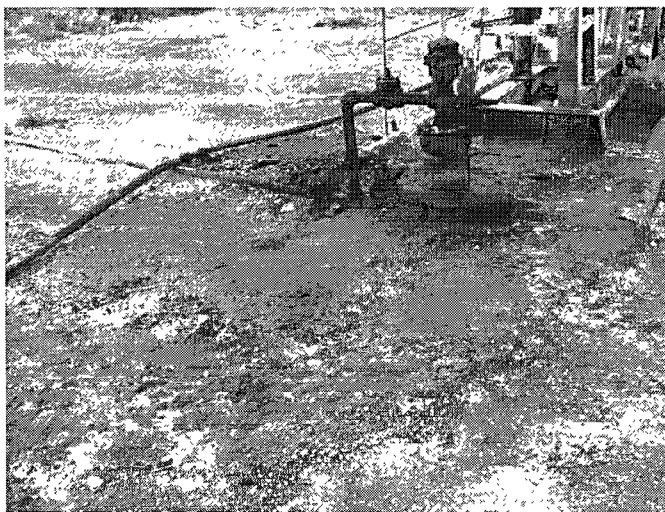
A release of oil occurred from the well head which extends approximately 10 feet in all directions. The table below presents field screening and the laboratory results from soil samples at the surface and at depths of 2.0, 3.0, 4.0, 5.0 and 6.0 feet below the stained area.

Total Petroleum Hydrocarbon (TPH) concentrations measured at the Levers No. 3 site exceeds the 1993 NMOCD Guideline levels but concentrations generally decrease from the surface to the auger refusal depth (6 feet below the surface). Most importantly, none of the regulated hydrocarbon concentrations exceed the 2006 NMED Guideline levels. The fact that the concentrations of regulated constituents do not exceed NMED Guidelines allows us to conclude that the impacted soil does not represent a threat to fresh water or public health. The recommended corrective action for this site is:

1. Remove out-of-service vessels or repair all leaks
2. Excavate the upper 1-2 feet of earth within the spill footprint
3. Mix the excavated spill material with 2-5 parts clean soil
4. Use this blended soil for the construction of firewalls around tank batteries (use now or stockpile on site for future use)
5. Collect a composite sample of the blended soil to demonstrate that constituents are at concentrations that comply with NMOCD Rules and provide letter report to NMOCD
6. At abandonment of the site the surface will be restored according to the landowner's specifications

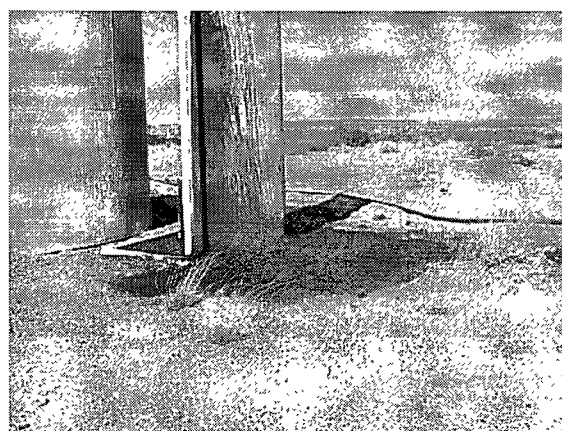
A release of heavy "tank bottom" oil occurred from a broken valve at the base and from a pipe joint near the top of the separator. The spill area extends approximately 30 feet down slope. Laboratory results of soil samples recovered using a hand auger at depths of 0.5, 1.0, and 3.0 feet below the free liquid and field screening are provided on the table below:

TPH concentrations measured from near the surface at the Red-12 Federal No. 1 site exceeds the 1993 NMOCD Guideline levels but decreases to below the guideline levels at 3 feet below the surface. None of the regulated hydrocarbon concentrations exceed the 2006 NMED Guideline levels. The fact that the concentrations of regulated constituents do not exceed NMED Guidelines allows us to conclude that the impacted soil does not represent a threat to fresh water or public health. The recommended corrective action for this site is:

1. Remove out-of-service vessels or repair all leaks
2. Excavate the upper 6-12 inches of earth within the spill footprint
3. Mix the excavated spill material with 2-5 parts clean soil
4. Use this blended soil for the construction of firewalls around tank batteries (use now or stockpile on site for future use)
5. Collect a composite sample of the blended soil to demonstrate that constituents are at concentrations that comply with NMOCD Rules and provide letter report to NMOCD
6. At abandonment of the site the surface will be restored according to the landowner's specifications

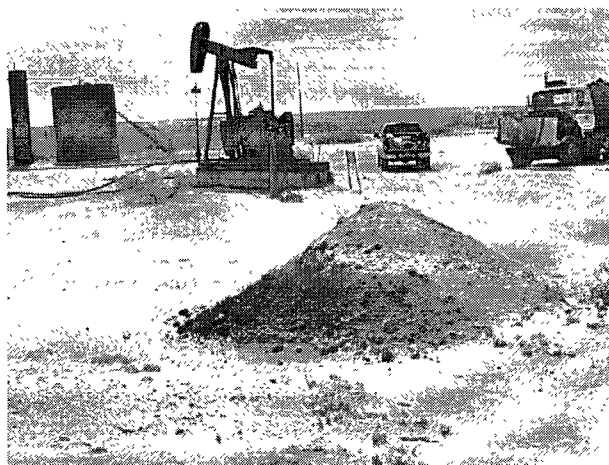
The operator excavated and stockpiled soil from an apparent release of oil that occurred prior to our characterization. Laboratory and field results from soil samples recovered from the stockpile and below the spill footprint are provided on the table below:

The hydrocarbon concentrations from the removed stockpiled soil at Cave State No. 4 site exceeds the 1993 NMOCD Guideline levels for TPH and the 2006 NMED Guideline levels for benzene. None of the hydrocarbon concentrations measured from the remaining (deeper) soil exceeds either the 1993 NMOCD or 2006 NMED Guideline soil screening levels.

The fact that the concentrations of regulated constituents do not exceed NMED Guidelines allows us to conclude that the impacted soil below the original spill footprint does not represent a threat to fresh water or public health.

We recommend that the operator mix the stockpile with clean soil and utilize it for the construction of a firewall at one of the active tank batteries.

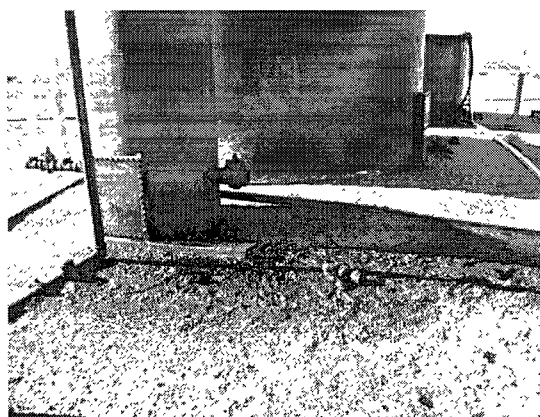
A release of heavy "tank bottom" oil occurred from a broken valve at the base of a separator and extends approximately 20 feet down slope. Results of laboratory and field analyses of soil samples recovered using a hand auger at depths of 0.5, 1.0, and 3.0 feet below the free liquid are provided on the table below:

TPH concentrations measured from near the surface at the Red-12 State No. 2 site exceeds the 1993 NMOCD Guideline levels but decreases to below the guideline levels at 3 feet below the surface. None of the measured hydrocarbon concentrations exceed the 2006 NMED Guideline levels. The fact that the concentrations of regulated constituents do not exceed NMED Guidelines allows us to conclude that the impacted soil does not represent a threat to fresh water or public health. The recommended corrective action for this site is:

1. Remove out-of-service vessels or repair all leaks
2. Excavate the upper 6-12 inches of earth within the spill footprint
3. Mix the excavated spill material with 2-5 parts clean soil
4. Use this blended soil for the construction of firewalls around tank batteries (use now or stockpile on site for future use)
5. Collect a composite sample of the blended soil to demonstrate that constituents are at concentrations that comply with NMOCD Rules and provide letter report to NMOCD.
6. At abandonment of the site the surface will be restored according to the landowner's specifications.

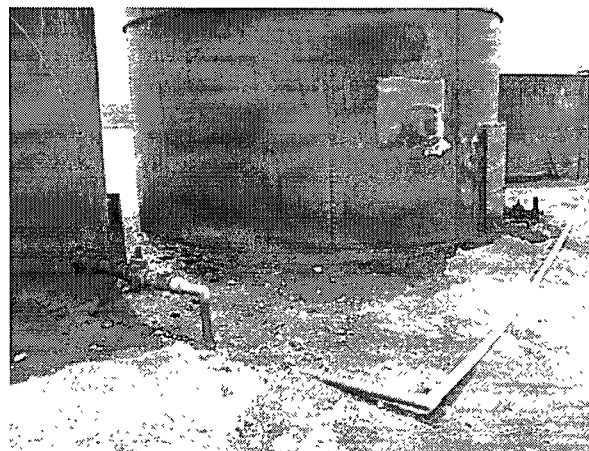
A release of heavy "tank bottom" oil occurred from leaks located at the base of a 500-bbl oil tank and a separator. The surface staining is present in an area of approximately 500 ft<sup>2</sup>. A composite surface soil sample was recovered from the stained area and subsurface soil samples were recovered from two hand auger borings at depths of 1.0 and 2.0 feet below the free liquid. Laboratory analyses were performed to determine the concentrations of benzene, toluene, ethylbenzene, xylenes; and gasoline, diesel, and oil range hydrocarbons. Field screening and laboratory results are provided on the table below:

TPH concentrations measured from near the surface at the Red-12 State No. 3 site exceeds the 1993 NMOCD Guideline levels but decreases to below the guideline levels at 1 and 2 feet below the surface. None of the measured hydrocarbon concentrations exceed the 2006 NMED Guideline soil screening levels. The fact that the concentrations of regulated constituents do not exceed NMED Guidelines allows us to conclude that the impacted soil does not represent a threat to fresh water or public health. The recommended corrective action for this site is:

1. Remove out-of-service vessels or repair all leaks
2. Excavate the upper 1-2 feet of earth within the spill footprint
3. Mix the excavated spill material with 2-5 parts clean soil
4. Use this blended soil for the construction of firewalls around tank batteries (use now or stockpile on site for future use)
5. Collect a composite sample of the blended soil to demonstrate that constituents are at concentrations that comply with NMOCD

Rules and provide letter report to NMOCD

6. At abandonment of the site the surface will be restored according to the landowner's specifications.

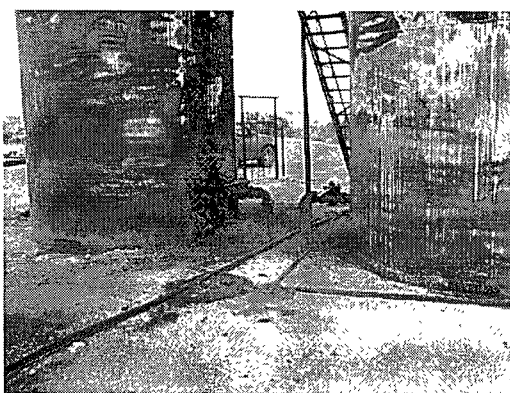
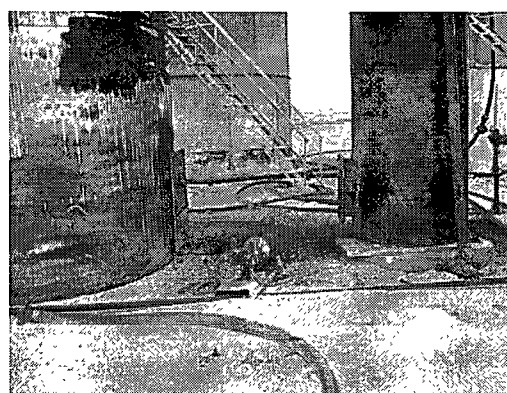
Historic spills within the tank battery have occurred resulting in an "asphalt-like" stained soil area of approximately 400 ft<sup>2</sup>. A composite surface soil sample was recovered from the stained area and laboratory analyses were performed to determine the concentrations of benzene, toluene, ethylbenzene, xylenes; and gasoline, diesel, and oil range hydrocarbons. Laboratory results are provided on the table below:

TPH concentrations measured from near the surface at the Red-12 State No. 4 battery site exceed the 1993 NMOCD Guideline levels but none of the measured hydrocarbon concentrations exceed the 2006 NMED Guideline levels. The fact that the concentrations of regulated constituents do not exceed NMED Guidelines allows us to conclude that the hydrocarbon-impacted soil does not represent a threat to fresh water or public health. The recommended corrective action for this site is:

1. Repair all leaks
2. Excavate the upper 1-2 feet of earth within the spill footprint
3. Mix the excavated spill material with 2-5 parts clean soil
4. Use this blended-asphaltic soil for the construction of firewalls around tank batteries (use now or stockpile on site for future use)
5. Collect a composite sample of the blended soil to demonstrate that constituents are at concentrations that comply with NMOCD Rules and provide letter report to NMOCD
6. At abandonment of the site, disc hay and other organic material into hydrocarbon-impacted soil to open soil structure and permit infiltration of precipitation. Repeat tilling and addition of organic material or other soil amendments as necessary to meet landowner mandates for surface restoration and thereby eliminate the threat to the environment (i.e. soil and habitat) posed by the hydrocarbon-impacted soils

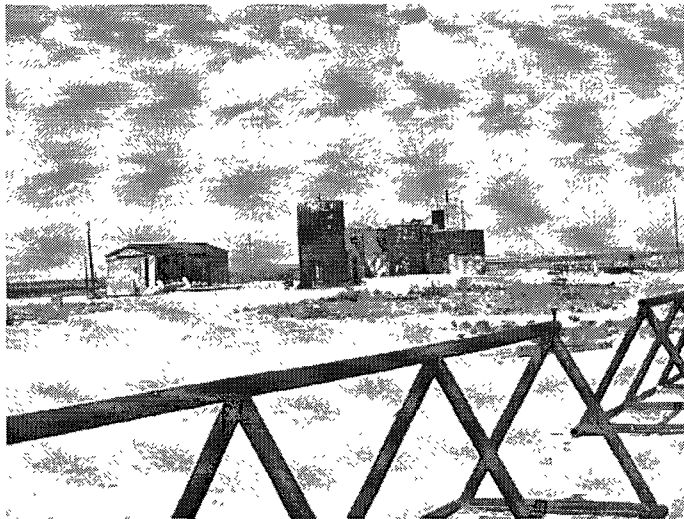
The tank battery is located on a topographically high area and much of the soil within the bermed area and the surrounding topographically low areas exhibit characteristics of one or more historic brine water releases. Three hand auger borings were installed in the low areas surrounding the tank battery in order to better characterize the extent of the chloride-impacted soil. Plate 2 is a site map drawn on a July 2005 satellite photograph that depicts the current extent of stressed vegetation, the location of the hand auger borings, and the laboratory results from soil samples recovered at the site. It should be noted that the extent of the stressed vegetation observed during the inspection has changed since 2005. Some of the vegetation to the north and south has decreased while areas to the west appear to have recovered.

At the topographically low areas to the north and west of the tank batteries chloride concentrations in soil prevent re-vegetation. The vertical extent of the impacted soil could not be determined due to auger refusal. Further investigations at the Red-12 State No. 4 site will be conducted to verify the vertical extent of the chloride-impacted soil in order to determine the potential threat to ground water. Following the completion of these activities a final report will be submitted to the NMOCD.
