Release Notification and Corrective Action

Name of Company	Purvis Operating Co.	Contact	Donnie E. Brown
Address	PO Box 51990, Midland, TX 79710	Telephone No.	432-682-7346
Facility Name	Gladiola SWD System (HOUSTON)	Facility Type	Saltwater Disposal System

Saltwater Leak
Gladisla SW D System
w/2 SW Sec 26 T129 R37E
Lea Co, New Mexico

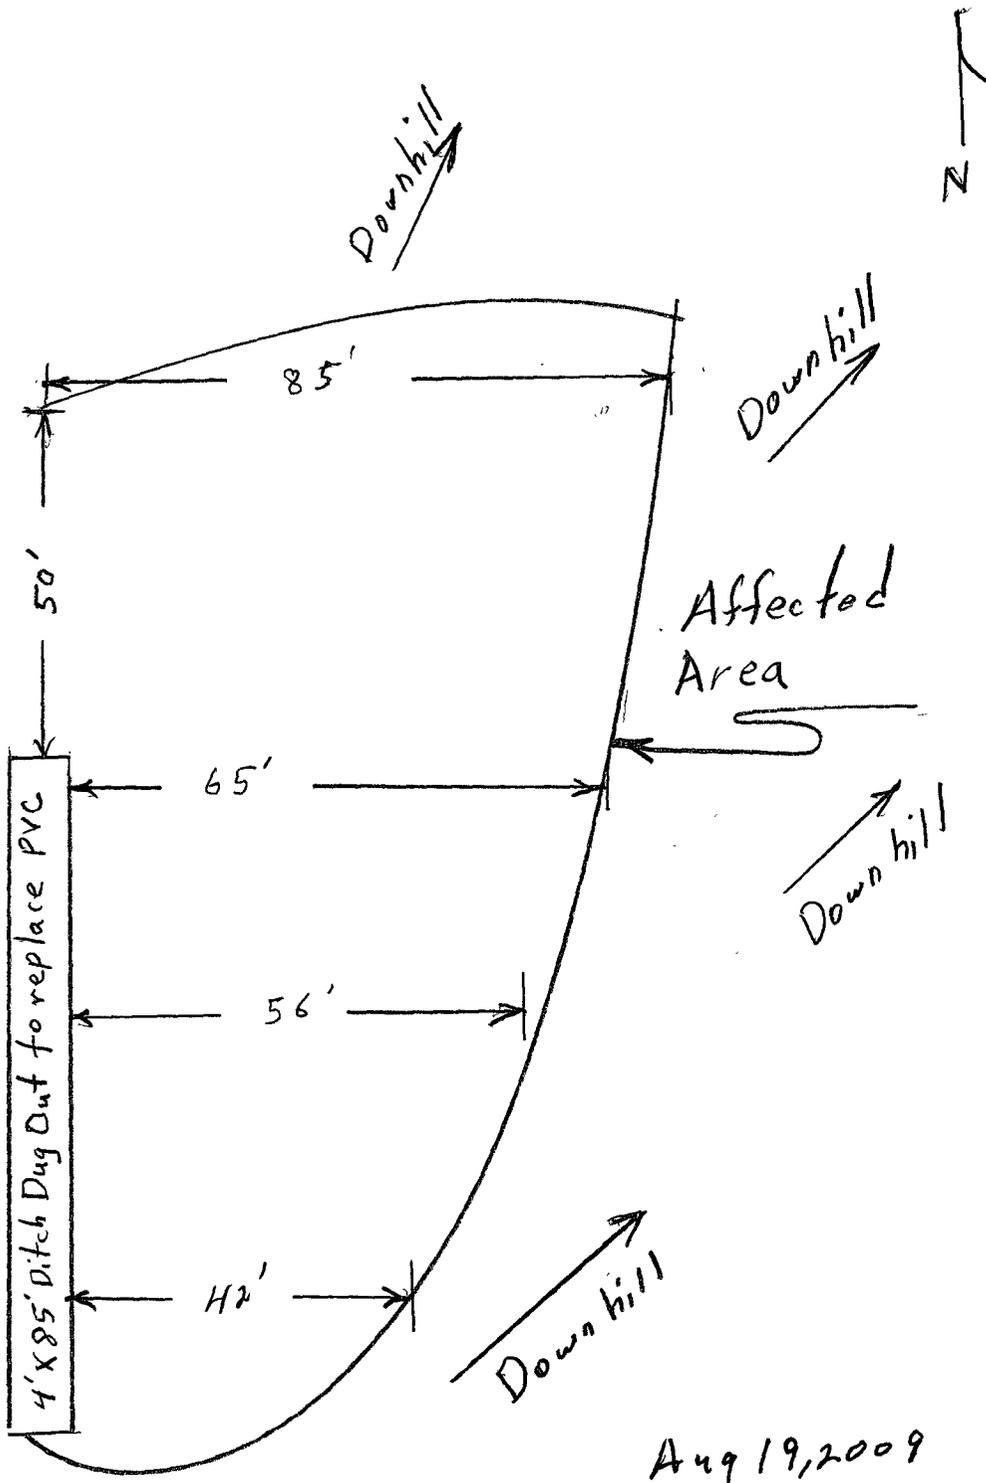
A 6" PVC saltwater disposal line developed a crack that leaked saltwater. The pipe was dug up and replaced with approximately 85' of new PVC pipe. The soil that was dug up was replaced with fresh soil. The saltwater-contaminated soil is in the process of being hauled to a land farm.

Describe Area Affected and Cleanup Action Taken.*
The area affected is approximately 0.26 acres in the form of an ellipse running 135' North and South from the source of the leak with the affected area being east and northeast 56' to 85' (see attached drawing). Vertical and lateral characterization of the affected area will be done before clean up action is started.
