### Release Notification and Corrective Action

Name of Company Occidental Permian Limited Partnership	Contact Steven M. Bishop
Address 1017 West Stanolind Road, Hobbs, N.M. 88240	Telephone No. (575) 397-8251
Facility Name South Hobbs Unit Injection System	Facility Type Production

RE: Remediation Plan  
South Hobbs Unit 12" Injection Trunk line  
from Central T/B to H-Pump #8  
SHU #141 is closest well API No 30-025-28344  
UL 'K', Sec. 4, T-19-S, R-38-E

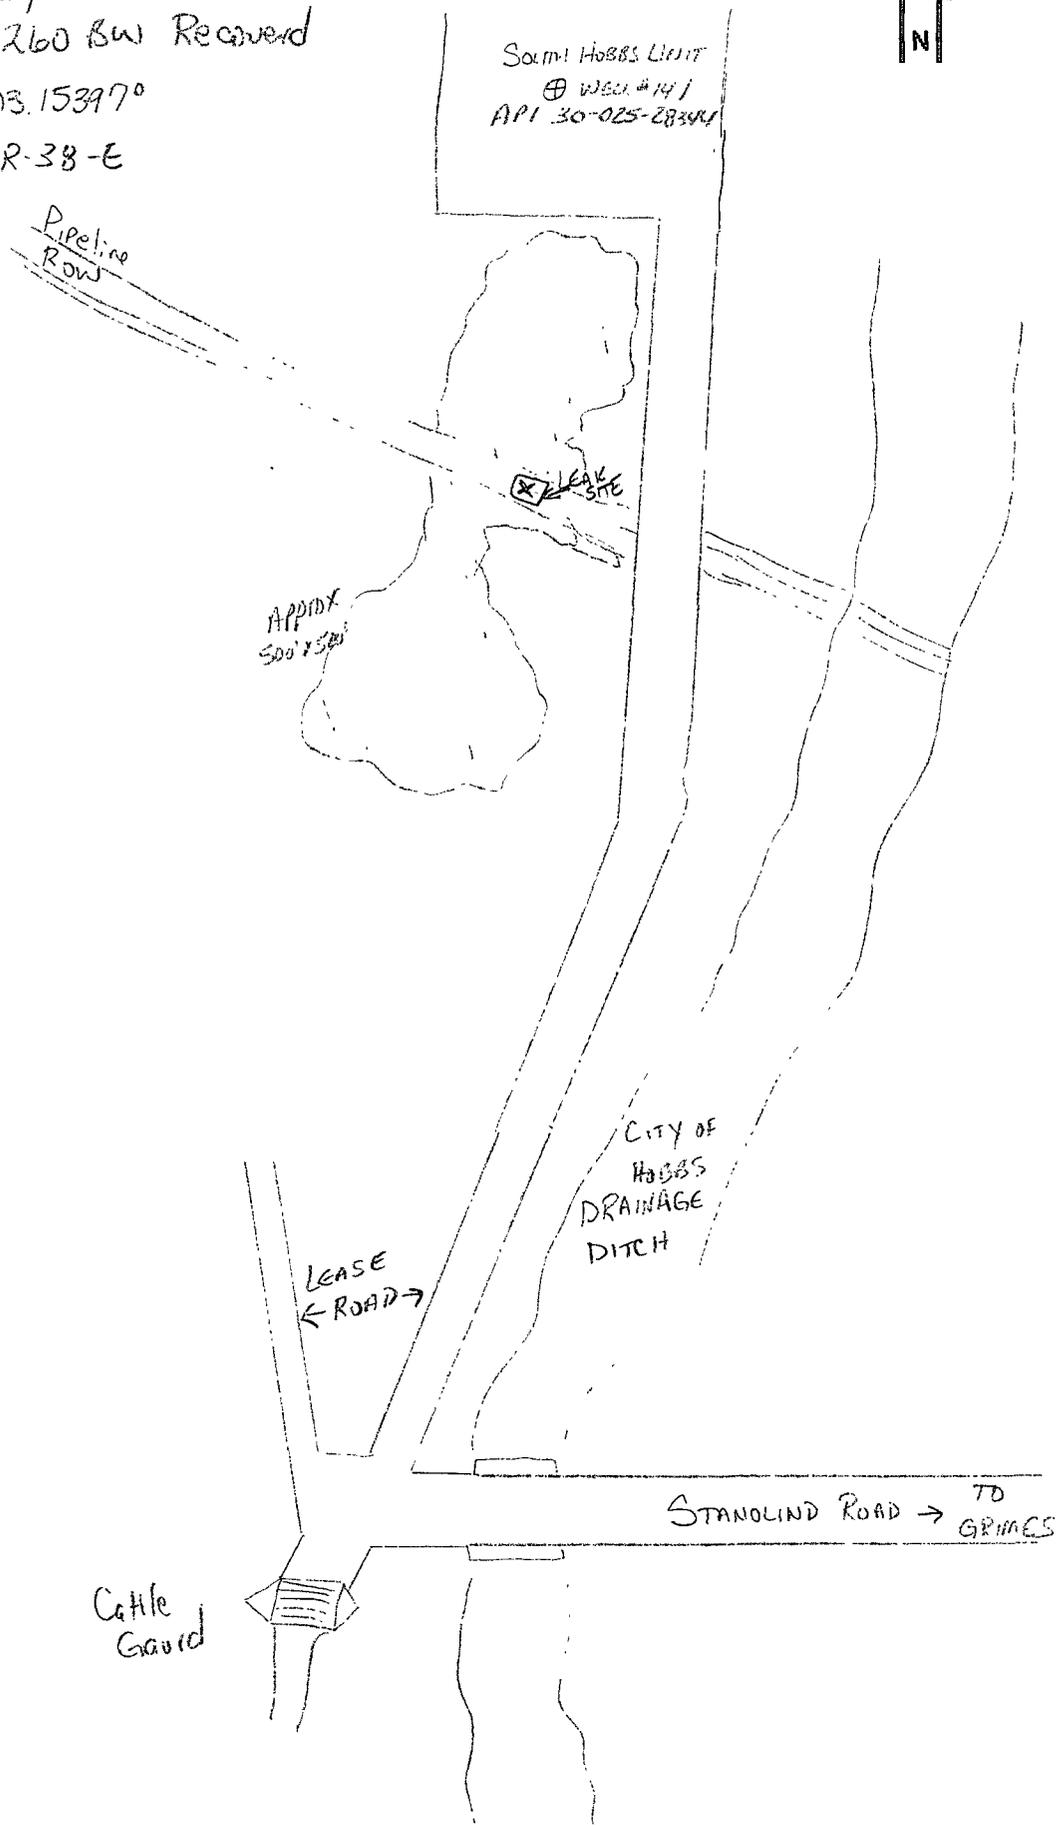
# SPILL MAP

Describe Cause of Problem and Remedial Action Taken.\* A 12" fiberglass injection trunk line from South Hobbs Unit Central T/B to South Hobbs Unit H-Pump #8 ruptured causing spill. Isolated the trunk line by shutting valves at both ends. South Hobbs Unit #141 is the closest well and the API number for this well was used for this report.

9/11/2009 12" FG H-Pump #8 LINE  
1000 BW Release, 260 BW Recovered  
N 32.68531°, W 103.15397°  
UL X' SEC 4, T-19-S, R-38-E

LEAK SITE

1. Piping will be excavated and repaired.
2. Affected area will be excavated and soil disposed of at approved facility.
3. Soil samples will be gathered from affected area.
3. NMOCD guidelines will be used to insure entire site is in compliance with guidelines.
4. Soils removed will be replaced with clean fresh soils, where needed.
5. Soil analysis data will be submitted with final closure letter.
