**REMEDIATION SUMMARY  
AND SITE CLOSURE STRATEGY**

*Fairway Resources Operating, LLC*

South Red Lake Grayburg Unit 41

Eddy County, New Mexico

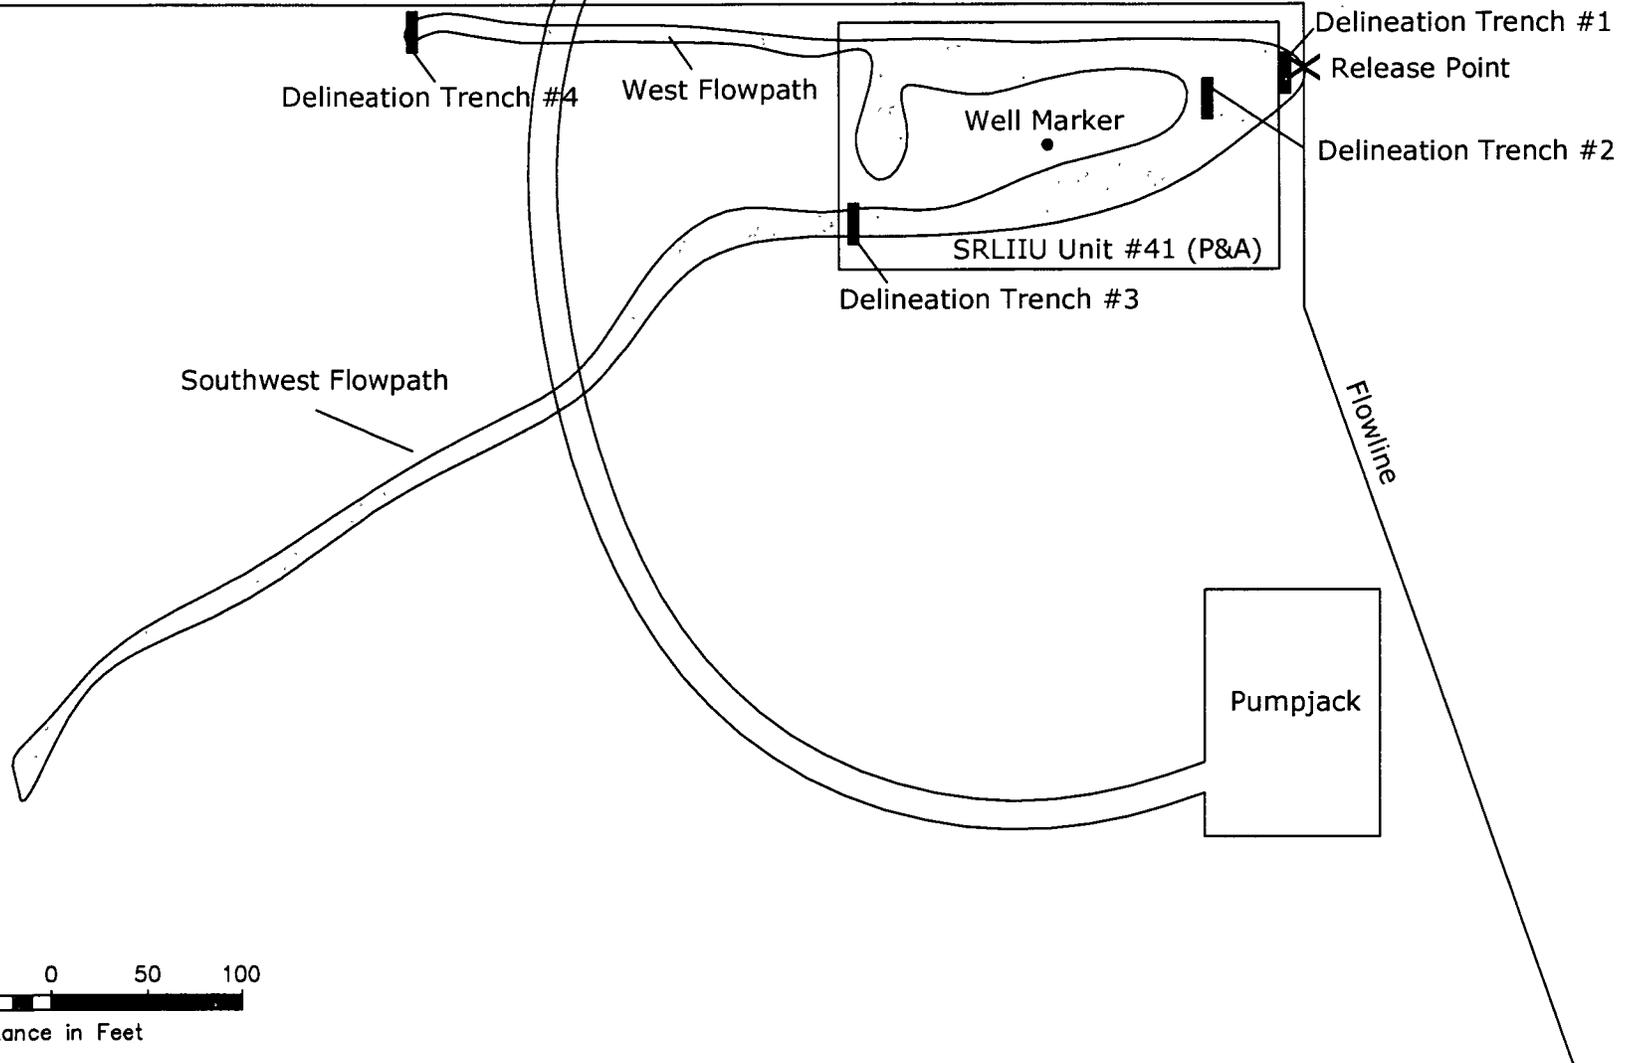
**Figure 2**  
**Site Map**  
**Fairway Resources**  
**South Red Lake Grayburg #41**  
**Eddy County, New Mexico**

Trench 1 was located at the release point and excavated to a total depth of approximately seven (7) feet bgs. Three (3) soil samples (Trench 1 @ 3', Trench 1 @ 6' and Trench 1 @ 7') were collected and the trench was backfilled. Results of the chloride field test indicated chloride concentrations ranged from 216 mg/Kg in soil sample Trench 1 @ 7' to 17,204 mg/Kg in soil sample Trench 1 @ 3'.

Trench 2 was located in the center of the release area and excavated to a total depth of approximately five (5) feet bgs. Two (2) soil samples (Trench 2 @ 2' and Trench 2 @ 5') were collected and the trench was backfilled. Results of the chloride field test indicated chloride concentrations ranged from 540 mg/Kg in the soil sample Trench 2 @ 5' to 2,884 mg/Kg in soil sample Trench 2 @ 2'.

Trench 3 was located in the southwest flow path and excavated to a total depth of approximately eight (8) feet bgs. Four (4) soil samples (Trench 3 @ 2', Trench 3 @ 5', Trench 3 @ 7' and Trench 3 @ 8') were collected and the trench was backfilled. Results of the chloride field test indicated chloride concentrations ranged from 856 mg/Kg in soil sample Trench 3 @ 8' to 4,860 mg/Kg in soil sample Trench 3 @ 5'.

Trench 4 was located in the west flow path and was excavated to a total depth of approximately eight (8) feet bgs. Four (4) soil samples (Trench 4 @ 2', Trench 4 @ 4', Trench 4 @ 6' and Trench 4 @ 8') were collected and the trench was backfilled. Results of the chloride field test indicated chloride concentrations ranged from 216 mg/Kg in soil sample Trench 4 @ 8' to 4,464 mg/Kg in soil sample Trench 4 @ 2'.

- Collect excavation floor confirmation soil samples and submit the soil samples for analysis of chlorides using EPA 300 Cl.

- If the confirmation analytical results indicate chloride concentrations exceed 1,000 mg/Kg, Fairway will continue the excavation of soil until analytical results indicate chloride concentrations are less than the NMOCD regulatory clean up level of 1,000 mg/Kg.
- If the confirmation analytical results indicate chloride concentrations are less than the NMOCD regulatory clean up level of 1,000 mg/Kg, Fairway will request NMOCD permission to backfill the excavation with locally purchased soil. Following backfilling activities, the site will be contoured to fit the surrounding topography and reseeded with a BLM approved seeding mixture.
