**Range Operating New Mexico, Inc.
SCB 23-19 Injection Facility
Section 23, Township 23 South, Range 28 East
Eddy County, New Mexico**

Work Plan

October 8, 2009

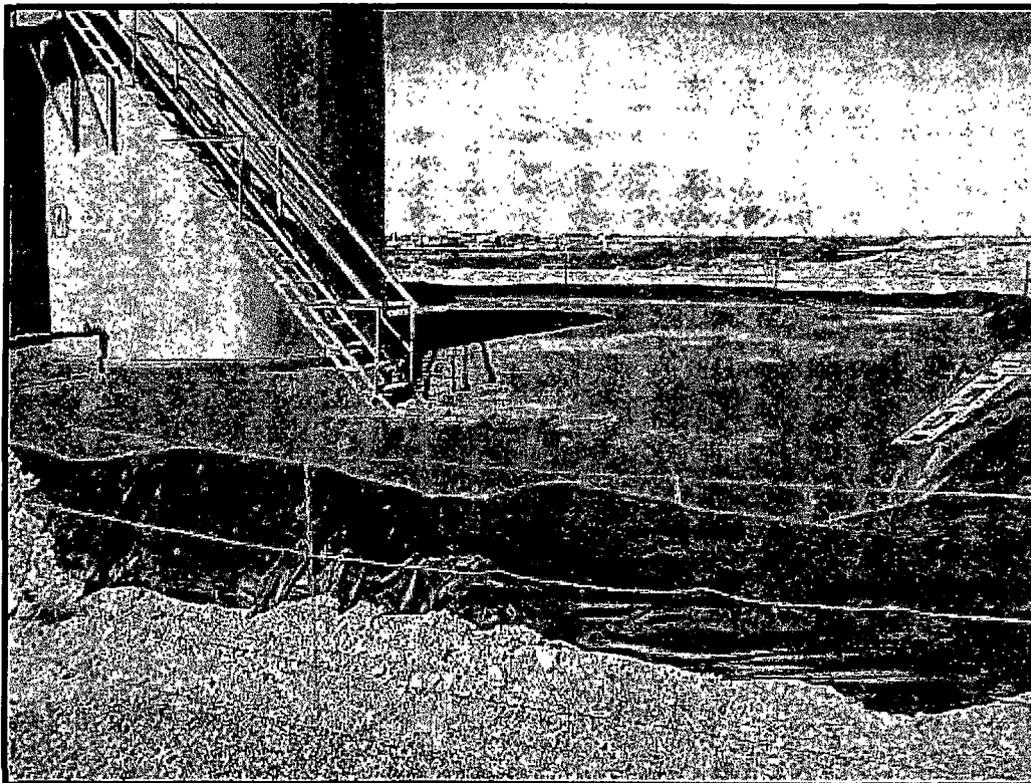
Inside Firewalls Facing SW

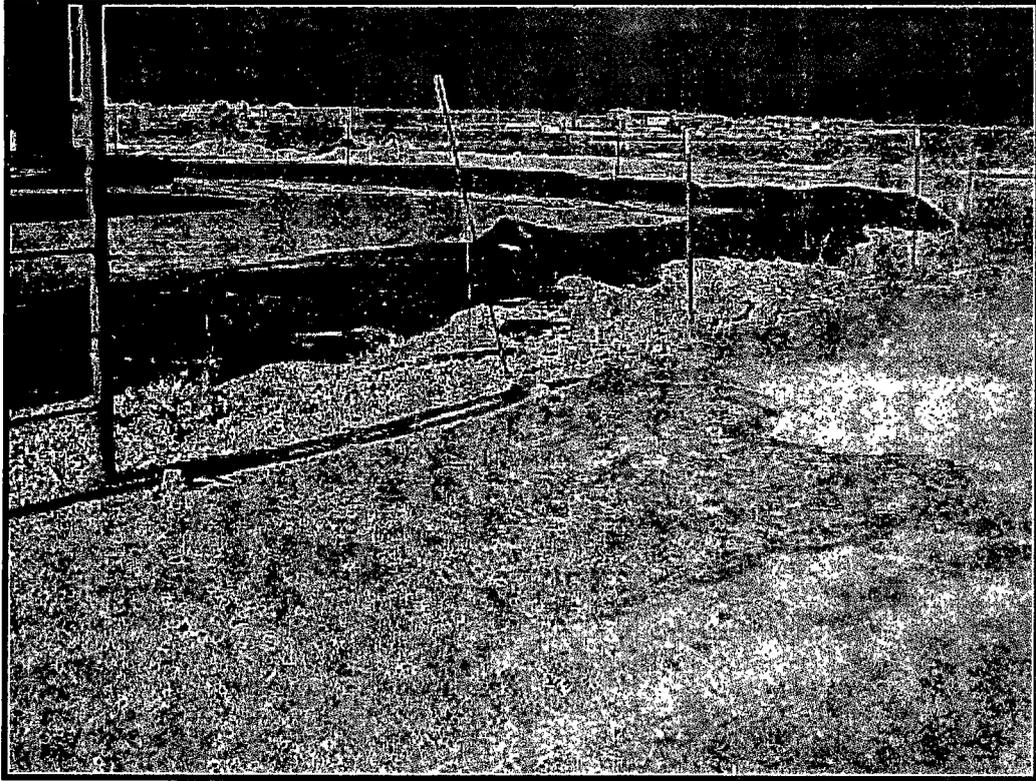
Release Facing SW

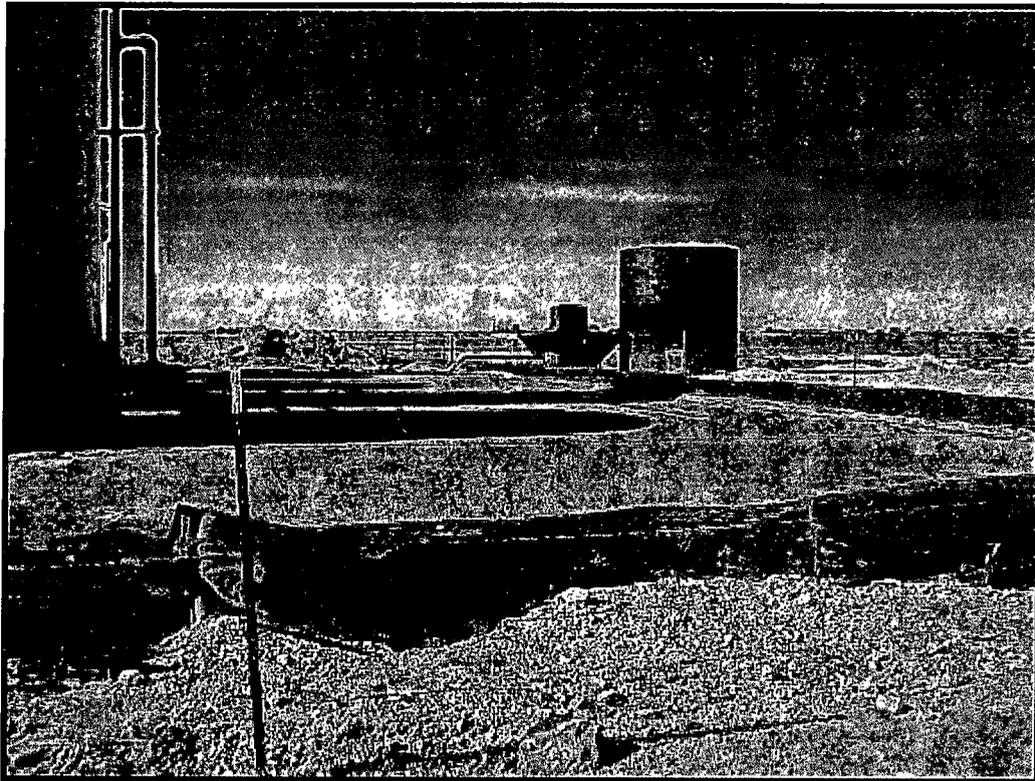
Inside Firewalls Facing South

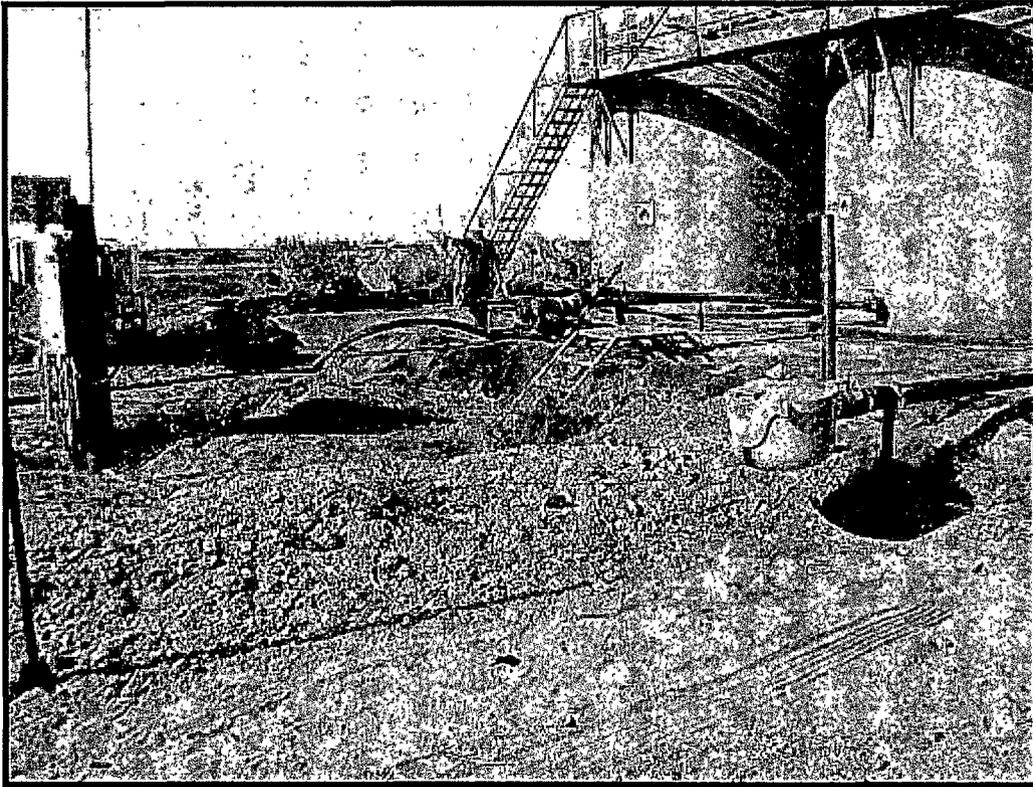
Inside Firewalls Facing SW

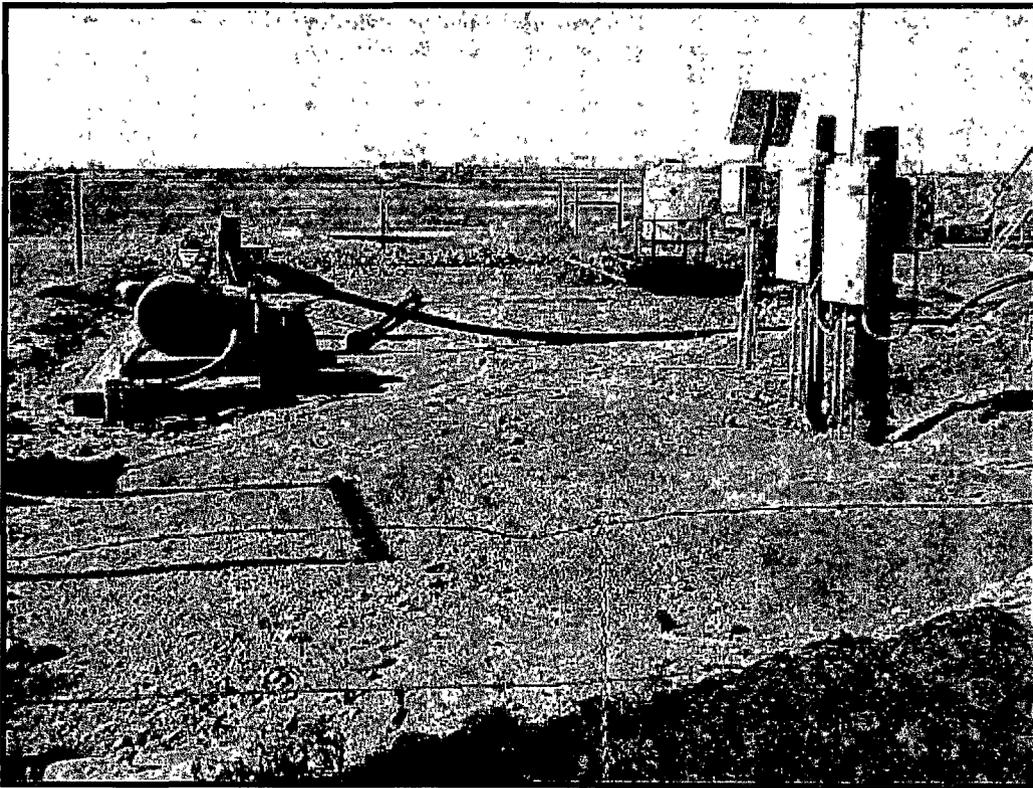
Inside Firewalls Facing South

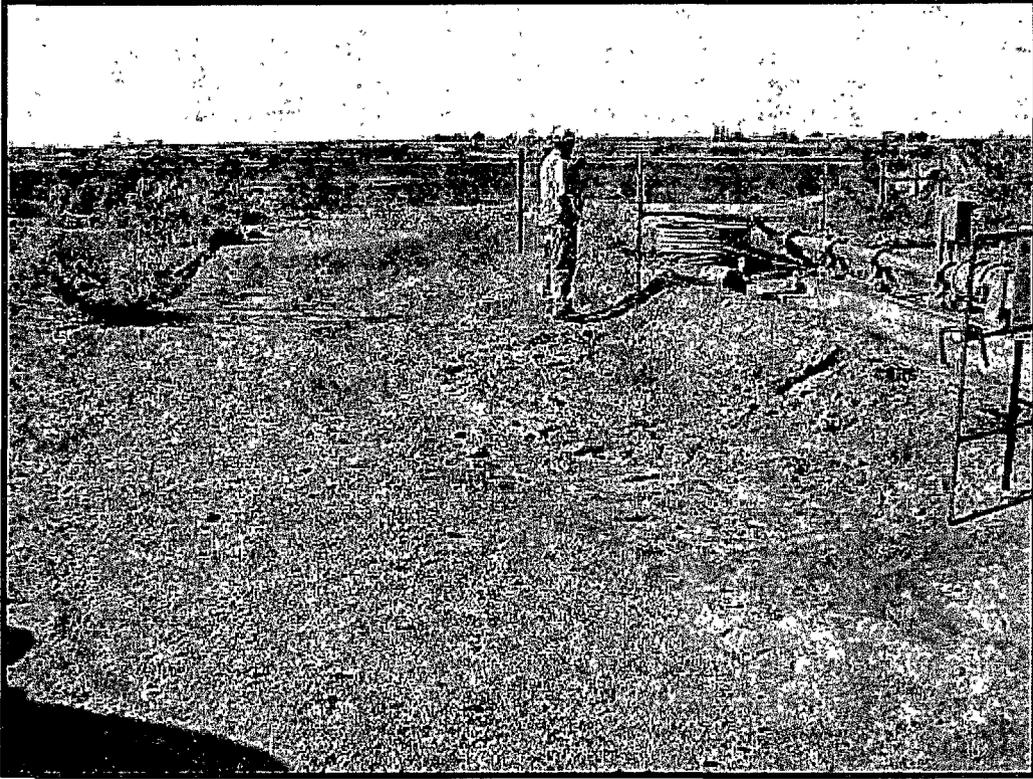
Release Facing South

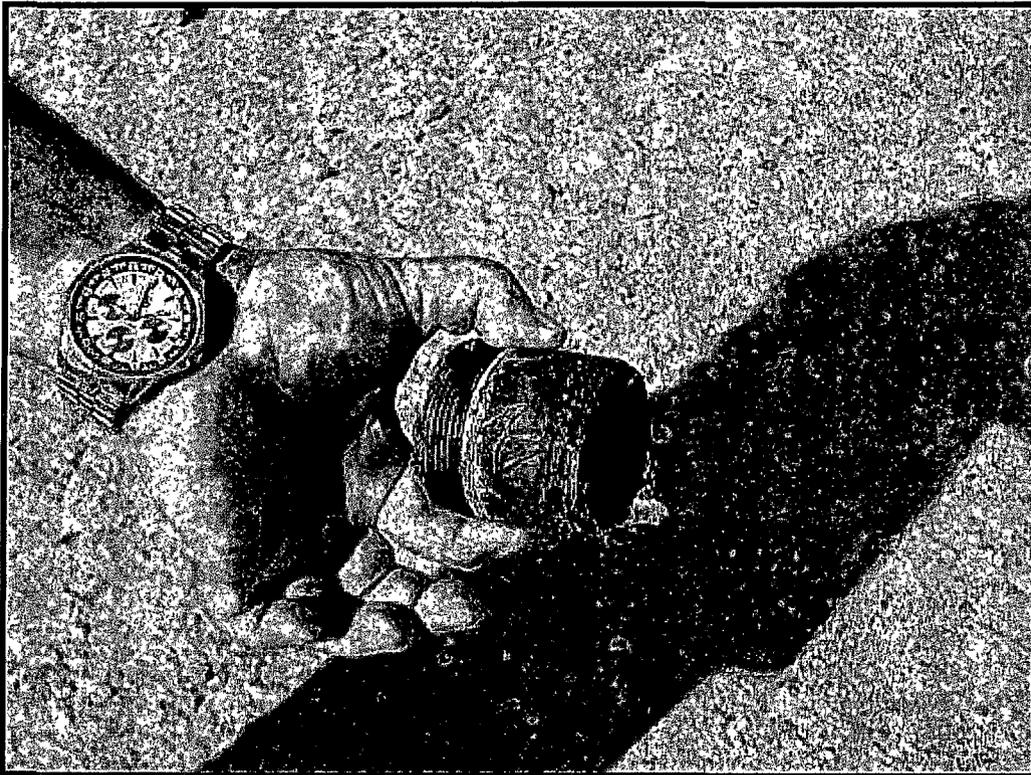
Safety and Environmental Solutions, Inc. (SESI) was engaged by Range Operating NM, Inc. to perform a site assessment at the SCB 23-19 Injection Facility. This is an active battery located in Section 23, Township 23 South, Range 28 East. A 2" nipple eroded off the end of a check valve on the H-pump releasing approximately 300 barrels of produced water of which 290 was recovered.

Failed 2" Nipple

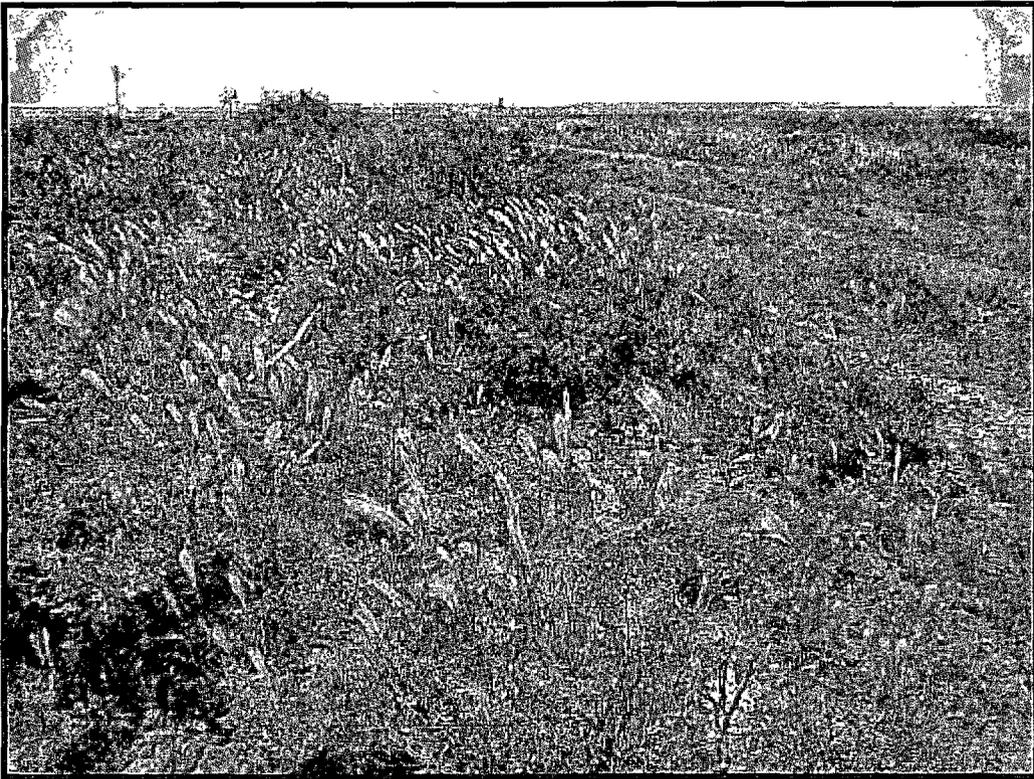
Release Facing East

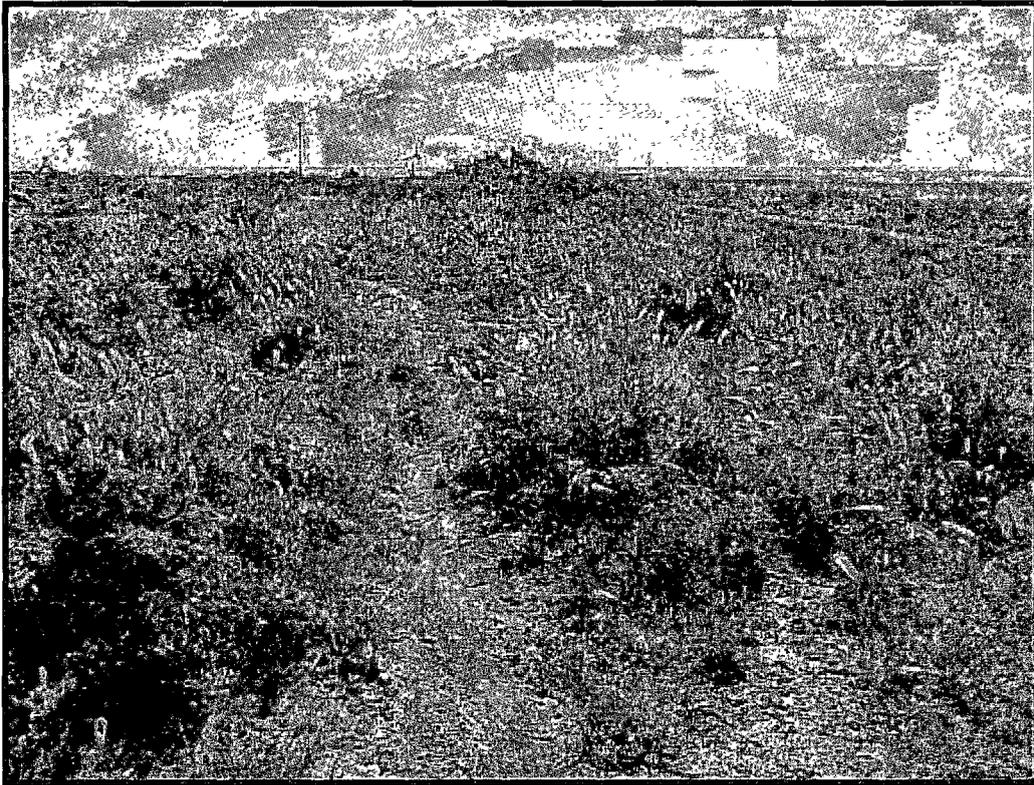
Release Facing East

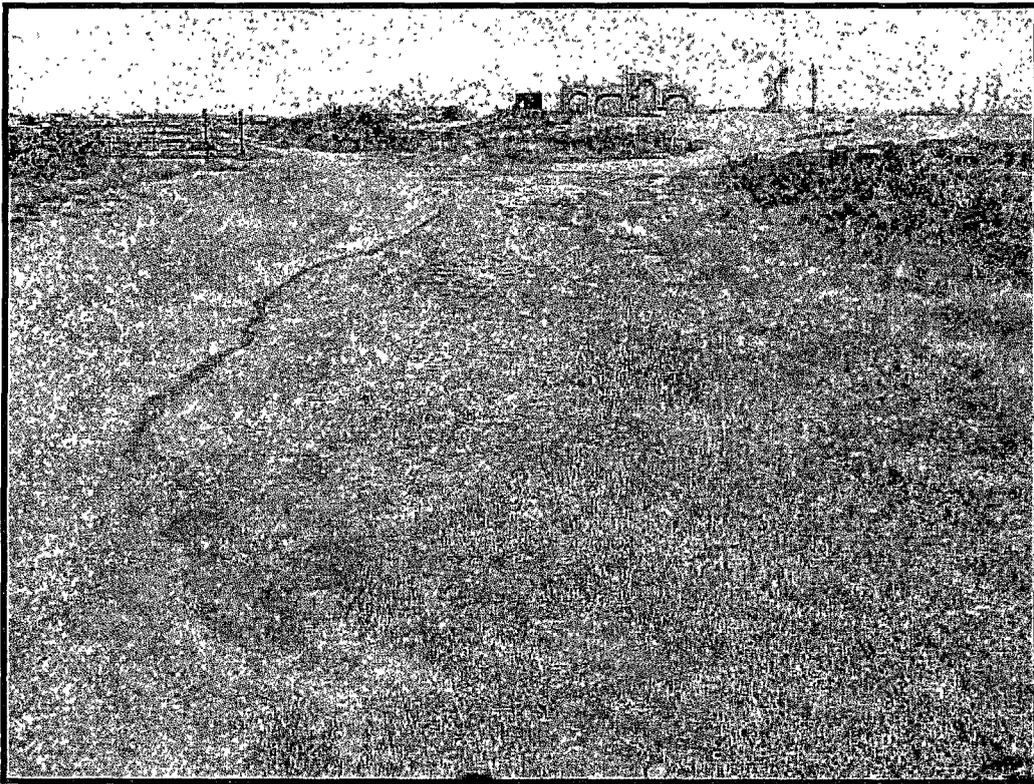
Release Facing West

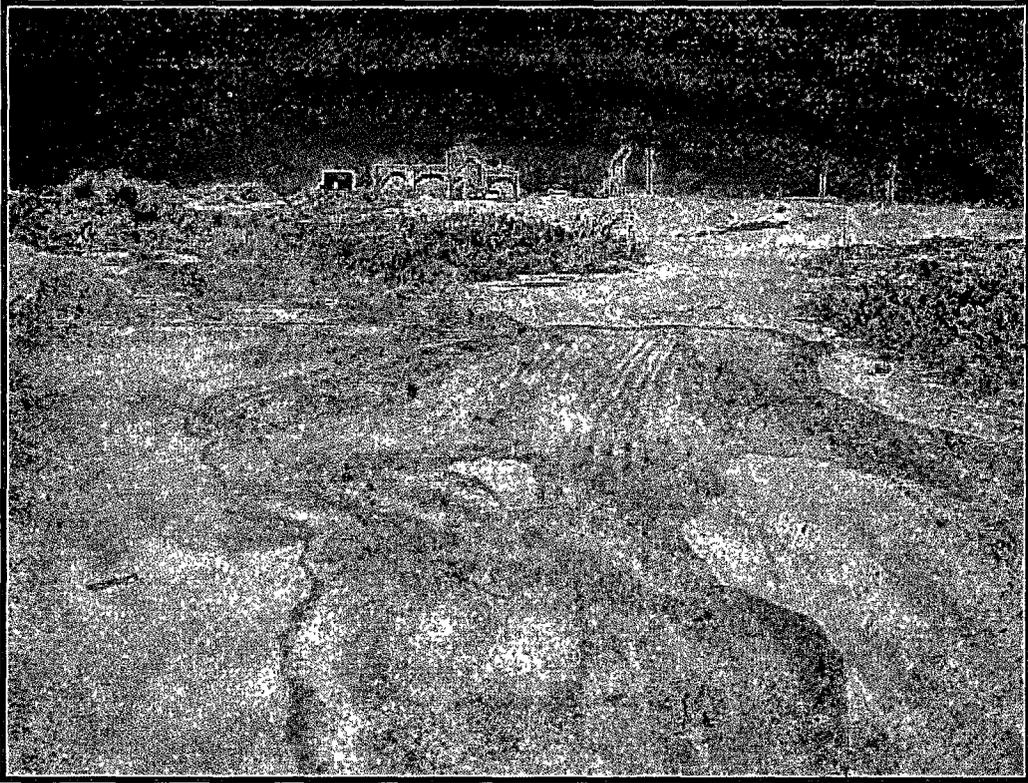
Release Facing West

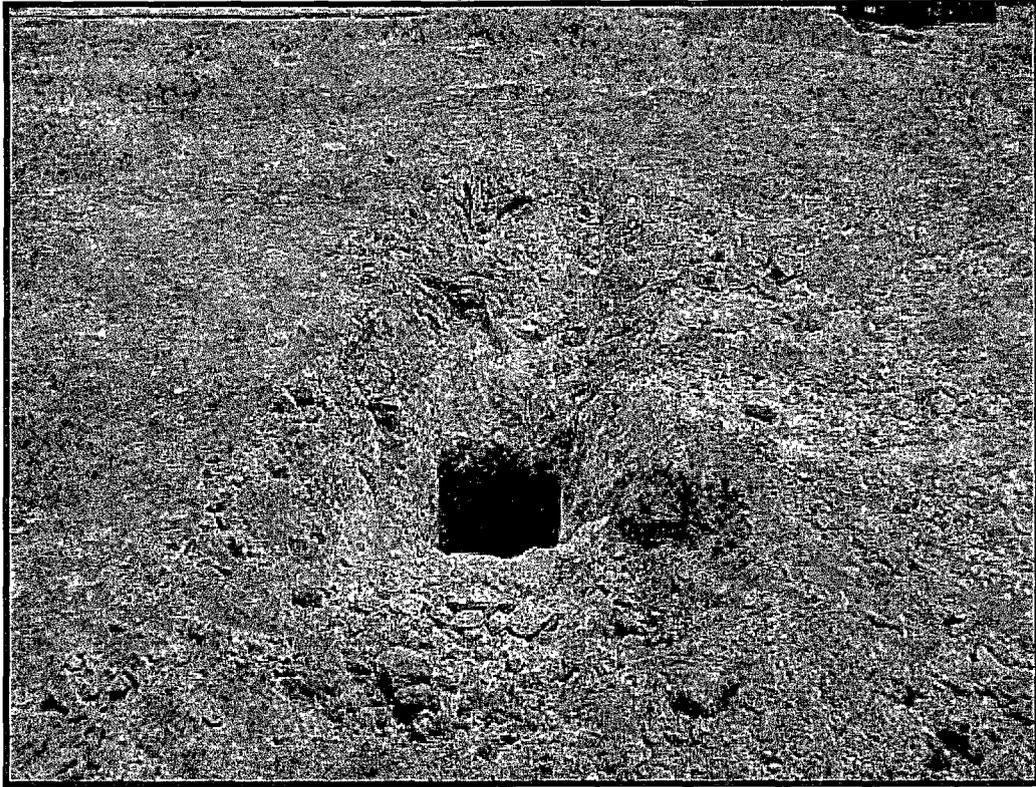
Test Trench #1

On August 20, 2009, SESI was onsite with M& J Backhoe Services to attempt to delineate the spill area. A total of three (3) test trenches were installed to a depth of 10' bgl within the affected area. Field grab samples collected from test trench #1 indicated a gradual increase in chloride concentrations. Field grab samples collected from test trenches #2 & #3 indicated a considerable decrease in chloride concentrations. Due to the limited reach of the backhoe, the affected area was unable to be fully delineated. The backhoe was then utilized to excavate the affected areas to a depth of 1' bgl removing the highly contaminated and saturated soils to prevent further migration. The excavated soils were transported to CRI a New Mexico Oil Conservation Division (NMOCD) approved facility for disposal.

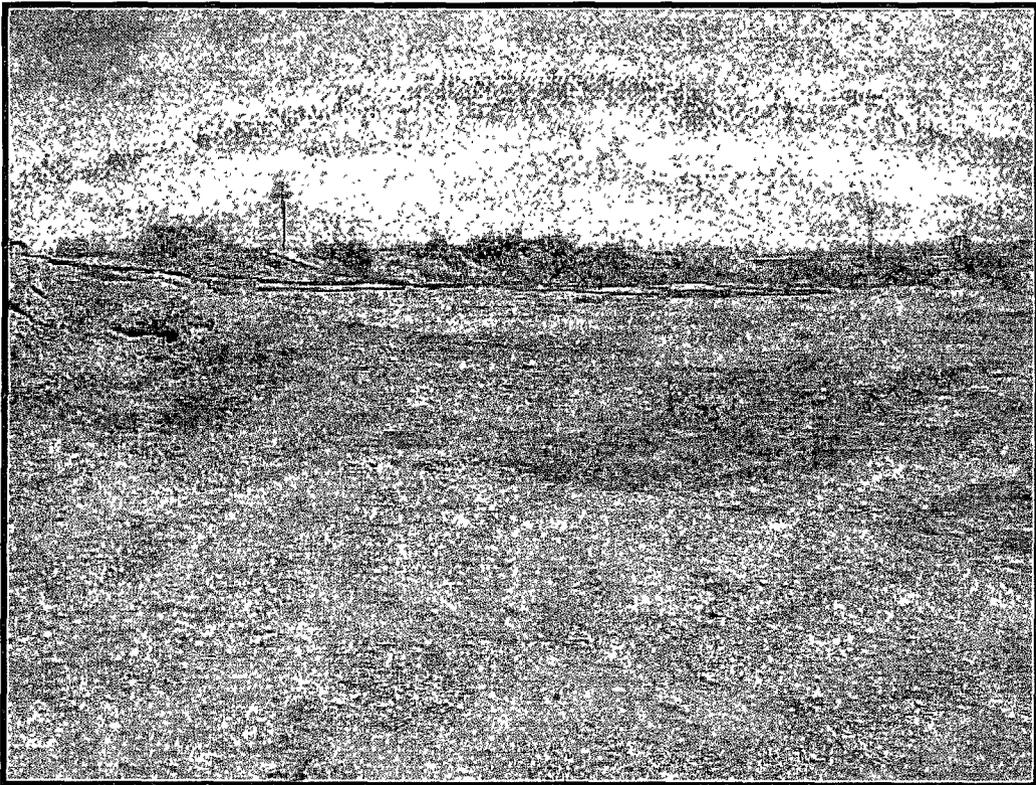
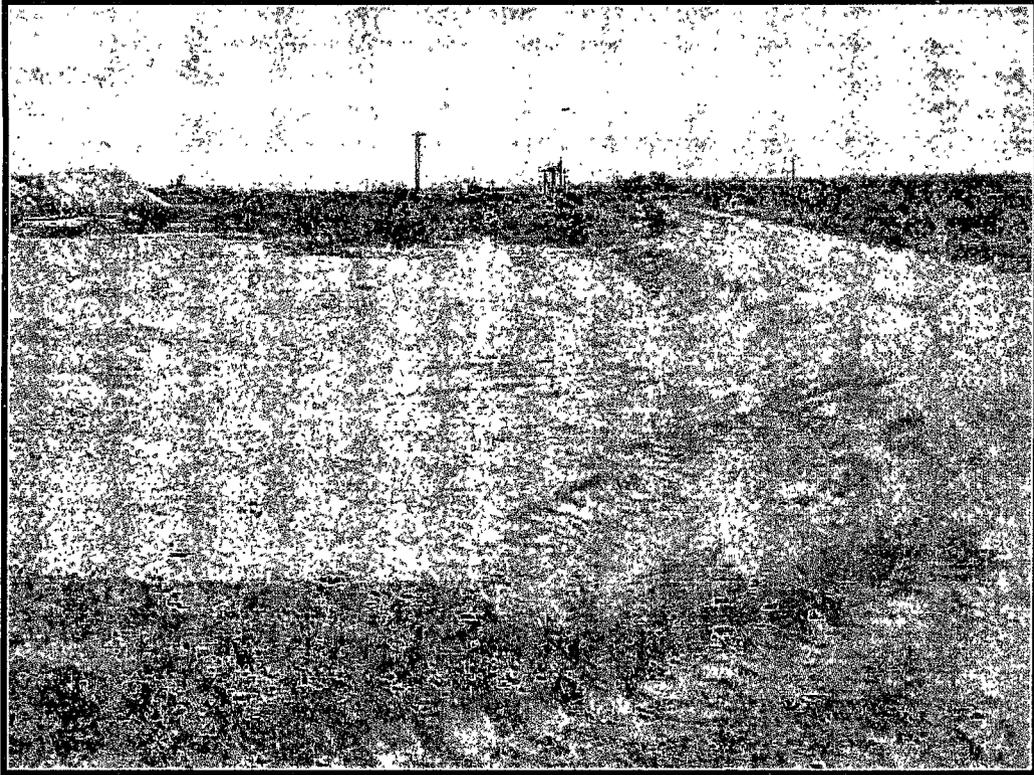
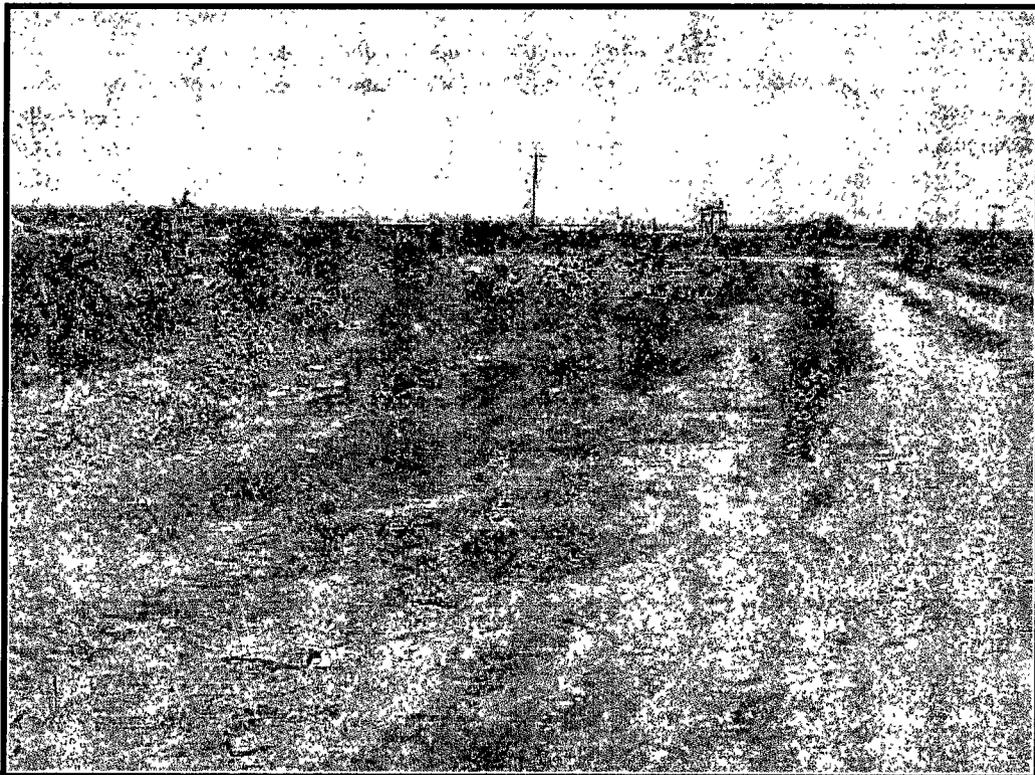
Partially Excavated Area Facing East

It is requested that the affected area be excavated to a depth of five (5) feet bgl. The excavated soils will be transported to a New Mexico Oil Conservation Division (NMOCD) approved facility for disposal. A 20 mil reinforced geo-membrane liner will be installed and the area will be backfilled with like soils and contoured to grade.

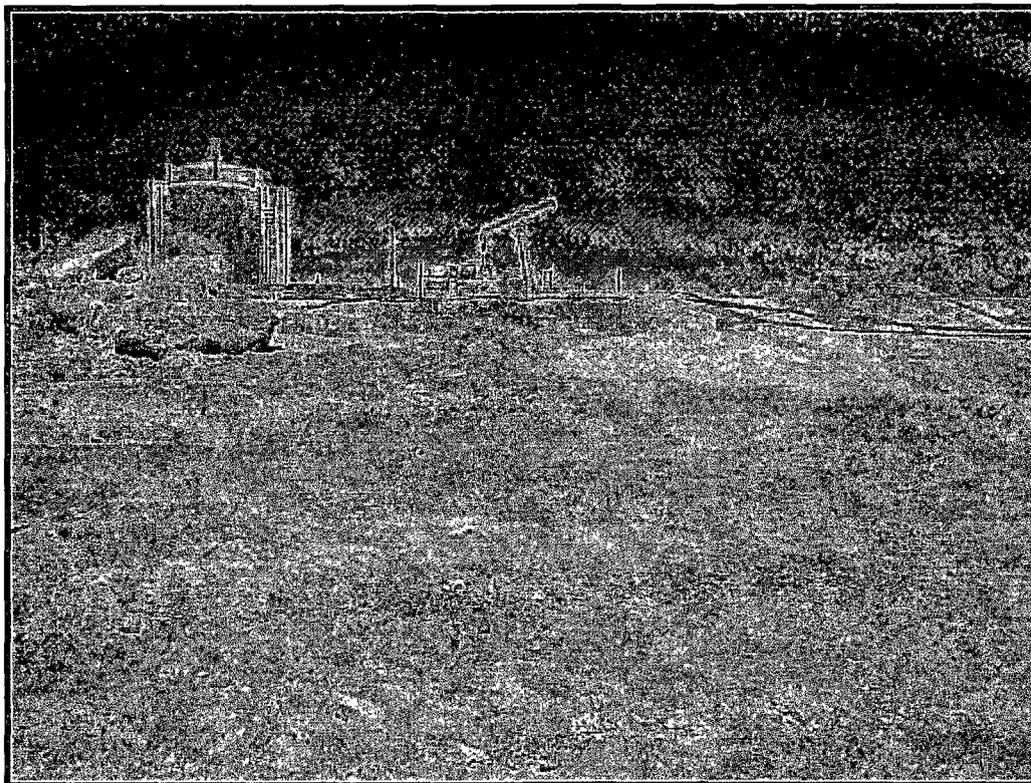
Partially Excavated Area Facing North
