**Range Operating New Mexico, Inc.
SCB 23-19 Injection Facility
Section 23, Township 23 South, Range 28 East
Eddy County, New Mexico**

Revised Work Plan

October 8, 2009

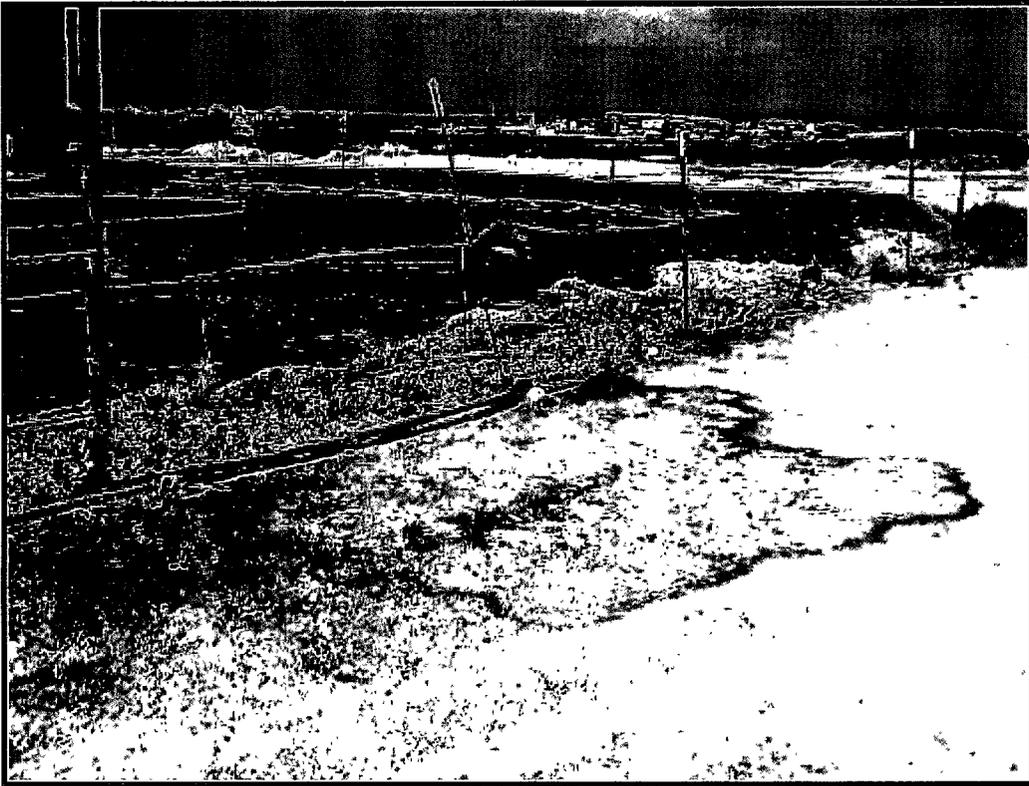
Release Facing SW

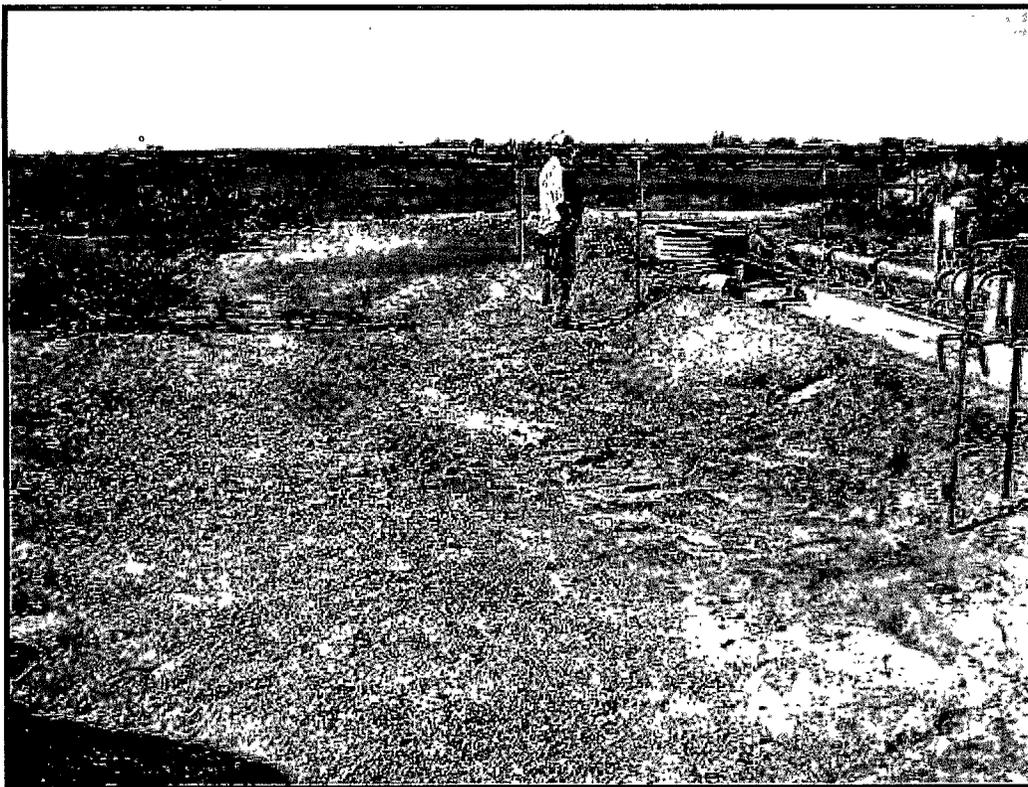
Release Facing South

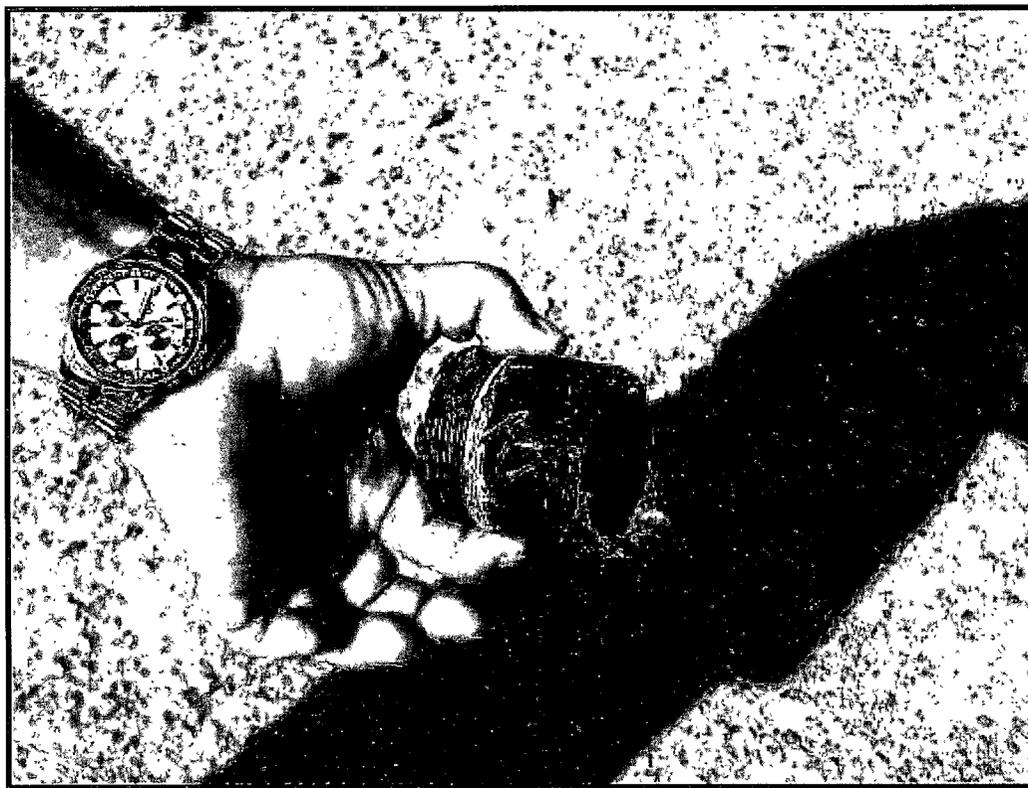
Safety and Environmental Solutions, Inc. (SESI) was engaged by Range Operating NM, Inc. to perform a site assessment at the SCB 23-19 Injection Facility. This is an active battery located in Section 23, Township 23 South, Range 28 East. A 2" nipple eroded off the end of a check valve on the H-pump releasing approximately 300 barrels of produced water of which 290 was recovered.

Failed 2" Nipple

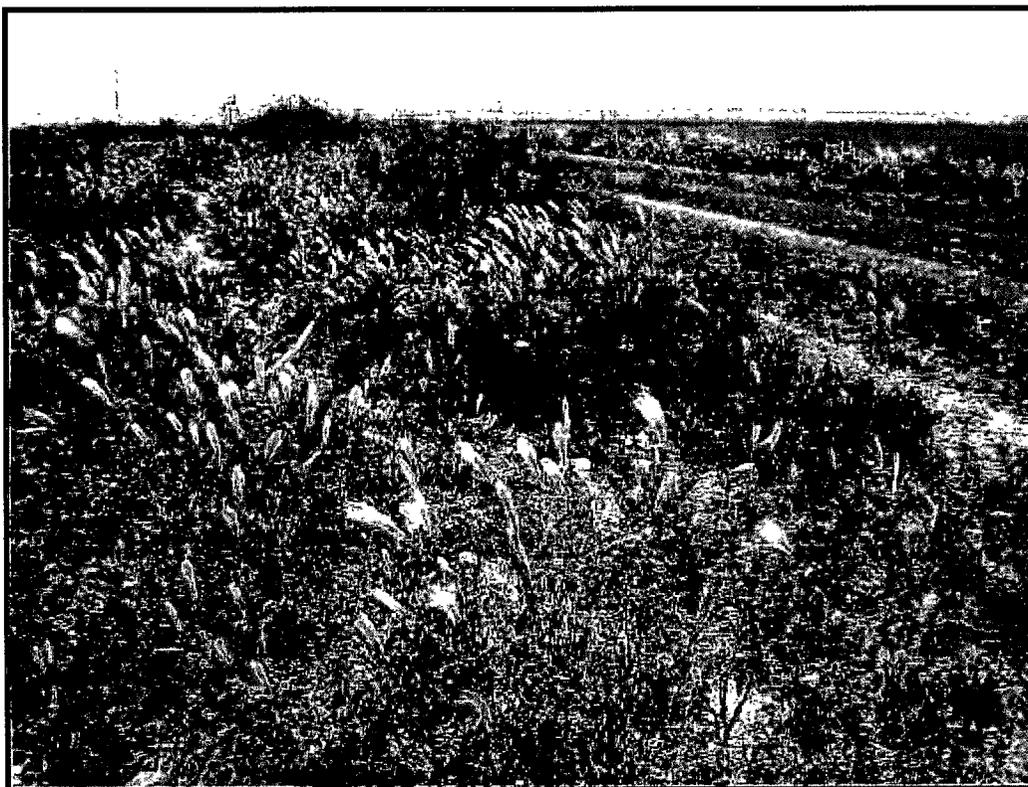
Release Facing East

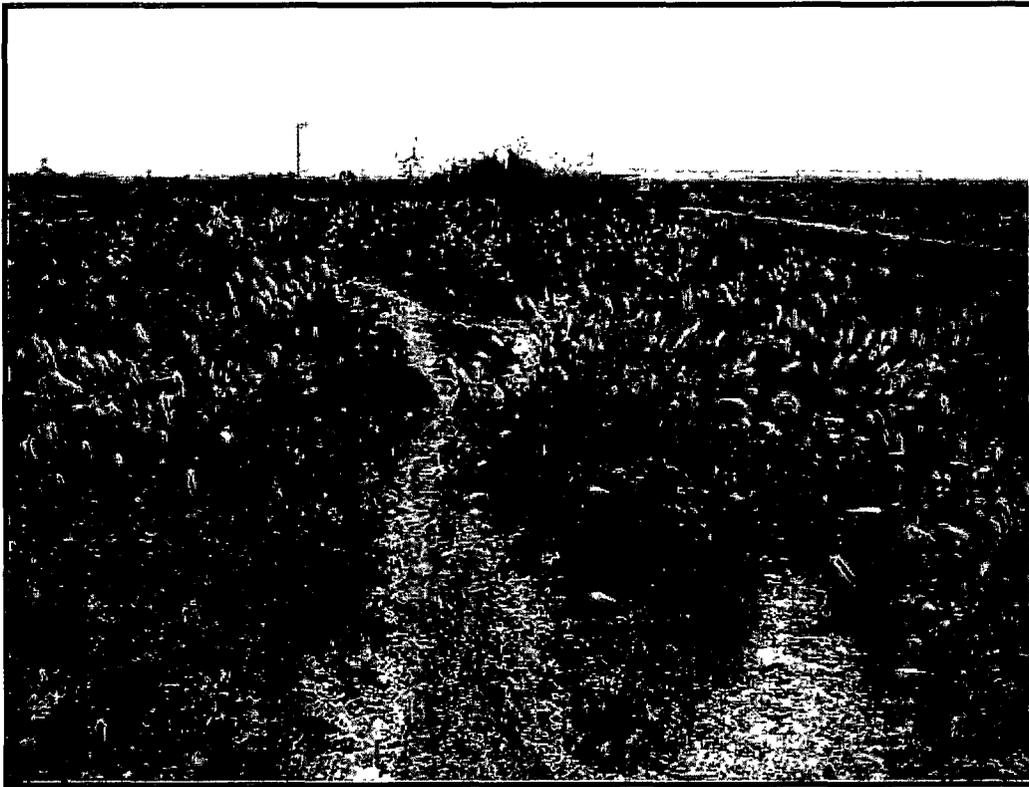
Release Facing East

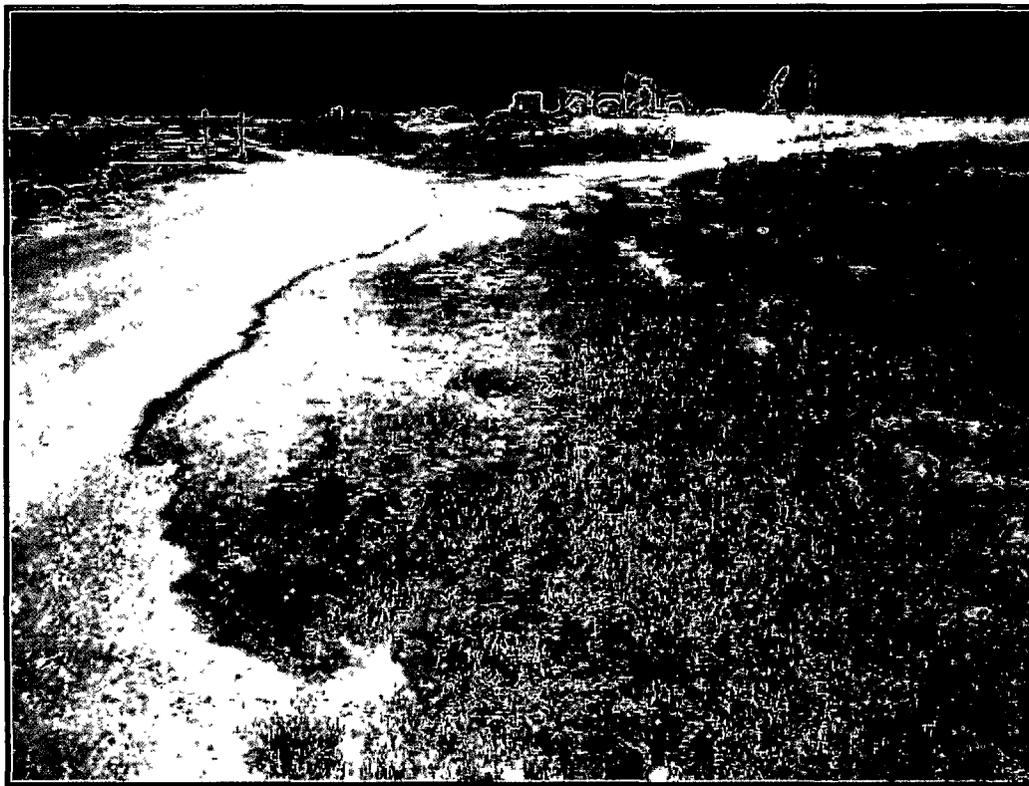
Release Facing West

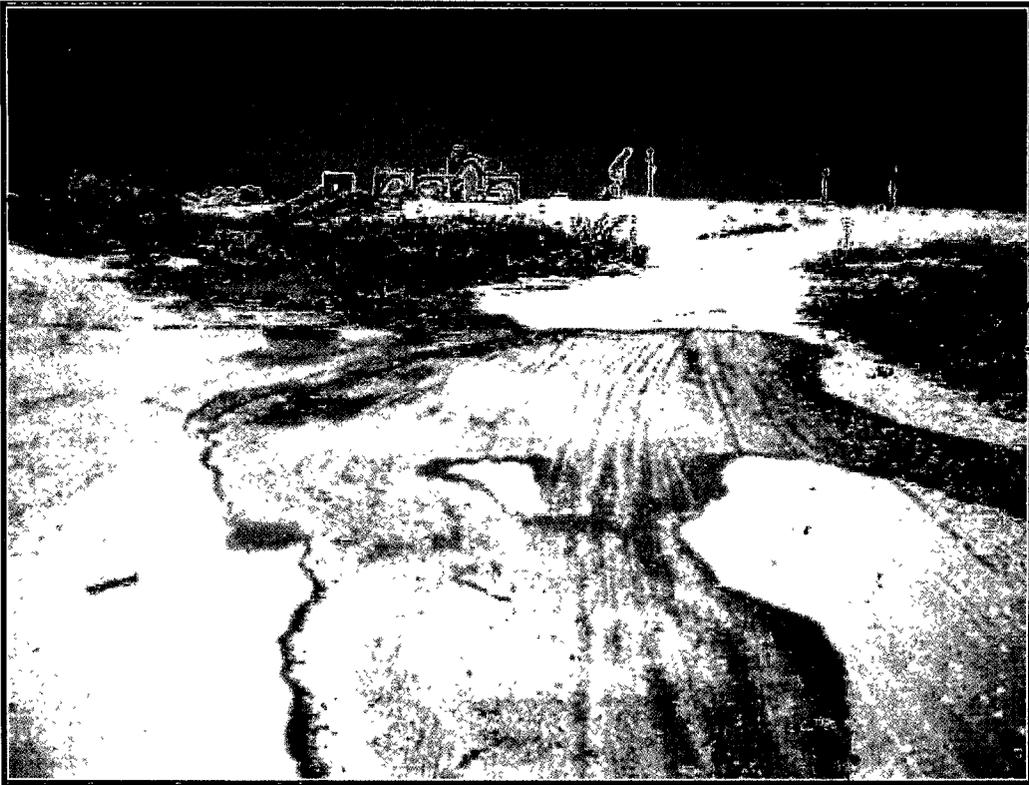
Release Facing West
