**Range Operating New Mexico, Inc.  
SCB 23-19 Injection Facility  
Section 23, Township 23 South, Range 28 East  
Eddy County, New Mexico**

**Delineation Report/ Work Plan**

**June 30, 2010**

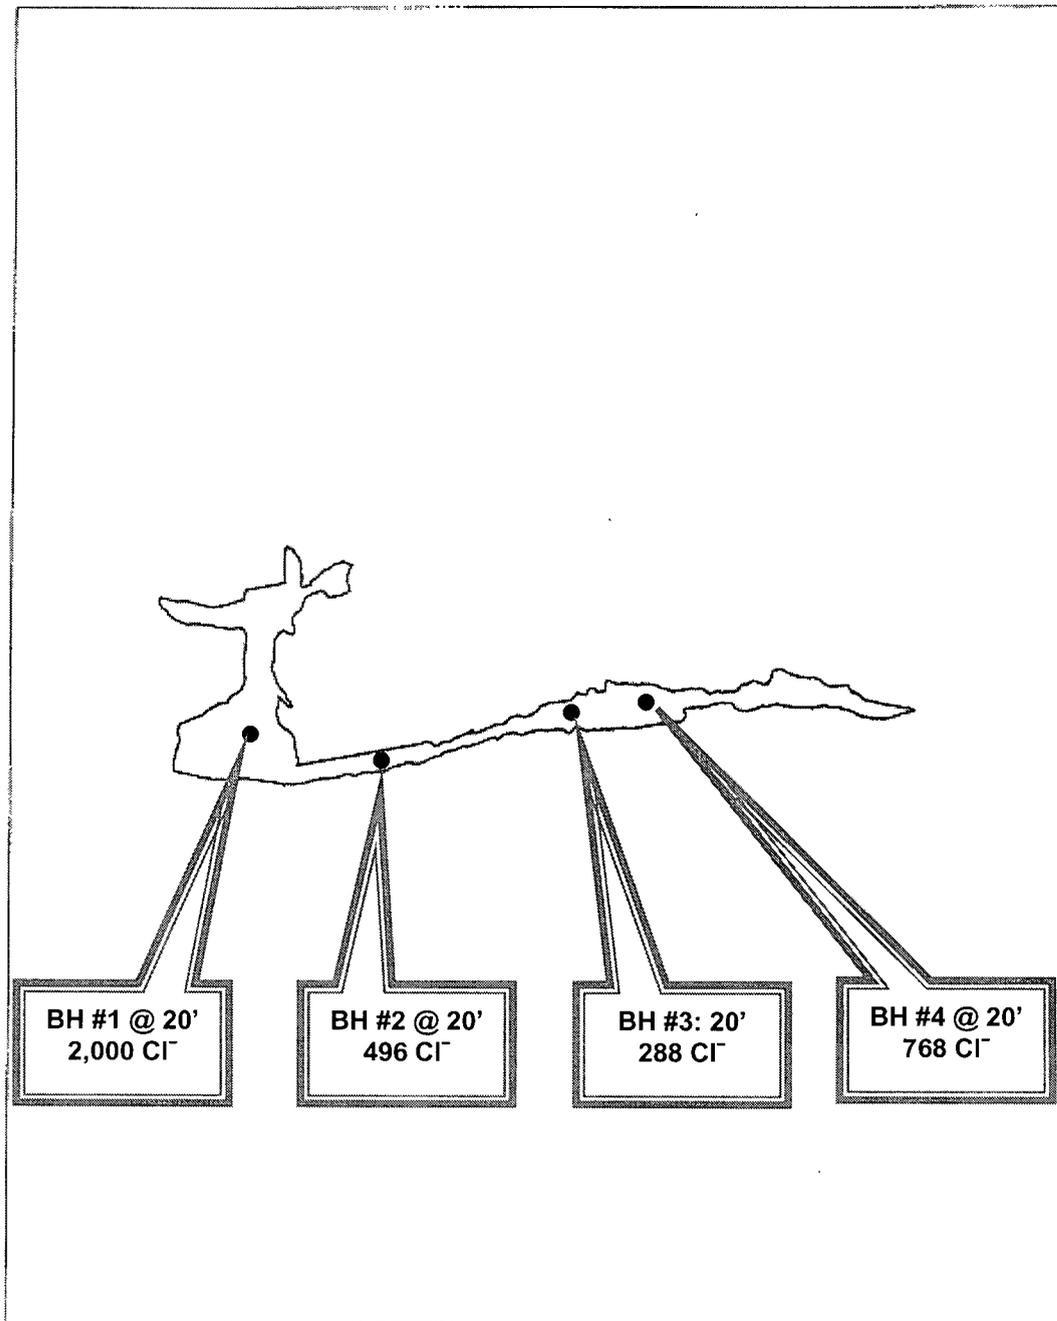
**Figure 2**  
**Site Plan**

On August 17, 2009, SESI was onsite to assess the affected area. The area was mapped using a Trimble Geo XM GPS. SESI observed that the release had runoff into the lined firewalls of the tank battery. The fluid had overflow onto the location on the north end then traveling approximately 200 yards to the east. A hand auger was utilized to attempt to delineate the spill area. A total of eight (8) auger holes were selected all resulting in auger refusal from 6" to 10" bgl.

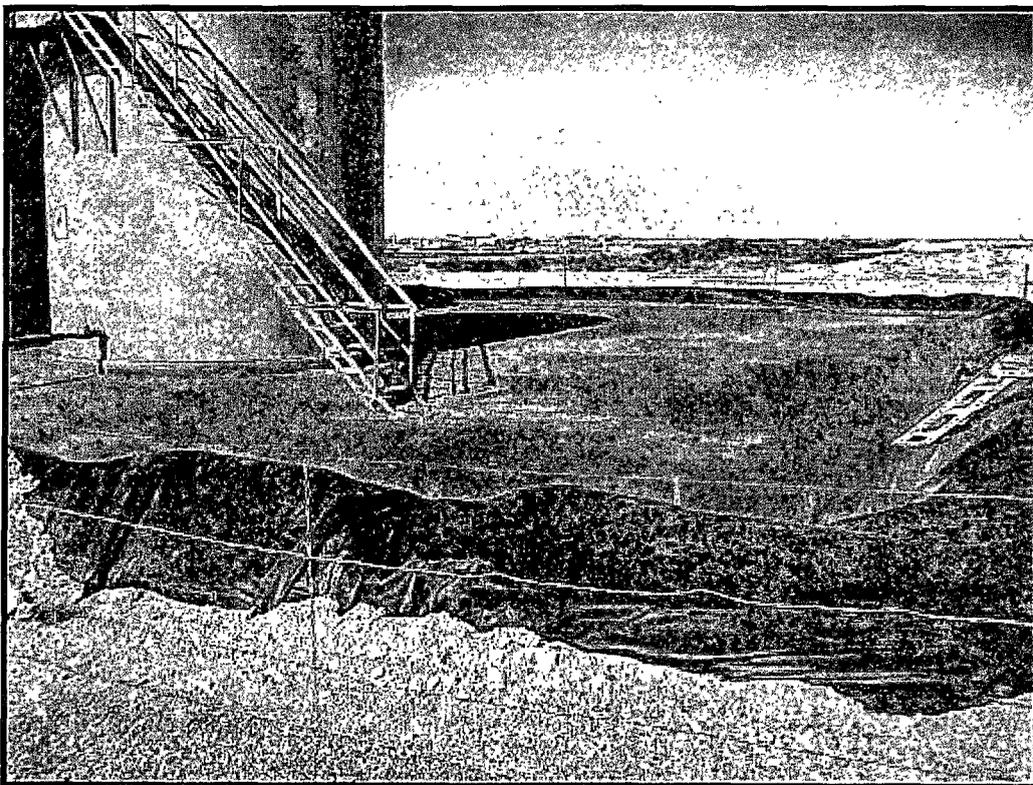
Inside Firewalls Facing SW

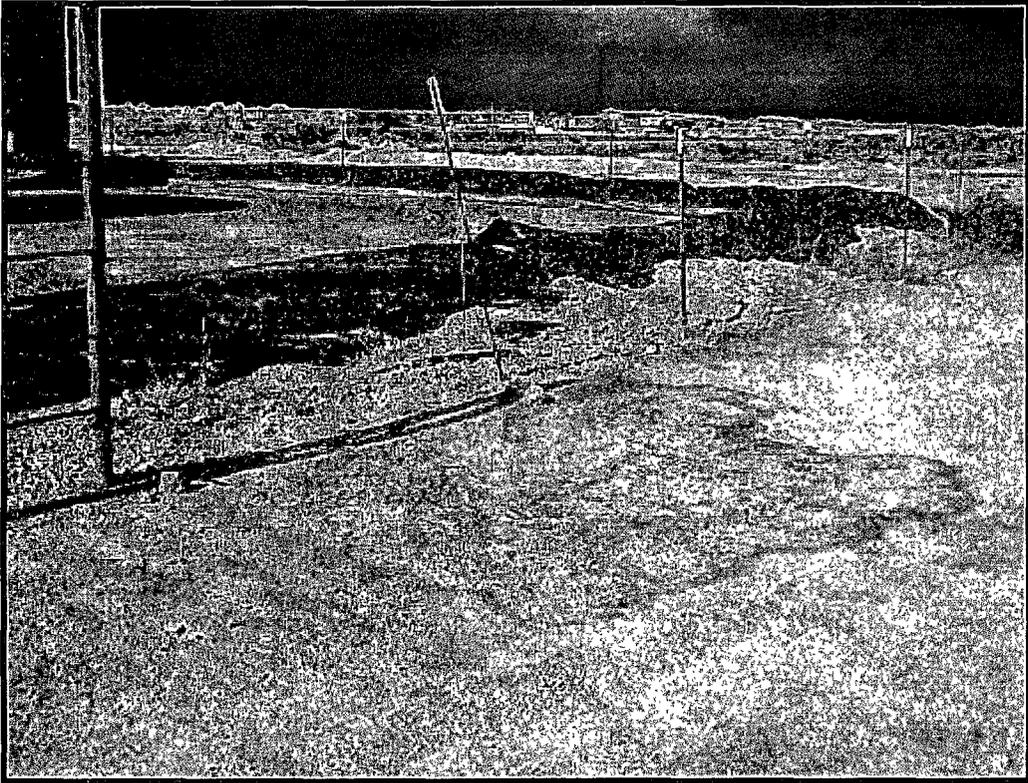
Release Facing SW

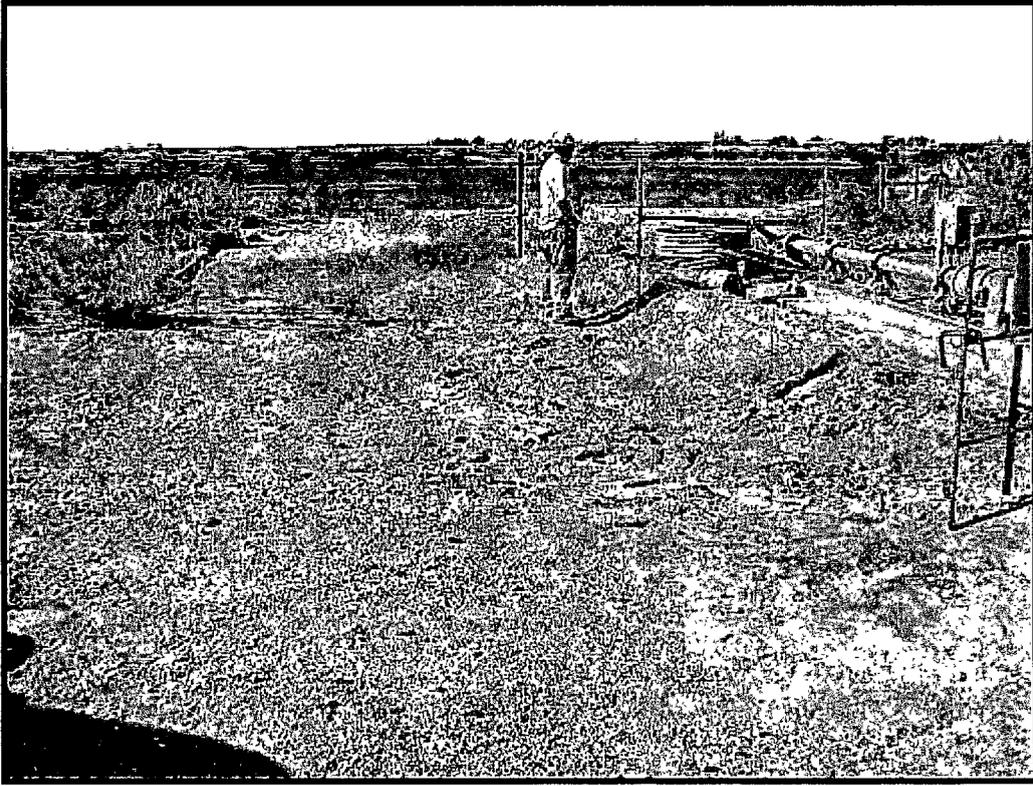
Release Facing South

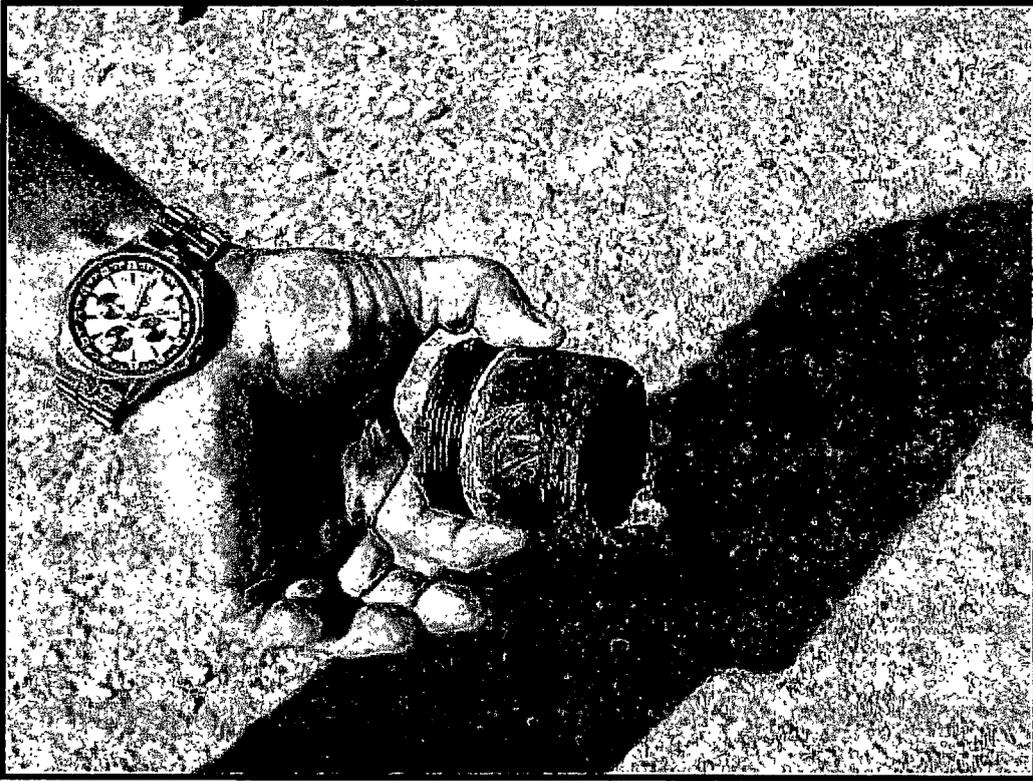
Safety and Environmental Solutions, Inc. (SESI) was engaged by Range Operating NM, Inc. to perform a site assessment at the SCB 23-19 Injection Facility. This is an active battery located in Section 23, Township 23 South, and Range 28 East. A 2" nipple eroded off the end of a check valve on the H-pump releasing approximately 300 barrels of produced water of which 290 was recovered.

Failed 2" Nipple

Describe Cause of Problem and Remedial Action Taken.\*  
A 2" nipple eroded off the end of the check valve on the H-Pump. The pump failed to shut off and resulted in water pumping into the lined tank battery and overflowing the firewalls.

It is requested that the most highly contaminated soils be excavated to a depth of four (4) to five (5) feet bgl. The excavated soils will be transported to a New Mexico Oil Conservation Division (NMOCD) approved facility for disposal. A 20 mil reinforced geomembrane liner will be installed and the area will be backfilled with like soils and contoured to grade. The firewalls surrounding the battery will be raised to prevent any future contamination.

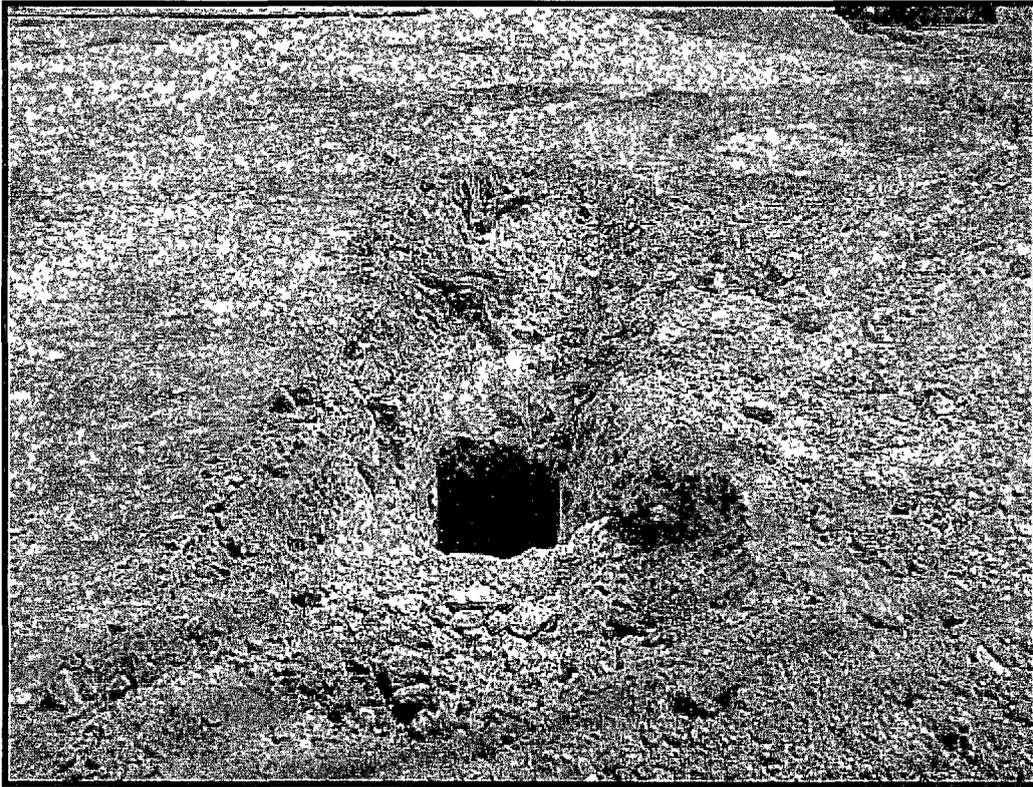
Test Trench #1

On August 20, 2009, SESI was onsite with M&J Backhoe Services to attempt to delineate the spill area. A total of three (3) test trenches were installed to a depth of 10' bgl within the affected area. Due to the limited reach of the backhoe, the affected area was unable to be fully delineated. The backhoe was then utilized to excavate the affected areas to a depth of one (1) foot bgl removing the highly contaminated and saturated soils to prevent further migration. The excavated soils were transported to CRI a New Mexico Oil Conservation Division (NMOCD) approved facility for disposal.
