Reference: 2RP 356

Enclosed, please find a copy of the proposed Melrose State 647 AC711 # 89 remediation plan. Please review and advise of any requested modifications.

Executive Summary Melrose Energy State 647 AC711 # 89 Remediation Plan

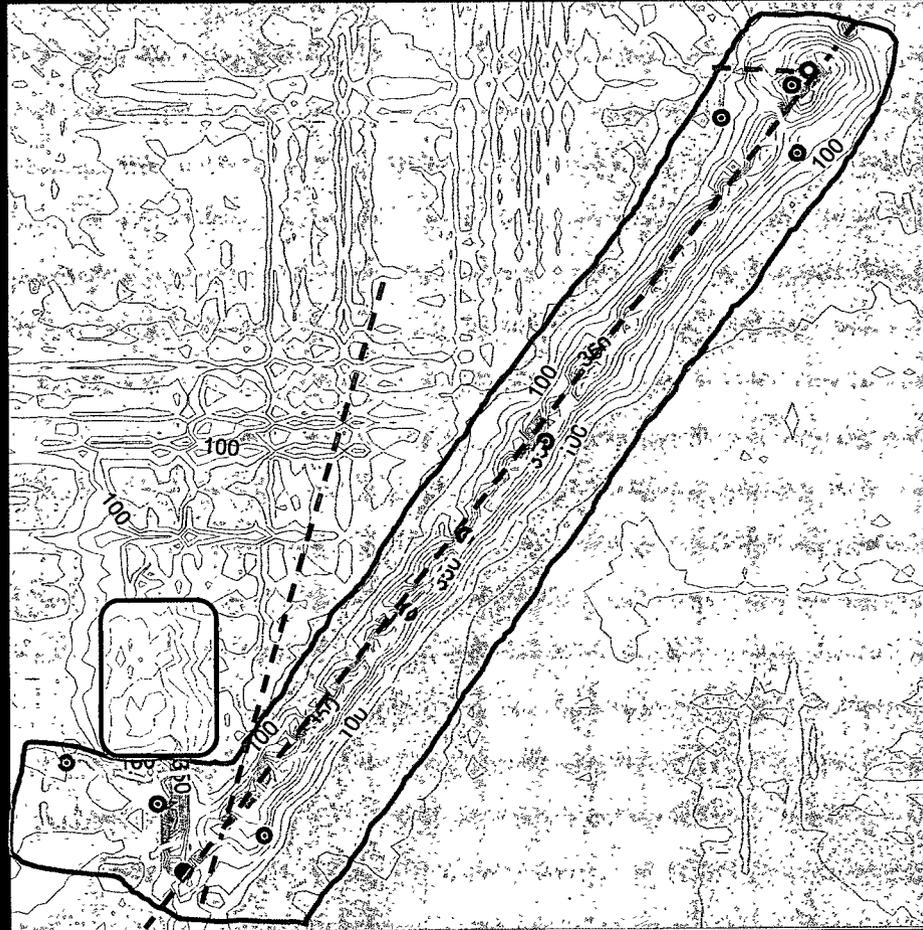
MELROSE OPERATING STATE 647-711 #89 LEAK SITE EM38 SURVEY VERTICAL 0'>5' BGS

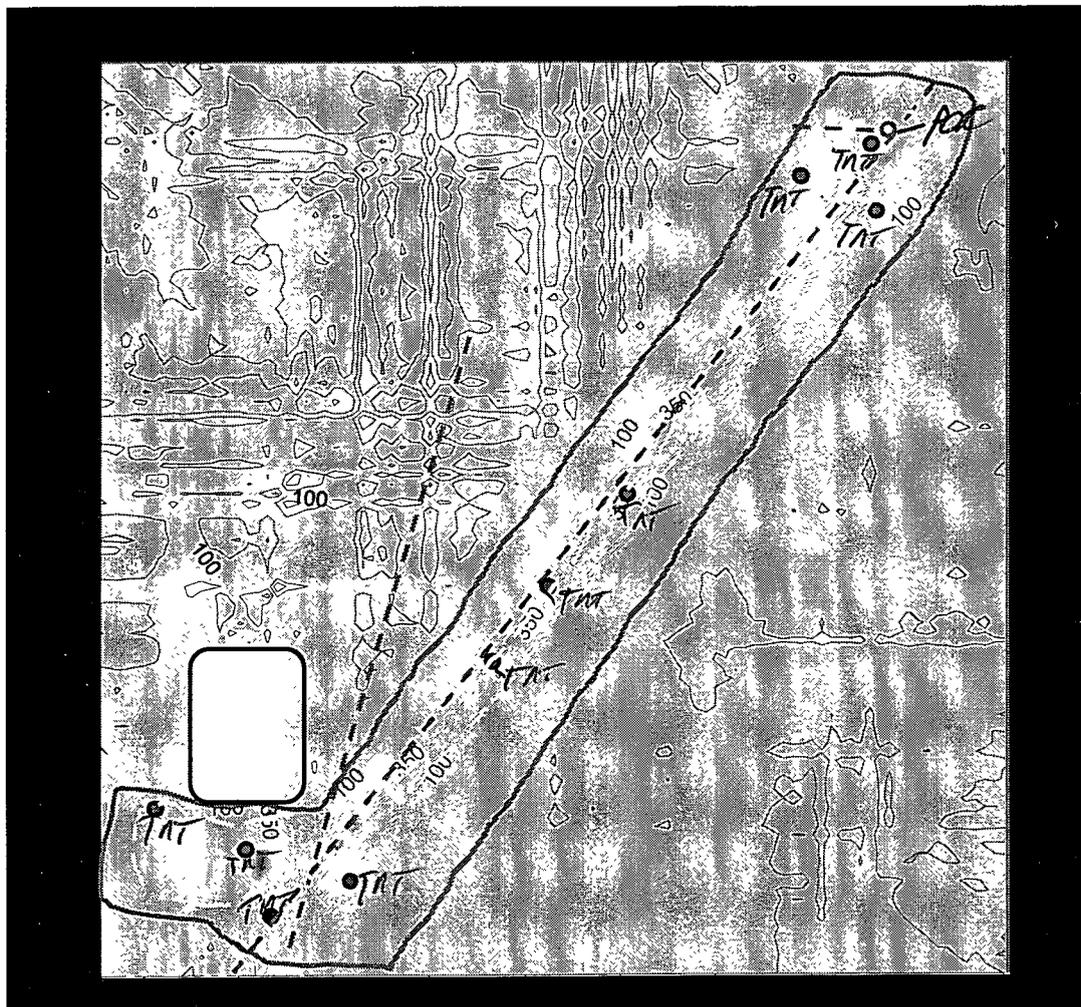
MELROSE OPERATING STATE 647-711 #89 LEAK SITE EM38 SURVEY VERTICAL 0'>5' BGS

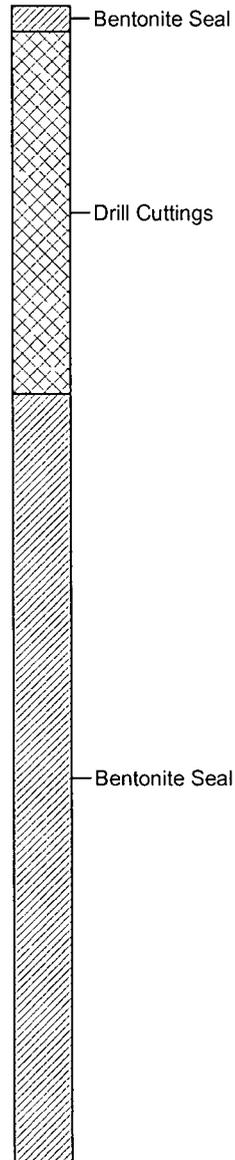
Log of Boring Melrose Soil Bore #1

Depth in Feet	GRAPHIC	USCS	Sample	DESCRIPTION
0			1	Caliche, silty clay, tan, firm, dry
			2	
5			3	Caliche, sand, tan, loose, dry
10			4	Layers of sand and cemented sand, reddish brown, firm, damp
15			5	
20			6	
25		SP	7	
30			8	
35			9	
40			10	Fine grained, poorly graded sand, brown, loose, damp
45			11	
50			12	
55			13	
60		SP	14	
65			15	
70			16	
75			17	
80			18	
85		CL	19	Clay, reddish brown, firm, damp
90			20	Total Depth 90' Conglomerate rock, hard. Auger refusal.

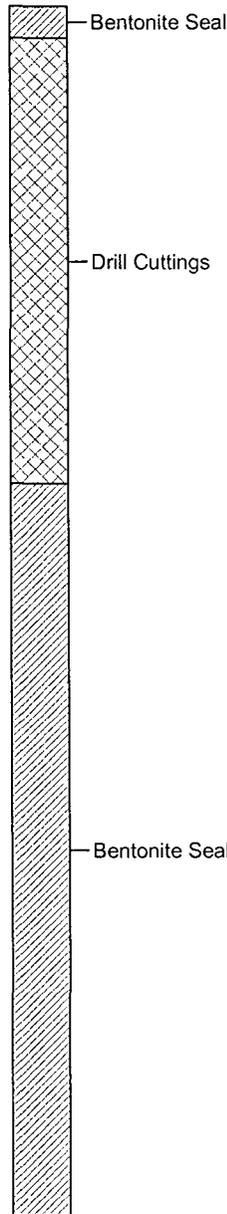
Log of Boring Melrose Soil Bore #4

Depth in Feet	GRAPHIC	USCS	Sample	DESCRIPTION
0			1	Caliche, tan, firm, dry
			2	
5		SC	3	Clayey sand, tan, soft, damp
			4	Clayey sand, reddish tan, loose, damp
10		SC		
			5	Sand and cemented sand layers, reddish tan, firm, damp
15		SP		
			6	Clayey sand, reddish tan, loose, damp
20			7	
		SC		
25			8	Sand and gravel, reddish tan, loose, red, damp
30			9	
		SW		
35			10	Poorly graded sand, red, loose, damp
40		SP		
			11	Clay, red, stiff, damp
45			12	
		CL		
50			13	Clayey gravel, red, loose, damp
55		GC		
			14	Sandy clay, red, loose, damp
60			15	
		CL		
65			16	
			17	Sandy clay, yellow, loose, damp
70				
		CL		
75				
				Total Depth 76'
80

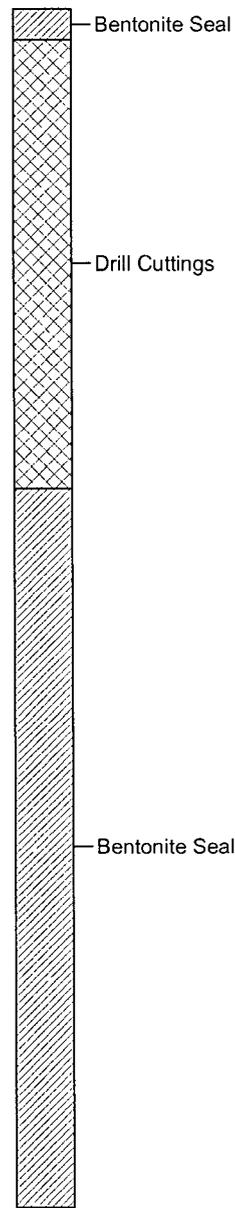
Log of Boring Melrose Soil Bore #5

Depth in Feet	GRAPHIC	USCS	Sample	DESCRIPTION
0			1	Caliche, tan, firm, dry
			2	
5			3	
10			4	Poorly graded sand cemented in layers, reddish brown, firm, dry
15		5		
20		6		
25		7		
30		8		
35		9		
40	SP	10		
45		11		
50		12	Poorly graded sand cemented in layers, rust yellow, firm, damp	
55		13		
60	SP	14		
65	SP	15		Poorly graded sand, reddish tan, loose, damp
70	SP	16		Poorly graded sand, yellowish tan, loose, damp
75		17	Total Depth 75'

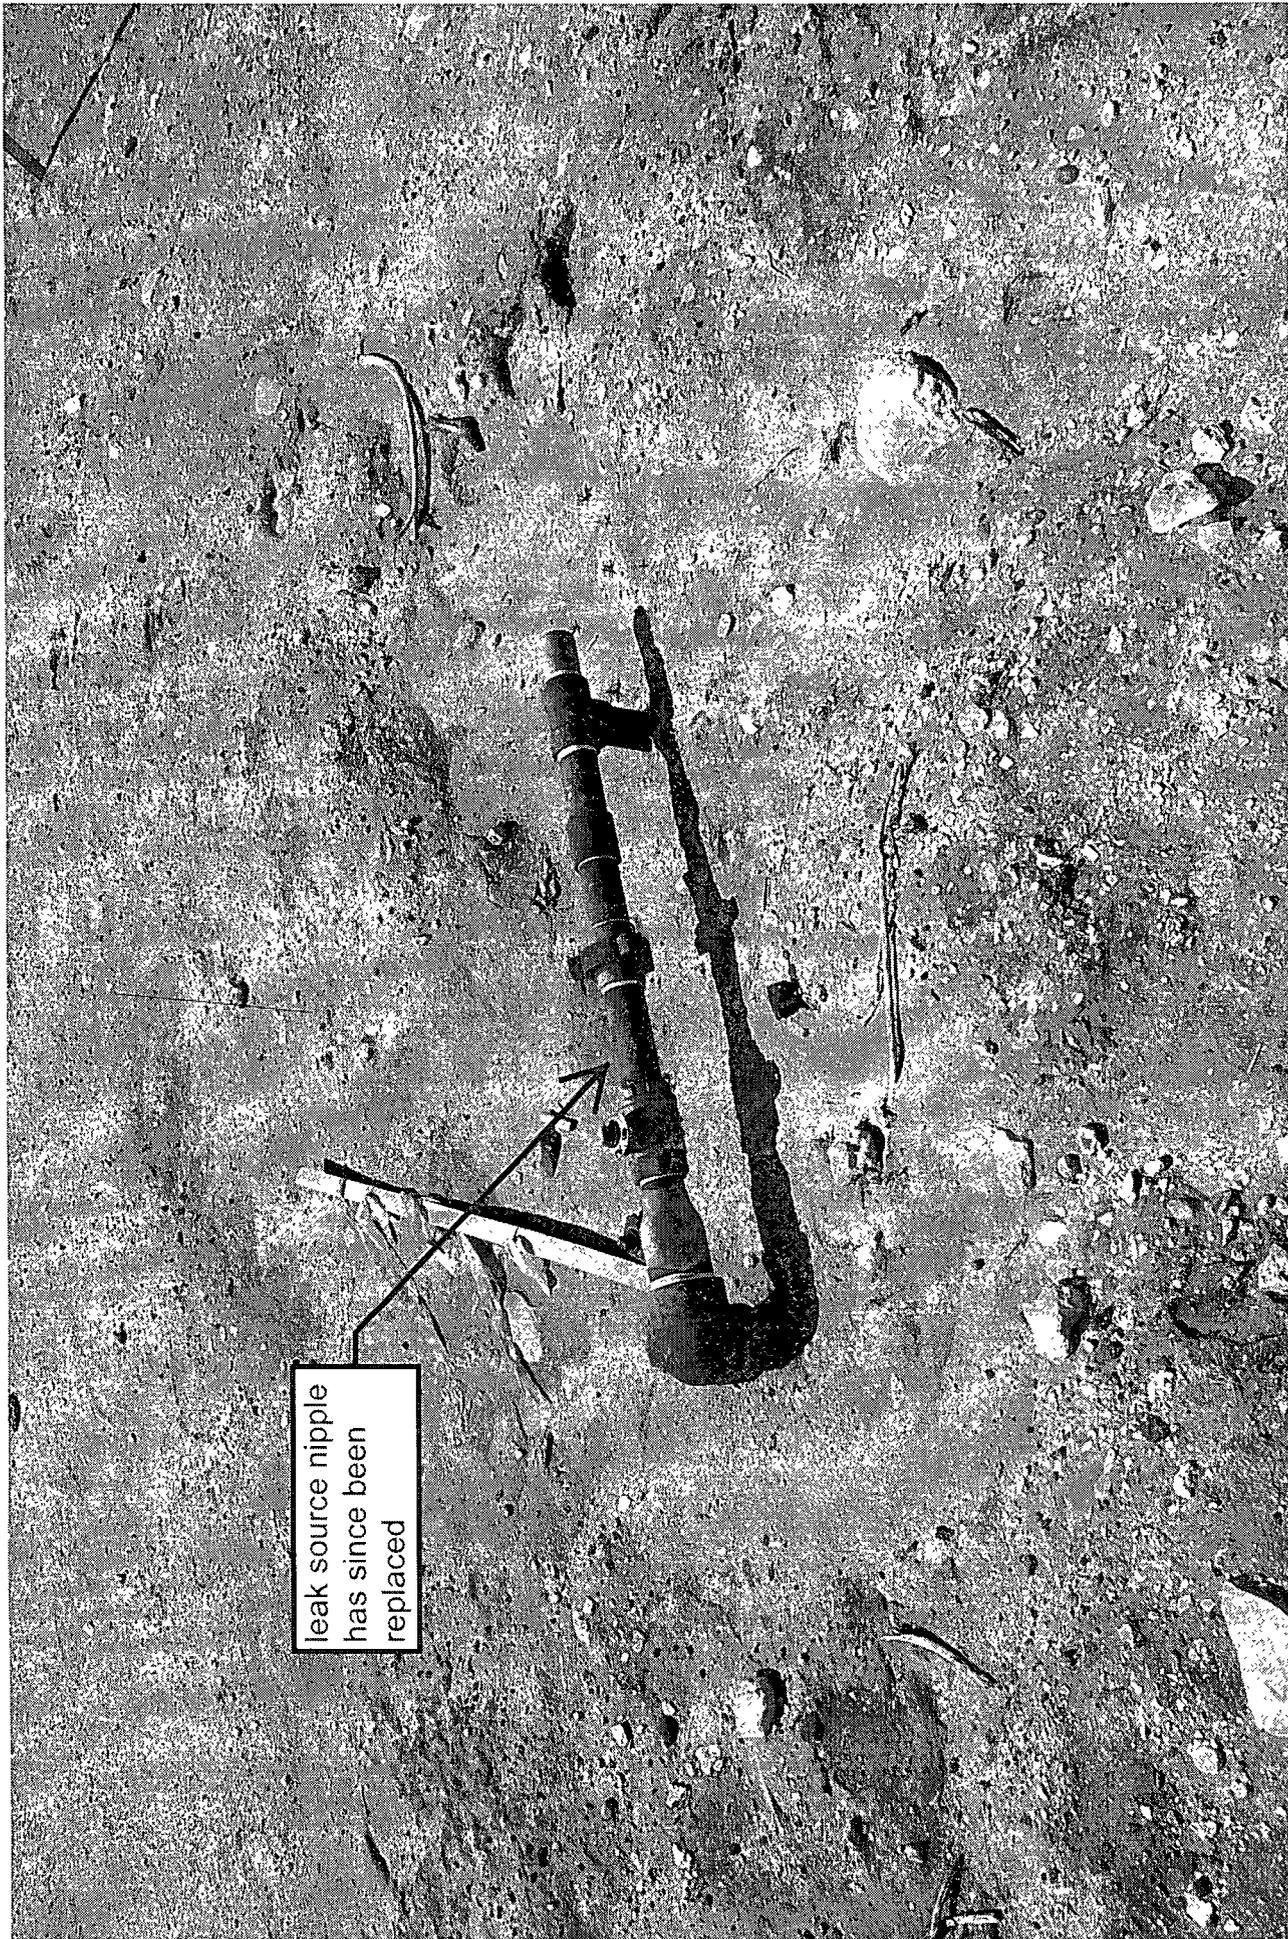
leak source nipple
has since been
replaced
