Enclosed, please find a copy of the final closure report for the Melrose State 647 remediation project.

### **Melrose Energy**

### **State 647 AC 711 #89**

### **Remediation Plan**

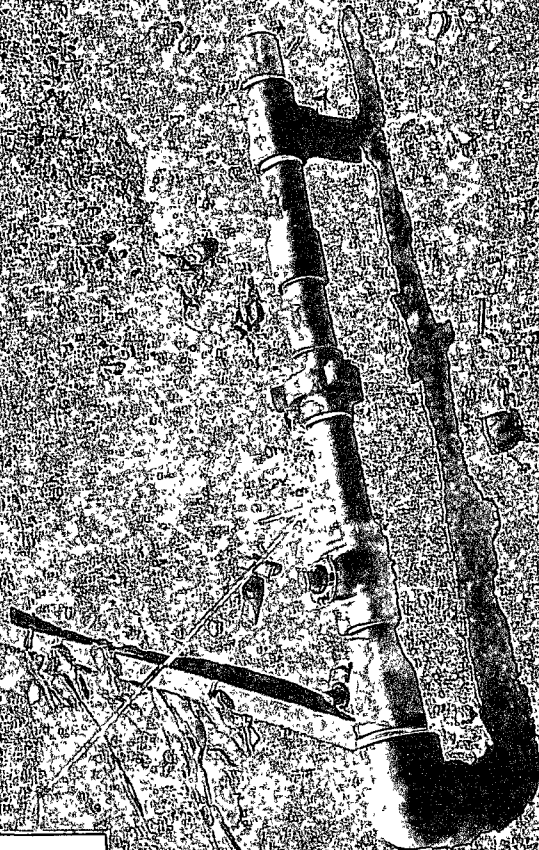
leak source nipple  
has since been  
replaced

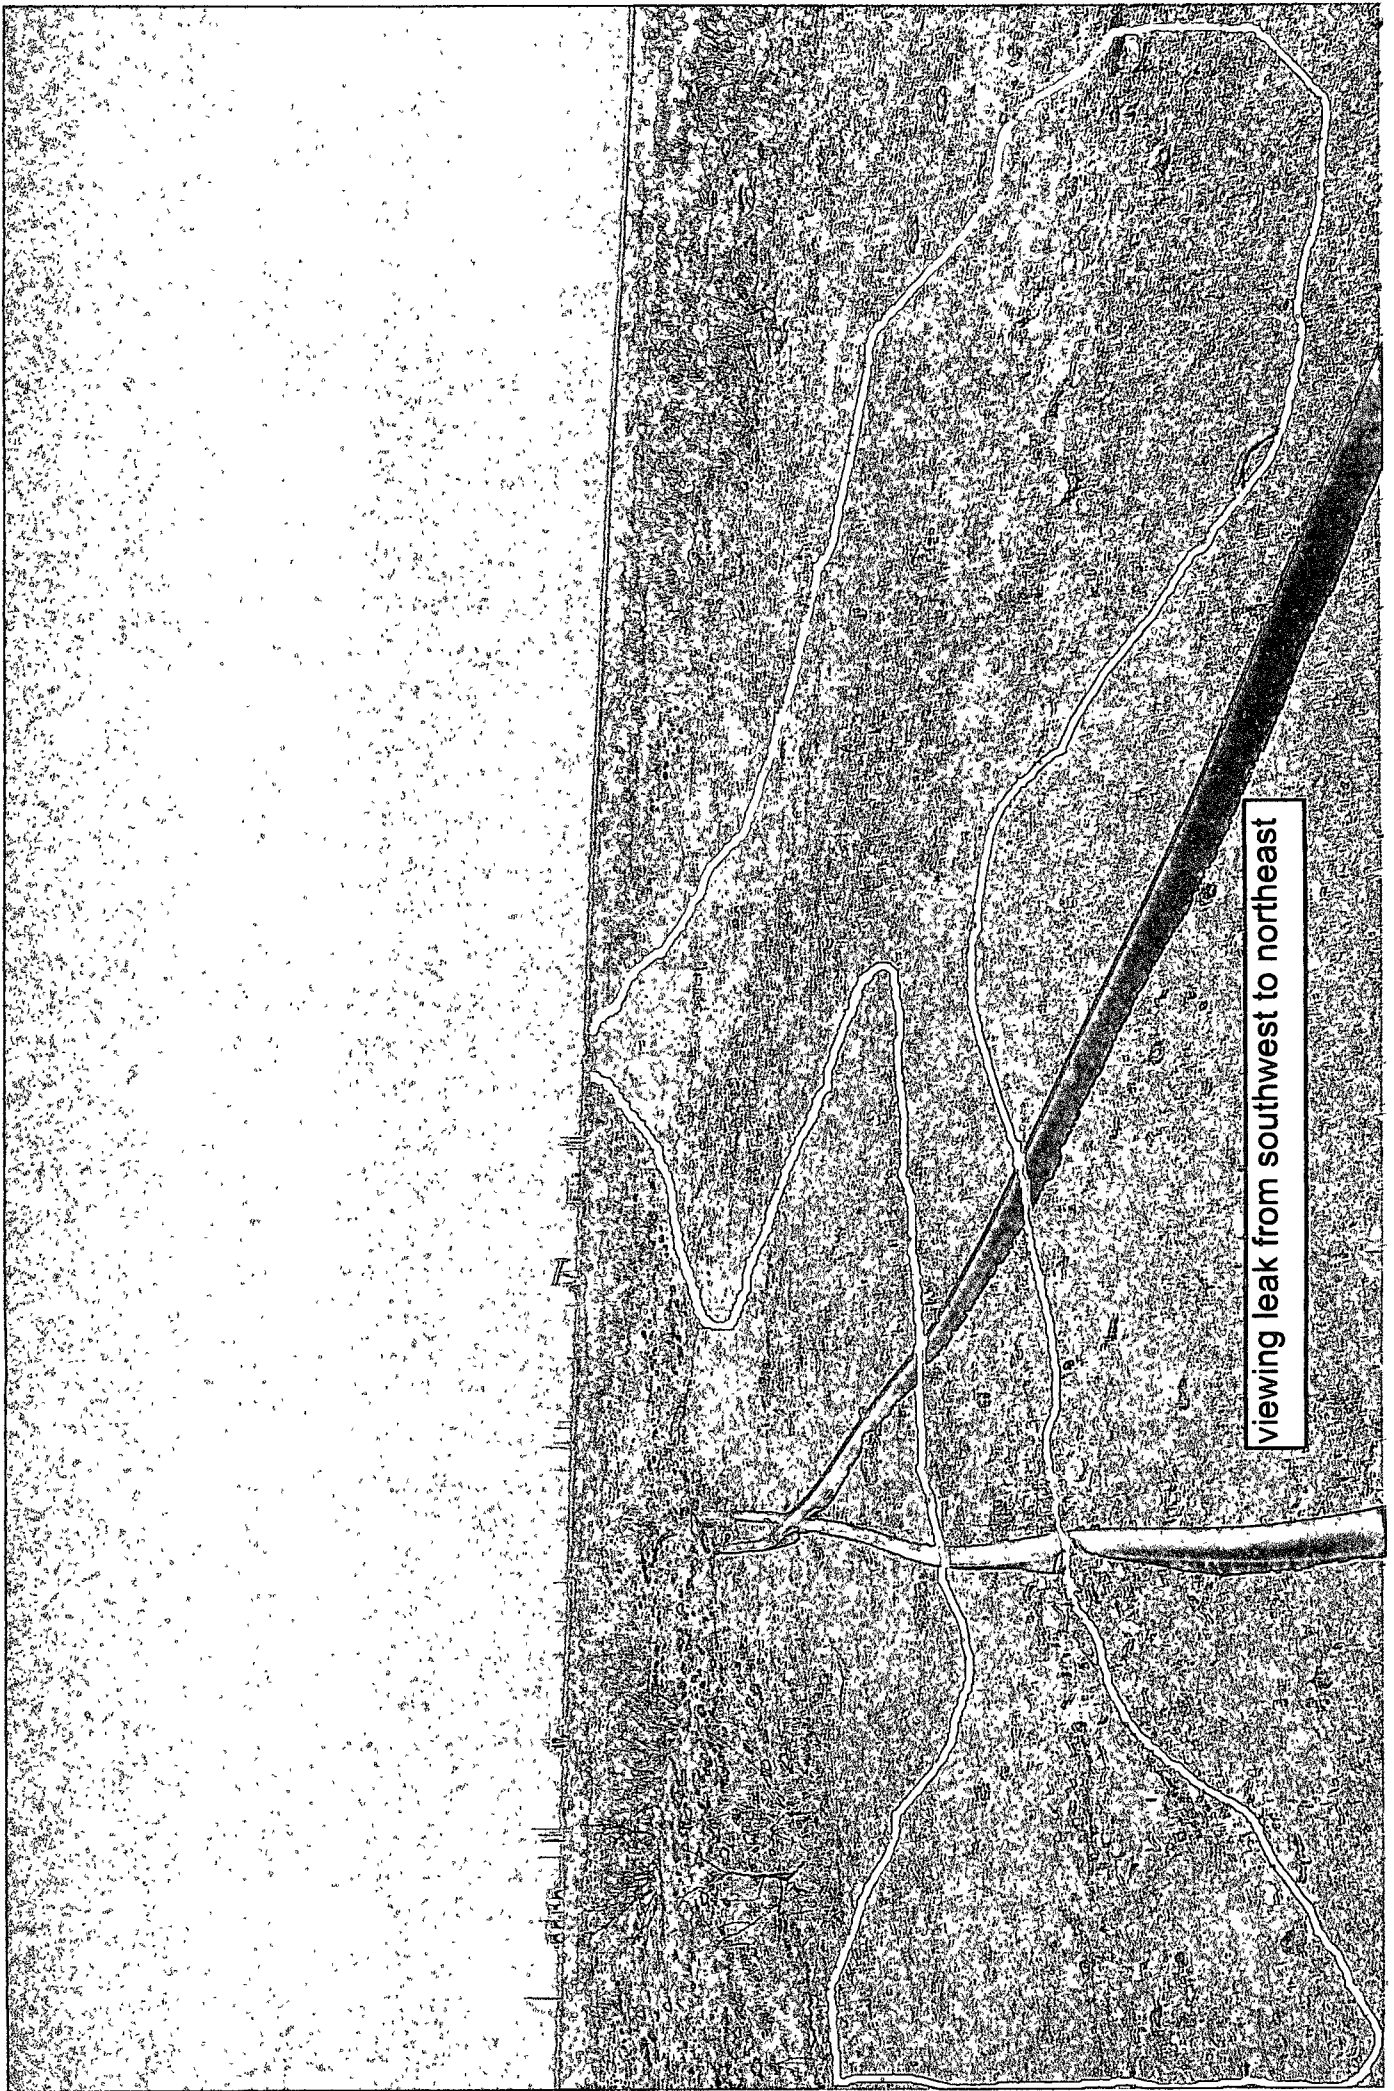
viewing leak from southwest to northeast

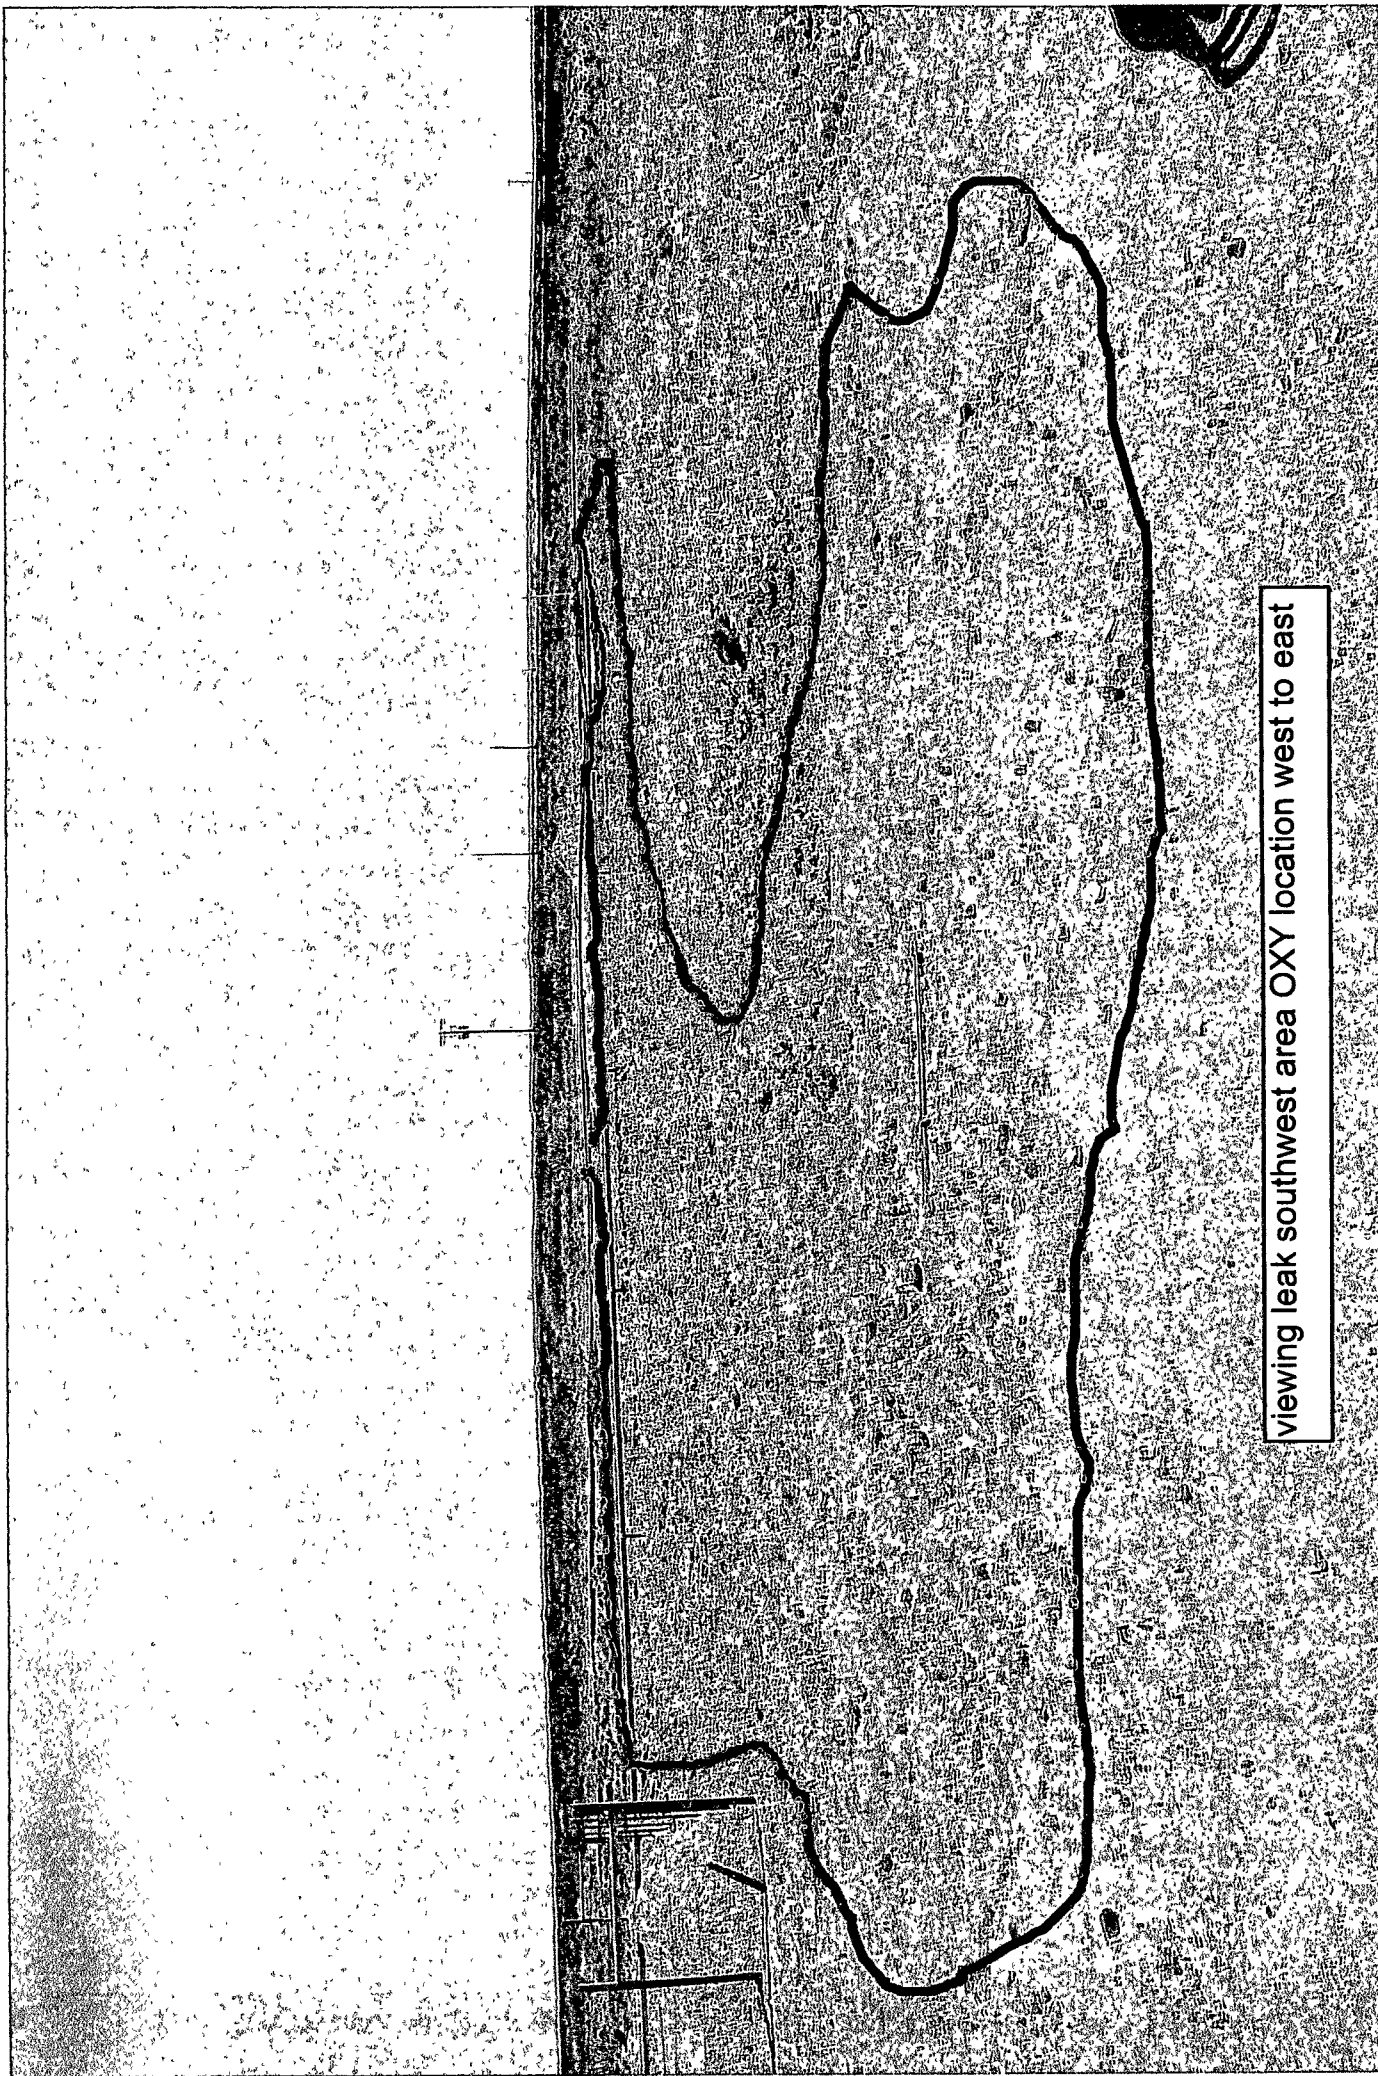
viewing leak southwest area OXY location west to east

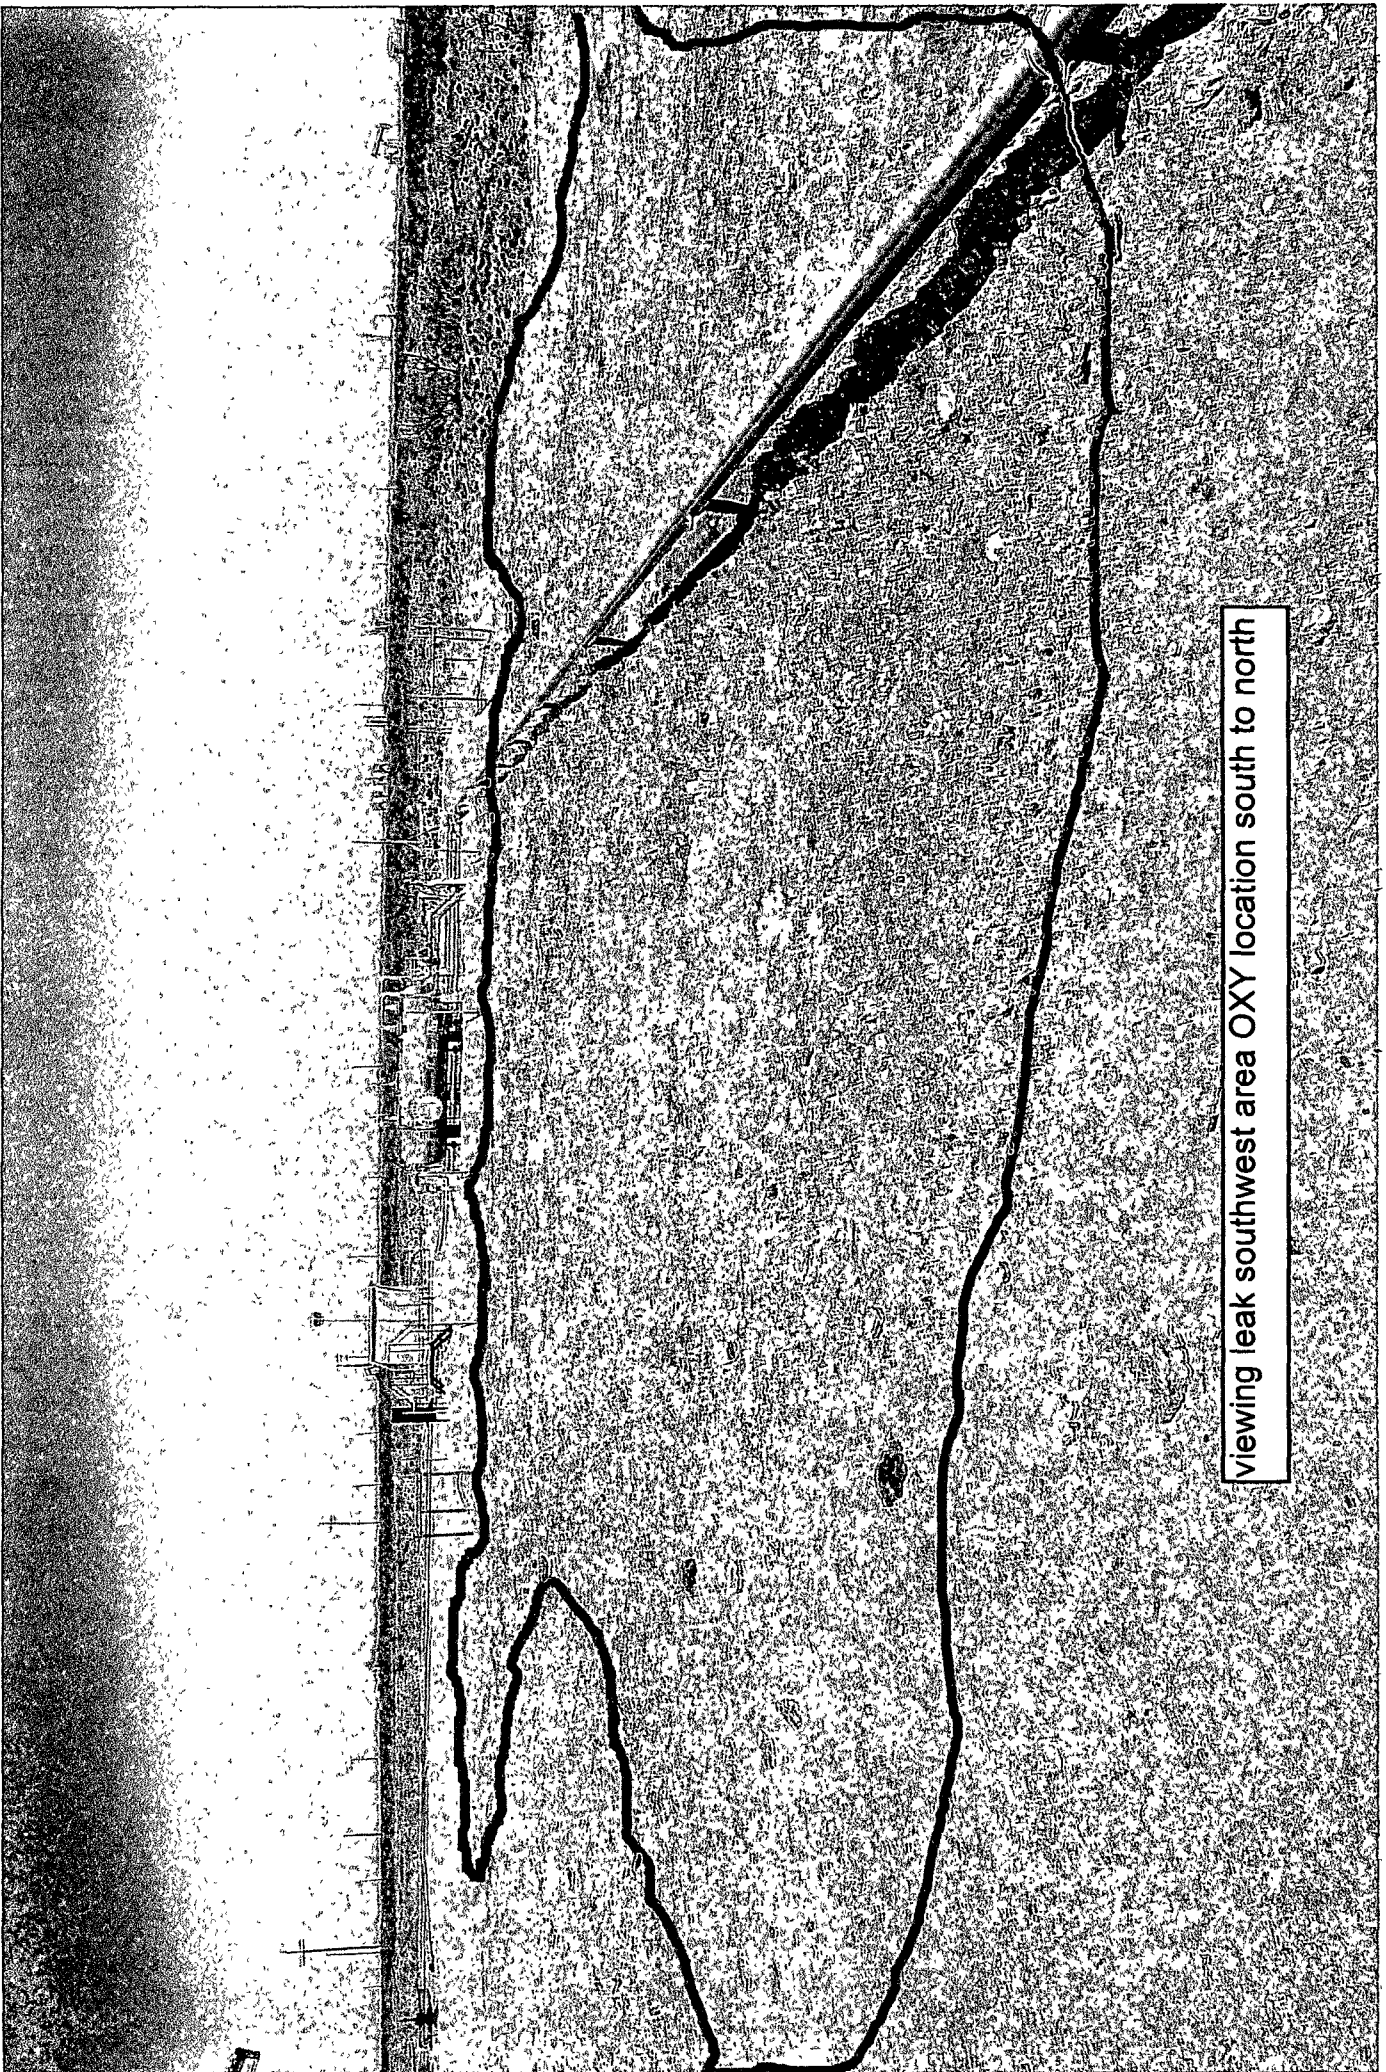
viewing leak southwest area OXY location south to north
