Release Notification and Corrective Action

**Holly Energy Partners
Monument Junction
Section 10, Township 20 South, Range 37 East
Lea County, New Mexico**

Closure Report

October 27, 2010

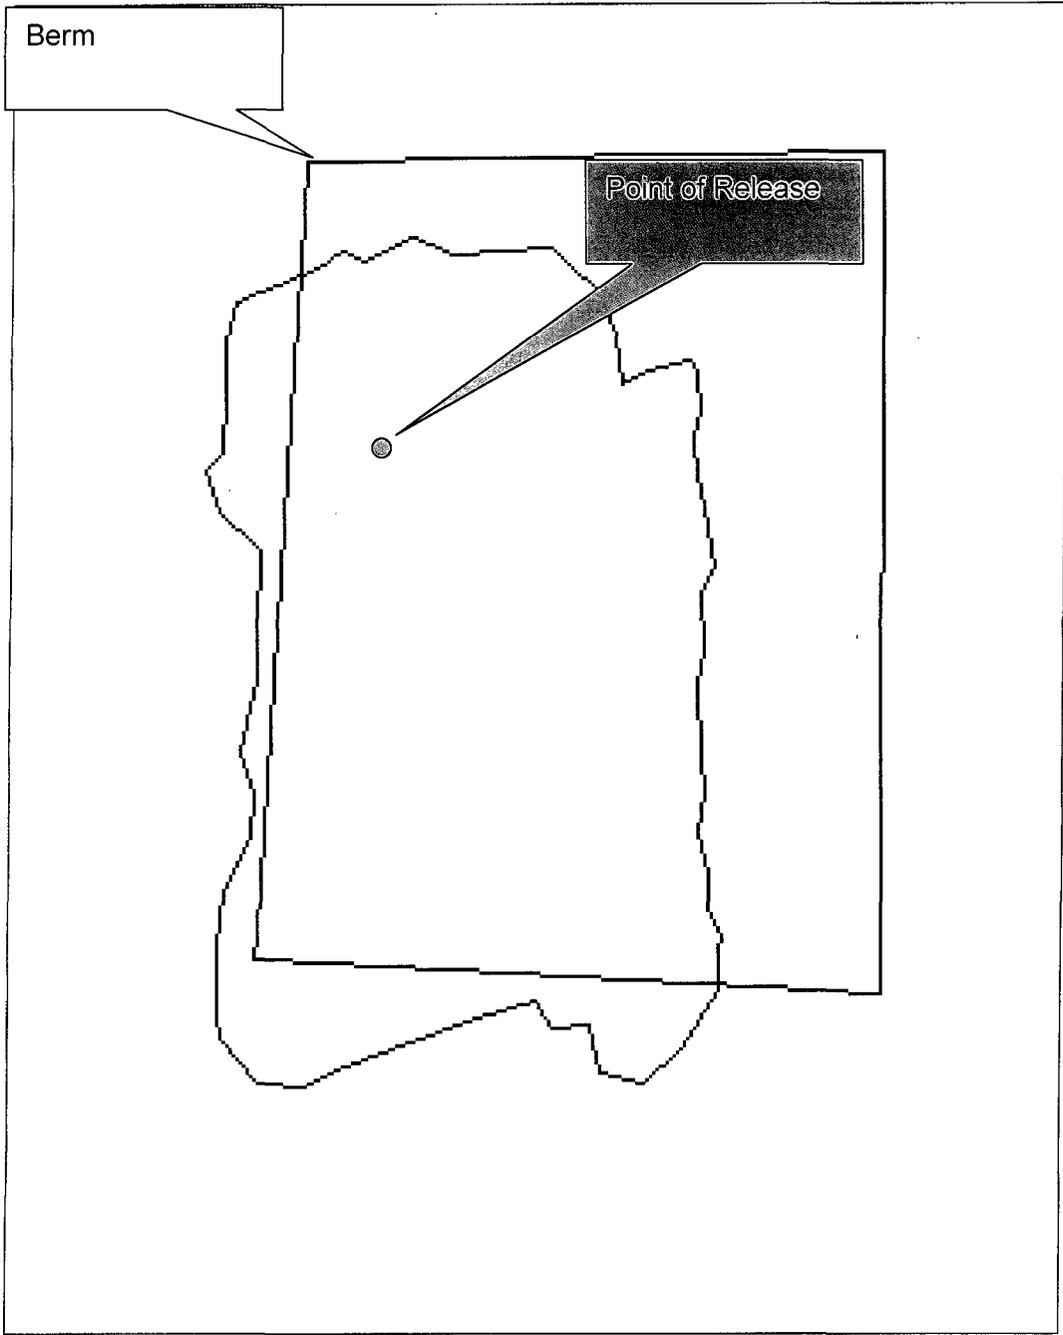
***Figure 2
Site Plan***

On February 10-16, 2010 Safety and Environmental Solutions, Inc. (SESI) was onsite with D&D Construction to start excavating from inside berm area. One (1) test trench was installed on the northwest corner of the tank release.

This area was excavated to a depth six (6) to eight (8) feet below grade surface. Samples were retrieved in the corners of excavation and transported to Cardinal Laboratories in Hobbs, NM under chain of custody to be analyzed for Total Petroleum Hydrocarbons (TPH EPA Method 418.1) and Benzene, Toluene, Ethyl Benzene, and Total Xylenes, (BTEX EPA Method 8021B).

The area was backfilled with approximately 700 yards of caliche from an offsite facility. Upon approval from Control Recovery Inc. (CRI), approximately 520 yards of soils were transported to disposal facility. The area was then contoured and a three (3) foot berm was placed around tank location to prevent any further release.

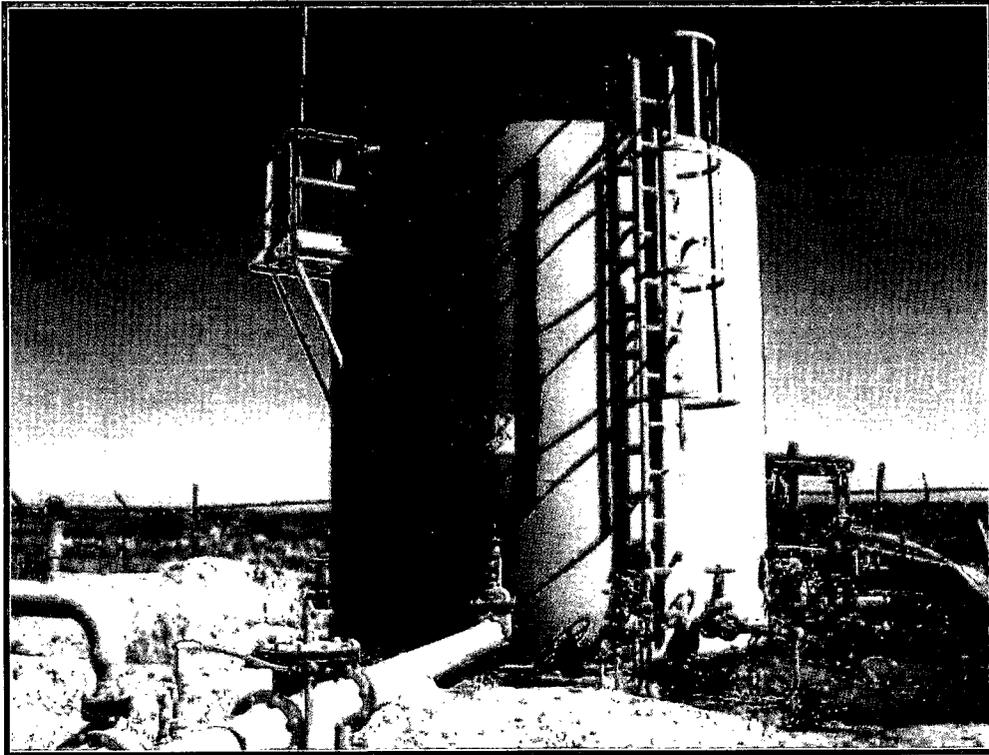
Tank

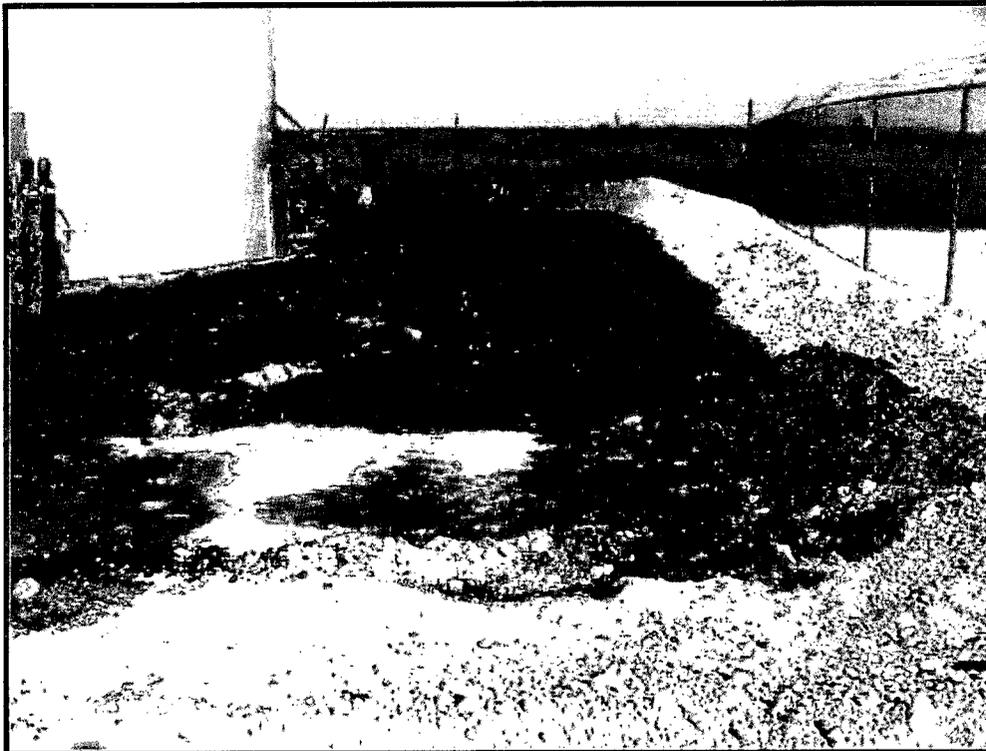
East of tank facing North

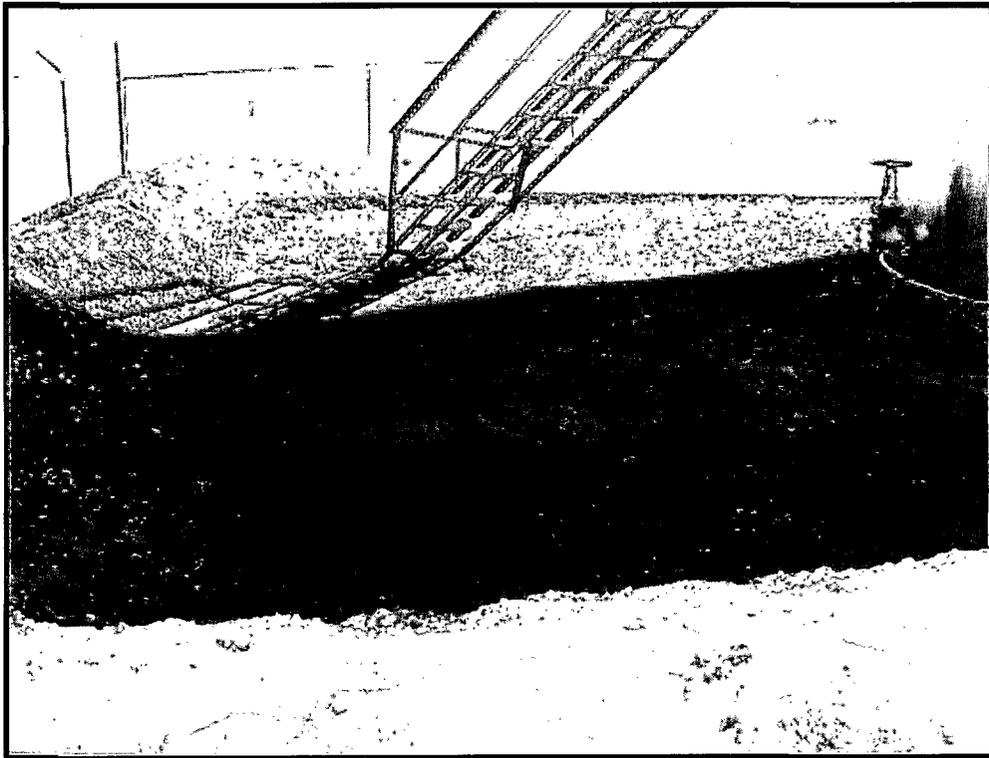
North of tank facing East

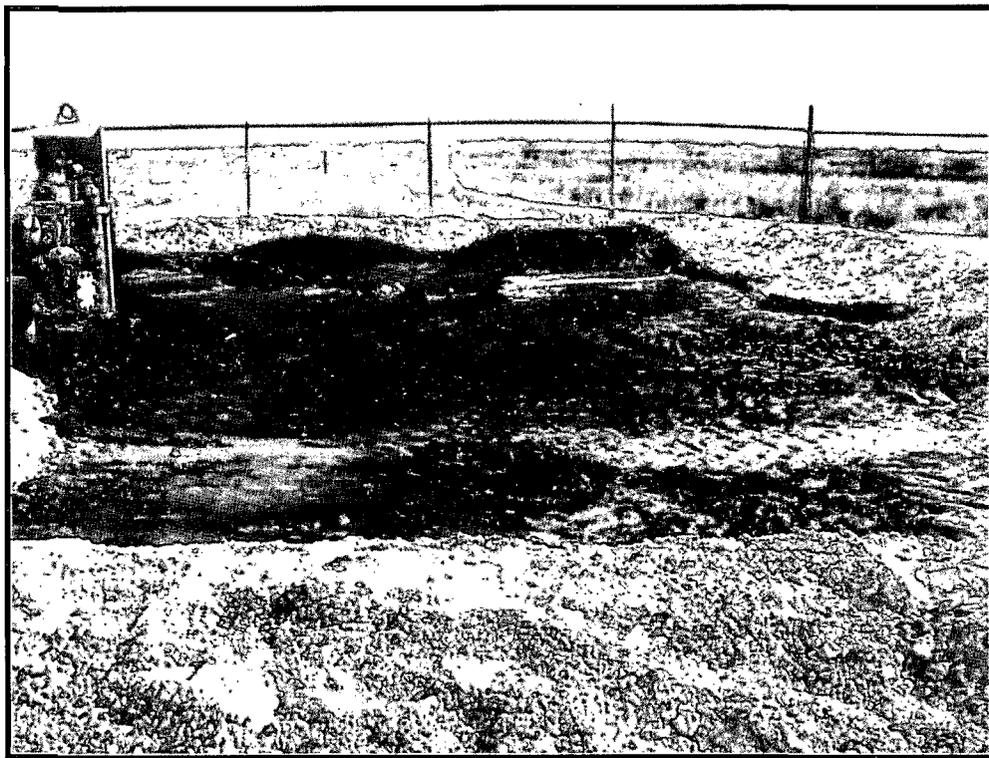
South of tank facing east

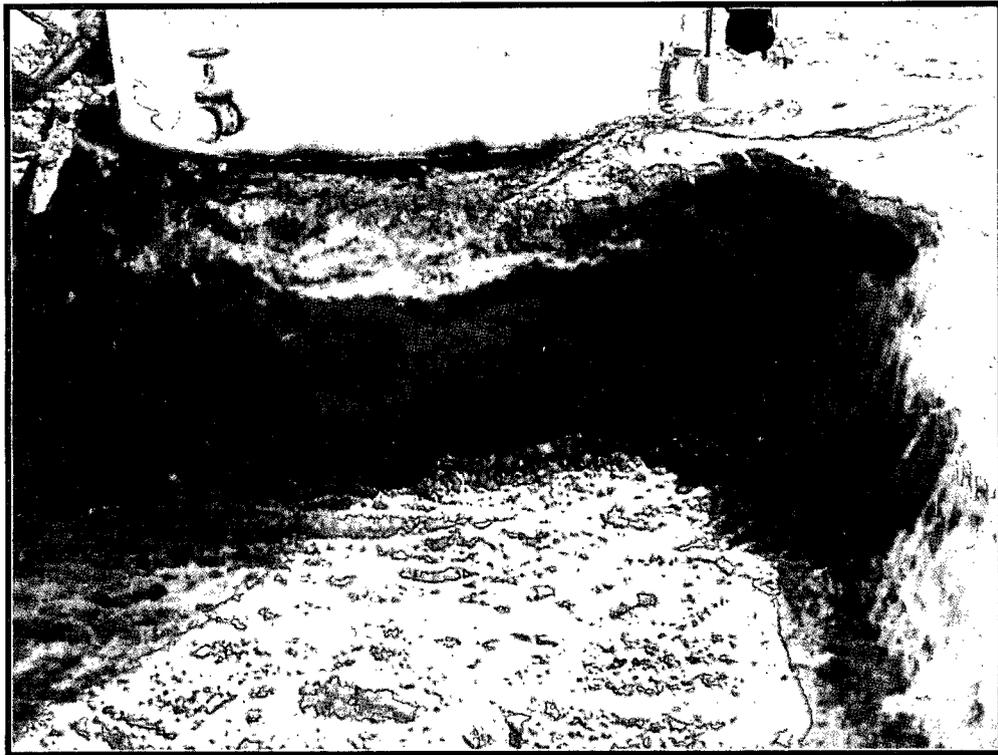
Northwest corner facing south

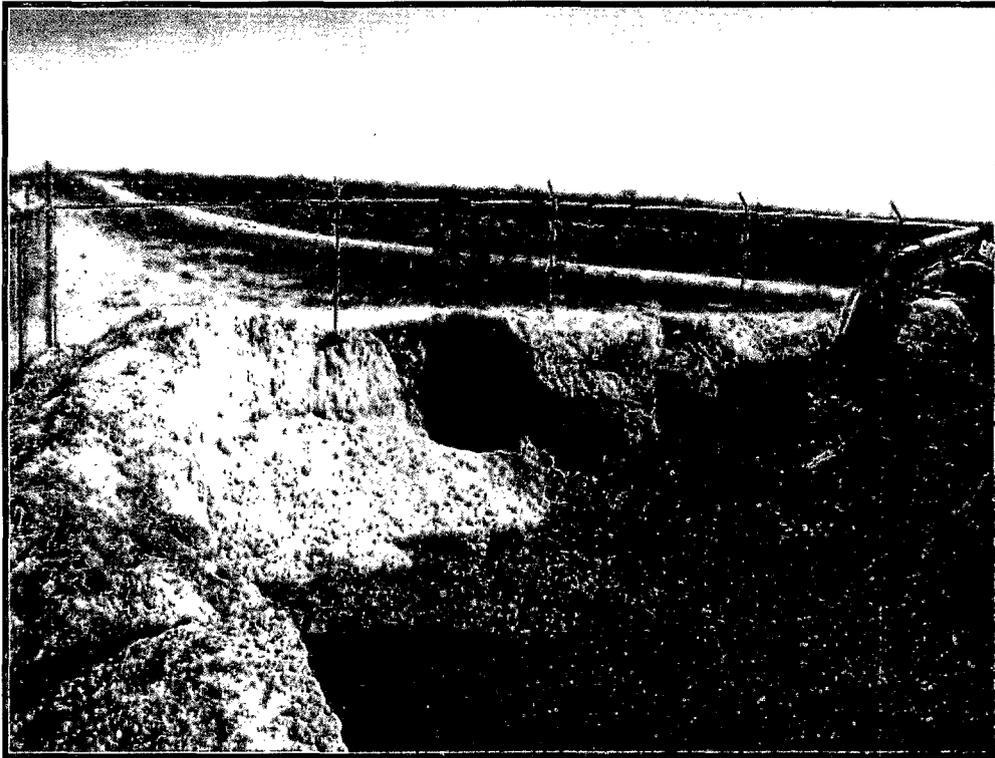
Northeast corner facing east

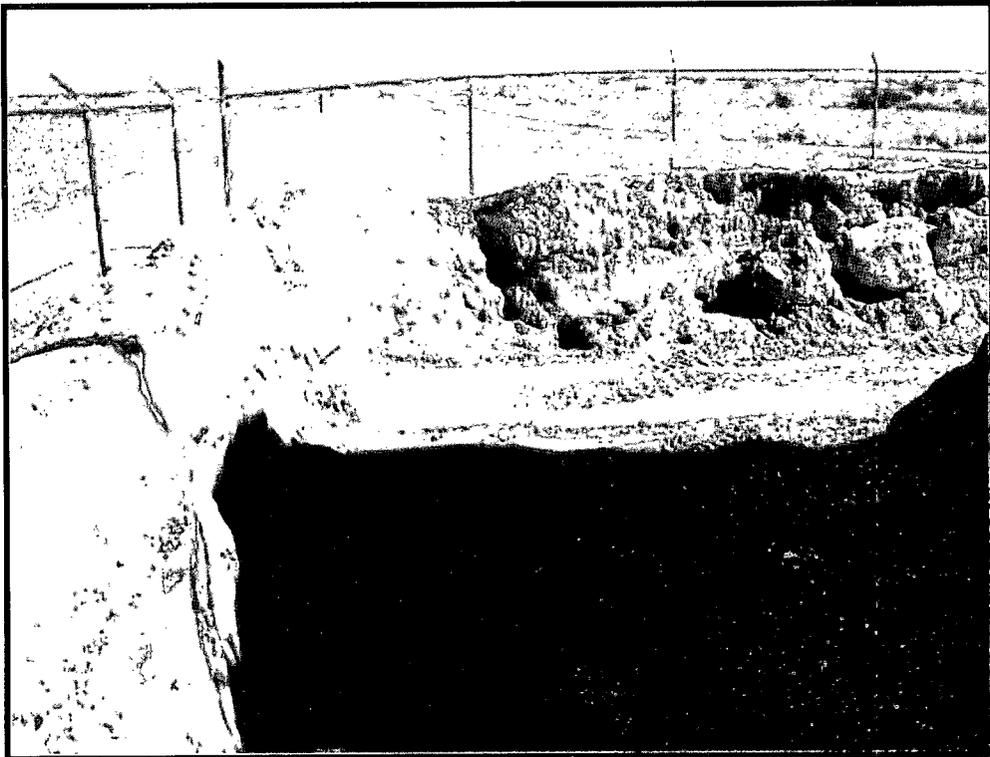
Excavated northeast corner facing east

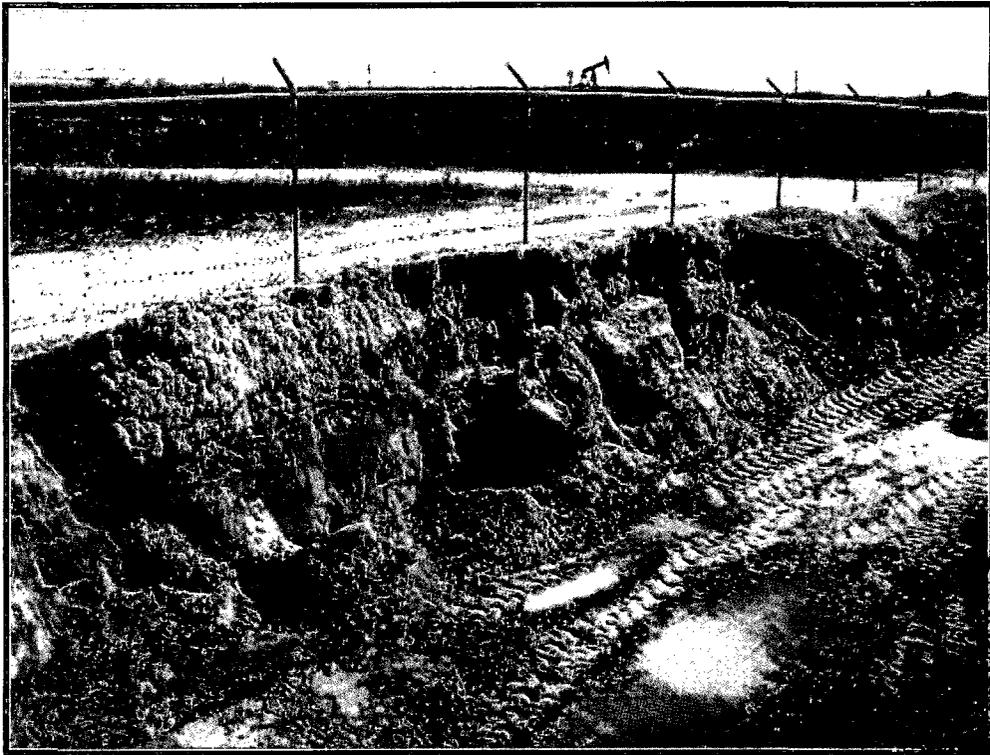
Excavated east wall facing southeast

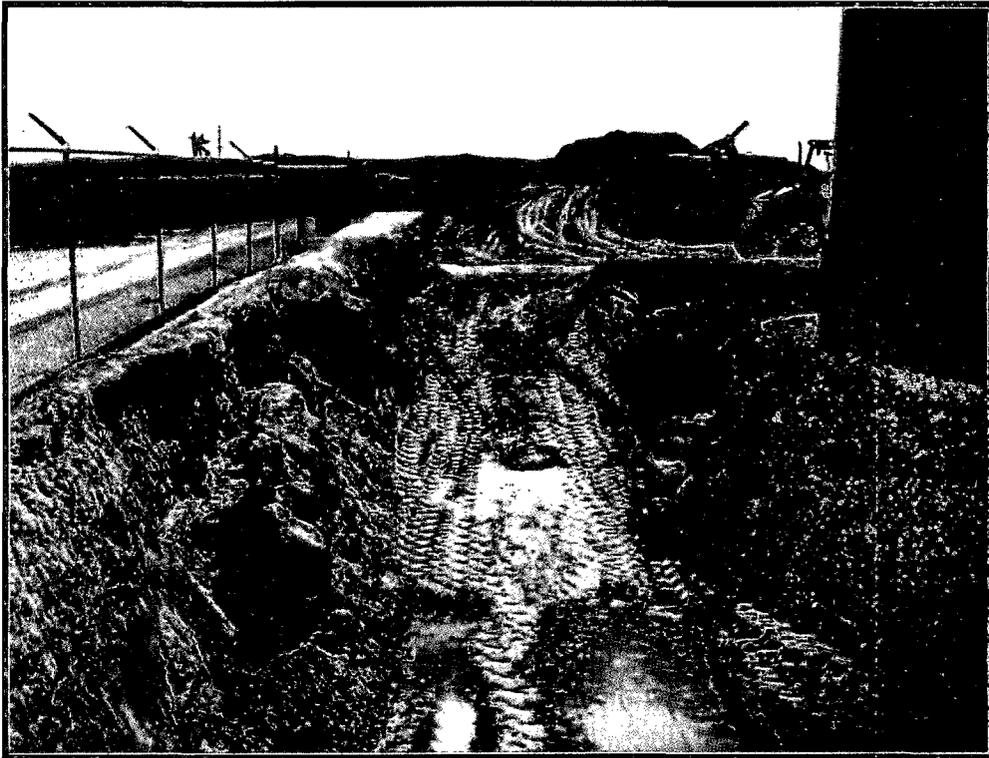
Excavated area facing south

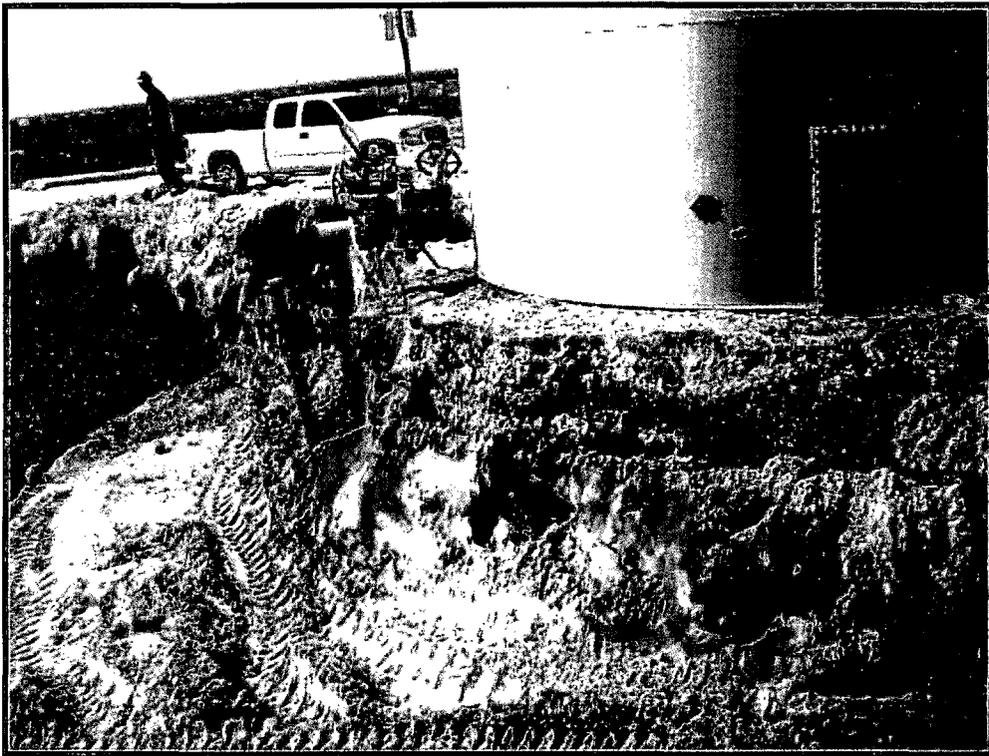
Excavated area facing west

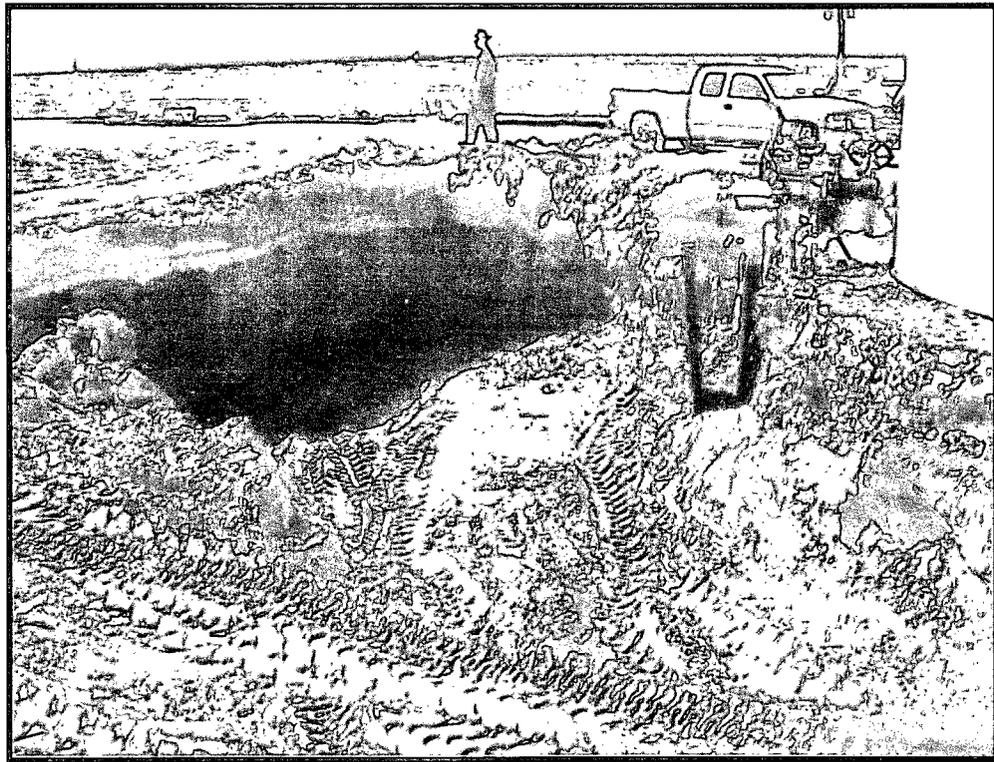
Excavated area facing southwest

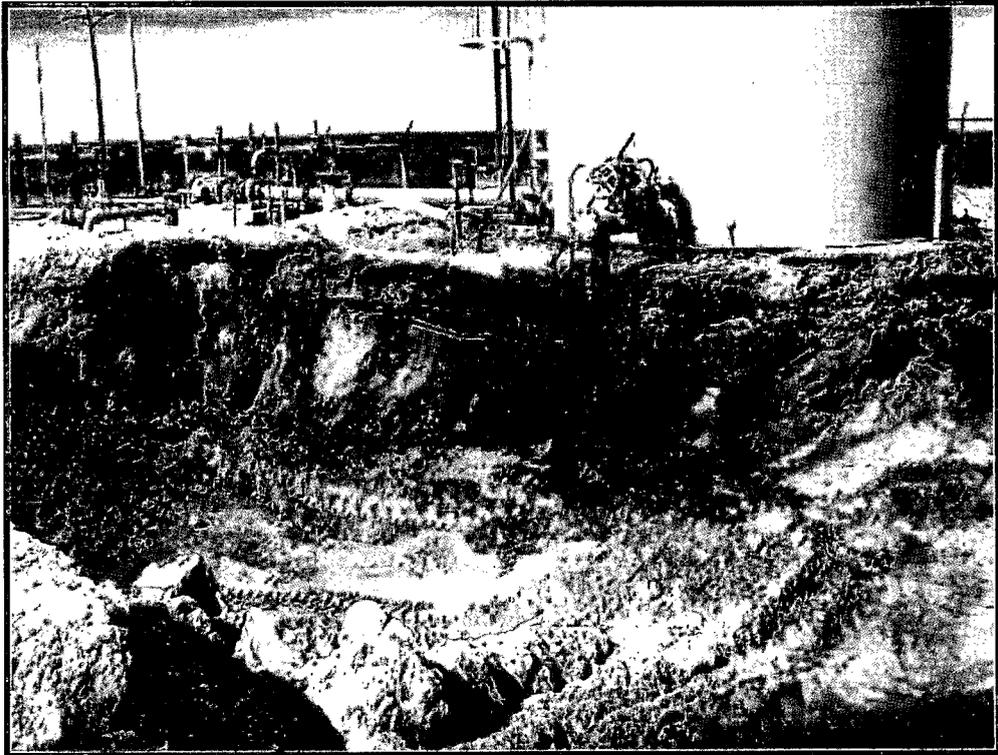
Excavated area around tank facing northwest

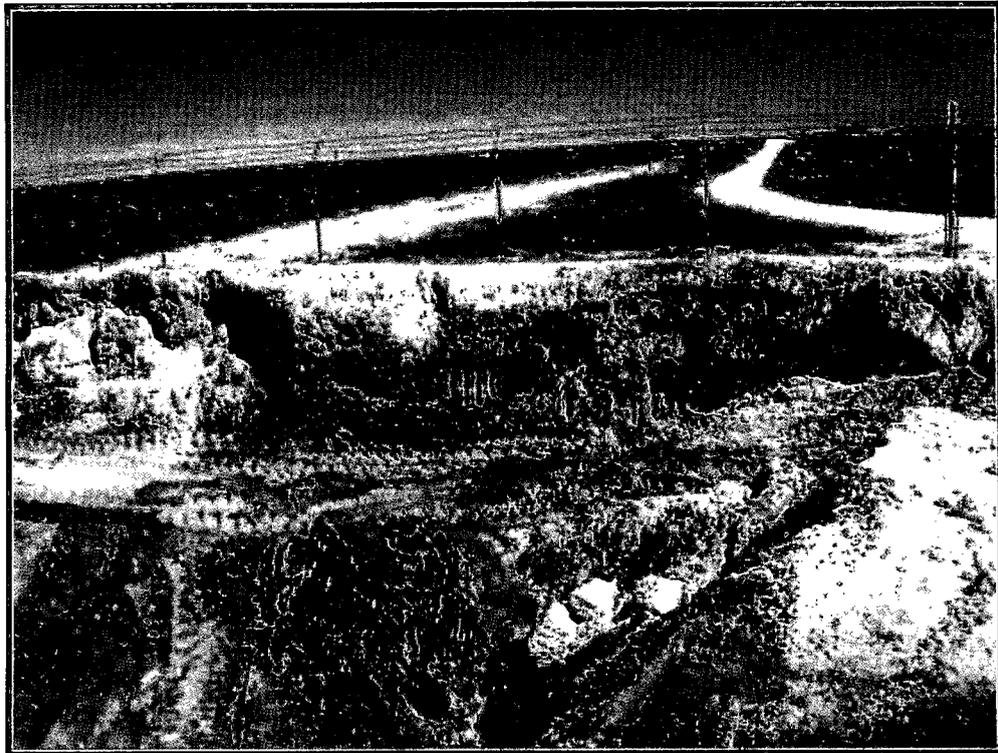
Excavated area facing east

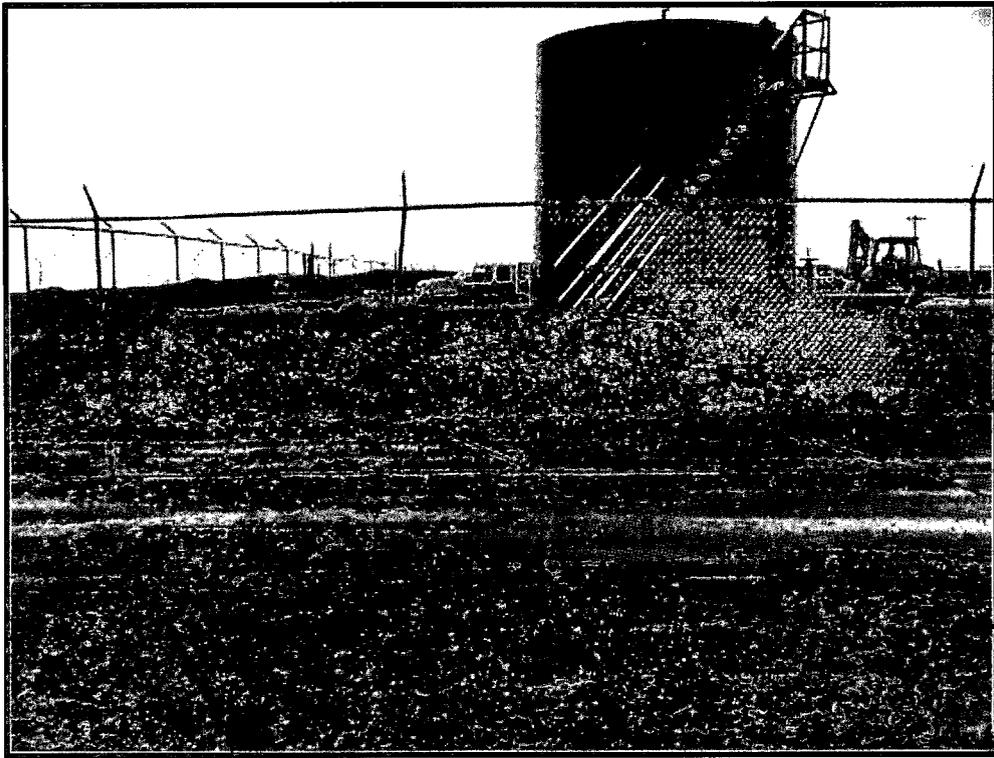
North of tank facing south

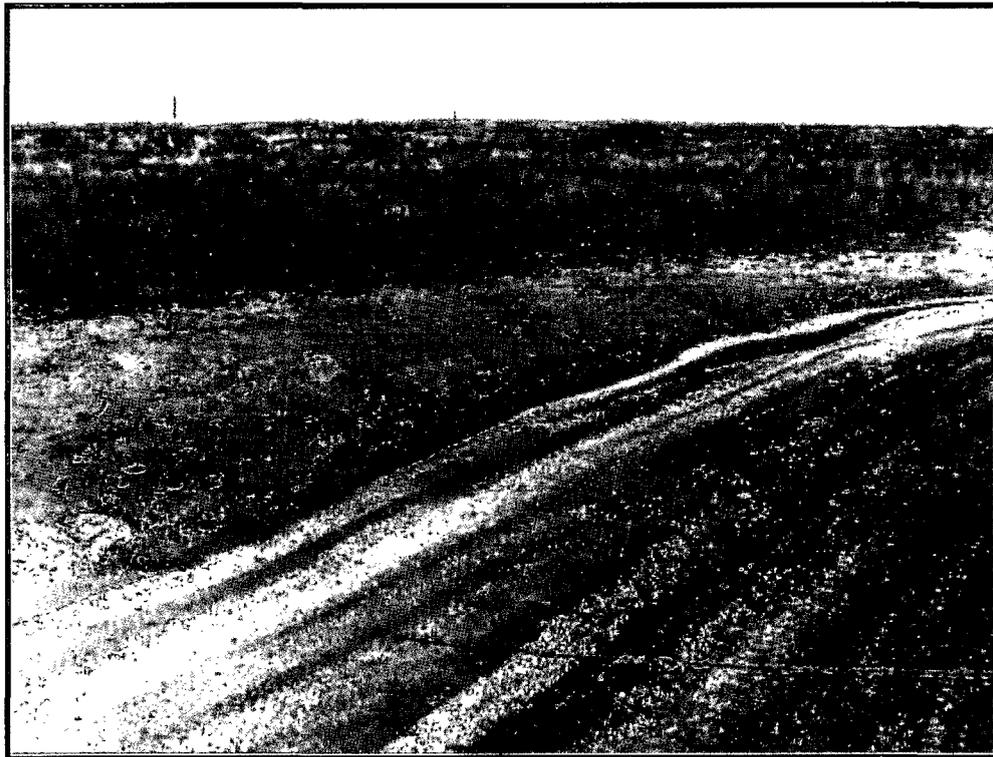
Overspray area facing northeast

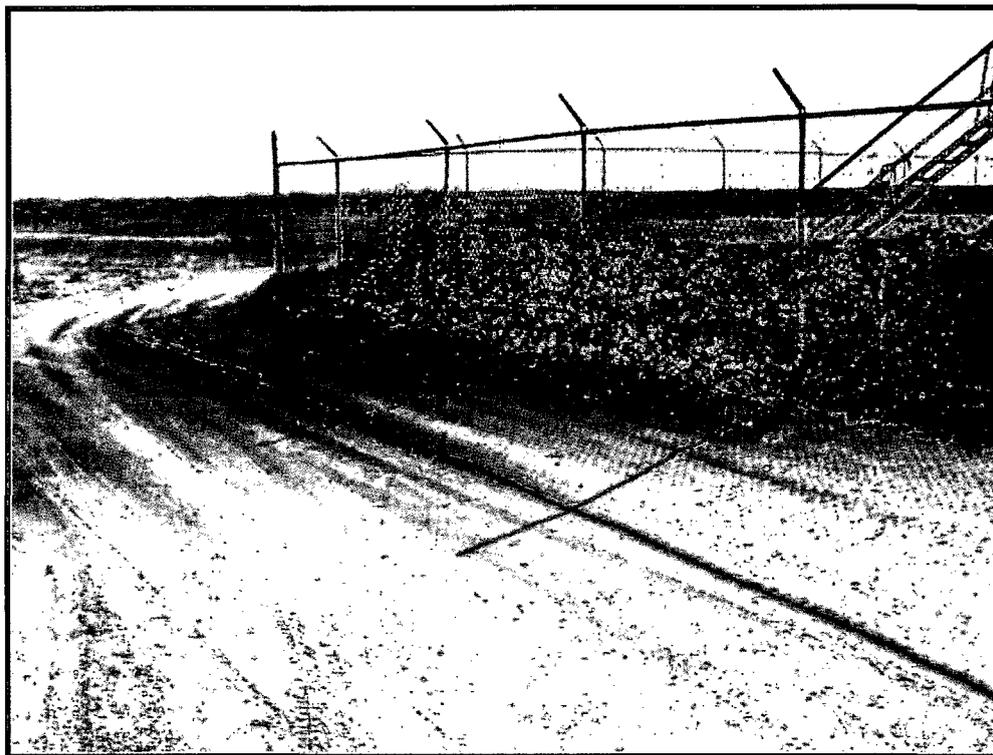
Overspray area north of location on lease rd

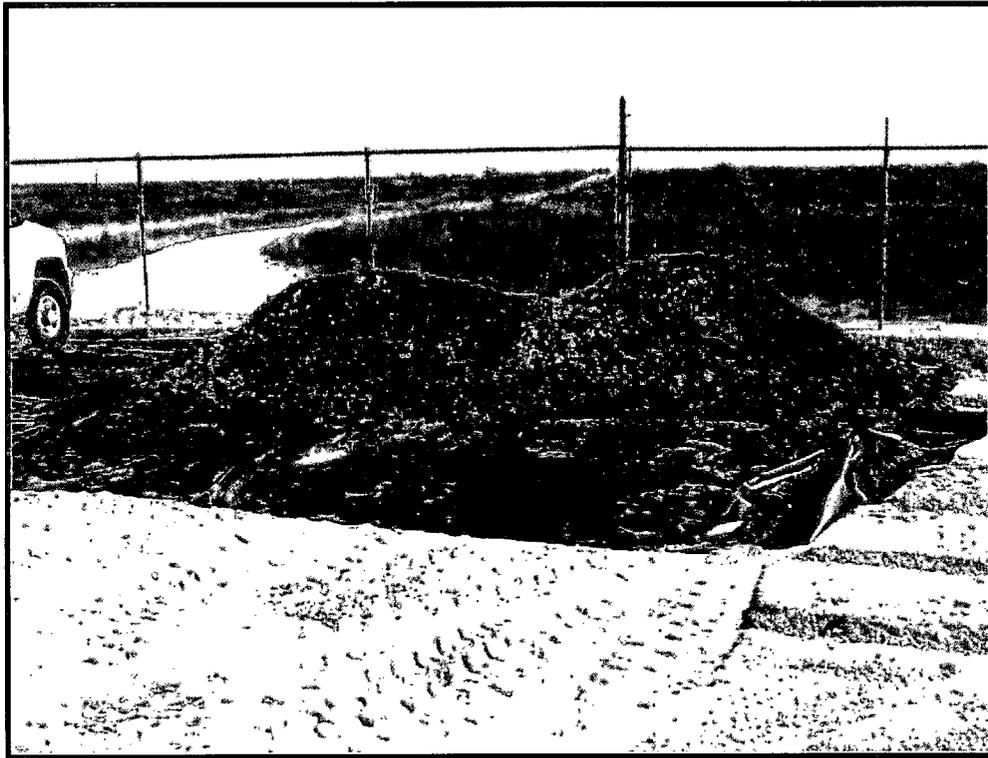
Spoils pile south of tank
