GW - 35

**INSPECTIONS &
DATA**

TK-1403
Internal Inspection and Repair Report
August 08, 2008

Conoco Inc. San Juan Gas Plant
OCD Discharge Plan Inspection
Inspectors: W Price, Ed Martin, B Martin

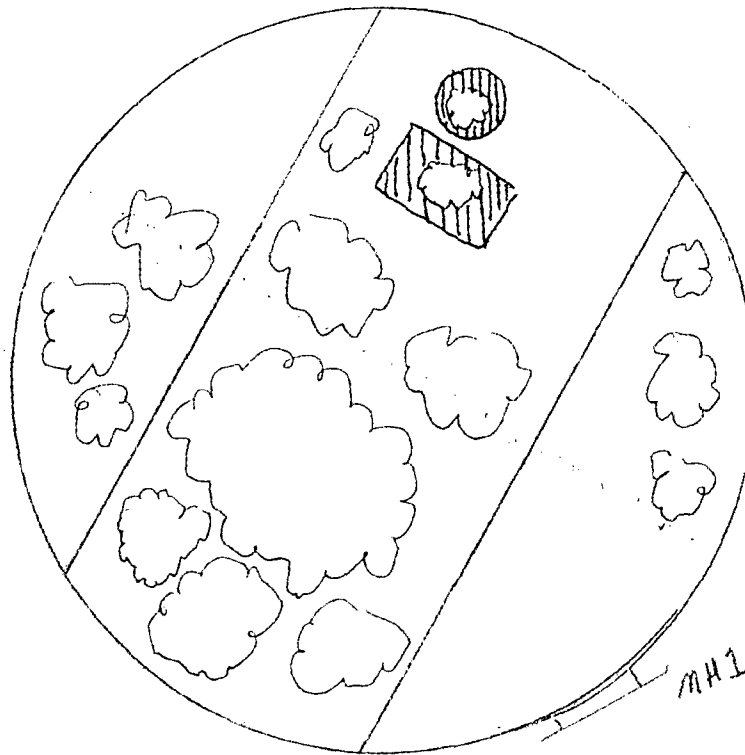
WELD MAP.

- Thickness measurements were taken of the tank floor, which showed general corrosion from 0.100" to 0.125", with isolated pitting to 0.240".
- The MHI nozzle had corrosion between the shell nozzle and the forged flange at the weld.
- The internal projection for nozzle D (drain) was badly deteriorated. The side facing the rear of the tank was deteriorated almost to the tank shell.
- The external caulking at the shell penetrations and the bottom of the tank had failed.

CORROSION 0.100" TO 0.150"

CORROSION OVER 0.240"

LAP PATCHES (WELD REPAIR)

- Clean the internal surfaces of the shell and floor of all corrosion product. Inspect the pitted areas for severe pitting greater than 0.210" deep. Any pits deeper than 0.210" should ground smooth, visually inspected for cracking, filled by deposition of weld metal, and inspected by the magnetic particle testing (MT) method. All areas should be coated up to 30" of the shell with a coating suitable for the intended service. The newly coated areas should be inspected by a suitable method of holiday (defect) detection.

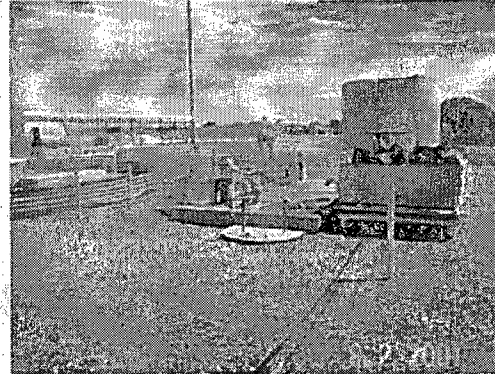
Pic #4 Skimmer Basin-single wall

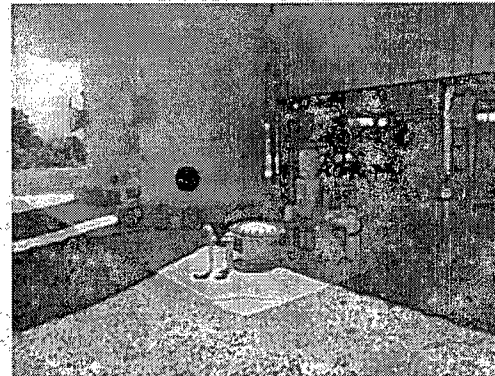
Pic #5 Lube Oil below grade tank- single wall

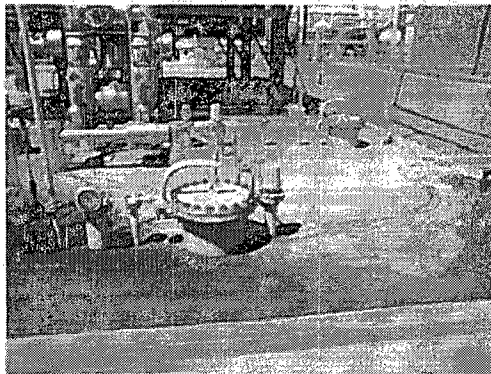
Pic #3 Amine Waste Sump area- Sumps are single wall.

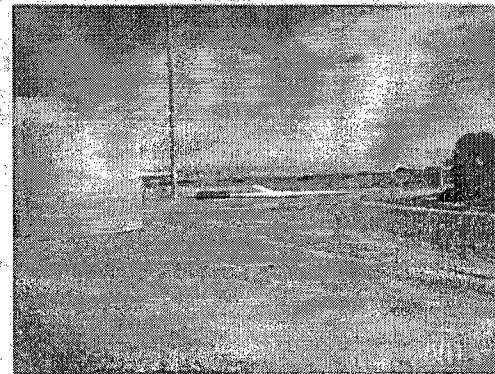
- PIC #1 - SIGN
- PIC #6 - STORMWATER POND UNLINED - BACKGROUND WEST EVAP POND
(CATCH BASIN) + FLARE STACK
- WEST POND LEAK DETECTOR SHOWING SIGNS OF LEAKAGE -

Pic #6- Looking SE. Stormwater unlined retention pond, fire water tank, flare stack, and background shows west plant evaporation pond. Leak detection indicates primary liner is leaking.
