From: Cheryl Winkler [cmwink@me.com]
Sent: Tuesday, January 18, 2011 2:20 PM
To: Bratcher, Mike, EMNRD
Cc: tbrandt@mar-win.com
Subject: Dublin 23 Federal No. 1 Photos
Attachments: IMG_5726.JPG; IMG_5942.JPG; IMG_5940.JPG; IMG_5939.JPG; ATT00001.txt

From: Cheryl Winkler [cmwink@me.com]
Sent: Tuesday, January 18, 2011 9:41 AM
To: Bratcher, Mike, EMNRD
Subject: Dublin 23 Federal No. 1 Analyticals
Attachments: Dublin 23 Fed. No. 1 Post 2nd Excavation.pdf; Dublin 23 No. 1 Spill Initial Summary.pdf

Project Name: Dublin Federal 23 No. 1

Project Name: Dublin 23 Fed. No. 1 Discharge
Project Number: Unauthorized Discharge

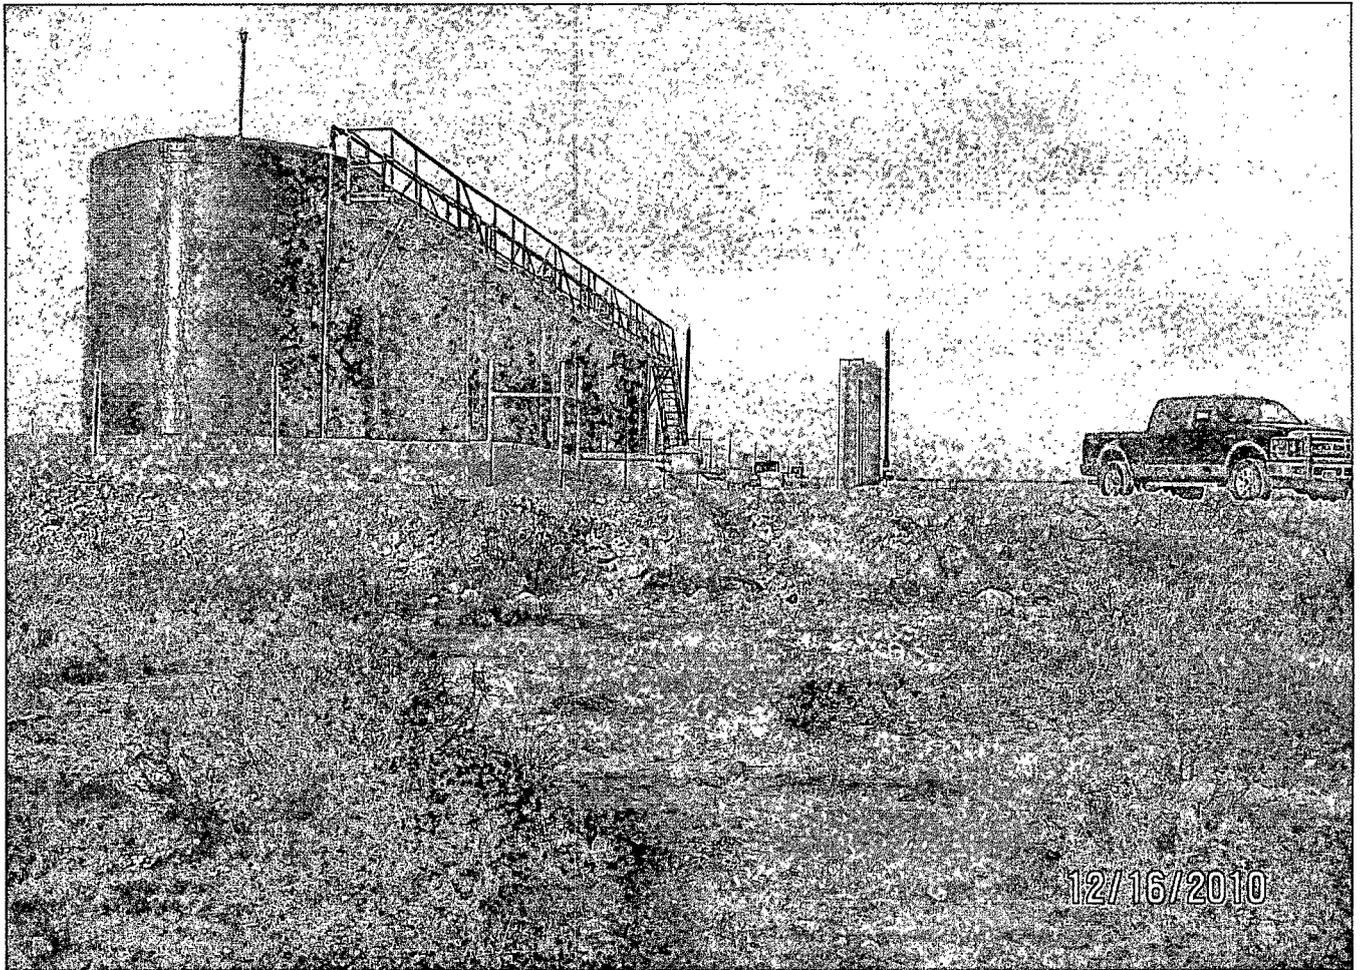
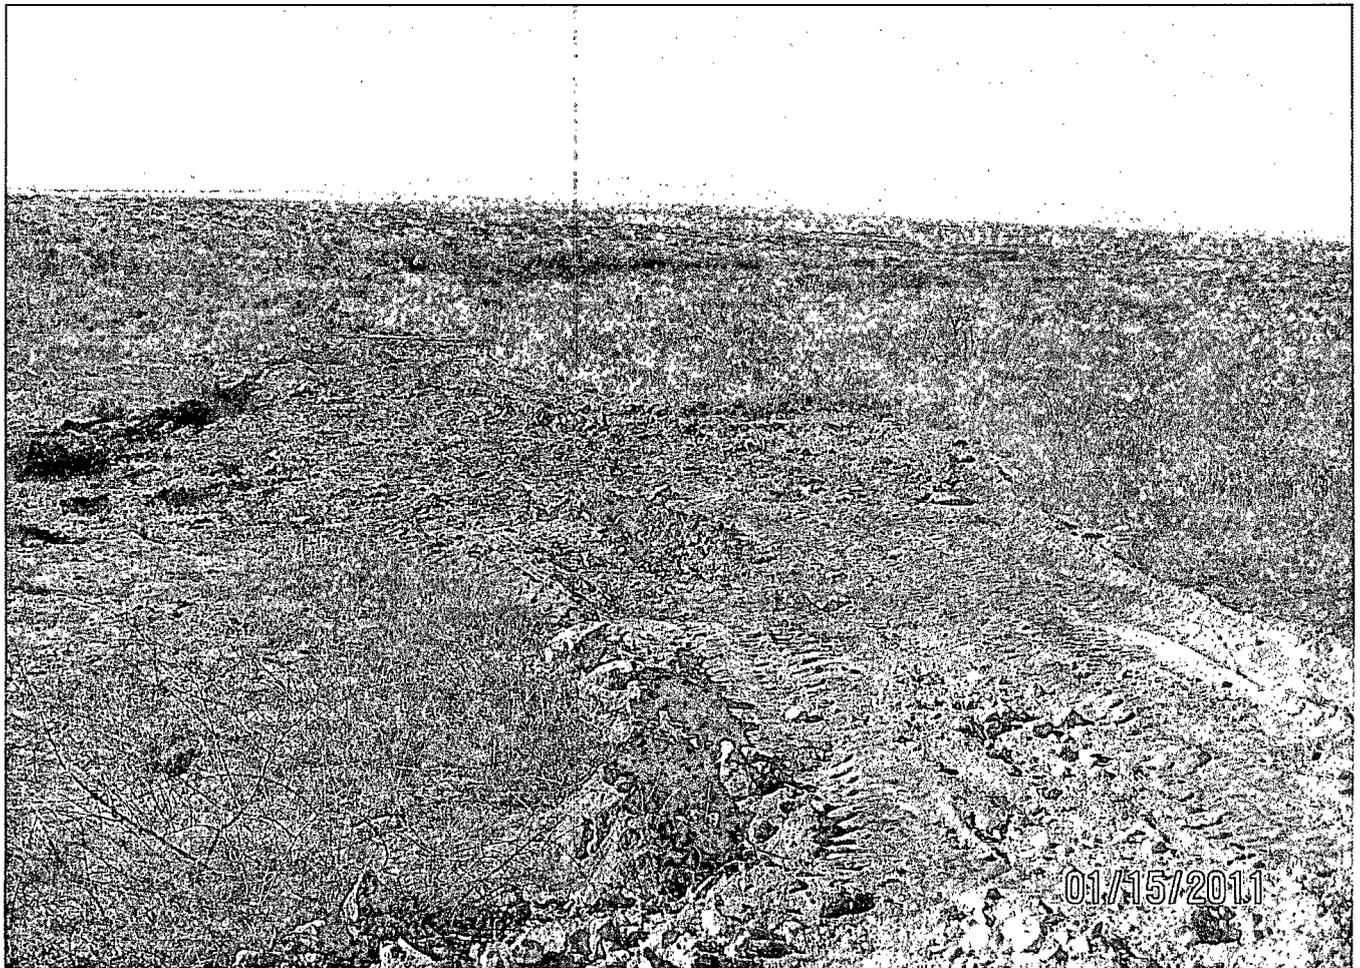
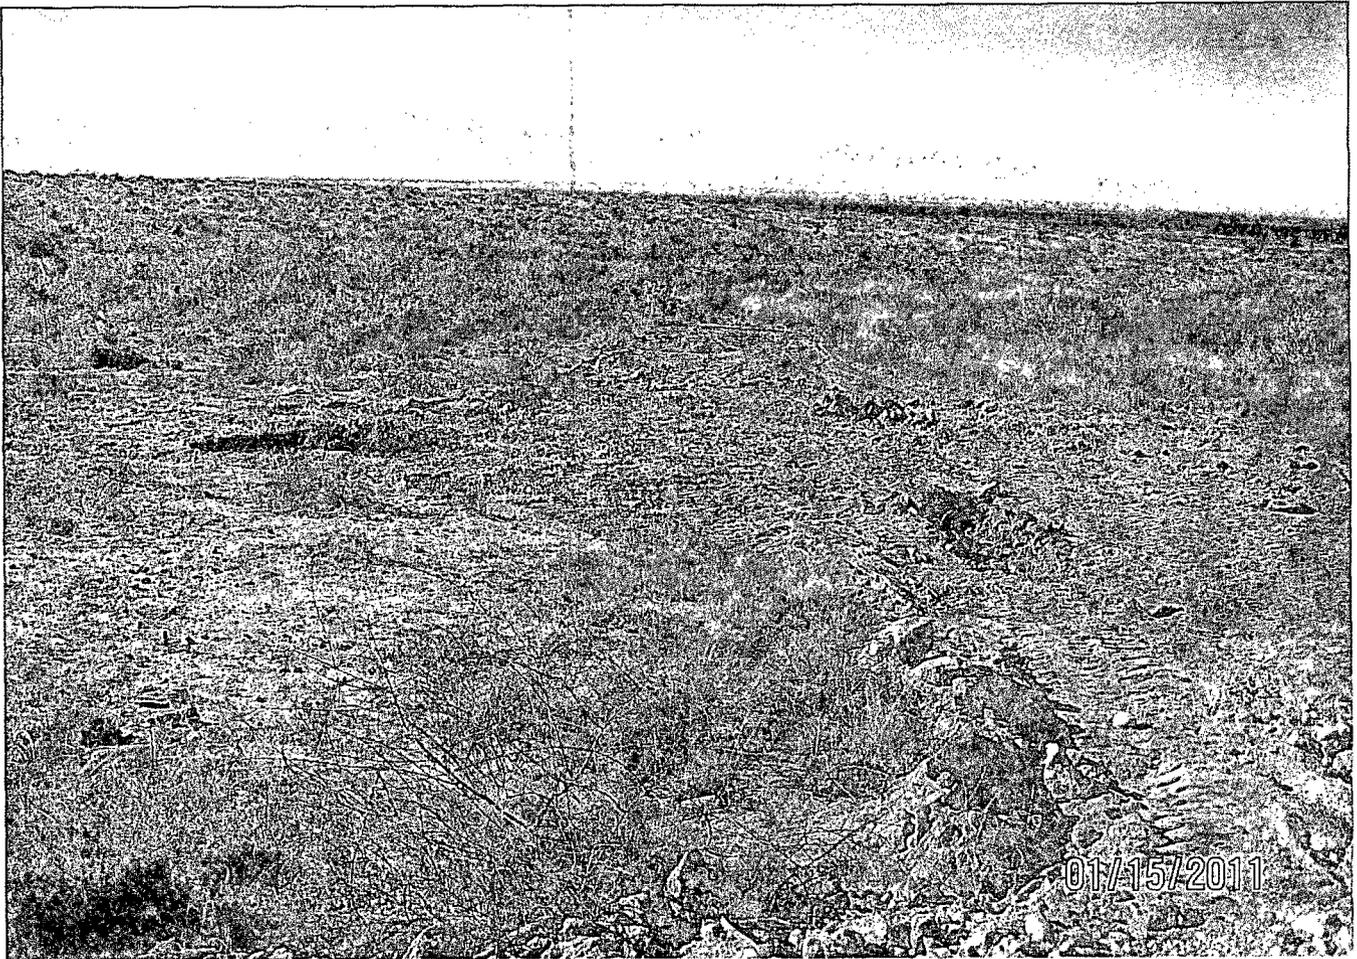
These photos were taken following the last excavation. It is extremely rocky. It may look like there is a lot of soil but we are on a solid rock cap and beneath the river rock in the area. One can see the ratio of rock to available soil which is only a paucity compared to the surface area which is occupied by the rock. Therefore, the soil chloride numbers are skewed completely because there is a small amount of soil absorbing the salt which makes it appear "hotter". The whitish dust seen in the foreground is caliche dust generated by the pad; transported by precipitous events (such as rainfall) and/or wind erosion - a "constant player" in the deserts of New Mexico. The effected area is small, approximately 120' x 30' at its widest point.

Anyway, it is also 400 feet to groundwater which was verified during drilling. Just thoughts but this way you have a visual, Mike.

I also included a photo of the discharge before excavation which will provide some orientation.
