Date: Friday, July 22, 2005  
To: Environmental Compliance Officer, NMOCD District II  
From: Chris Beadle  
Subject: Levers A State 2 - 30-015-26895

Date: Thursday, October 20, 2005  
To: Environmental Compliance Officer, NMOCD District II  
Subject: Levers A State Tank Battery - Sandlott Energy

Sandlott Energy  
Levers A St 002  
30-015-26895

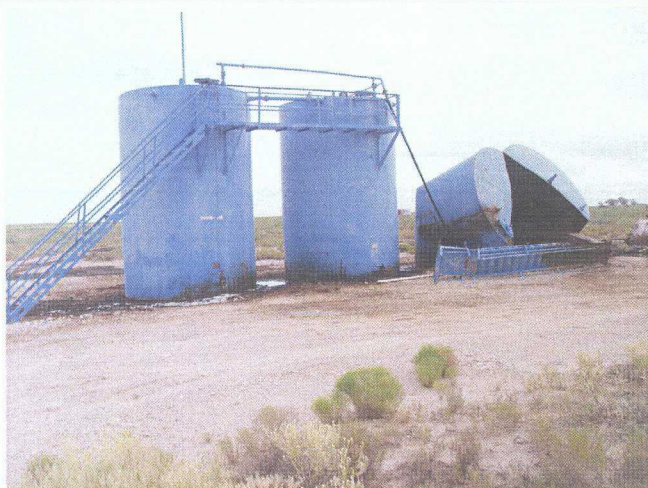
Photo of Tank Battery, collapsed tank and liquids pooling & chloride buildup.

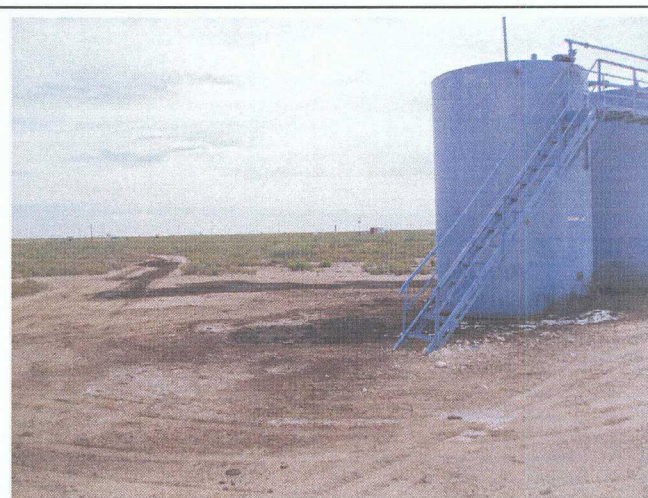
Photo of runoff from tank battery.

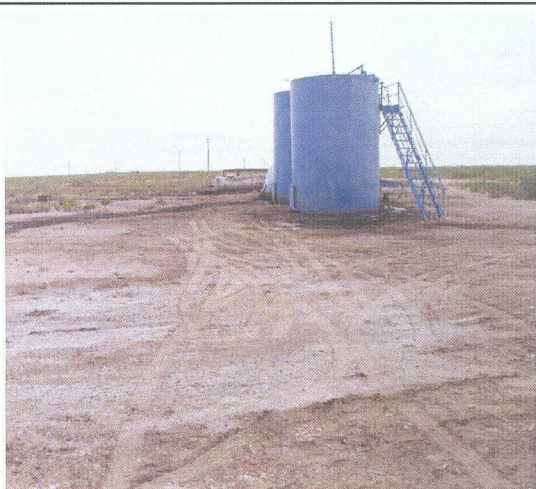
Photo of chloride pooling area.

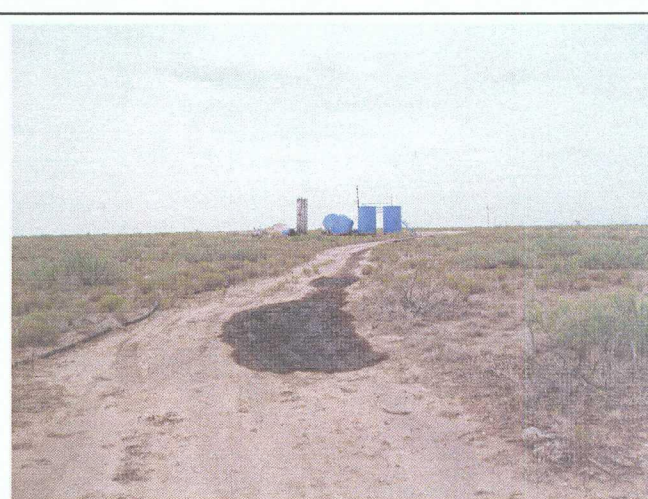
Photo from well area looking back up road to runoff from tank battery.

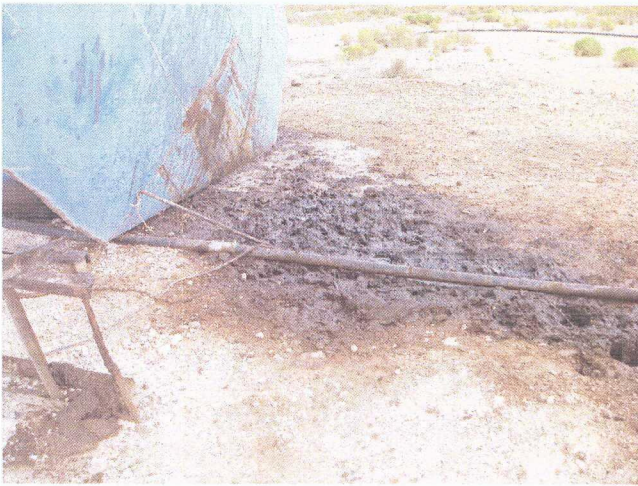
Photo of saturated soils at tank battery.

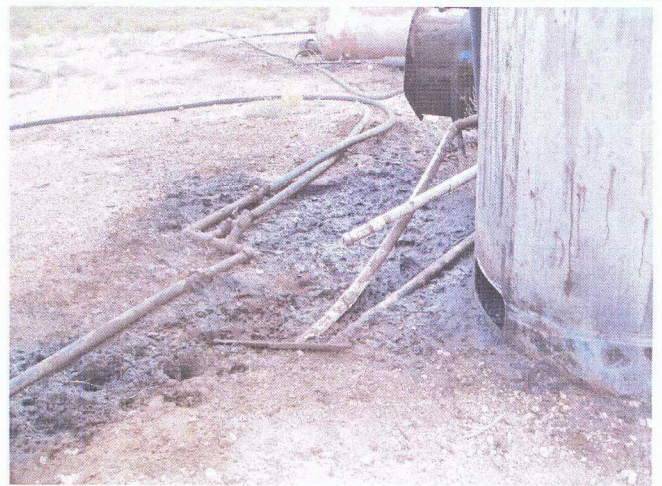
Photo of saturated soils at tank battery.

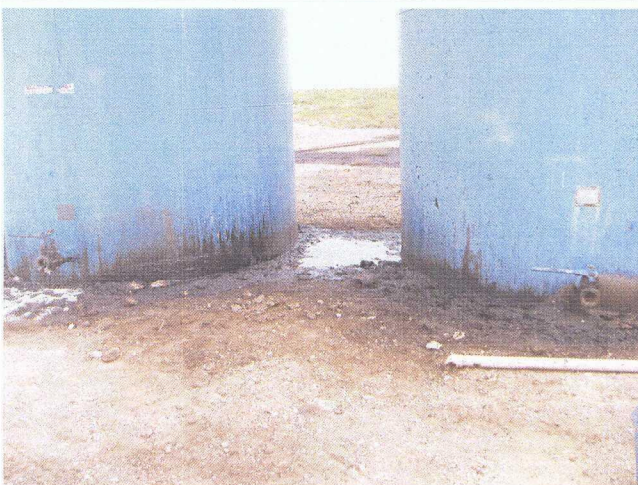
Photo of oil pooling at tank battery, chloride buildup on left hand tank.

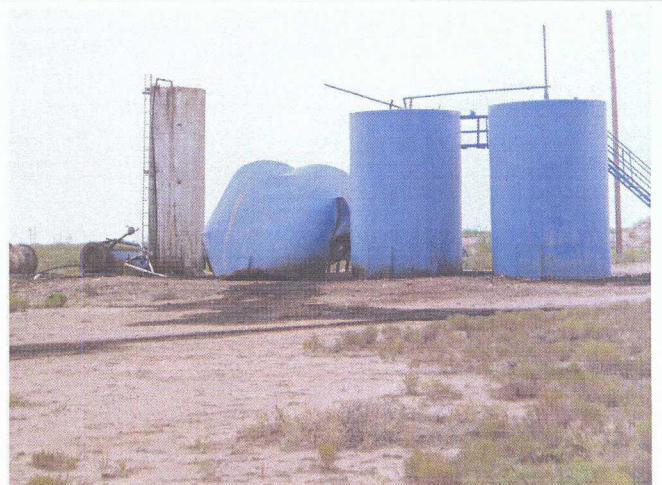
Photo of tank battery runoff.

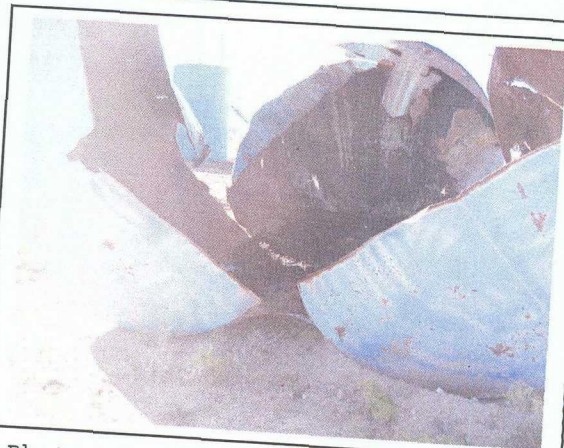
Photo of collapsed tank from the battery-lying northwest of tanks.
