Basic Energy Services Bondurant Fed #10 Closure Report

**Section 1, T19S, R32E
Lea County, New Mexico**

December 9, 2014

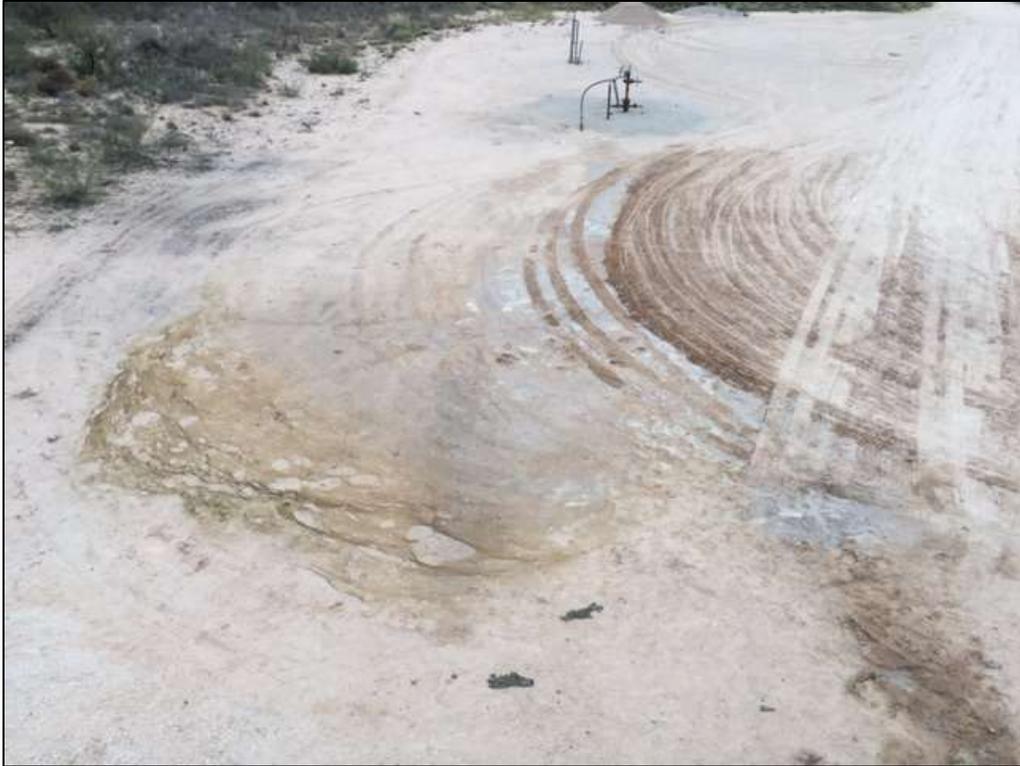
North Part of Release

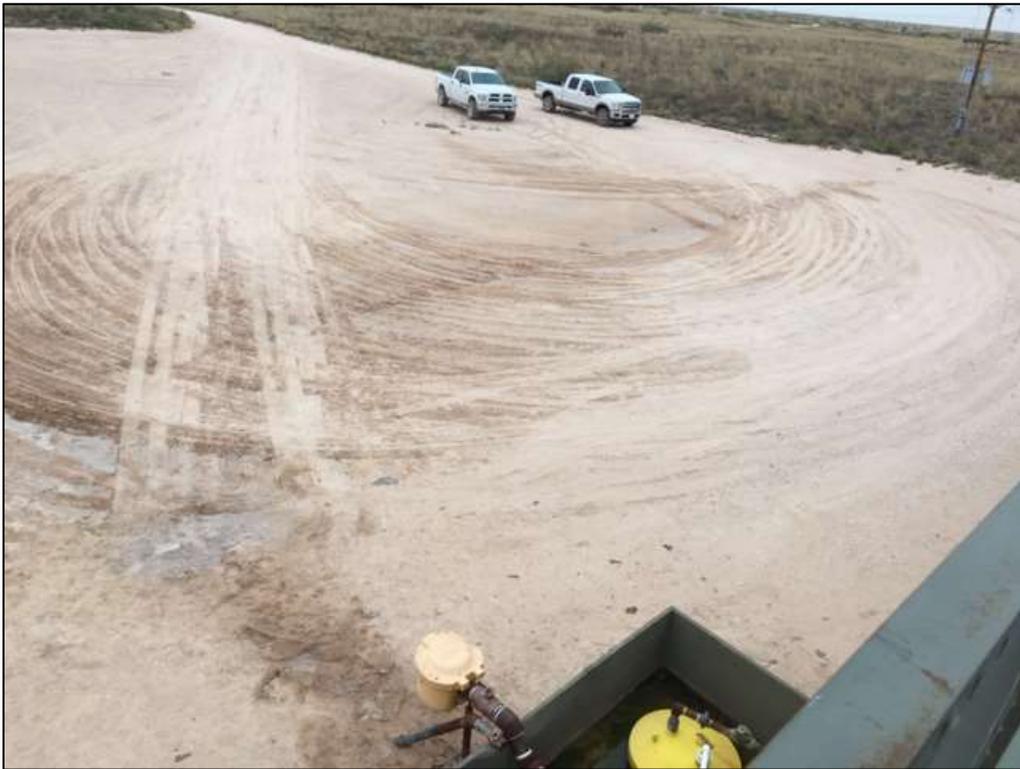
South Part of Release

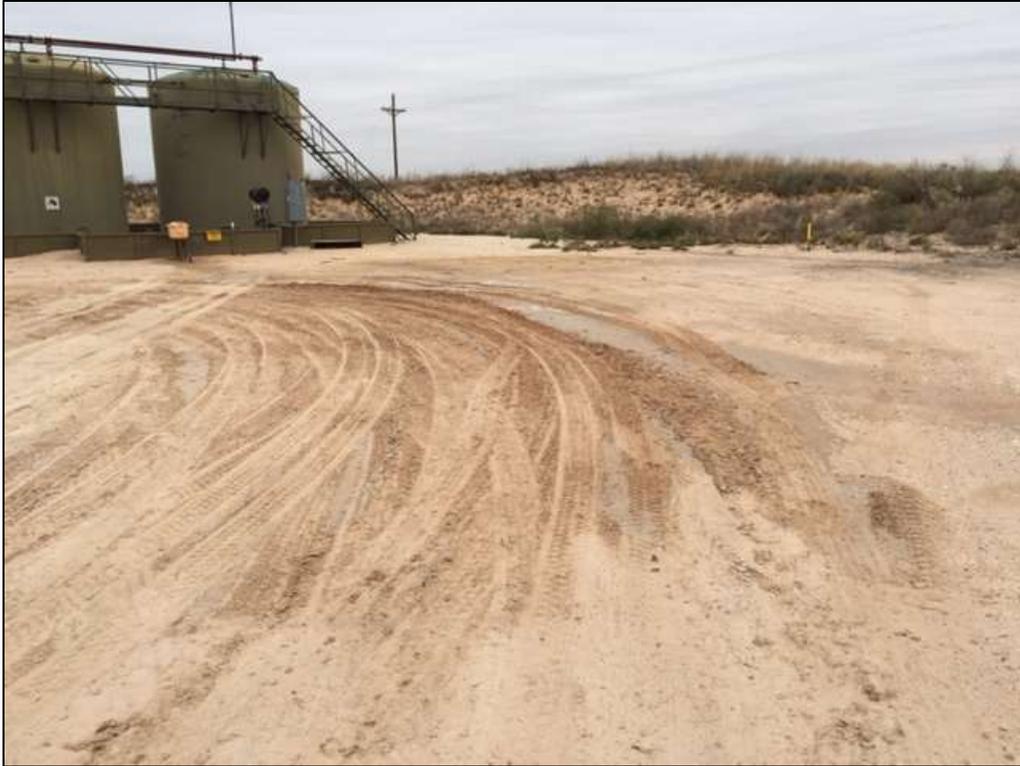
North Part of Release

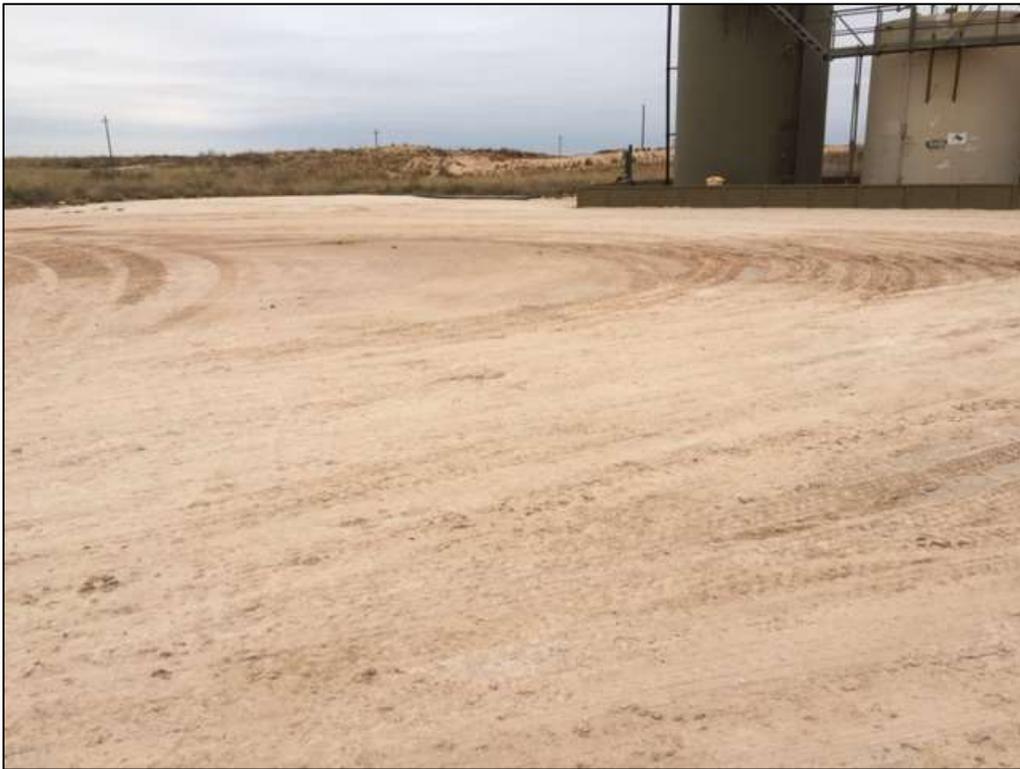
South Part of Release
