# Caprock Maljamar Unit #38

## REMEDIATION WORK PLAN

API No. 30-025-01485

**RE: Linn Energy Caprock Maljamar Unit #38 – Remediation Work Plan**  
UL/C, Section 19, T17S, R33E  
API No. 30-025-01485

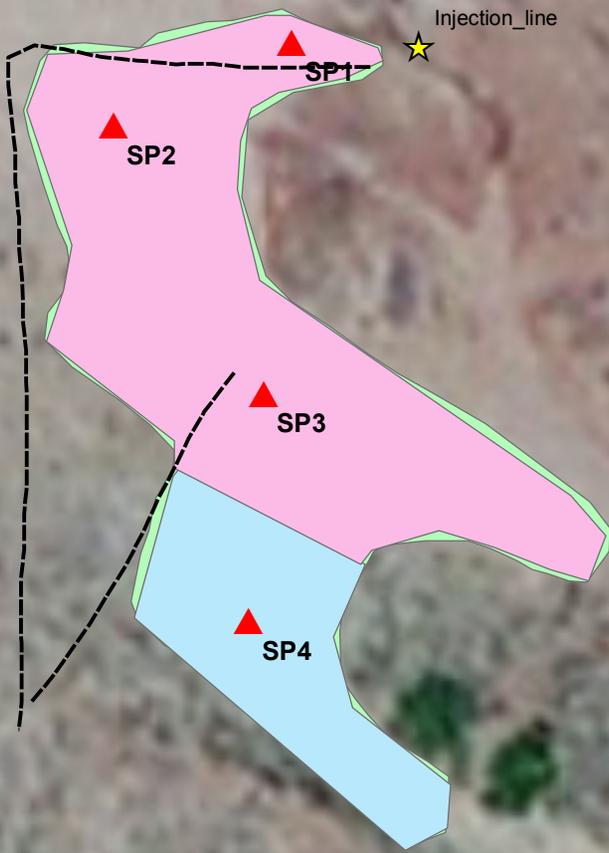
# Site Diagram

Pink shaded area: Excavate to 6 inches BGS  
Blue area; Excavate to 4' BGS

Spill Area:  
3,615 sq. ft.

Scrape the affected area of the caliche pad to 6" bgs and backfill with clean caliche. Remove the pasture impacted soil (SP 3 and 4) down to 4' bgs, then backfill with native topsoil. Seed with a BLM, OCD approved seed mix.
