**SUMMARY REPORT
EVAPORATION POND
REPAIRS (1)**

RE: LETTER REPORT
EVAPORATION POND 7 DIKE BREACH
WESTERN REFINING SOUTHWEST INC., GALLUP REFINERY
EPA ID # NMD000333211
HWB-WRG-15-MISC

SUMMARY REPORT EVAPORATION POND REPAIRS

Western Refining Southwest, Inc.

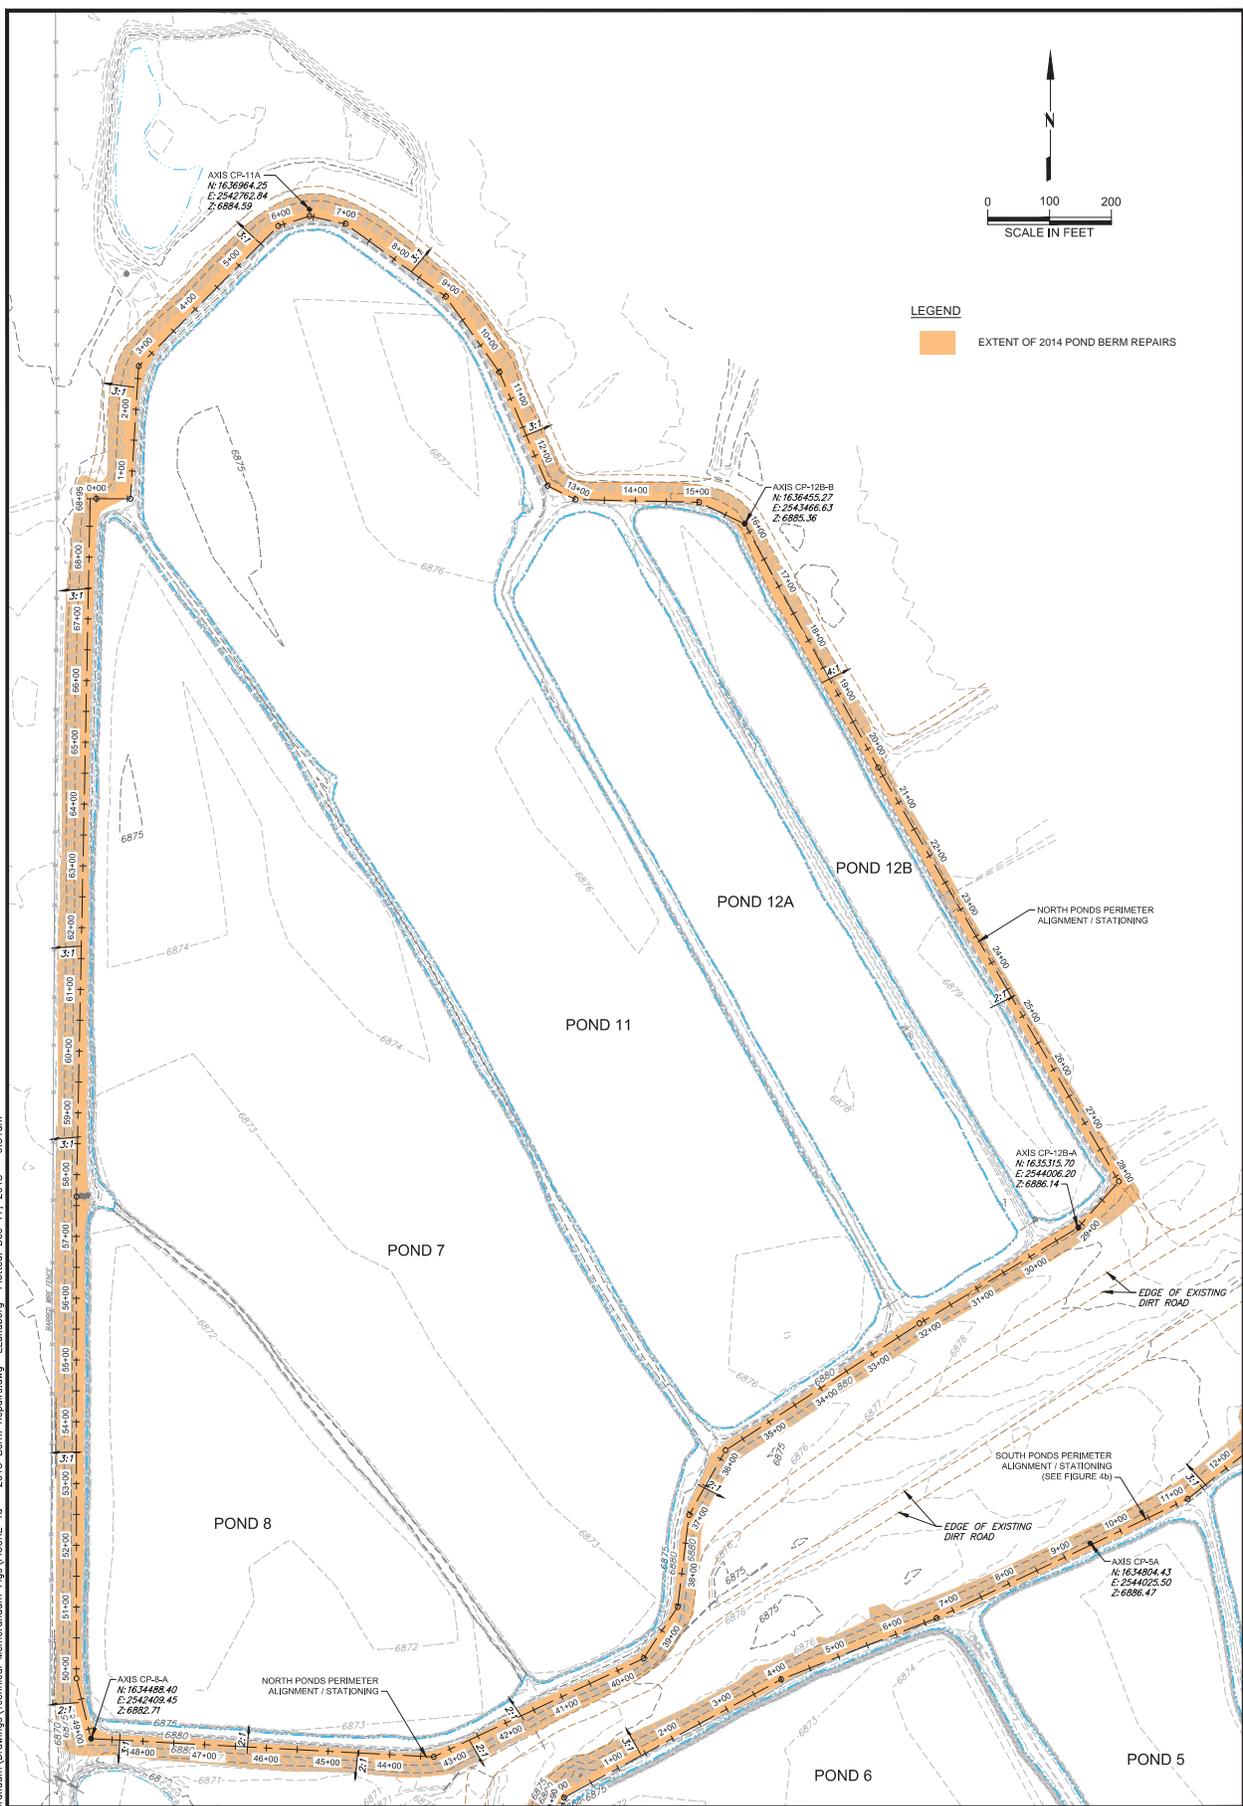
4a

Figures 3a, 3b, and 3c illustrate the pond limits and crest heights prior to the improvements made in 2014. Figures 4a, 4b, and 4c illustrate the pond limits and crest heights after Phase 1 upgrades and repairs were complete. Figure 6b provides cross sections illustrating the limits where additional fill material was placed on the pond containment berms during 2014. Photographs of the 2014 berm upgrade activities are included in Appendix A (Photos #1 through #6).

1. Adding additional new fill material to the outside slopes and crests of the containment berms;
2. Shaping the berm slopes; and
3. Building up the berm crest height and width;

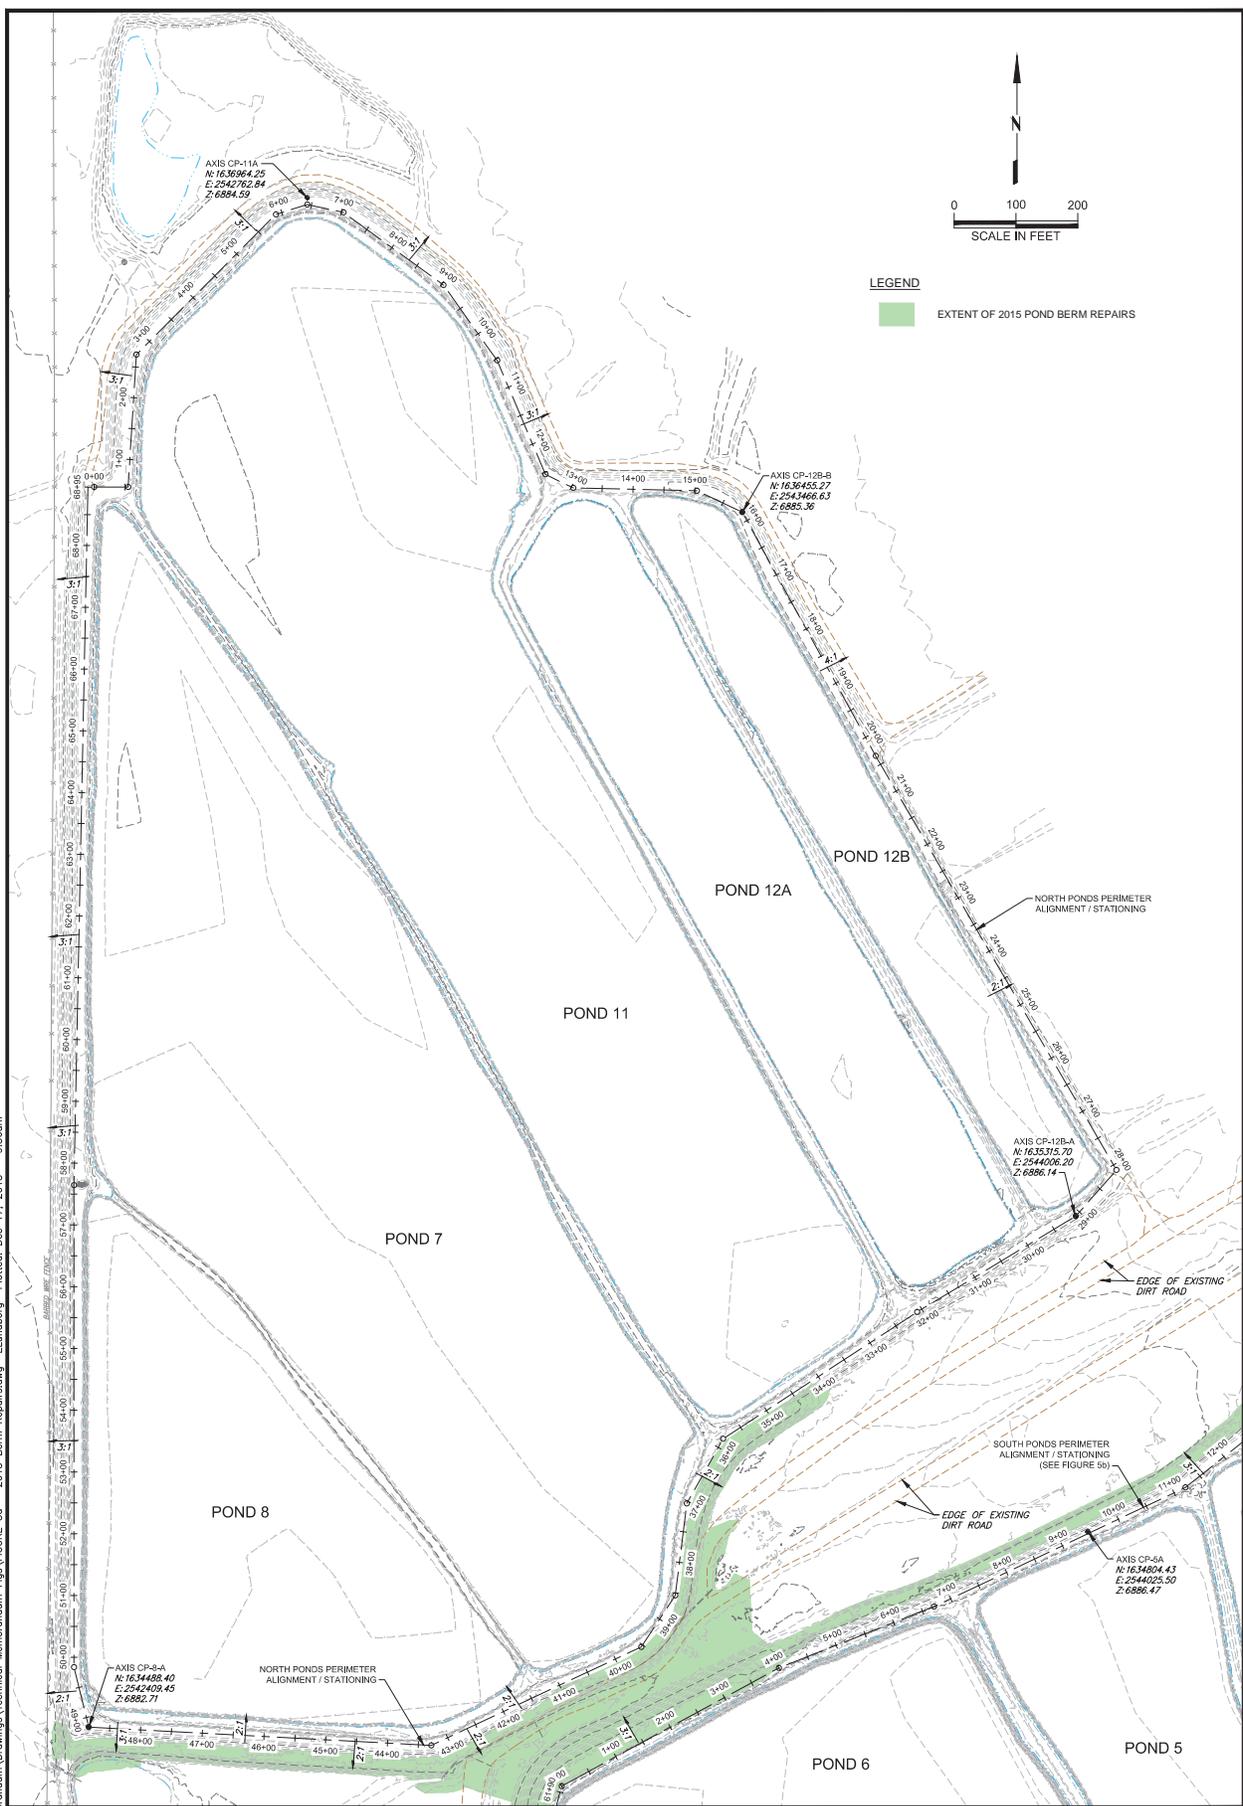
Figures 5a and 5b illustrate the pond limits and crest heights after the Phase 2 upgrades and repairs were complete. Figure 6b provides cross sections illustrating the limits where additional fill material was placed on the pond containment berms during 2015. Photographs of the 2015 berm upgrade activities are included in Appendix A (Photos #7 through #14).

1. Adding additional new fill material to the outside slopes of the containment berms;
2. Shaping the berm slopes; and
3. Building out the berm crest width;

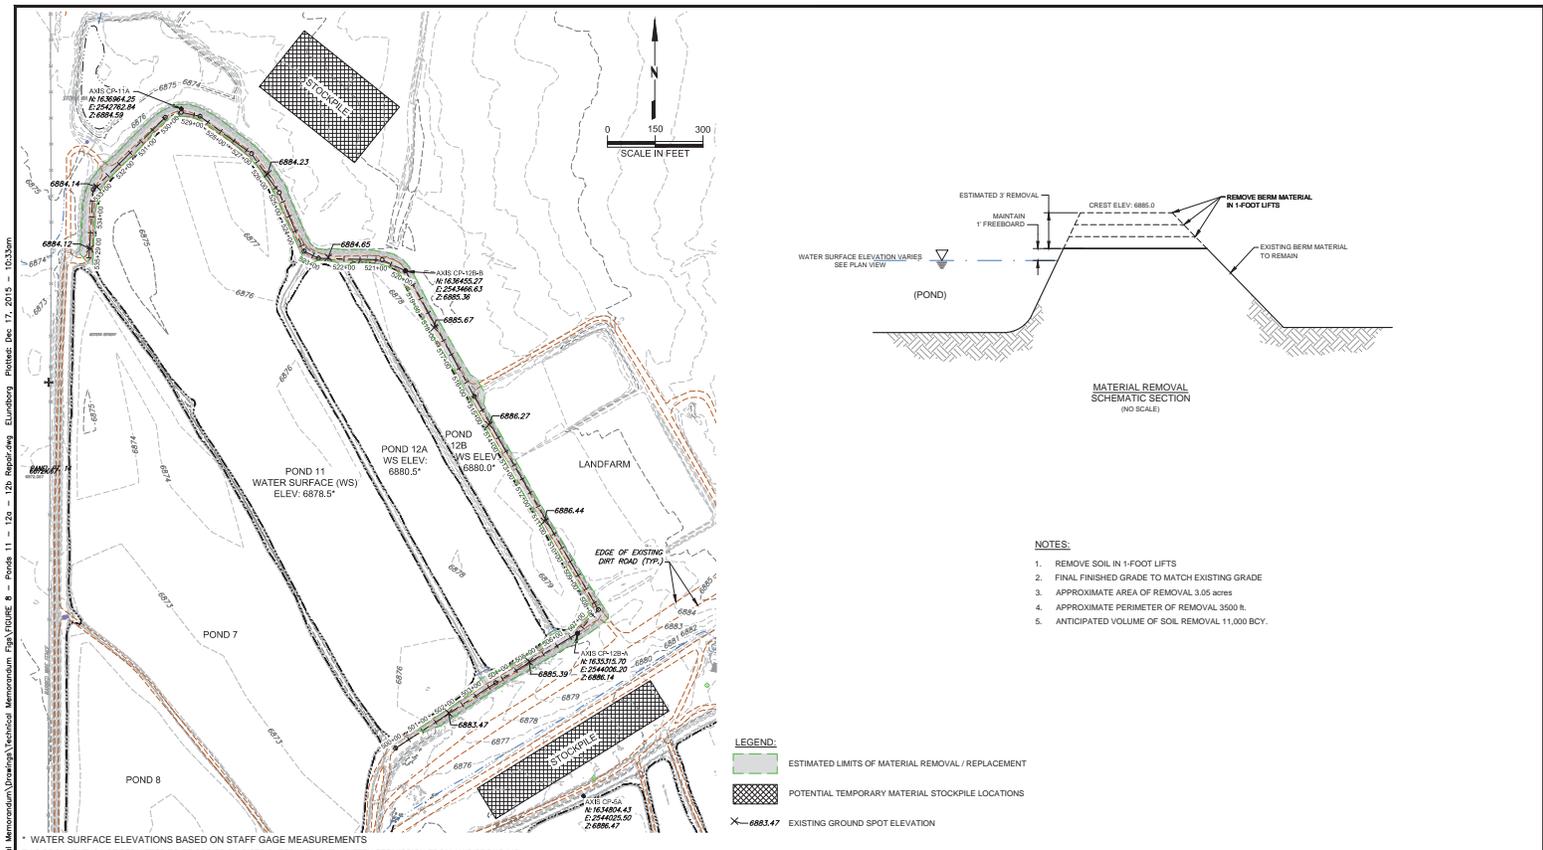
Western plans to rework and repair the material along the containment berms of Ponds 11, 12A, and 12B. Figure 8 illustrates the design work limits for Ponds 11, 12A, and 12B. Western intends to complete this work in 2016.

1. Rework and repair the berm material on Ponds 11, 12A, and 12B as required;
2. Improve the Pond 9 north berm;
3. Regrade the stormwater drainage channel between Pond 6 and Pond 9;
4. Improve the west berm along Pond 7 and Pond 8;
