Evaporation Pond
Repairs
(2 of 2)

REVISED SUMMARY REPORT EVAPORATION POND REPAIRS

Gallup Refinery

Revision 1 Date: February 15, 2017

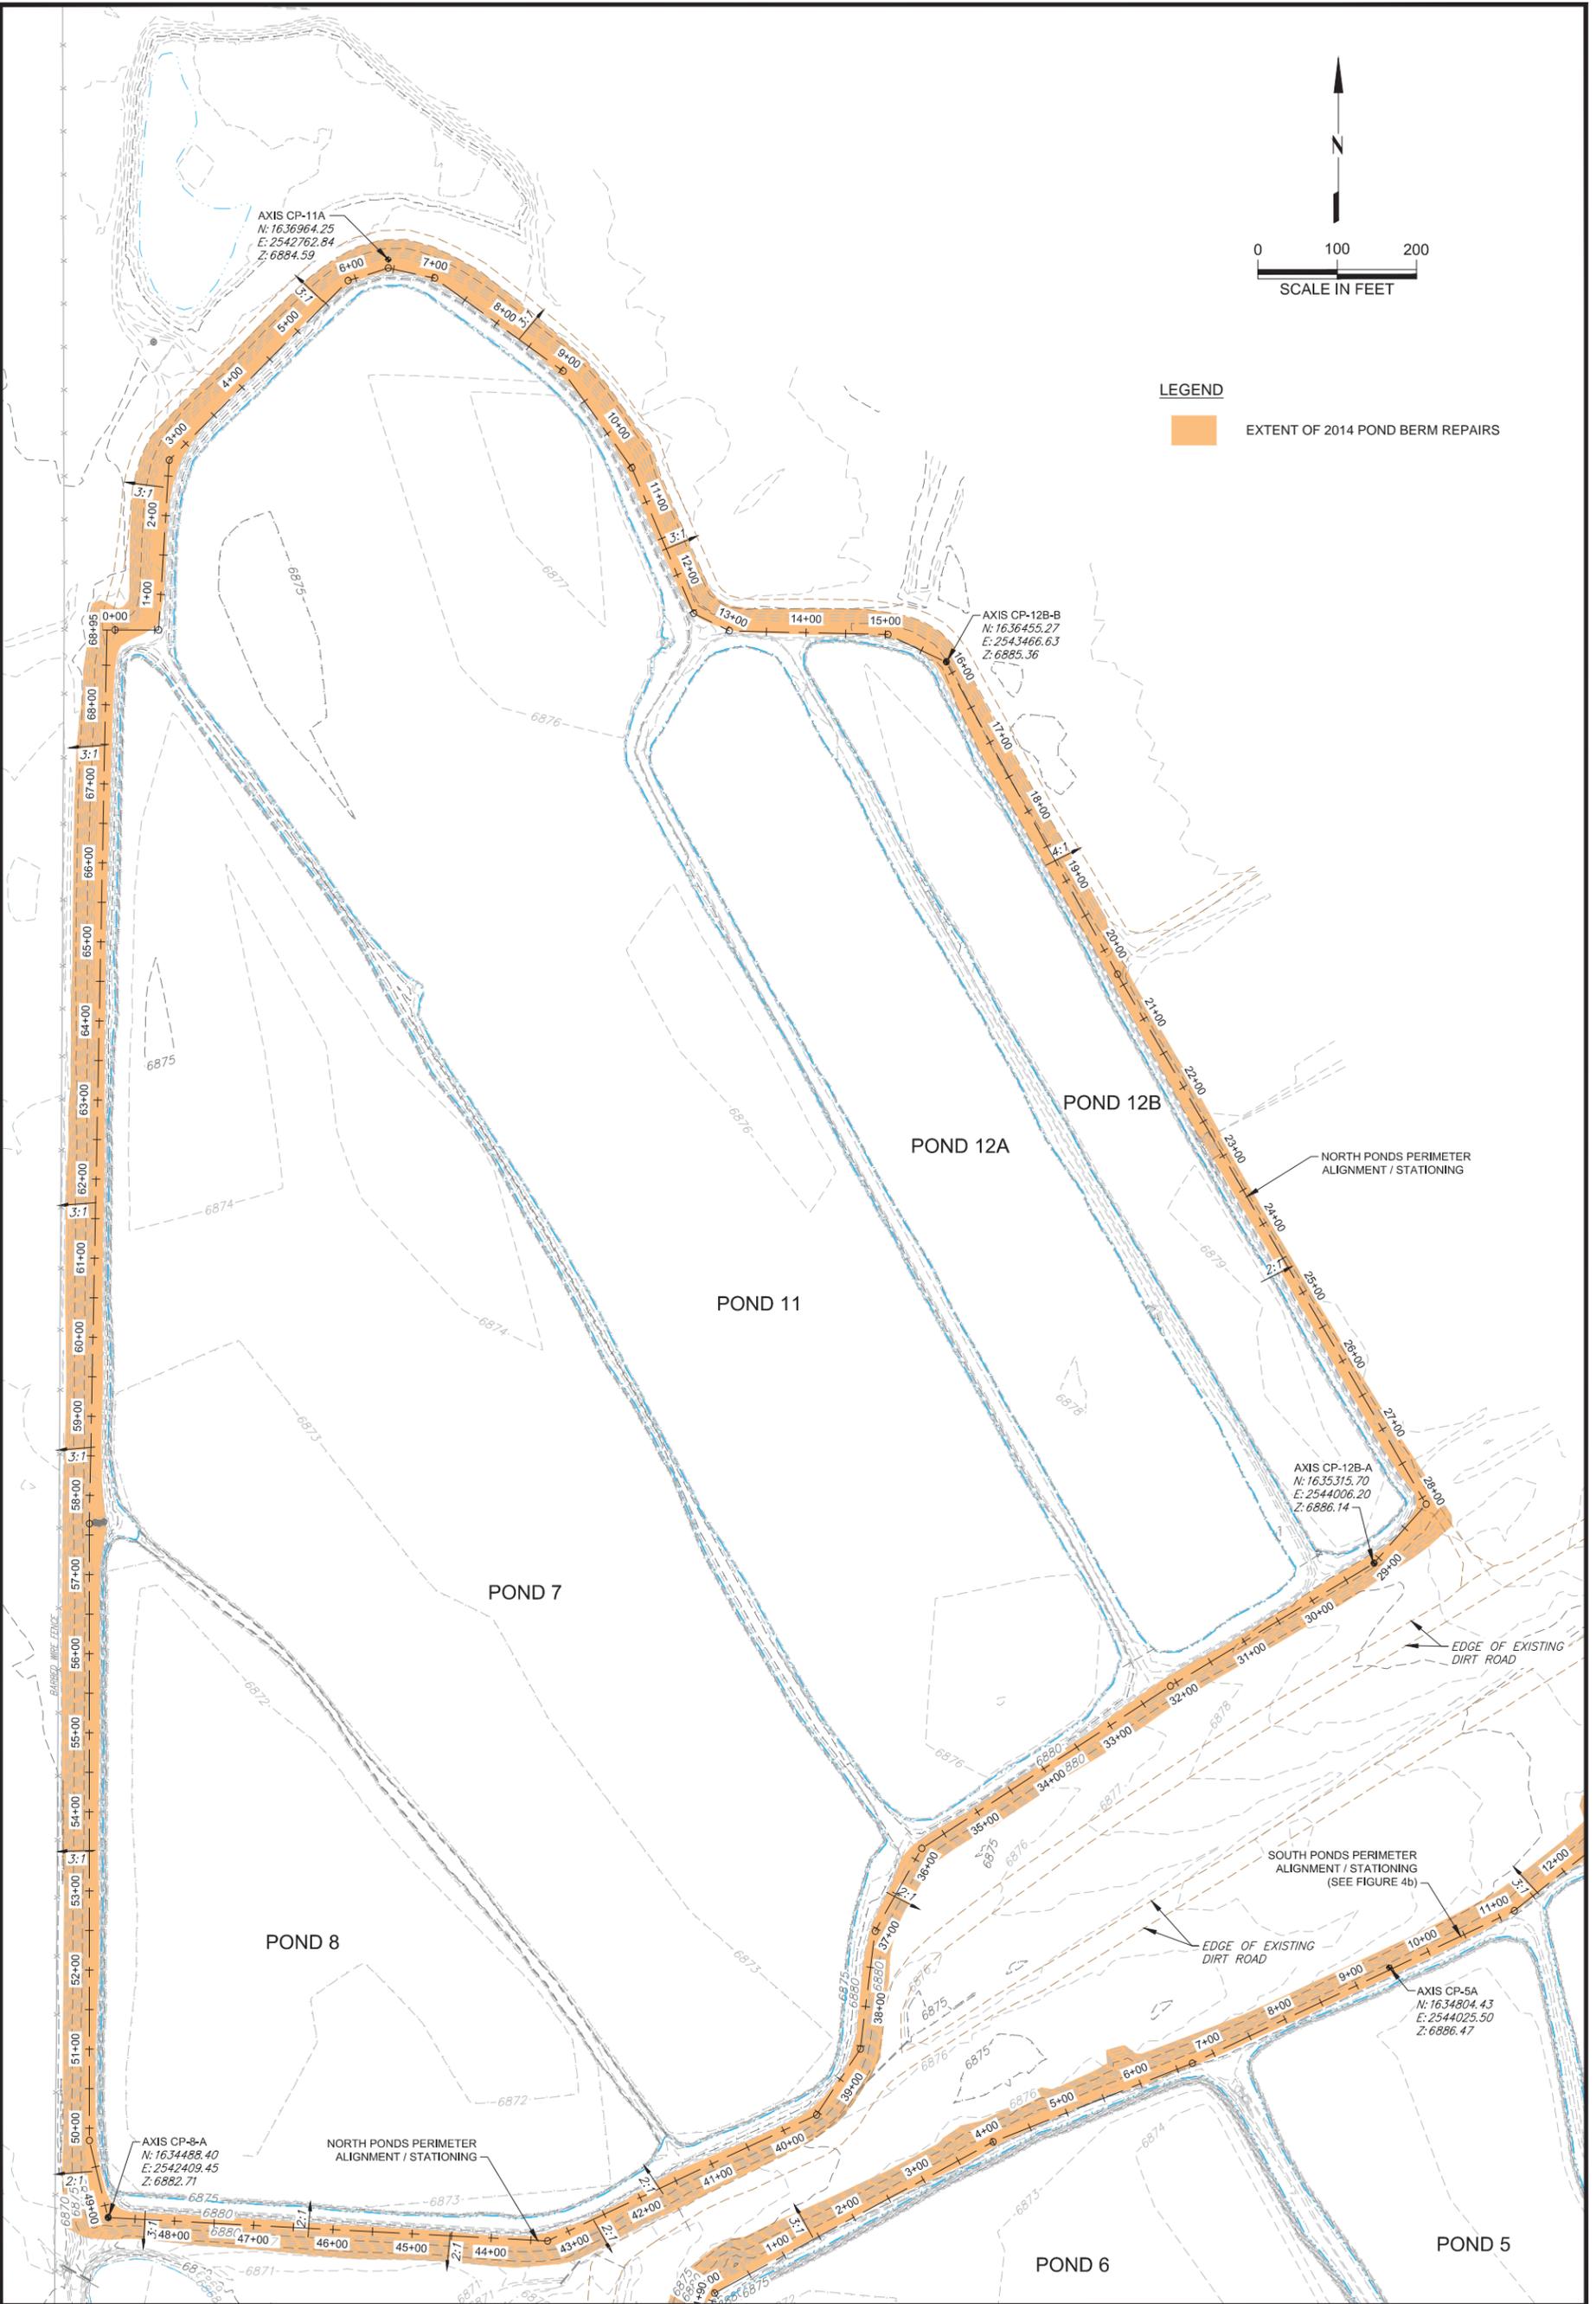
<p>1101 WEST MINERAL AVENUE SUITE 102 LITTLETON, COLORADO. 80120 (303) 332-5757</p>	WESTERN REFINING SOUTHWEST, INC. - GALLUP REFINERY, NEW MEXICO		DRAWING NO.:
	2014 POND UPGRADES AND REPAIRS NORTH PONDS		4a
PROJ. NO.: 15-112	DATE: 11-06-2015	DRAWN BY: JAY	CHECKED BY: JWB

Figures 3a, 3b, and 3c illustrate the pond limits and crest heights prior to the improvements made in 2014. Figures 4a, 4b, and 4c illustrate the pond limits and crest heights after 2014 upgrades and repairs were complete. Figure 7b provides cross sections illustrating the limits where additional fill material was placed on the pond containment berms during 2014. Photographs of the 2014 berm upgrade activities are included in Appendix A (Photos #1 through #6).

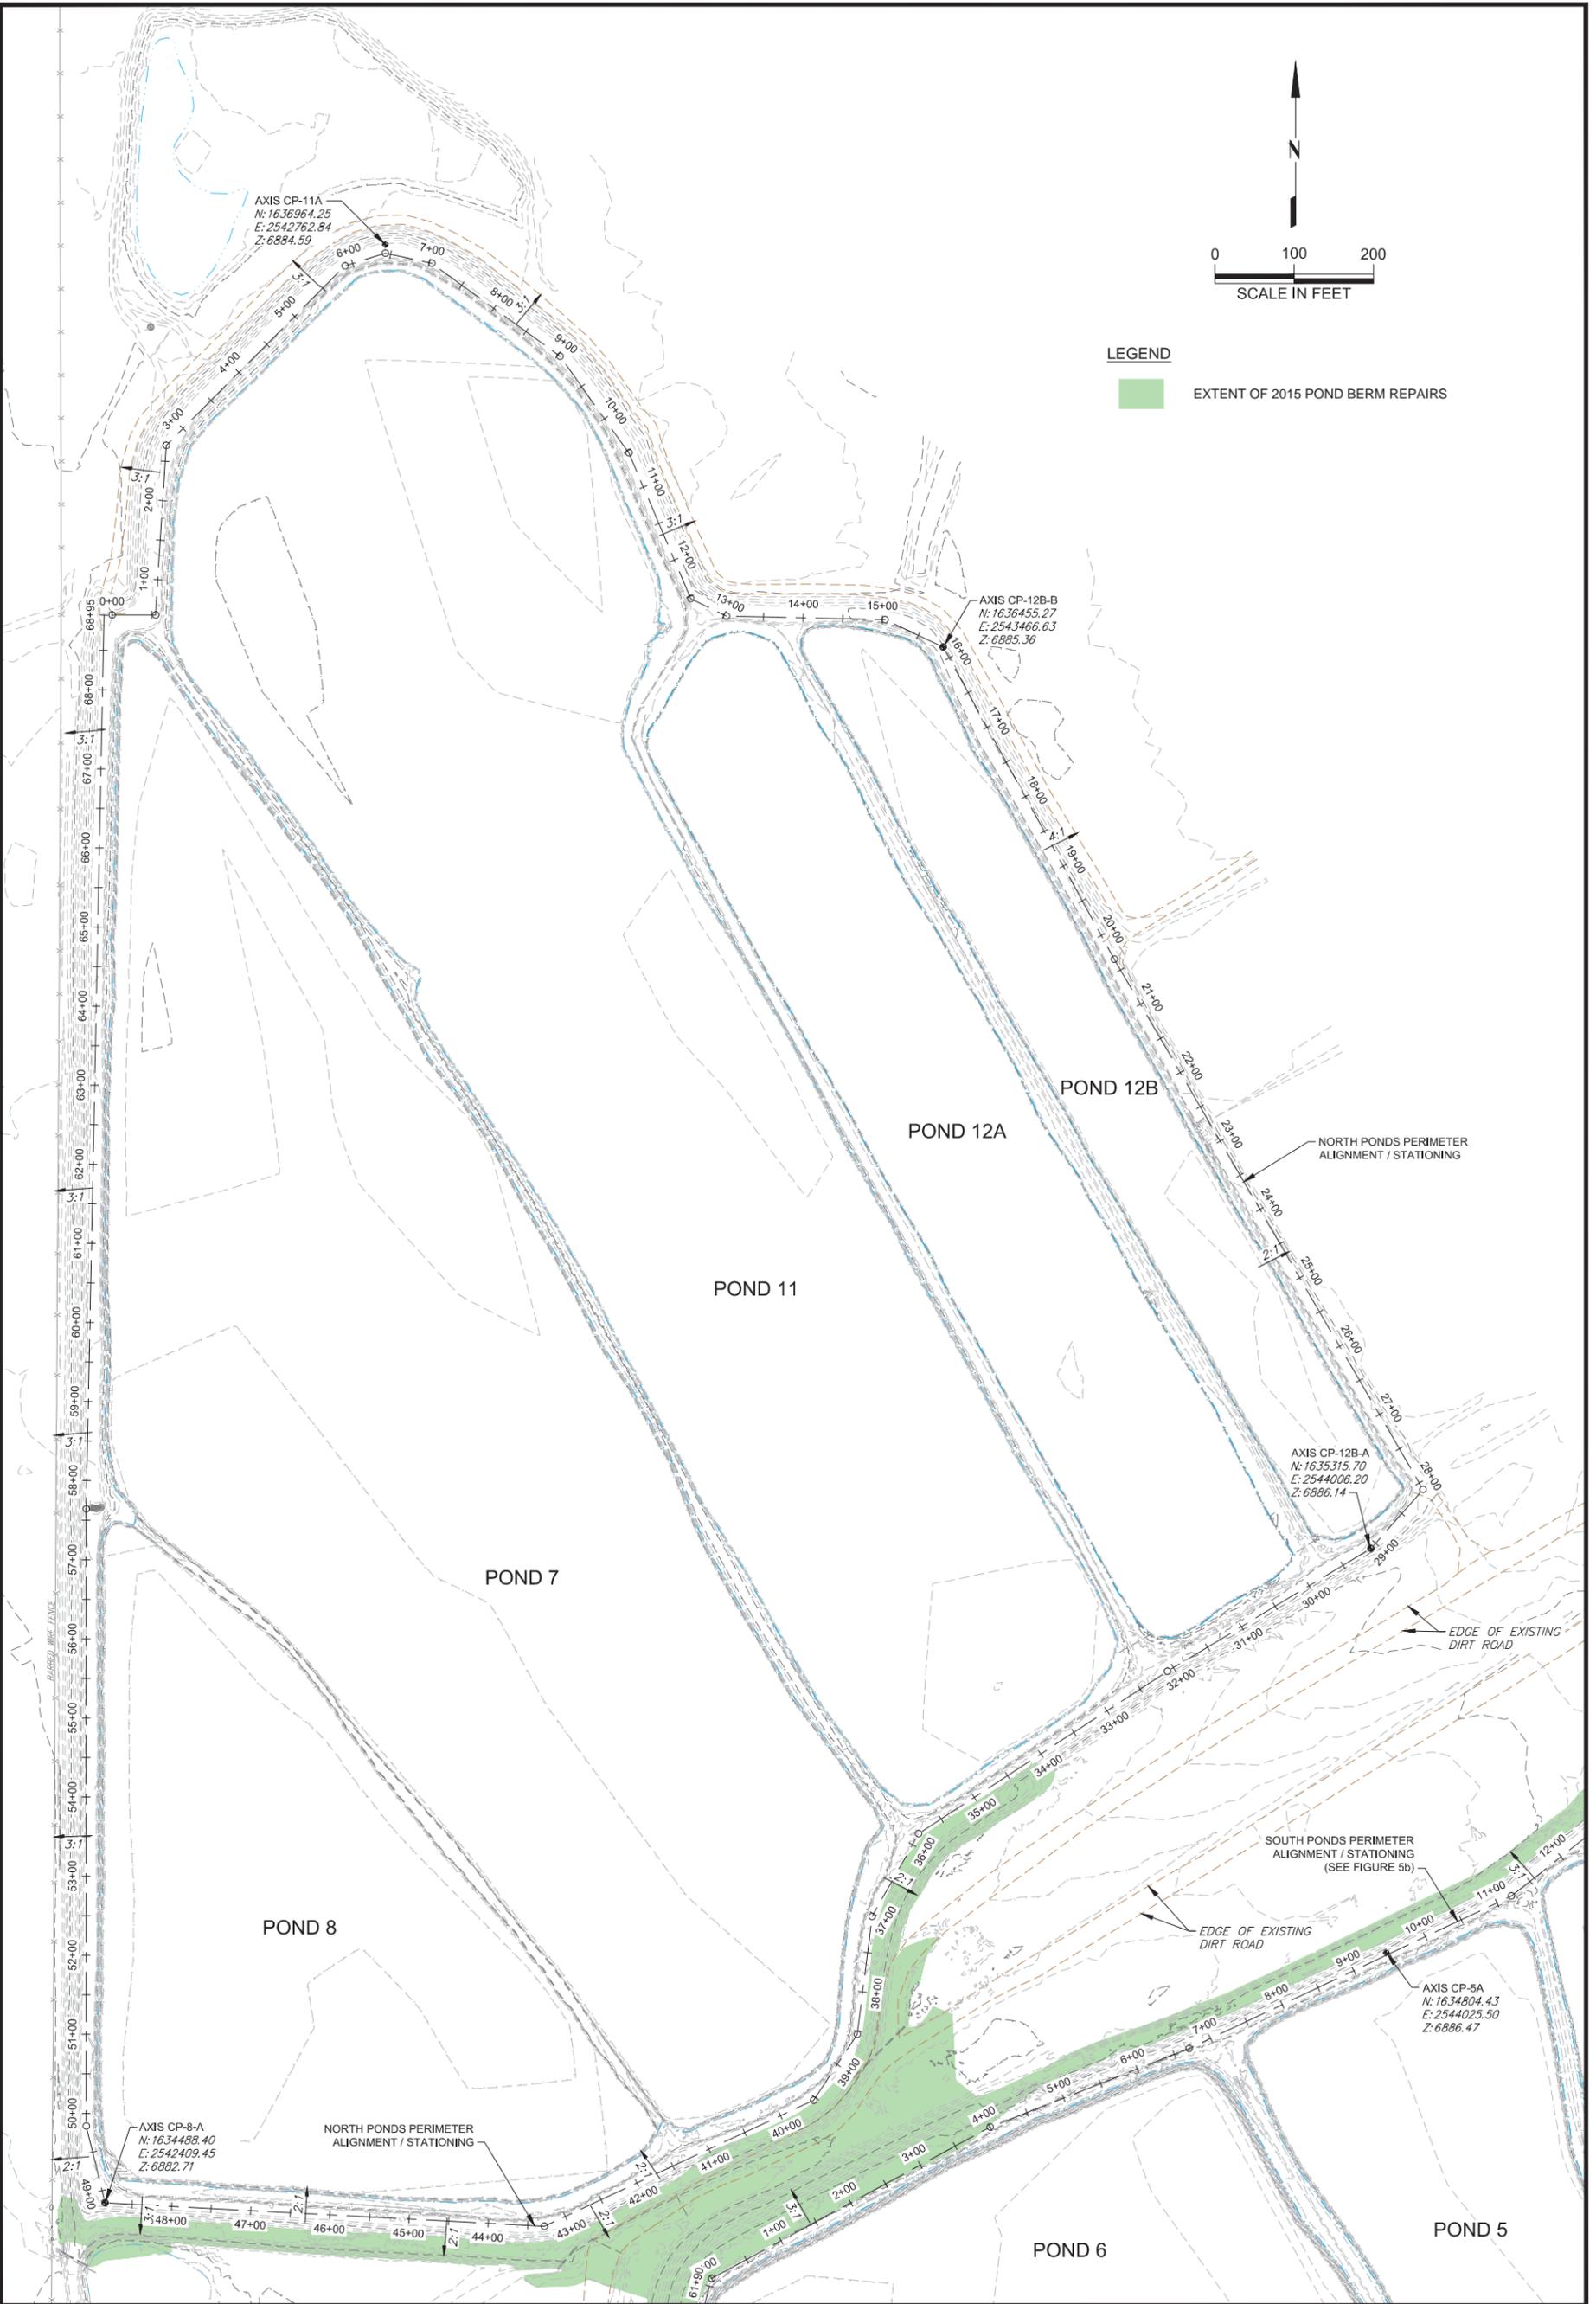
Figures 5a, 5b, and 5c illustrate the pond limits and crest heights after the 2015 upgrades and repairs were complete. Figure 7b provides cross sections illustrating the limits where additional fill material was placed on the pond containment berms during 2015. Photographs of the 2015 berm upgrade activities are included in Appendix A (Photos #7 through #14).

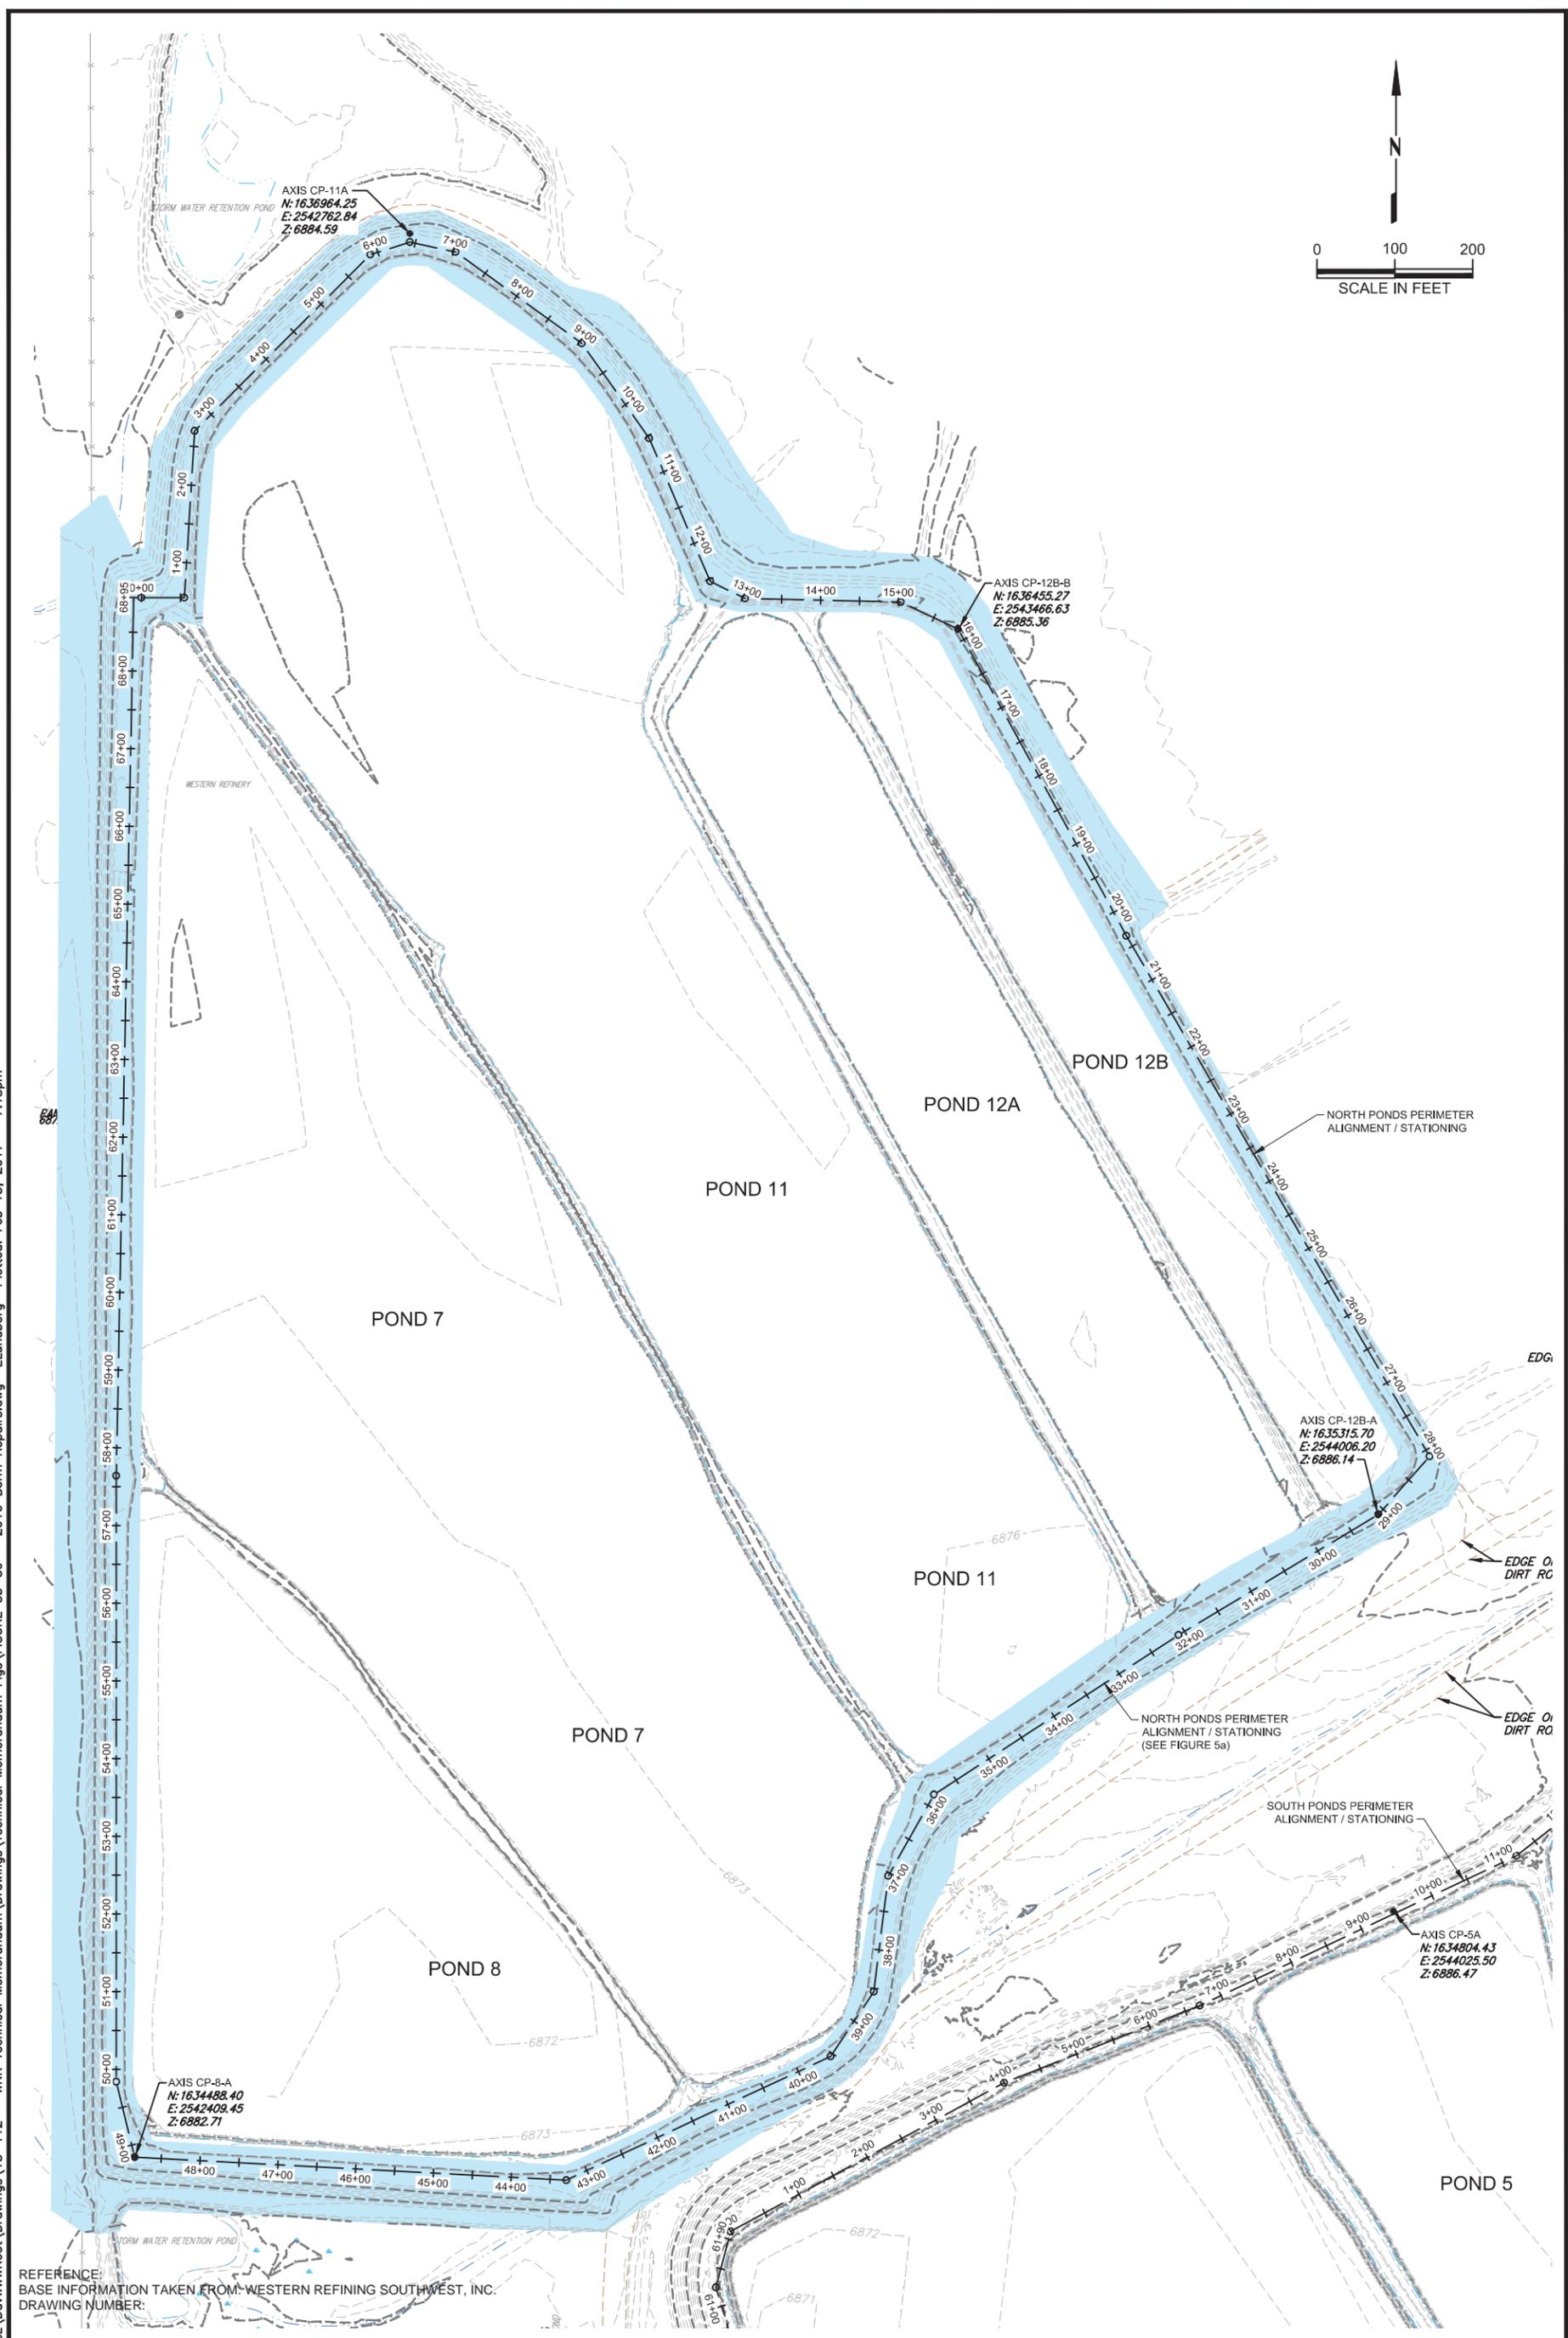
<p>1101 WEST MINERAL AVENUE SUITE 102 LITTLETON, COLORADO. 80120 (303) 332-5757</p>	WESTERN REFINING SOUTHWEST, INC. - GALLUP REFINERY, NEW MEXICO	DRAWING NO.:
	2016 POND UPGRADES & REPAIRS NORTH PONDS	6a
PROJ. NO.: 15-112	DATE: 11-06-2015	DRAWN BY: JAY
	CHECKED BY: JWB

In 2016, Western improved the Pond 7/8 berms from Station 68+95 to Station 41+00 by adding fill material to buttress the outer slopes of the south and west berms. Figure 6a illustrates the 2016 repair work limits for Pond 7/8 berms. Photographs of this work are included in Appendix A.

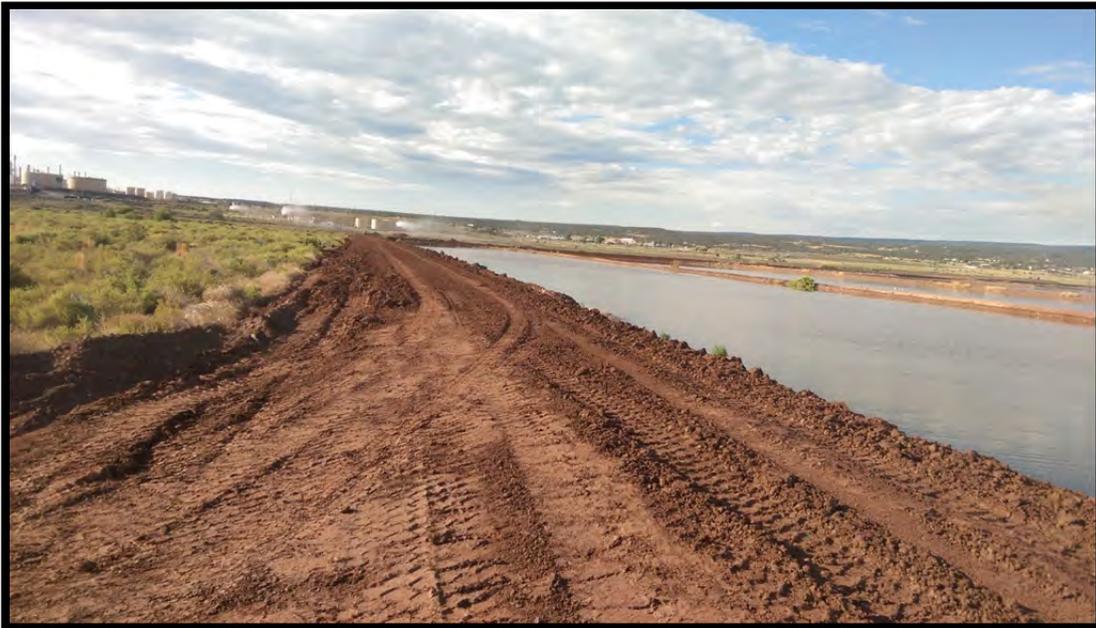
Photo #17: Pond 11-12 Berm Being Removed and Reworked

In 2016, Western reworked and repaired the soil material of the outer containment berms around Ponds 11, 12A, and 12B. During routine pond inspections, Western noted that soils in the upper two to three feet of the Pond 11, 12A, and 12B outer berms needed to be repaired. Figure 6a illustrates the 2016 repair work limits for Pond 11, 12A and 12B berms. Photographs of this work are included in Appendix A.

The 2016 repair work of the Pond 11, 12A, and 12B berms began by stripping vegetation from the upper three-feet of the berms. From stations 36+00 to 28+00 and 20+00 to 0+00, the upper 3 feet of soil was scraped from the berms and stockpiled at the toe of the slope where it was reworked and cleaned of any large pieces of wood or rocks. This reworked soil was then replaced on the outer slopes of the berms to flatten the outer slope. From stations 28+00 to 20+00, the upper 3 feet of soil was removed and placed in the nearby borrow area for future use. The removed soil could not be cast to the outer slope in this area as the berm is too close to the existing Land Treatment Unit.

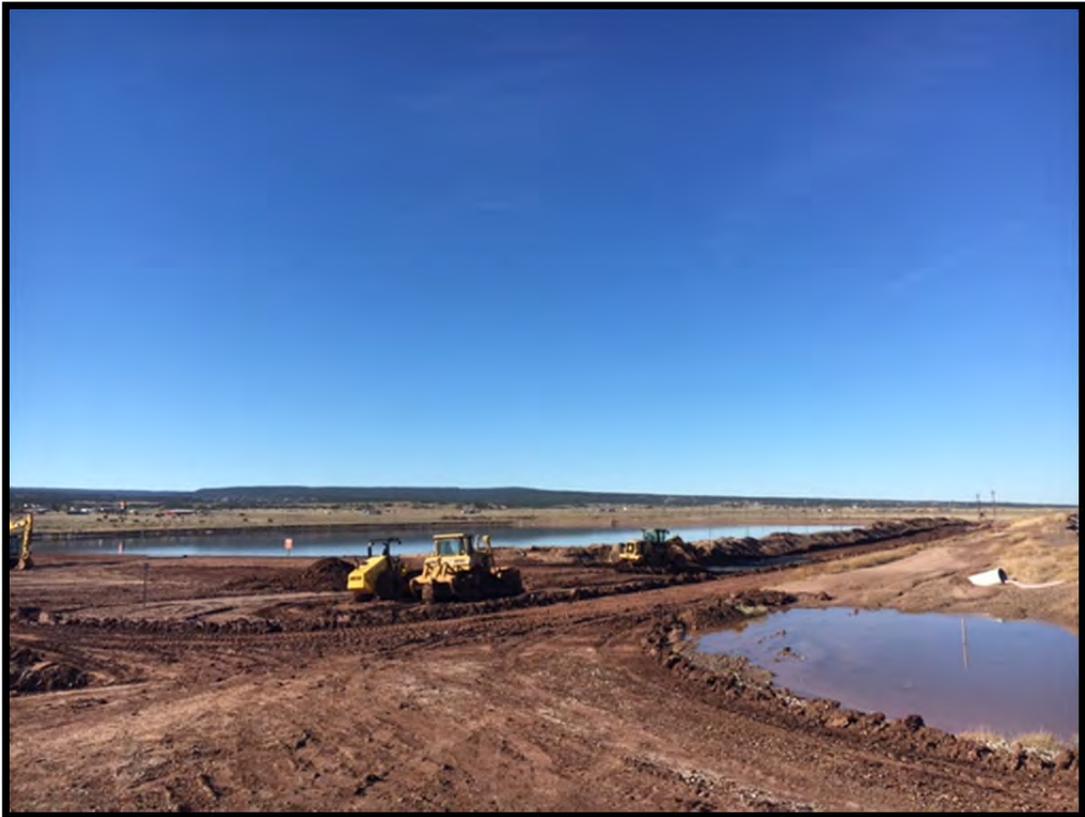
Photo #18: Pond 11-12 Berm Fill Repair Completed.

Clay soil from the on-site borrow area was then used to rebuild the upper three feet of the berms to their original crest elevations. Prior to placing the first lift, the berm soil was scarified as appropriate, wetted, and then the borrow soil was placed in horizontal layers up to 8-inches thick. Each lift was moisture conditioned and compacted to a minimum of 95-percent (95%) of a standard Proctor as outlined in the specifications. The outer slopes were then graded meet the final design grades resulting in compacted and flatter outer slopes.
