SUBJECT: Leaking Oil Storage Tanks

**RE: Enersource, Inc. Oil Treating Plant Permit Order R-8148
Re-permitting under Rule 711 and
Change of Operator to Commercial Exchange, Inc.
9.56 acres located in the NE/4 of Section. 1, Township 20 South, Range 36 East,
NMPM, Lea County, New Mexico**

ATTACHMENT 1
INSPECTION REPORT
ENERSOURCE, INC.

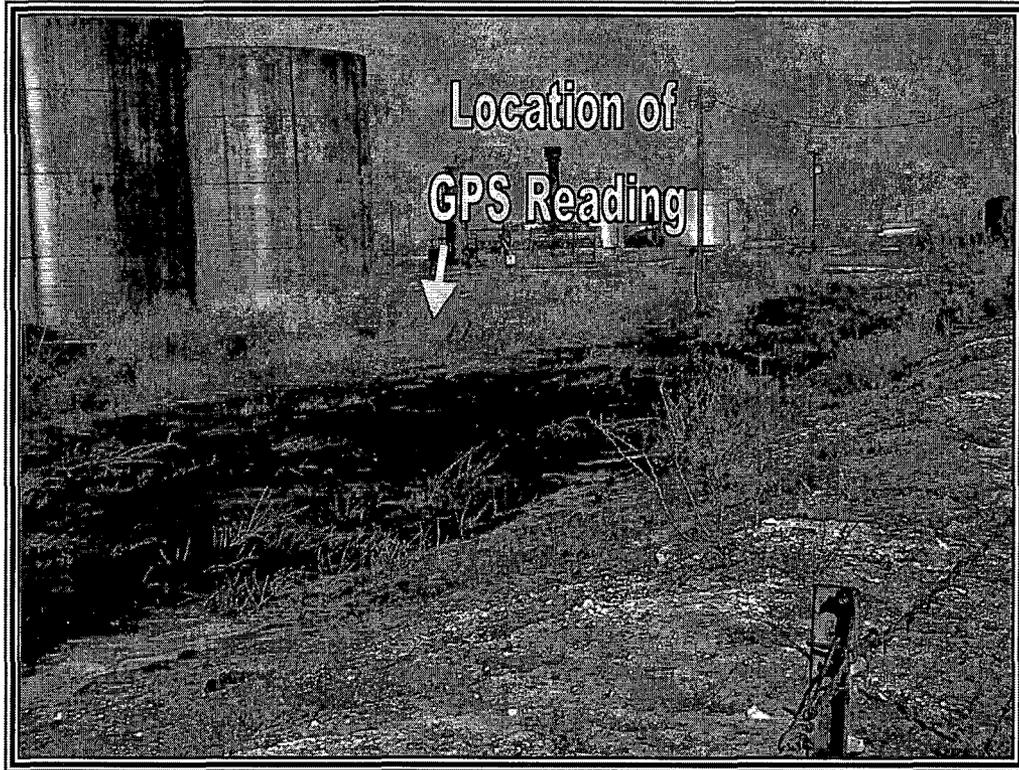
Looking at south side of tank yard location

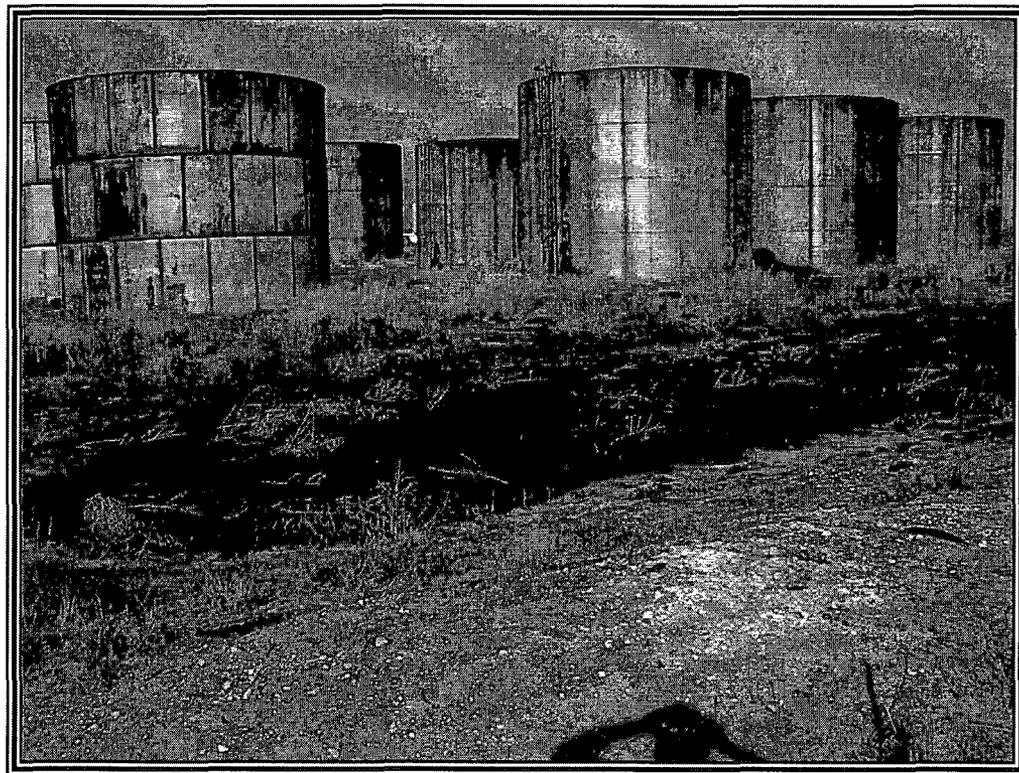
Looking at south fence separating State Trust land and Patented Land

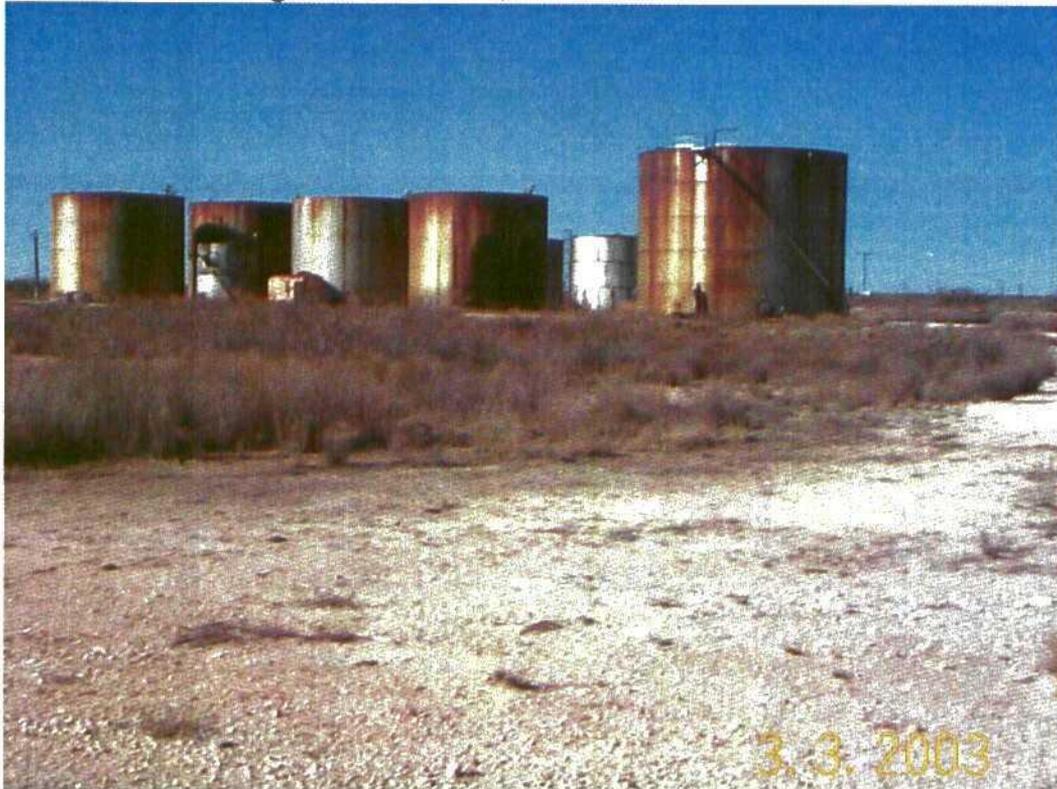
The tanks and other vessels are not labeled as to their contents and hazards (see photos 2, 4, 5, 6, 8, 9, 10, 12, 13, 14 and 15).

Photo 2: From left to right, 6-500 bbl tanks and 1-1000 bbl tank. One smaller tank and metal box container in front of 500bbl tanks. Looking southwest

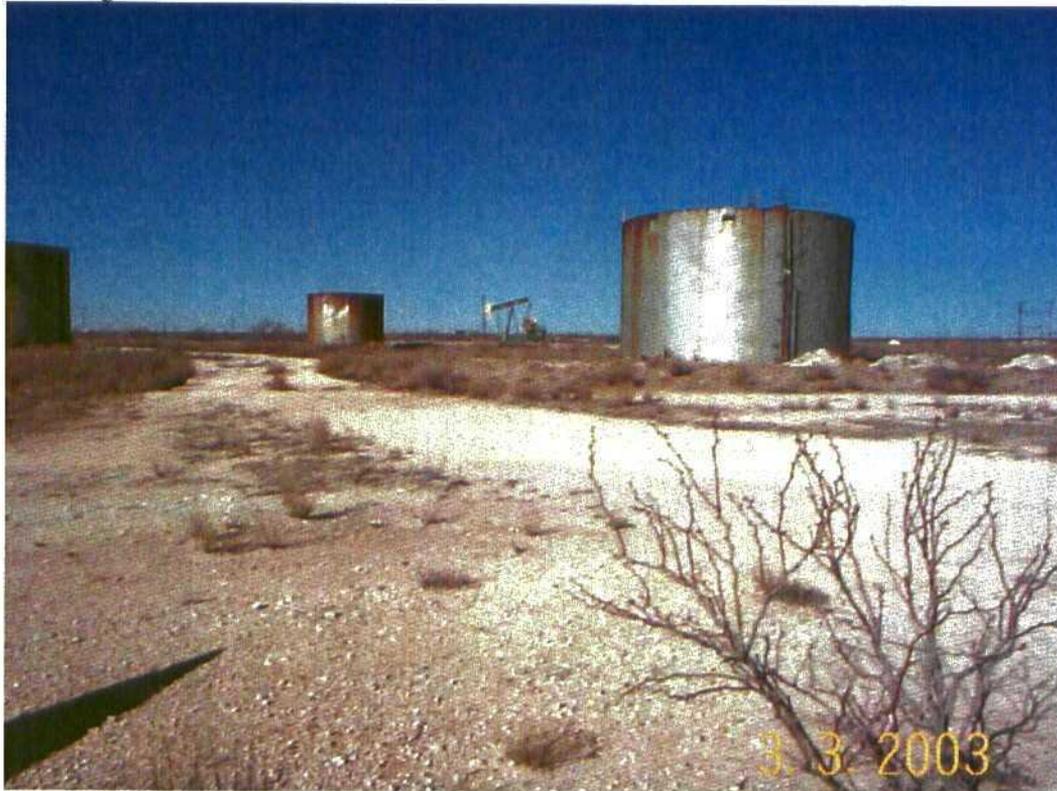
Photo 4: From left to right, 3-1000 bbl tanks. Looking west southwest.

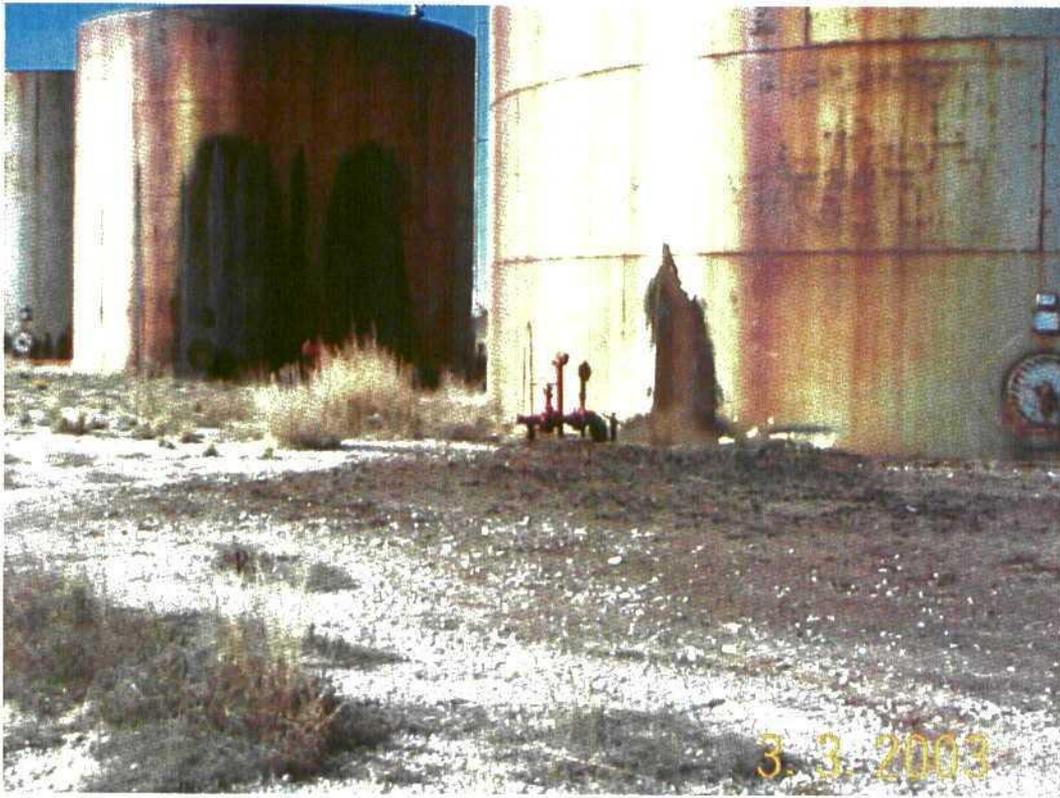
There was evidence of leaks and/or spills around the above grade tanks (see photos 5, 6, 7, 8, 9 and 10). The contaminated soil must be either removed to an OCD approved disposal facility or remediated on site according to OCD remediation guidelines.

There were no identifiable berms at the facility. The berms surrounding the above ground tanks need to be built or re-constructed to contain one-third more than the total volume of all interconnected tanks. There were several tanks with obvious leaks (see photos 5, 6, 7 and 8). The material in these tanks must be emptied into viable tanks as soon as possible. Based on the OCD inspection, the apparent age of the tanks and the condition of the tanks, the OCD requires that all tanks at the facility must be emptied and cleaned. If the operator wishes place any of the tanks back into operation the tanks must be emptied, cleaned, and then an OCD approved integrity test must be performed.

Adequate berms are needed to ensure that any spills or overflows stay within the facility. The contaminated soil around the base of the tanks indicate leaks or spills have been reaching the ground surface (see picture 5, 6, 7, 8, 9 and 10). Leaking valves, pumps, motors and other equipment should have secondary impermeable containment.

Photo 5: Leaking 500 bbl tanks and 1000 bbl tank. Looking south.

The contaminated soil from leaking tanks must be removed. The material may be remediated on sight and/or removed to an OCD approved disposal facility (see photos 5, 6, 7, 8, 9 and 10).

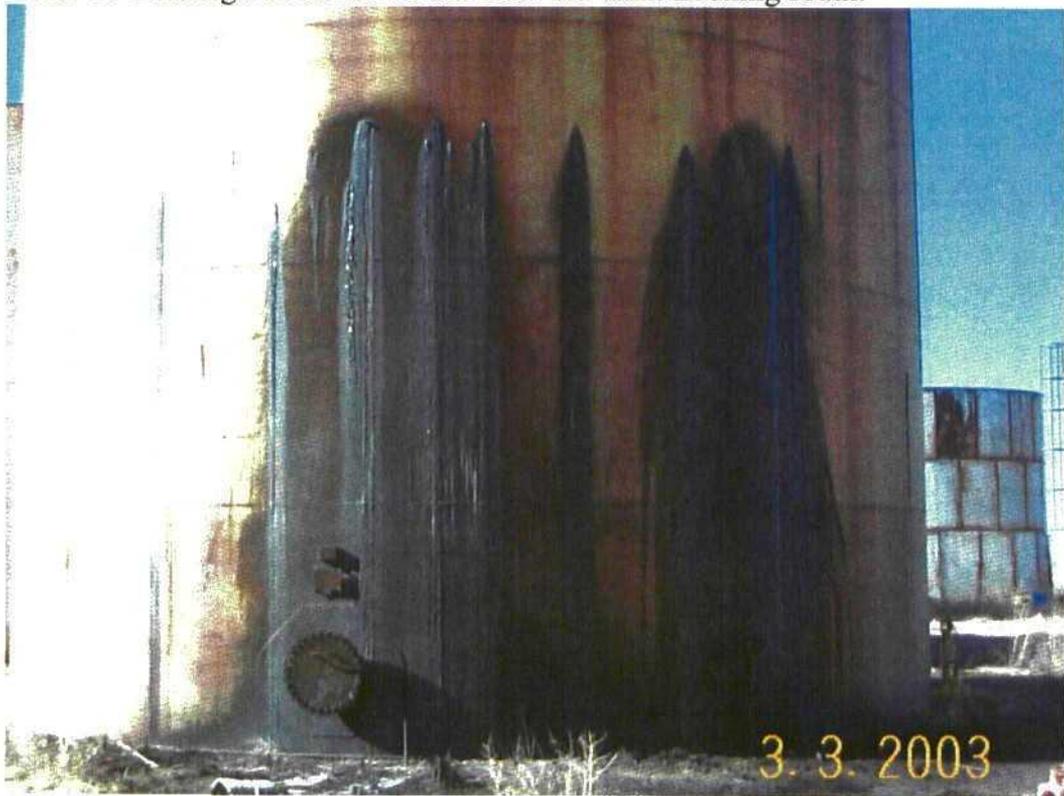
Photo 6: Leaking 500 bbl tank and contaminated soil. Looking southwest.

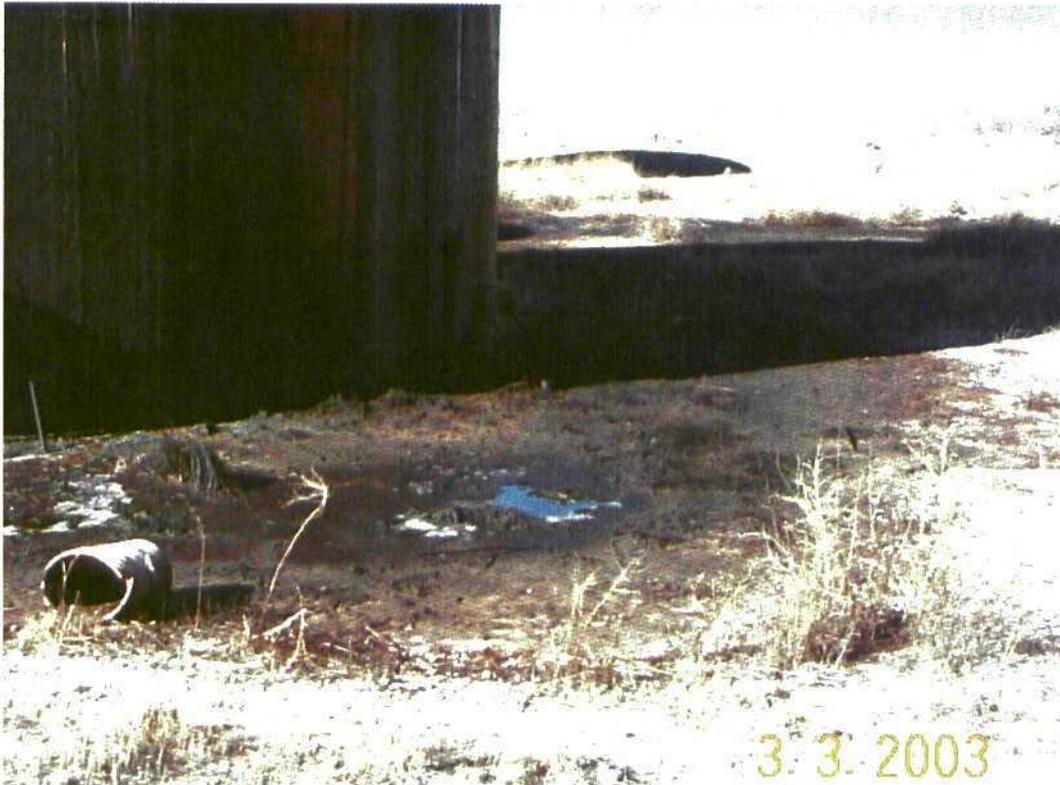
Photo 7: Contaminated soil surrounding the leaking 500 bbl tank.

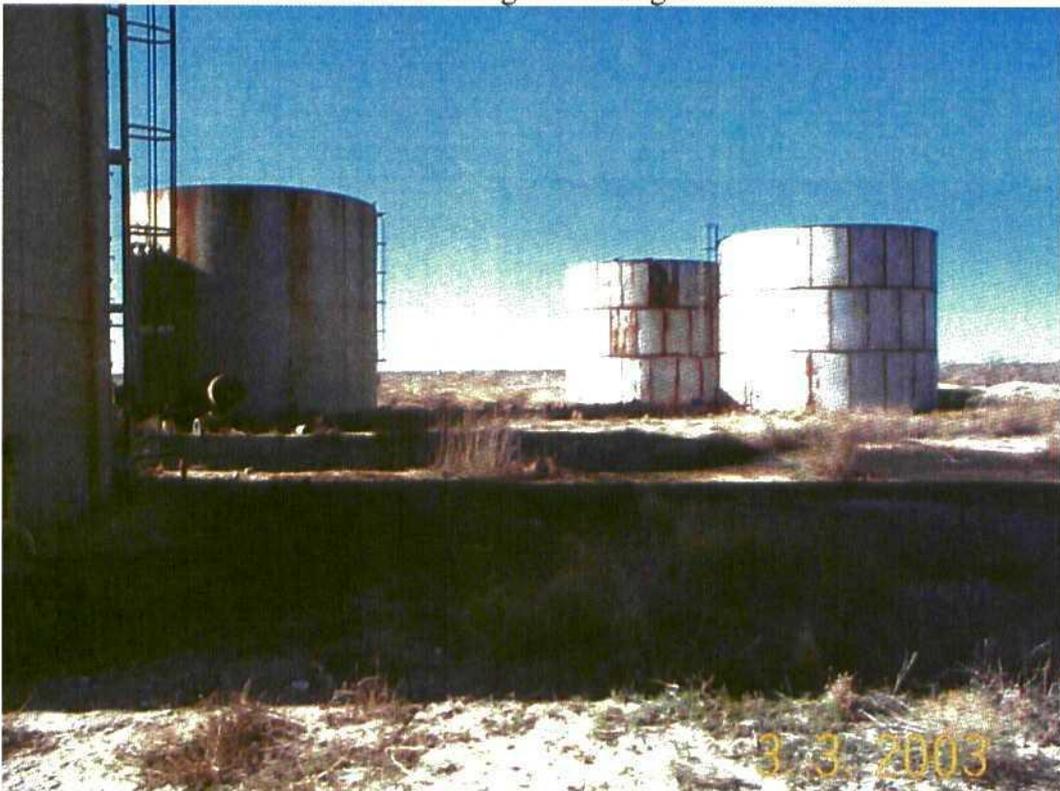
Photo 8: Contaminated soils and 4-500 bbl tanks. Looking southwest.

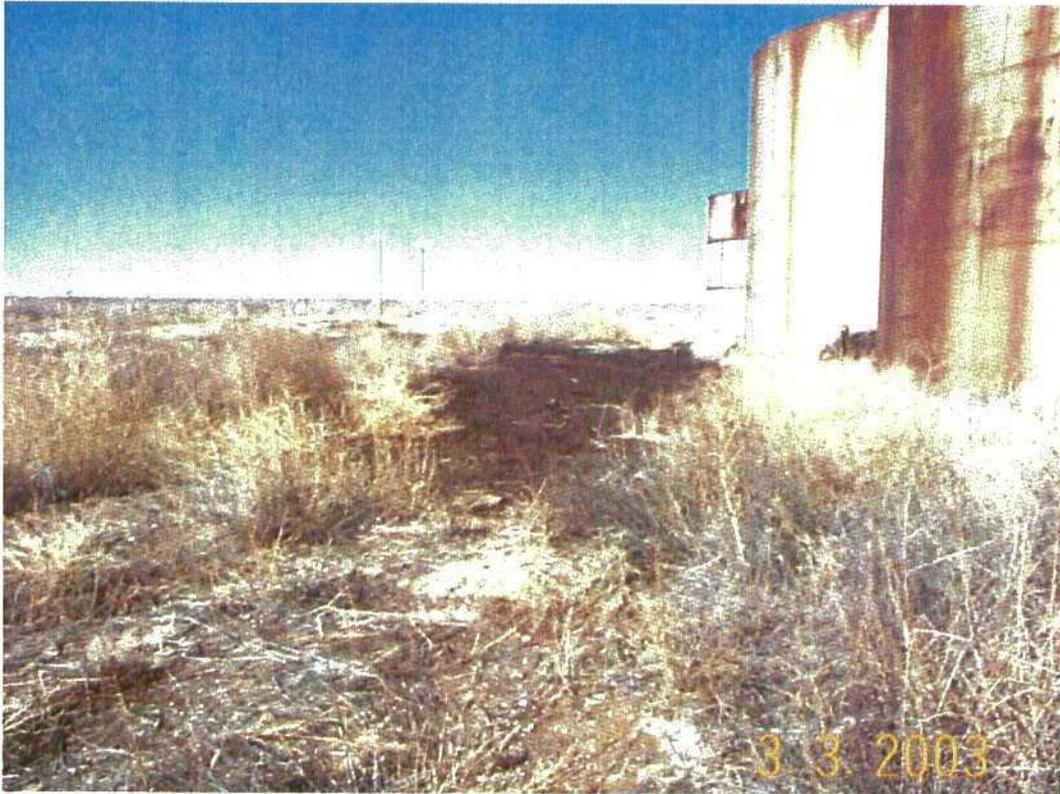
Photo 9: Contaminated soil along south side of the row of 500 bbl tanks. Looking west.

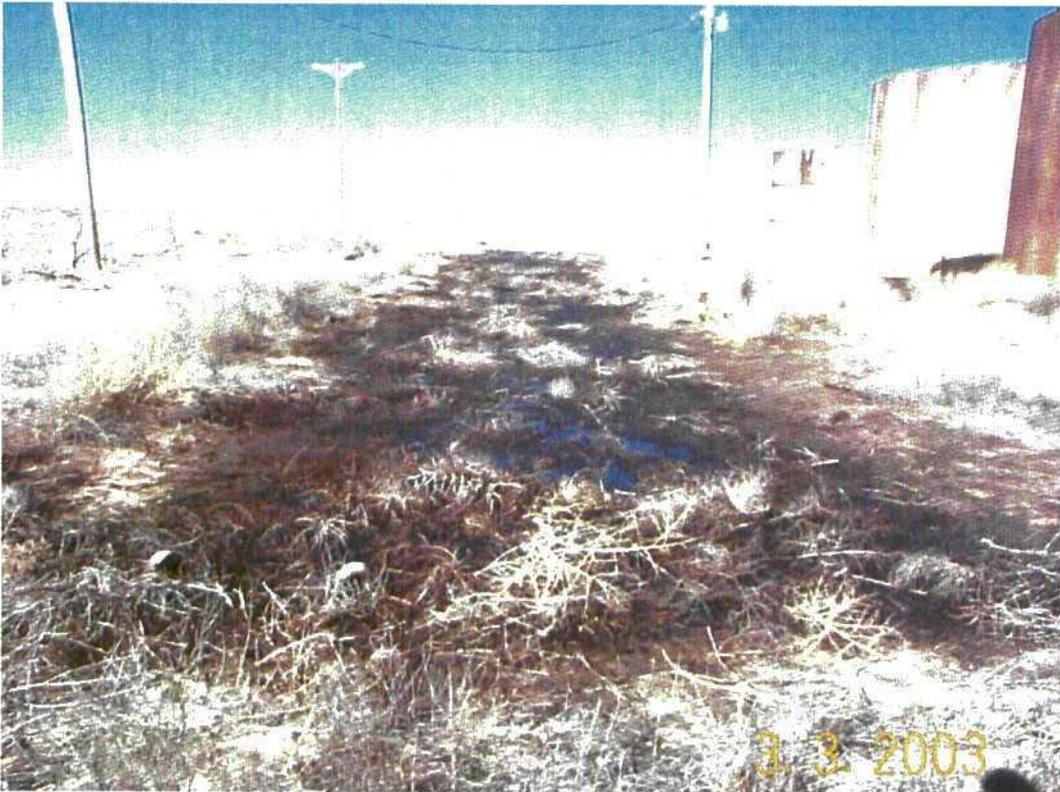
There did not appear to be any open top tanks. The low depression/pit on the south side of the facility did contain oil and could potentially be a hazard to migratory

birds (see photo 10). This unlined depression/pit must be rendered non hazardous to migratory birds.

It is unknown if there are below grade tanks or sumps located at this facility. There is one pit/depression on site (see photo 10). The contaminated soil within this unlined pit/depression must be either removed to an OCD approved disposal facility or remediated on site according to OCD remediation guidelines.

Photo 10: Pit/depression containing oil along south side of the row of 500 bbl tanks. Looking west.

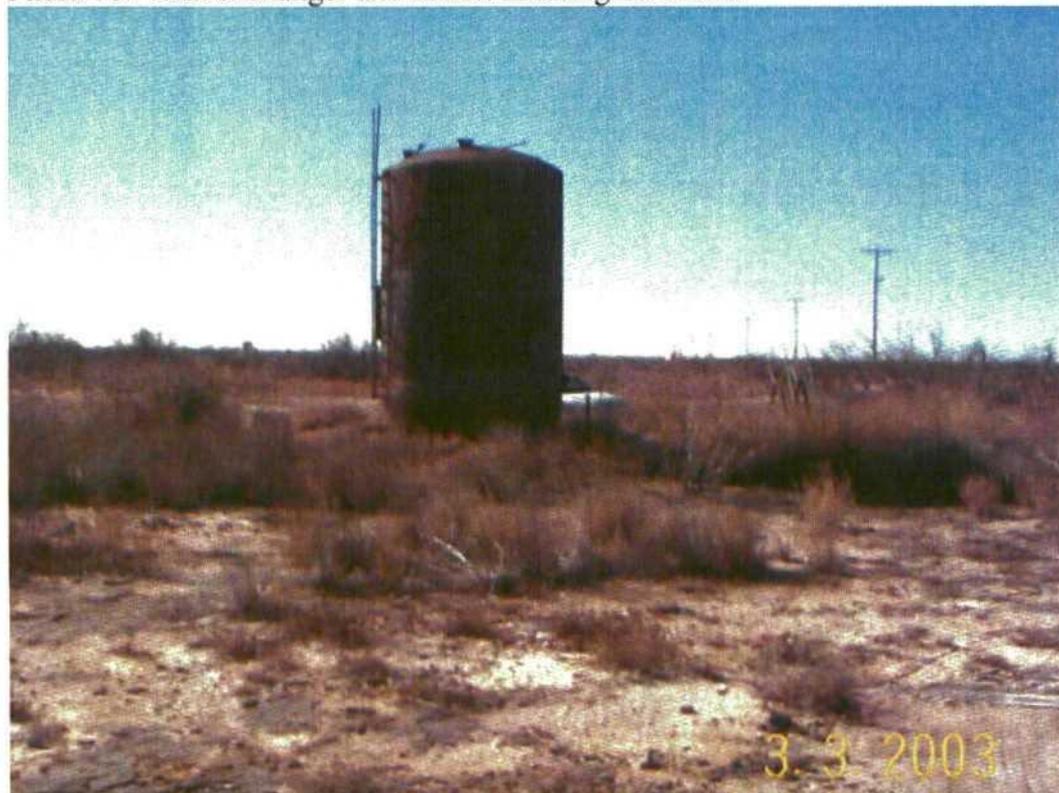
Photo 12: 10'x16' vessel. Looking south.

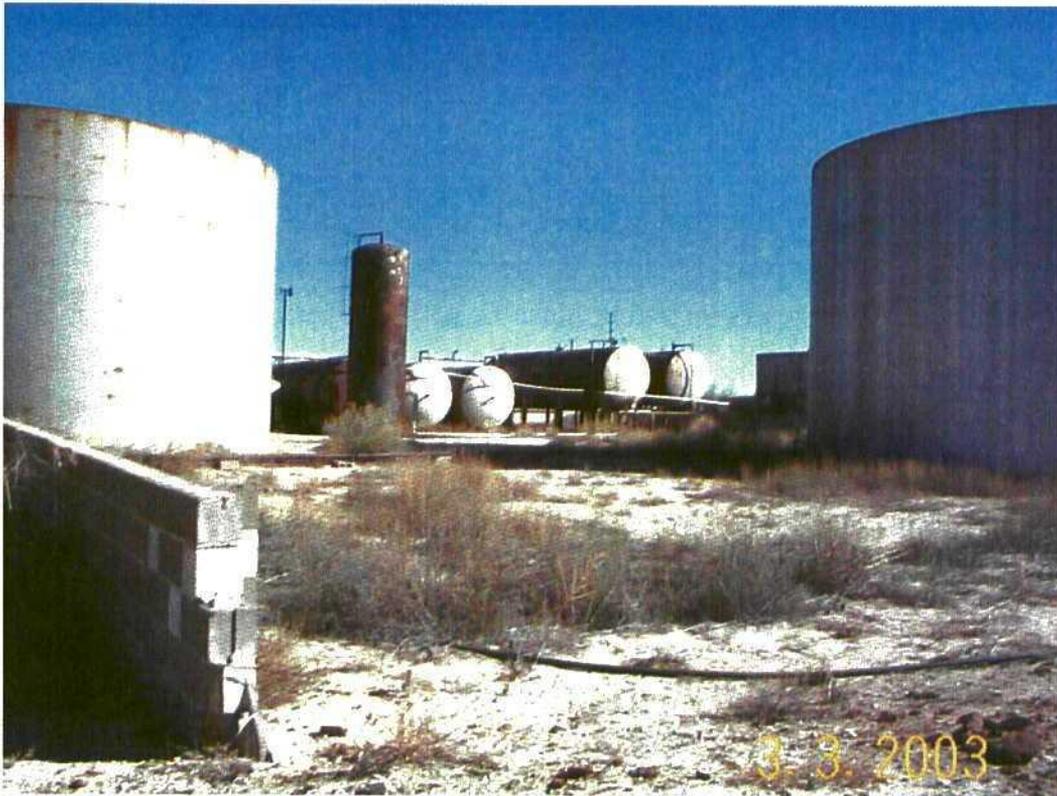
There was no berm or impermeable pad and curb containment below the existing above ground saddle tanks located at this facility (see photos 13, 14 and 15). All above ground tanks which contain fluids other than fresh water must be bermed to contain a volume of one-third more than the total volume of the largest tank or of all interconnected tanks.

Photo 13: 2-3000 bbl tanks, 5-vertical tanks and 1-vertical tank/separator. Looking southeast inside broken cinder block wall.

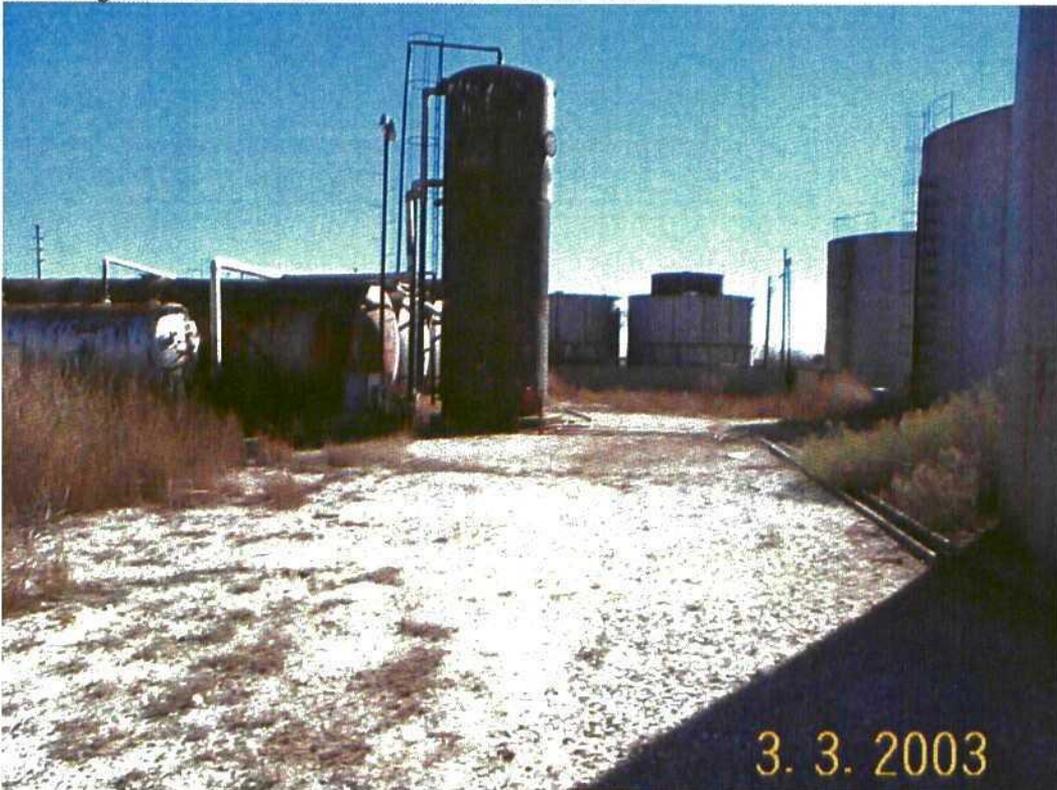
Photo 14: From left to right, 5-horizontal tanks, 1-vertical tank/separator, and 3-3000 bbl tanks on the right. Looking east.

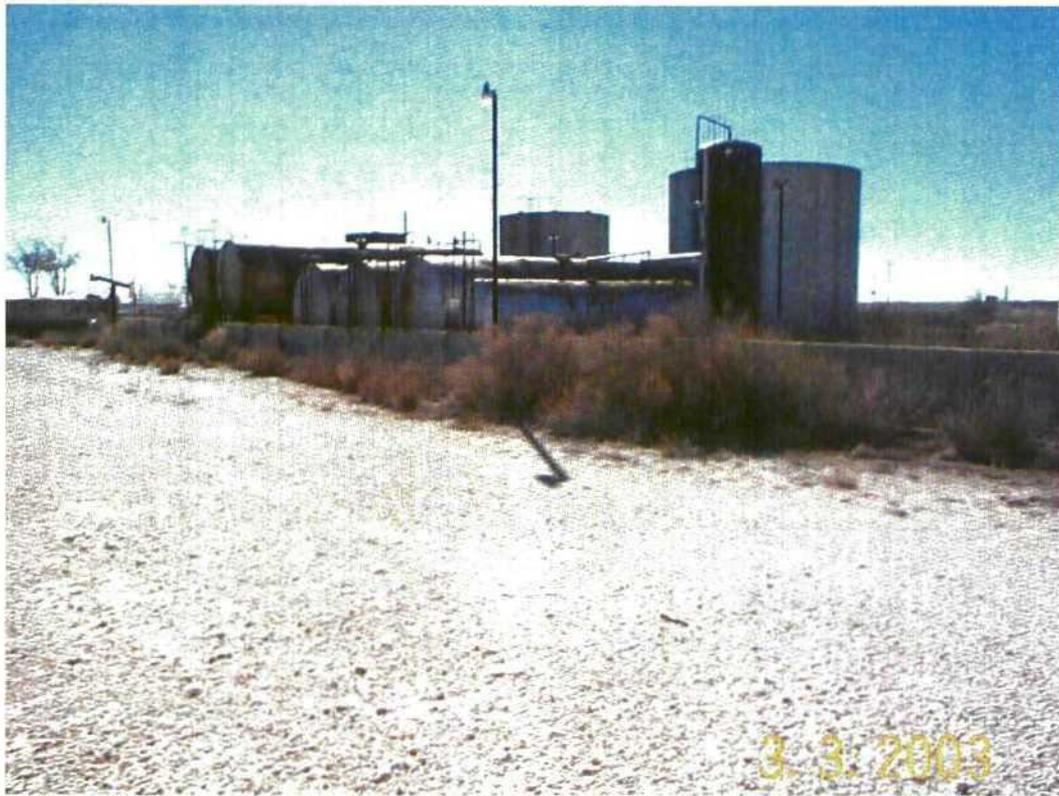
Photo 15: From left to right, 5 horizontal tanks, 1 vertical tank/separator, and two 3000 bbl tanks. Looking Southeast.

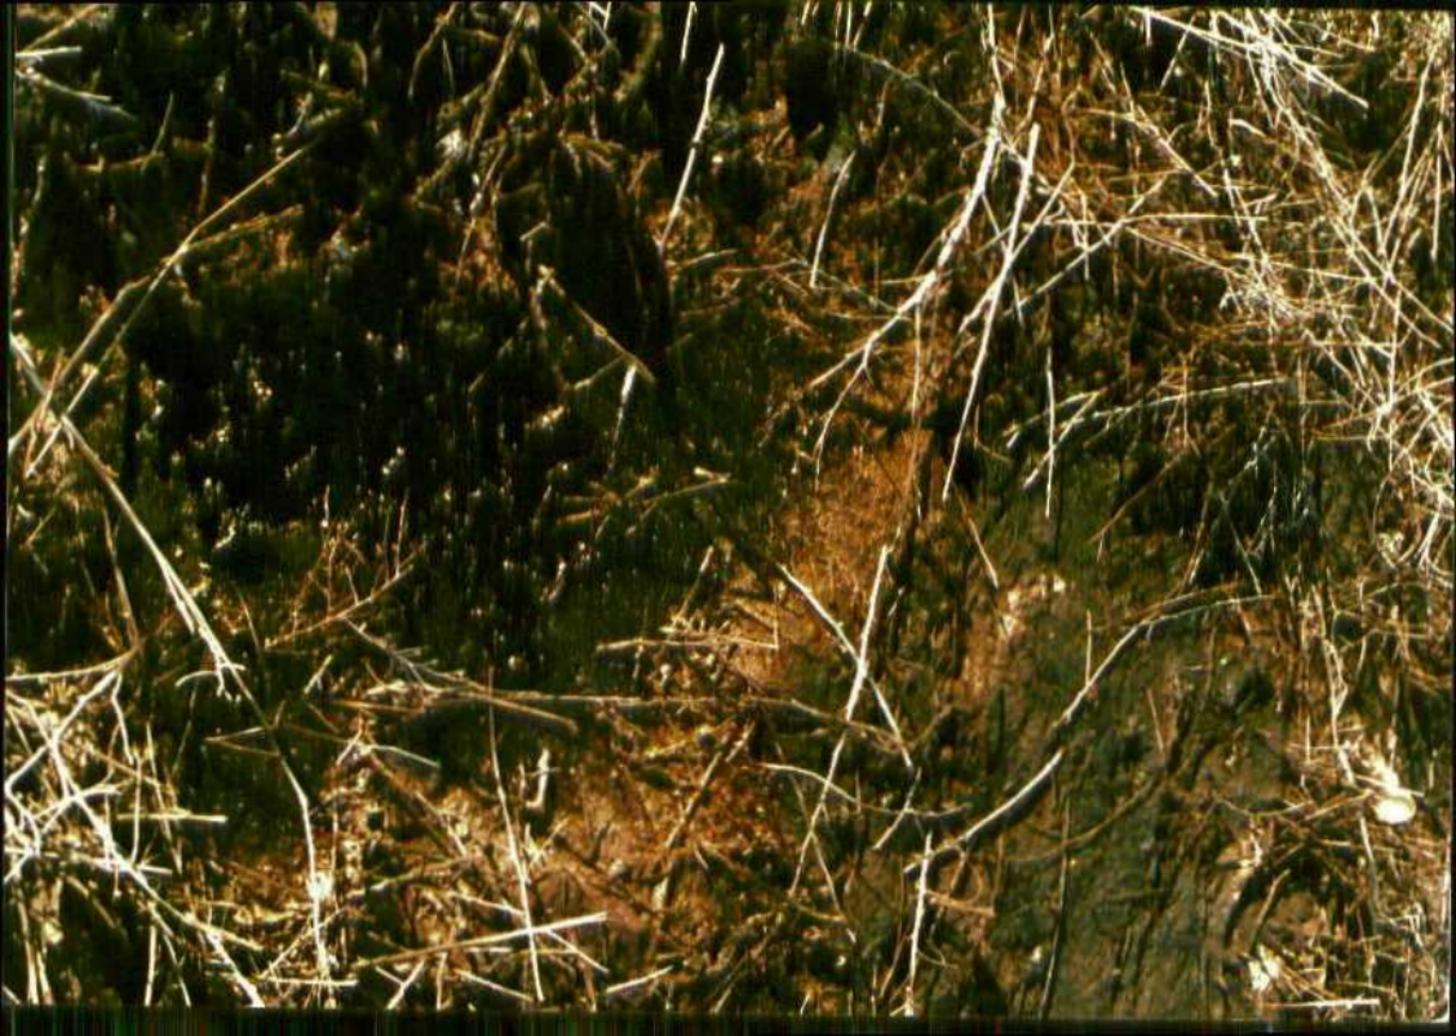
Close-up of oily sludge
on state land approx. 4 mi.
W Monument, NM in
Lea County

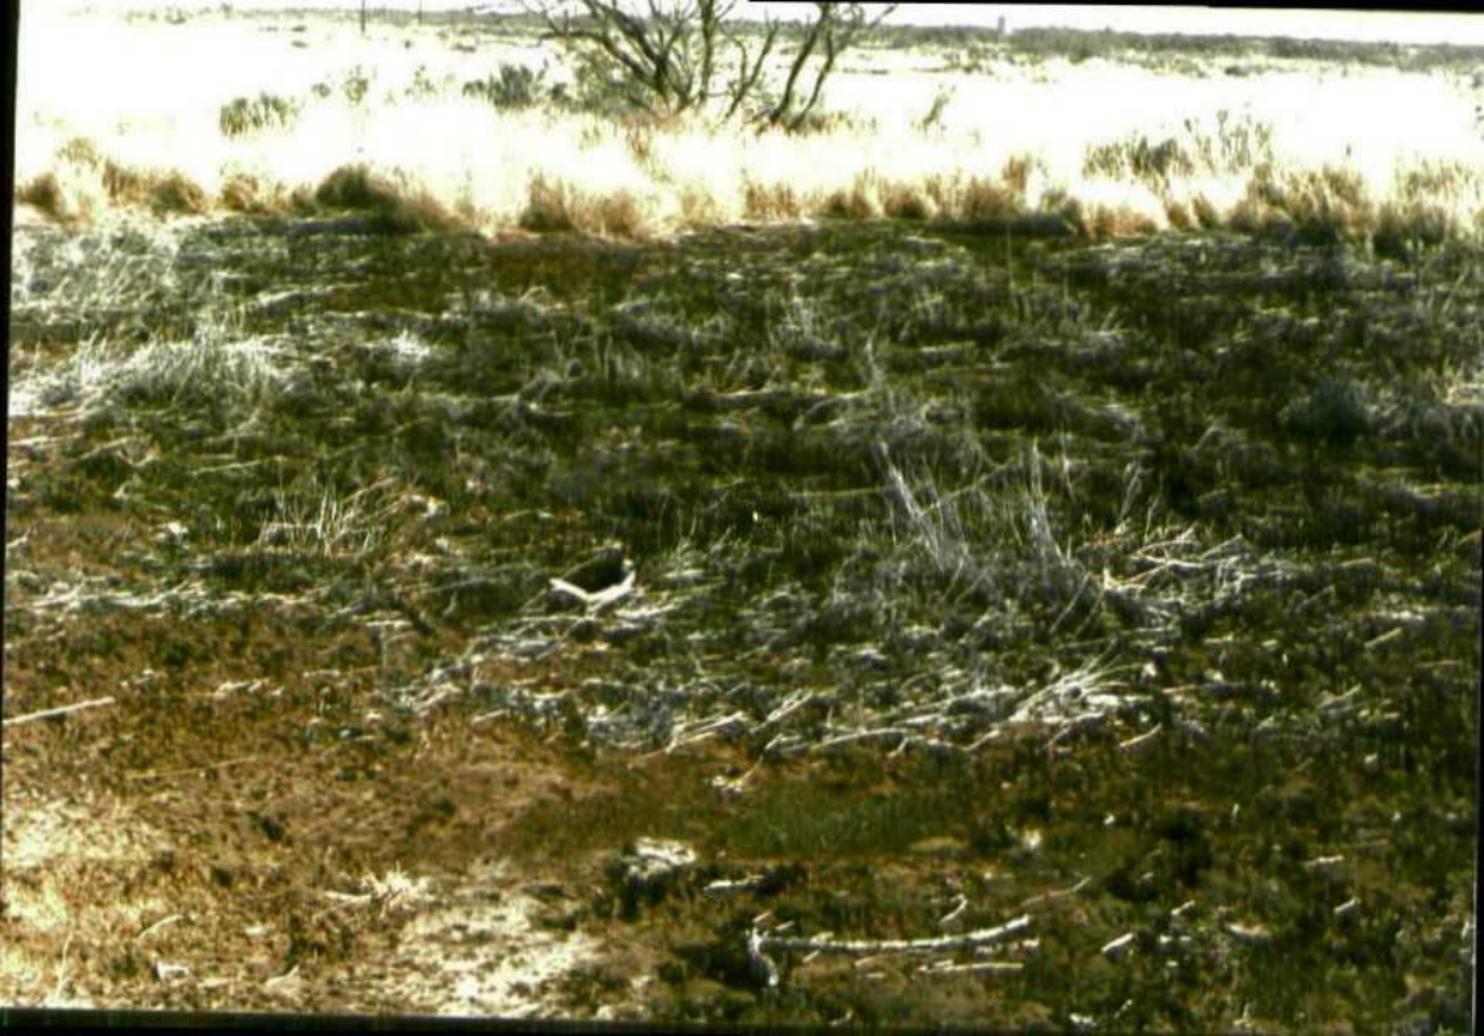
Oily sludge dumped/leaked
into natural depression on
state land in Lea County
4 mi. W Monument. 2 Old
crude/brine gathering lines
near site. Contaminated
area appx. 35-40 meters
in diameter. 91 C. Shoen
11-20-

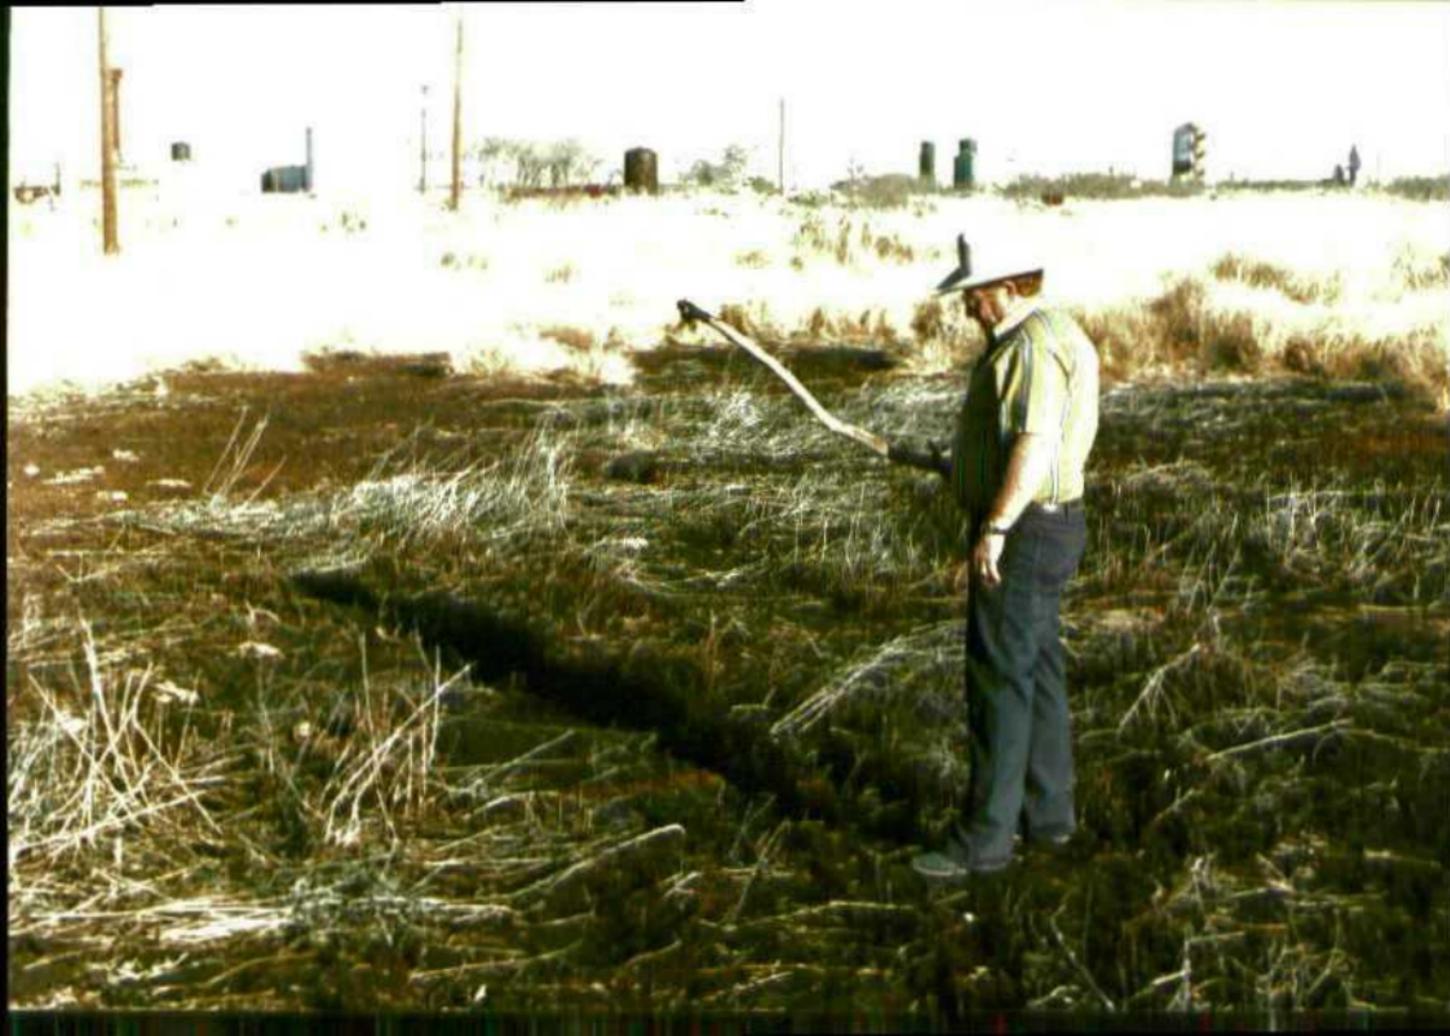
J. R. "Red" Byrd, local
Cattleman + Hobbs Fire Dept.
lieutenant, inspects oily sludge
dumped on state land south
of Warren Pet. Co. + Cimarron
Chemical Co. Monument
plants. Facility in background
is EPNT Compressor station.
11-20-91 C. Shuen

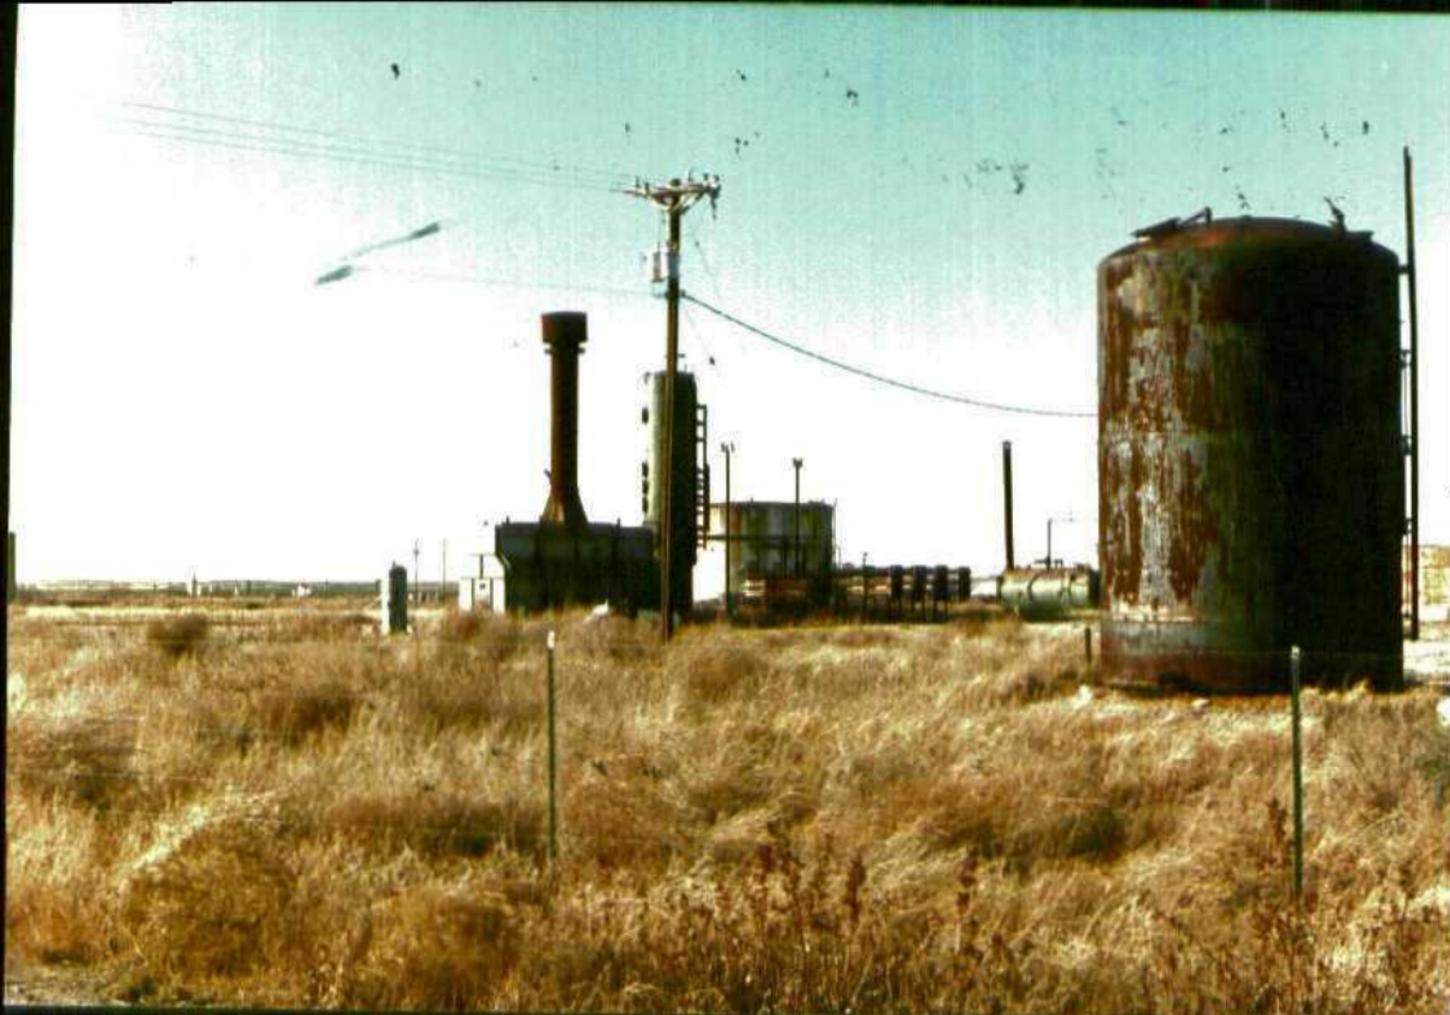
Tank, heater-treater at Warren/Fameris
facility. Heater-treater did not appear
to be operating; locals say this part
of facility is abandoned.

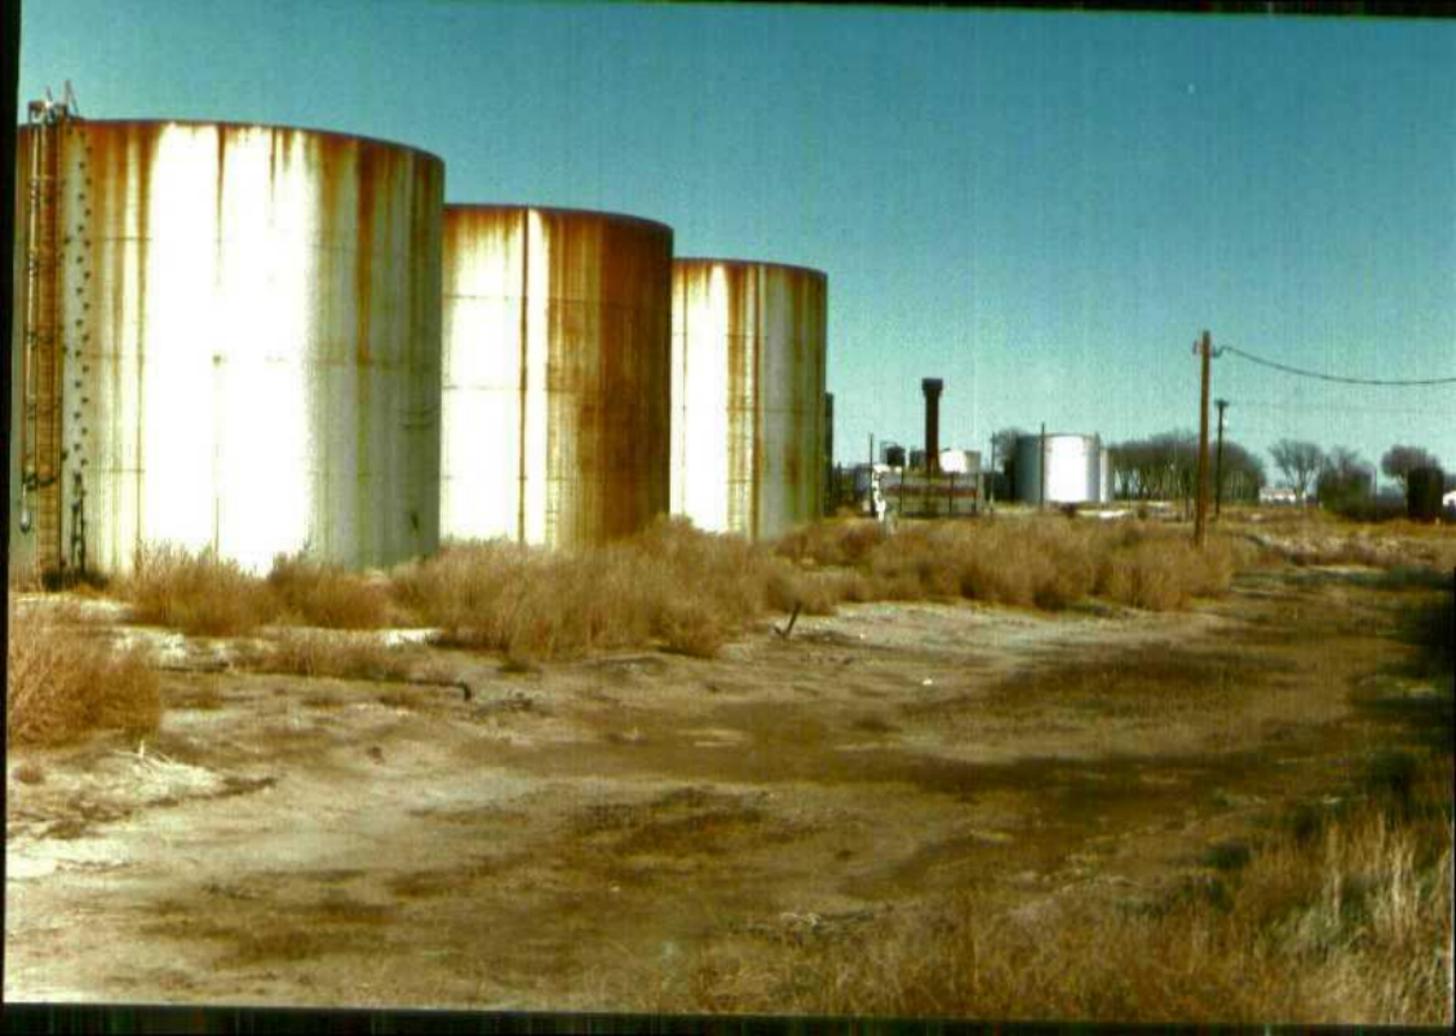
Staining in low-lying
area near HC storage
tanks at SW corner
of Warren Pet. Co. 6P
~ 3 mi W Monument,
Lea County
