YEAR(S):

Dye TRACER STUDY

2006

RE: Responses to NMED comments of the Ciniza Refinery Dye Tracer Study

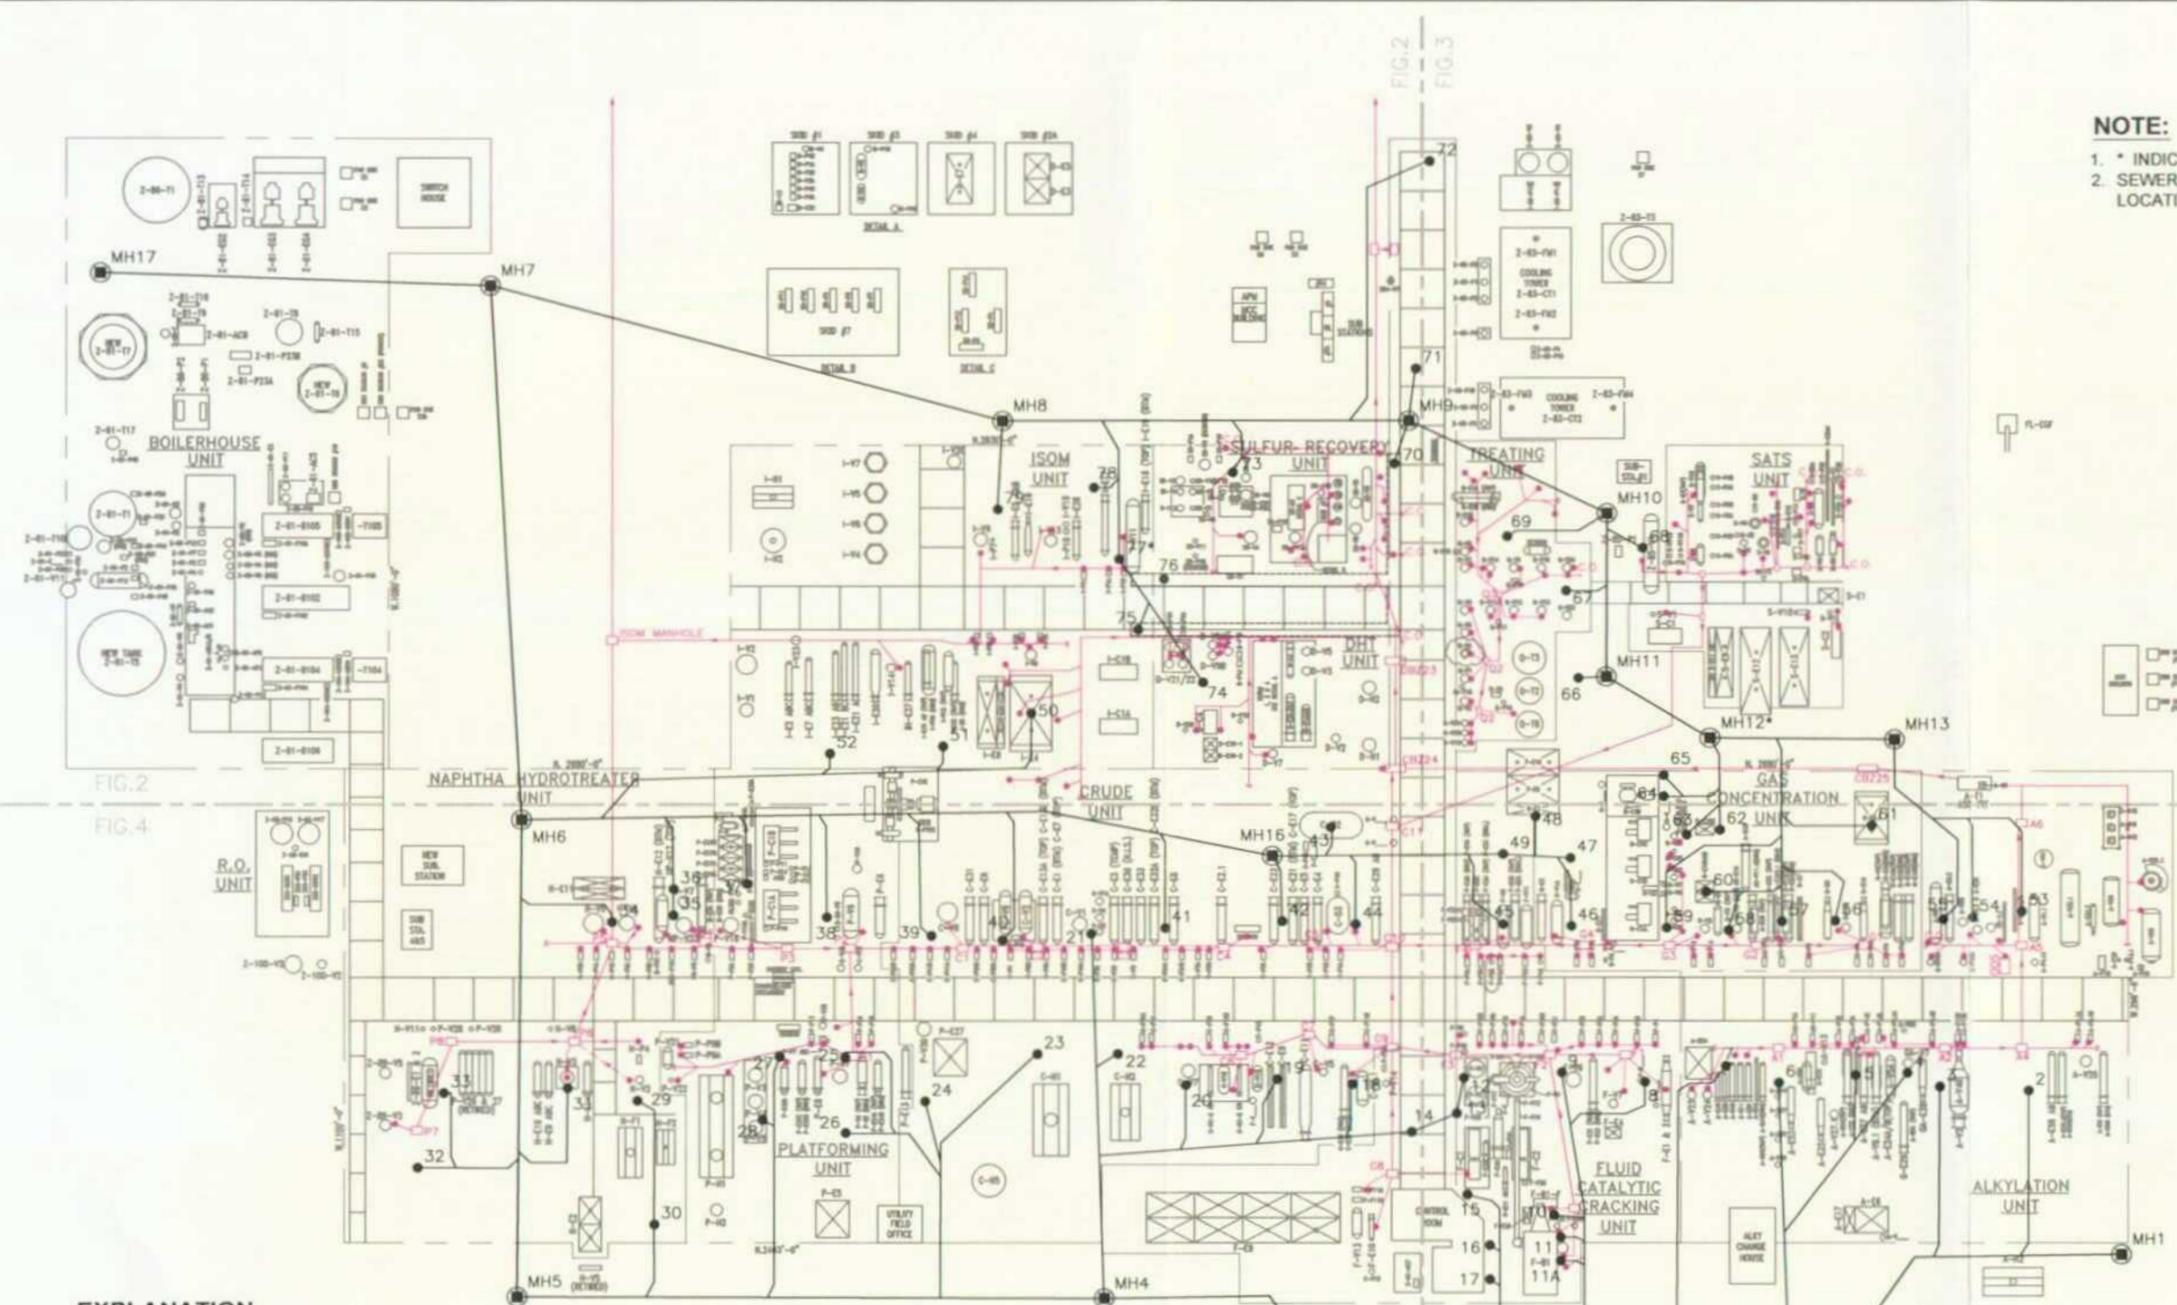
**FIGURE 1**  
**STORMWATER / NON-PROCESS**  
**WASTEWATER SEWER SYSTEM**  
 2006

*Please see Figure 1 attached to this letter. Figure 1 shows the process sewer drain locations and the stormwater sewer drain locations on a Master Plot Plan of the Ciniza Refinery. The process sewer is designated by magenta lines and the storm sewer is designated by black lines.*

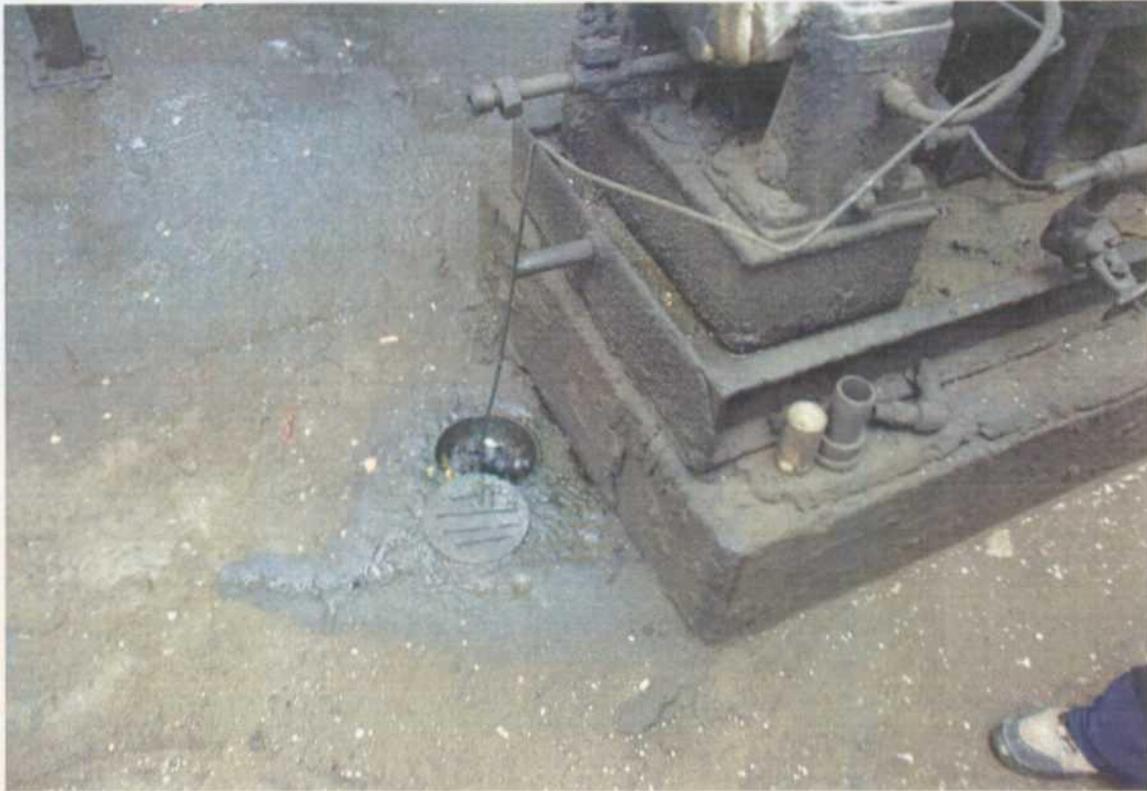
*Trihydro partially concurs with NMED regarding the presence of "green oil" in that it signifies a leak or spill entering the storm sewer drains. It is not possible at the time of the study to determine the source of the above-ground leak or spill that occurred during the dye tracer study. However, Giant strongly suspects a storm sewer drain in the FCCU unit was the point of entry for the leaked liquid because it is located near a filter pot that filters the green slurry oil. The leak or spill was most likely temporary because the green substance was not observed in all samples collected during the study. Giant has since sealed off the storm sewer drain in the FCCU area where the green slurry oil likely leaked during the dye tracer study.*

*During a subsequent visit to the Ciniza Refinery, green colored oil was observed in the Fluid Catalytic Cracking Unit (FCCU). The FCCU was undergoing a turnaround during this visit and thus bundle exchangers were being cleaned and pumps were being drained. Figure 6 is a photo, taken during a site visit in September 2006 that shows green oil residue on an FCCU pump process drain. Green oil was also observed at the bundle cleaning pad. Bundle exchangers were being cleaned using high pressured fire water. Thus, the green color was only due to the green oil. Operations personnel were interviewed and the green oil was confirmed to be slurry oil.*

Figure 6: Green oil residue on an FCCU process drain. Picture taken September 22, 2006.
