GW - 211

**Re: Inspection Report, GW-211
Largo Compressor Station, Enterprise Products Operating, L.P.
Rio Arriba County, New Mexico**

OCD Inspection: Enterprise Largo GW - 211

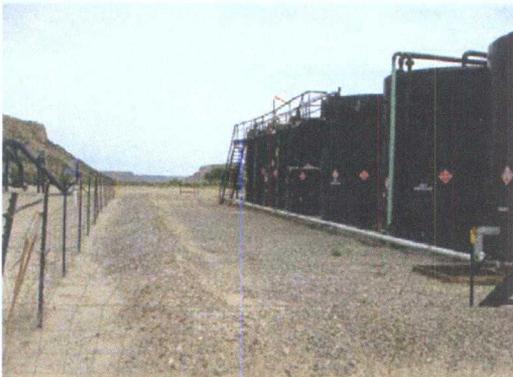
1. **Photos 1 – 3:** A spill occurred in early 2008. The spill has impacted ground water at a depth of 25 feet. The spill has been monitored for 1.5 years. Owner/operator shall initiate remediation as soon as possible of groundwater contamination. Submit all historical monitoring documentation to the Santa Fe office. Photo 2 – 3, two below-grade tanks are shown, one of the two tanks has fluids within its leak detection system. Owner/operator shall investigate the cause for these fluids and prove integrity of the tank.

Photo 1: Unlined AST's where spill occurred 1.5 years ago.

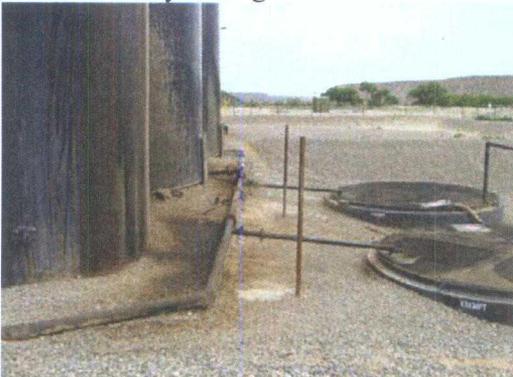
Photo 2: BGT's behind unlined AST's where spill occurred. GW impacted, as of inspection monitored only but not remediated.

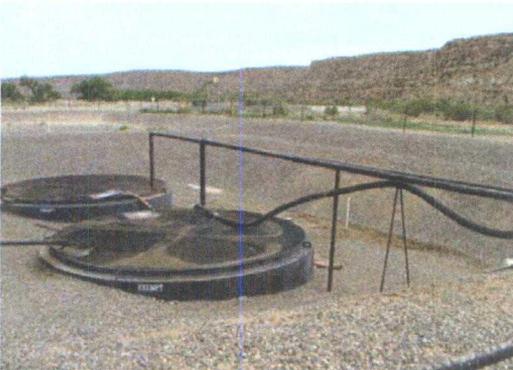
Photo 3: Leak detection of one BGT has fluids the other BGT could not verify leak detection system due to un-removable port.

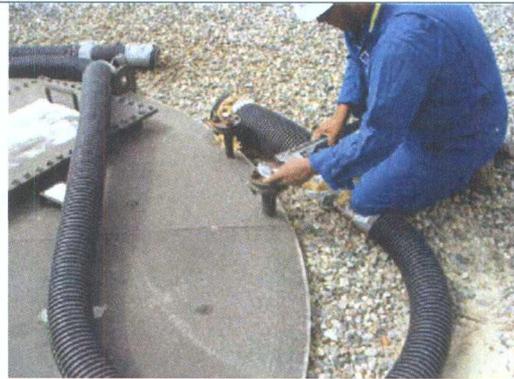
2. **Photo 4:** This below-grade tank's leak detection system was verified to be dry. During the inspection, the leak detection systems for two of the three BGT ports were not easily accessible indicating that the leak detection systems are not frequently inspected. Owner/operator shall monitor and keep record of all leak detection systems on a monthly basis. All leaks shall be addressed accordingly. See condition 11 for details.

Photo 4: BGT verified DRY.

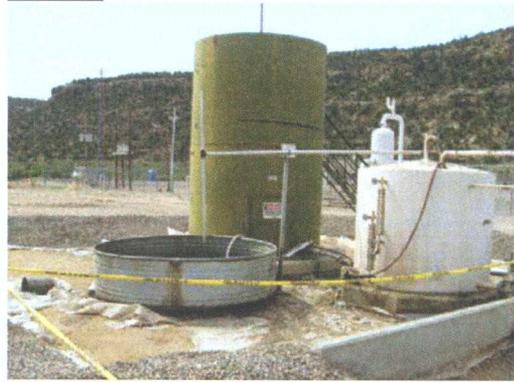
3. **Photo 5 - 7:** The liner within this bermed, above ground storage area has deteriorated. Photo 7, there appears to be residuals seeping through the berm. Owner/operator shall re-establish a liner for the ASTs area and clean up all contamination. Submit all proposed plans to the OCD for approval.

Photo 5: AST's with deteriorated lining.

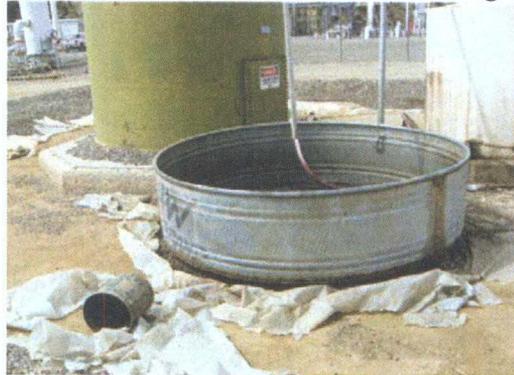
Photo 6: Torn lining.

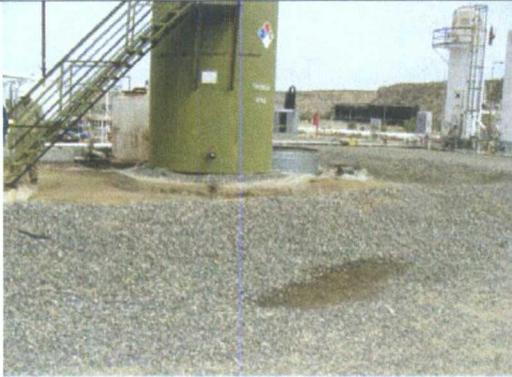
Photo 7: Exterior of bermed area of unlined AST's appears to have seepage.

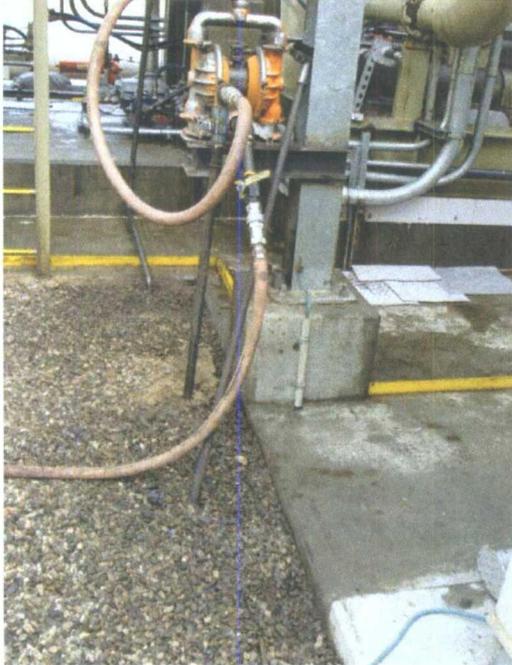
4. **Photo 8 – 10:** There were a few areas with visual stained soils within the facility's yard. Owner/operator shall follow best management practices to prevent such future discharges. If such discharges occur owner/operator shall address them accordingly. See Condition 14, 15, and 18 for details.

Photo 8: Around compressor have discharges on to ground.

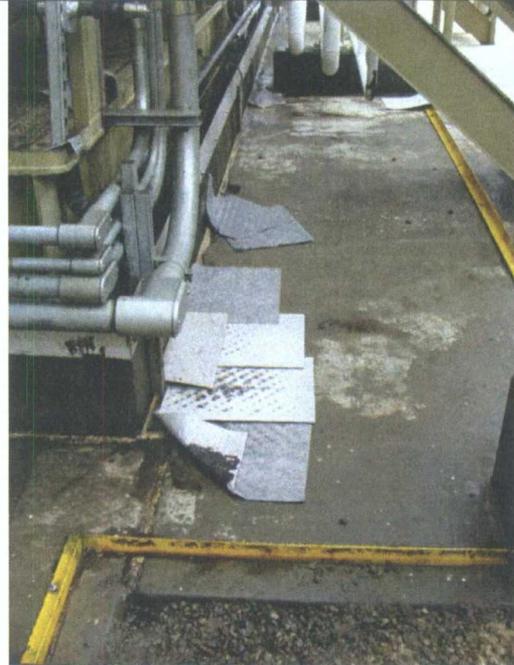
Photo 9: Discharges around compressor.

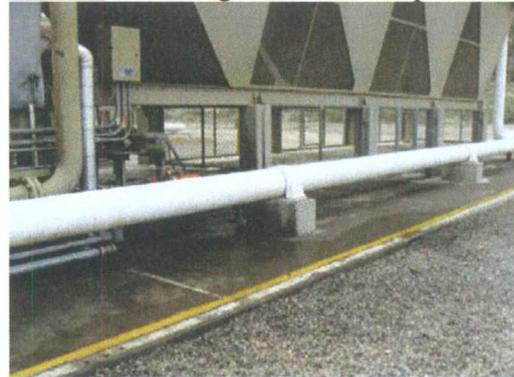
Photo 10: Discharges near compressor.

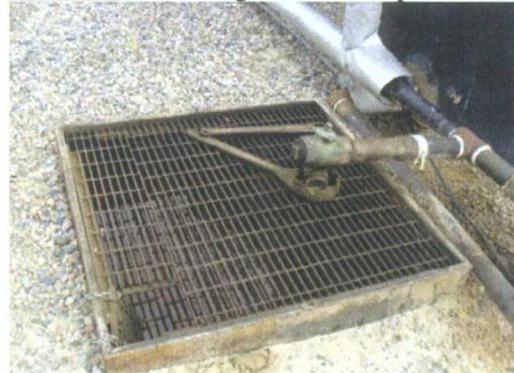
5. **Photo 11:** Fluids were noted to be present within a catch basin. Owner/operator shall clean out and inspect the containment area. The presence of fluids and its below-grade construction qualifies this containment as a below-grade tank, unless the owner/operator treats it as a sump. Fluids must be removed within 72 hours. See Condition 11 and 14 for details.

Photo 11: Catch pan has fluids.

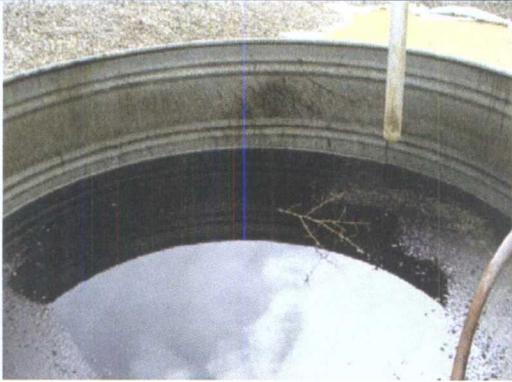
6. **Photo 12 – 13:** This open top container appears to have integrity issues. There is seepage at the corners of the containment. Owner/operator shall either repair or replace container. All fluids shall be removed within 72 hours. See Condition 14 for details.

Photo 12: Containment has idle fluids, not water.

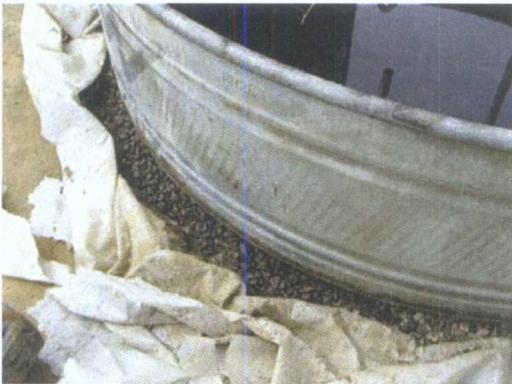
Photo 13: Containment in photo 12 appears to have seepage of contents.
