**GW - 330**

NEW MEXICO ENERGY, MINERALS  
& NATURAL RESOURCES DEPARTMENT

**RE: Facility Inspections  
Former PNM facilities  
San Juan County, New Mexico**

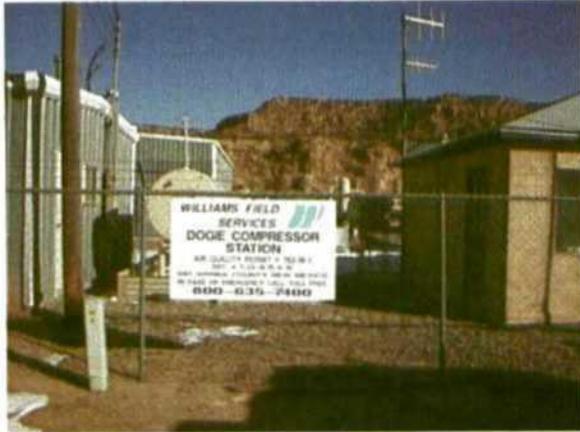
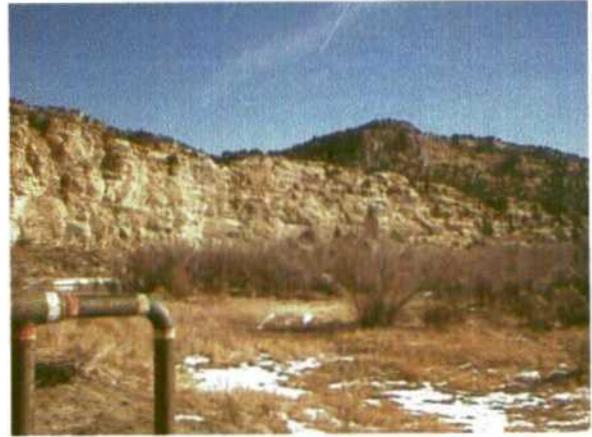
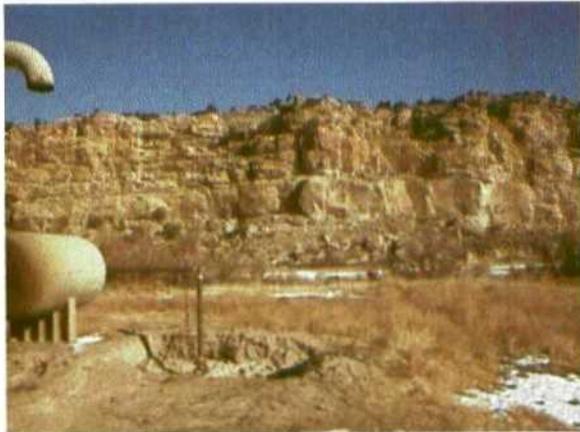
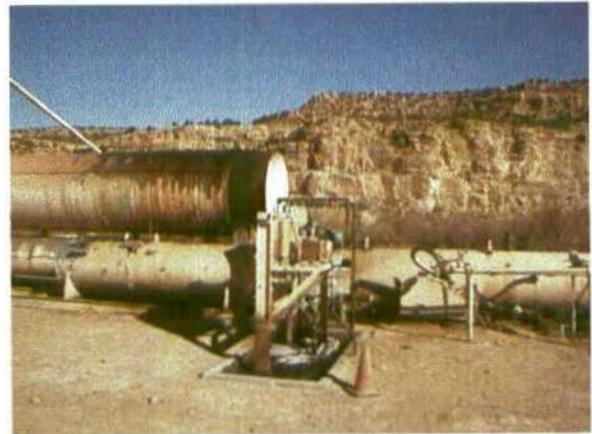
## Dogie Compressor Station

1. **Dogie Compressor Station,( Inspected 01/12/00)**
  - A. The overall housekeeping and pollution prevention in place at the site requires some upgrading to prevent discharges to the ground surface. It should be noted that the lube oil saddle tanks at the site did not have pad and curb type containment under them although they were within an unlined bermed area.
  - B. It was noted the dehydrator blowdown separator has leaked to the ground surface and currently has staining around the vent and below some fittings. This condition requires immediate correction.

- C. Soil staining was noted outside the compressor building resulting from overflow leaks onto the concrete floor within the compressor building. Remediation of the affected soils requires attention together with the prevention of similar events in the future
- D. Diesel tank should be placed on a concrete and curbed pad.

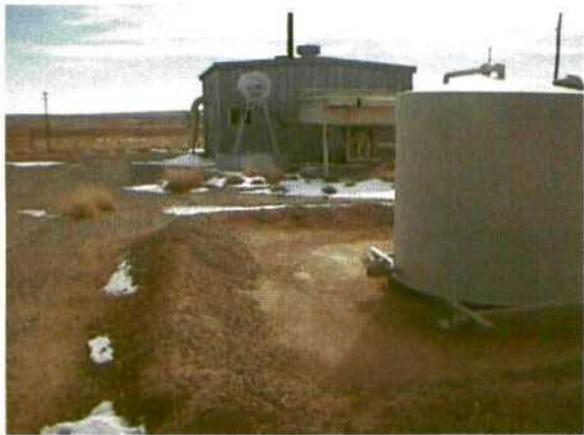
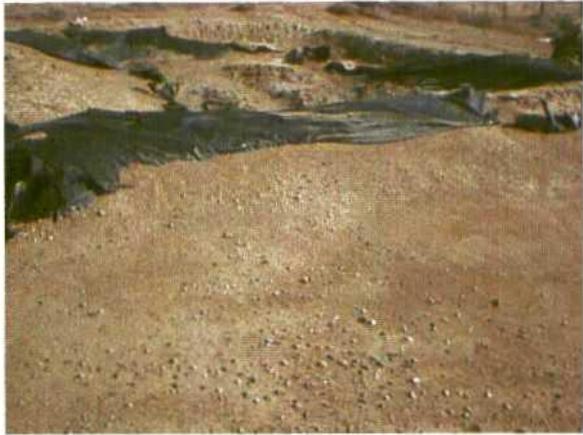
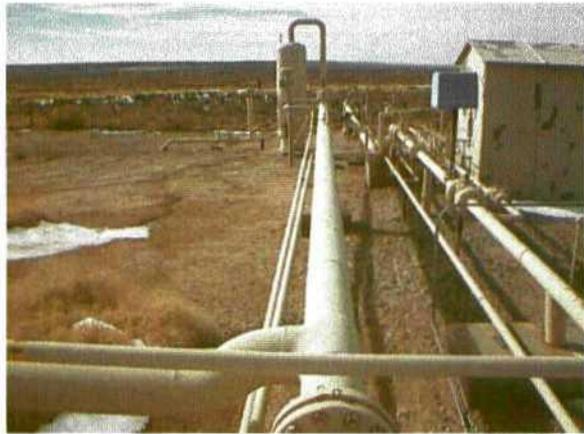
**ATTACHMENT NO.2**  
**Huerfano Compressor Station**

- A. The subject facility is currently not in operation.
- B. Waste issues – there is an open pit located in the southeast corner of the facility site. The impermeable lining in the pit is ripped and it appears that the underlying soils are stained.

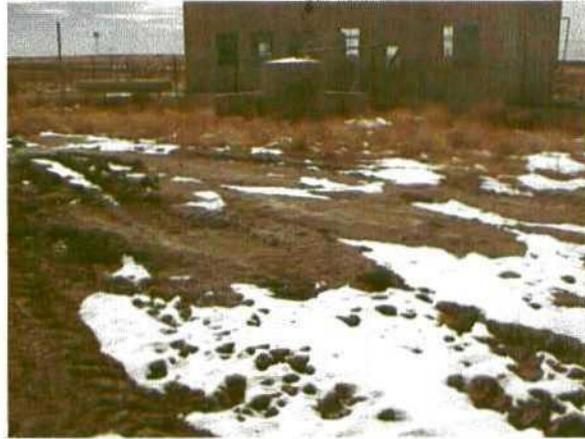
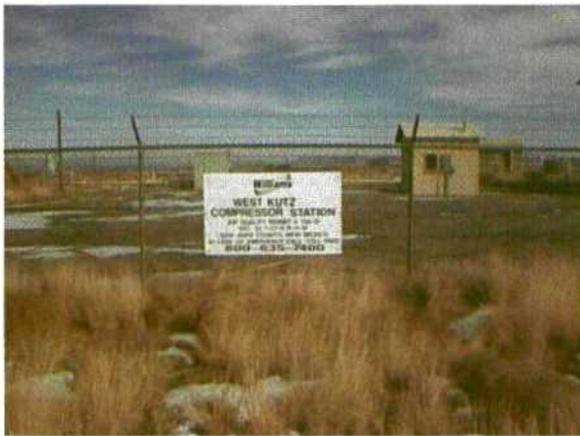
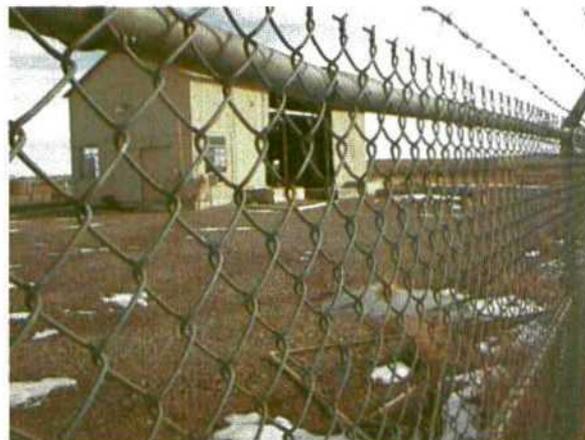
## West Kutz Compressor Station

- A. The subject facility is currently not in operation.

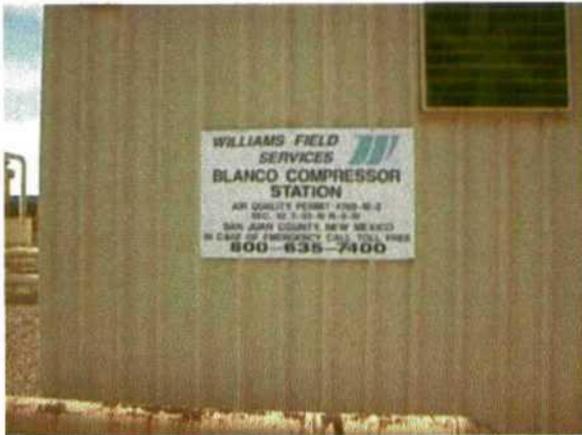
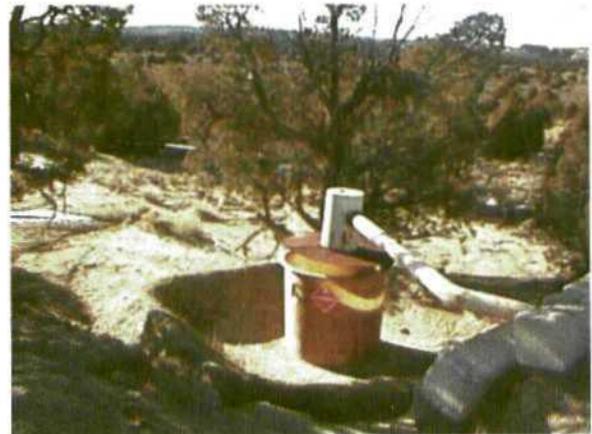
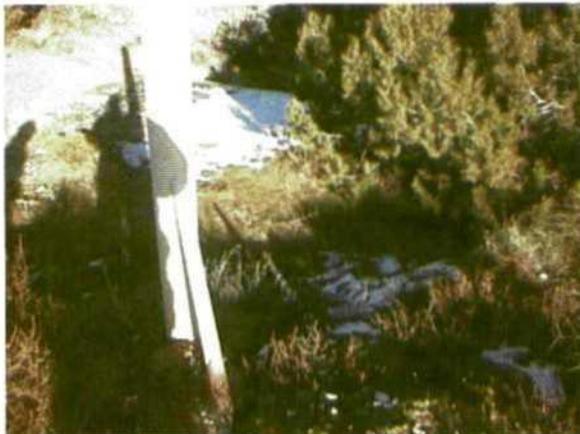
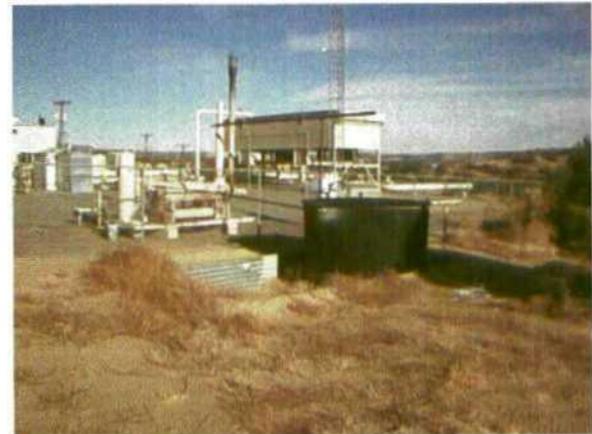
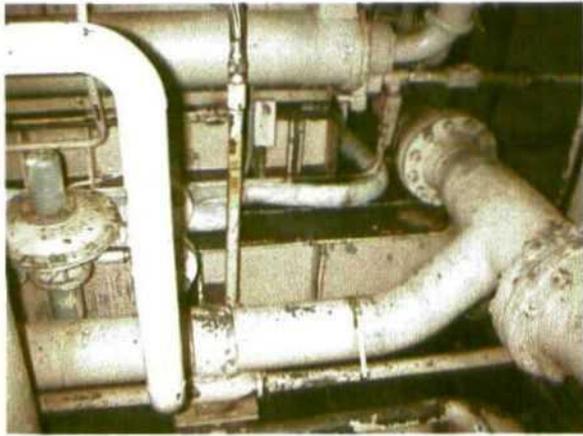
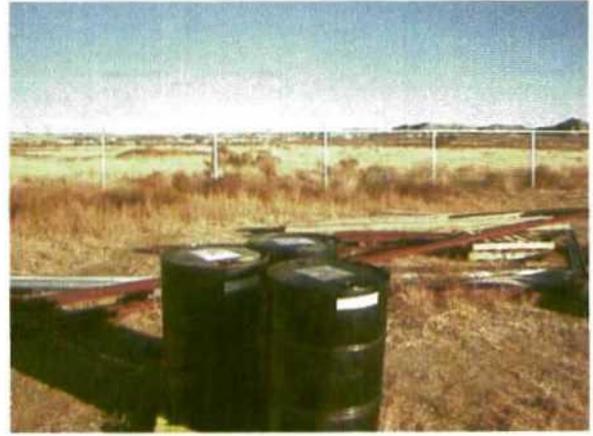
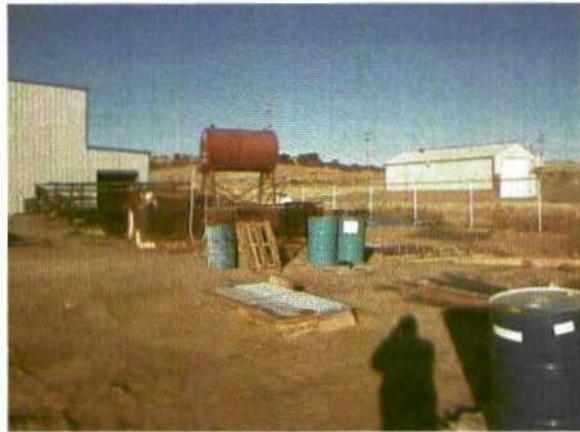
## Blanco Compressor Station

- A. Permanent diesel tank is located within a metal unlined containment area. Slop oil collection tank is double bottomed and also within a metal unlined containment.
- B. Underground drain lines require testing for integrity.
- C. Blowdown vents (stacks) have indication of releases of fluids on and around the base of the vents.
- D. Soils around pigging station tanks appear stained from releases.

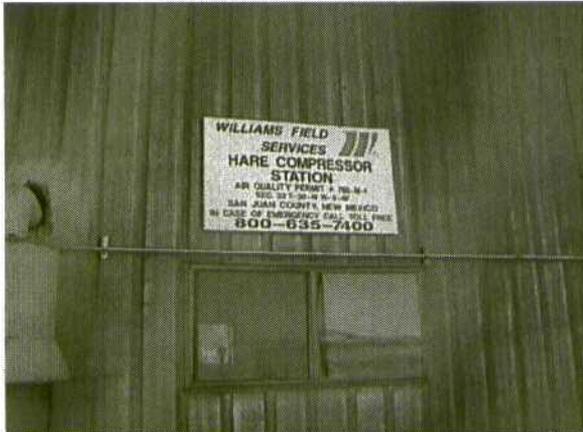
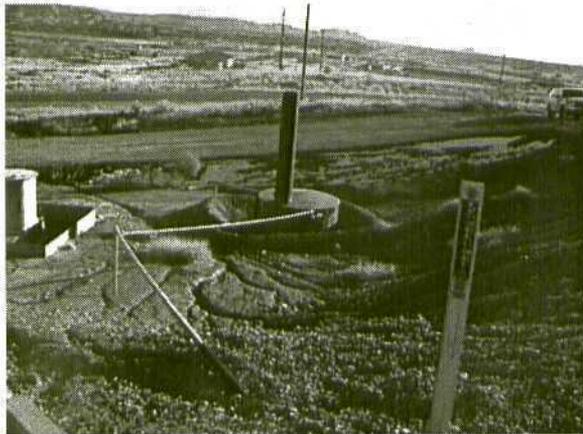
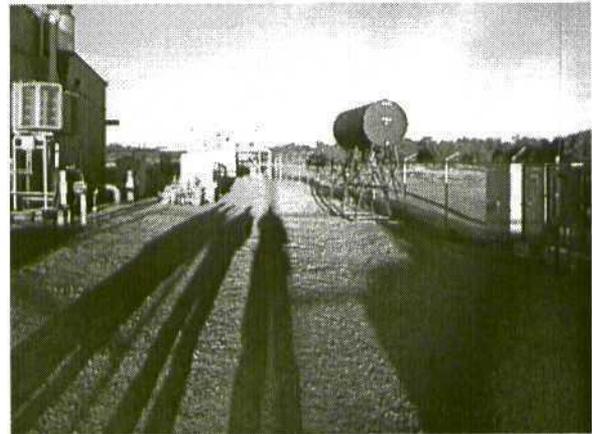
## Hare Compressor Station

- A. Soil staining from hydrocarbon releases was found outside of the compressor building. Remediation of these soils need to be addressed. Cooling water tank also collects drainage from compressor building floor.
- B. Lube oil saddle tank located within an unlined metal containment indicated leaks from dispenser valve on the the ground surface.

- C. . Overflow steel tank from separator and un-used tank (empty) are mis-labeled.
  - D. Separator valve drain leaking and appears to have been leaking for a period of time.

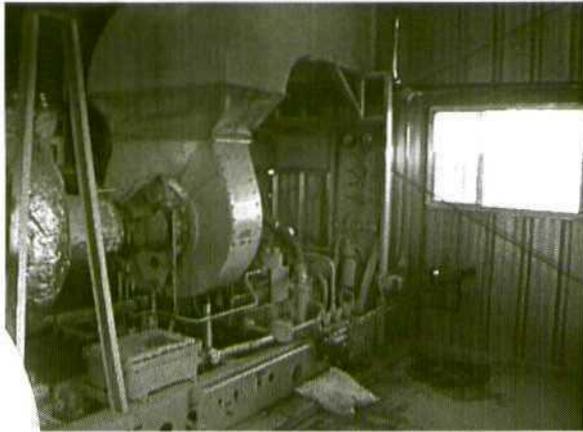
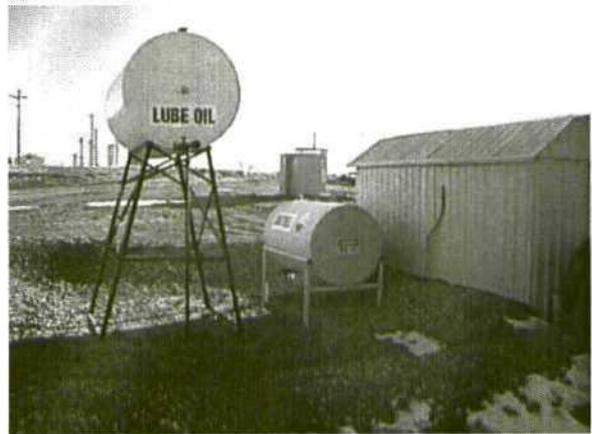
## Thompson Compressor Station

- 6. Thompson Compressor Station, (Inspected 01/12/00)**
- A. Blowdown tank for compressors indicate overflow conditions have occurred.
  - B. Waste water collection tank has no leak detection. Vent pipe indicates evidence of liquid overflow.

- C. Suction and fuel lines leading into compressor building indicate leaks onto ground surface with stained soil and hydrocarbon odors.
  - D. Compressor with White manufactured engine leaking lube oil onto concrete floor and to outside of building.

- E. Lube oil tank requires label of contents.
  - F. Unused unlined suction dehydrator pit requires testing and closure plan.
- 7. Crandall Compressor Station (Inspected 01/12/00)**

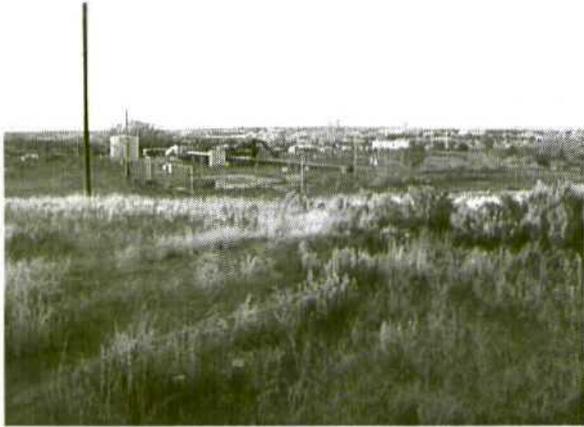
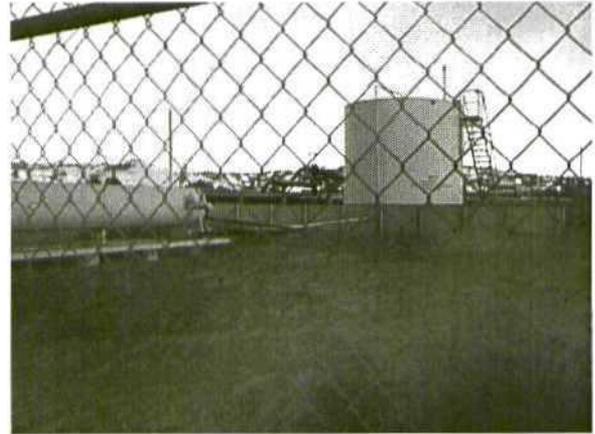
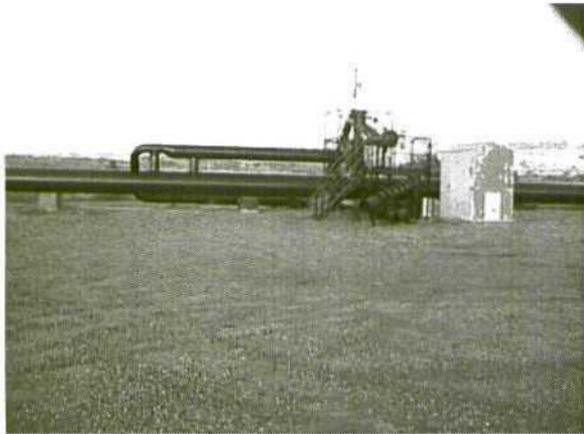
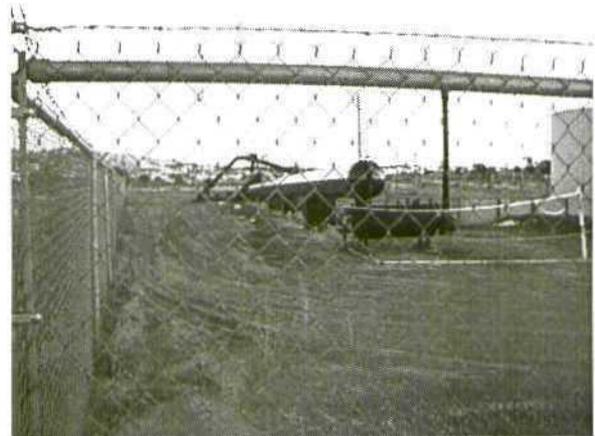
**Attachment No. 7**  
**Crandall Compressor Station**

- A. All compressor equipment has been removed from facility site.
  - B. Extensive pigging piping and tankage remain at this facility.
