Preliminary Assessment
of
Gooch's Tank Service
Tatum, New Mexico

February 6, 1992

Susan A. Morris
Environmental Specialist
New Mexico Environment Department

Date: February 6, 1992
Prepared by: Susan A. Morris
Site Name: Gooch's Tank Service
Site Address: Highway 380 West
Tatum, New Mexico
EPA ID No: Not Assigned
TDD No: Not Assigned

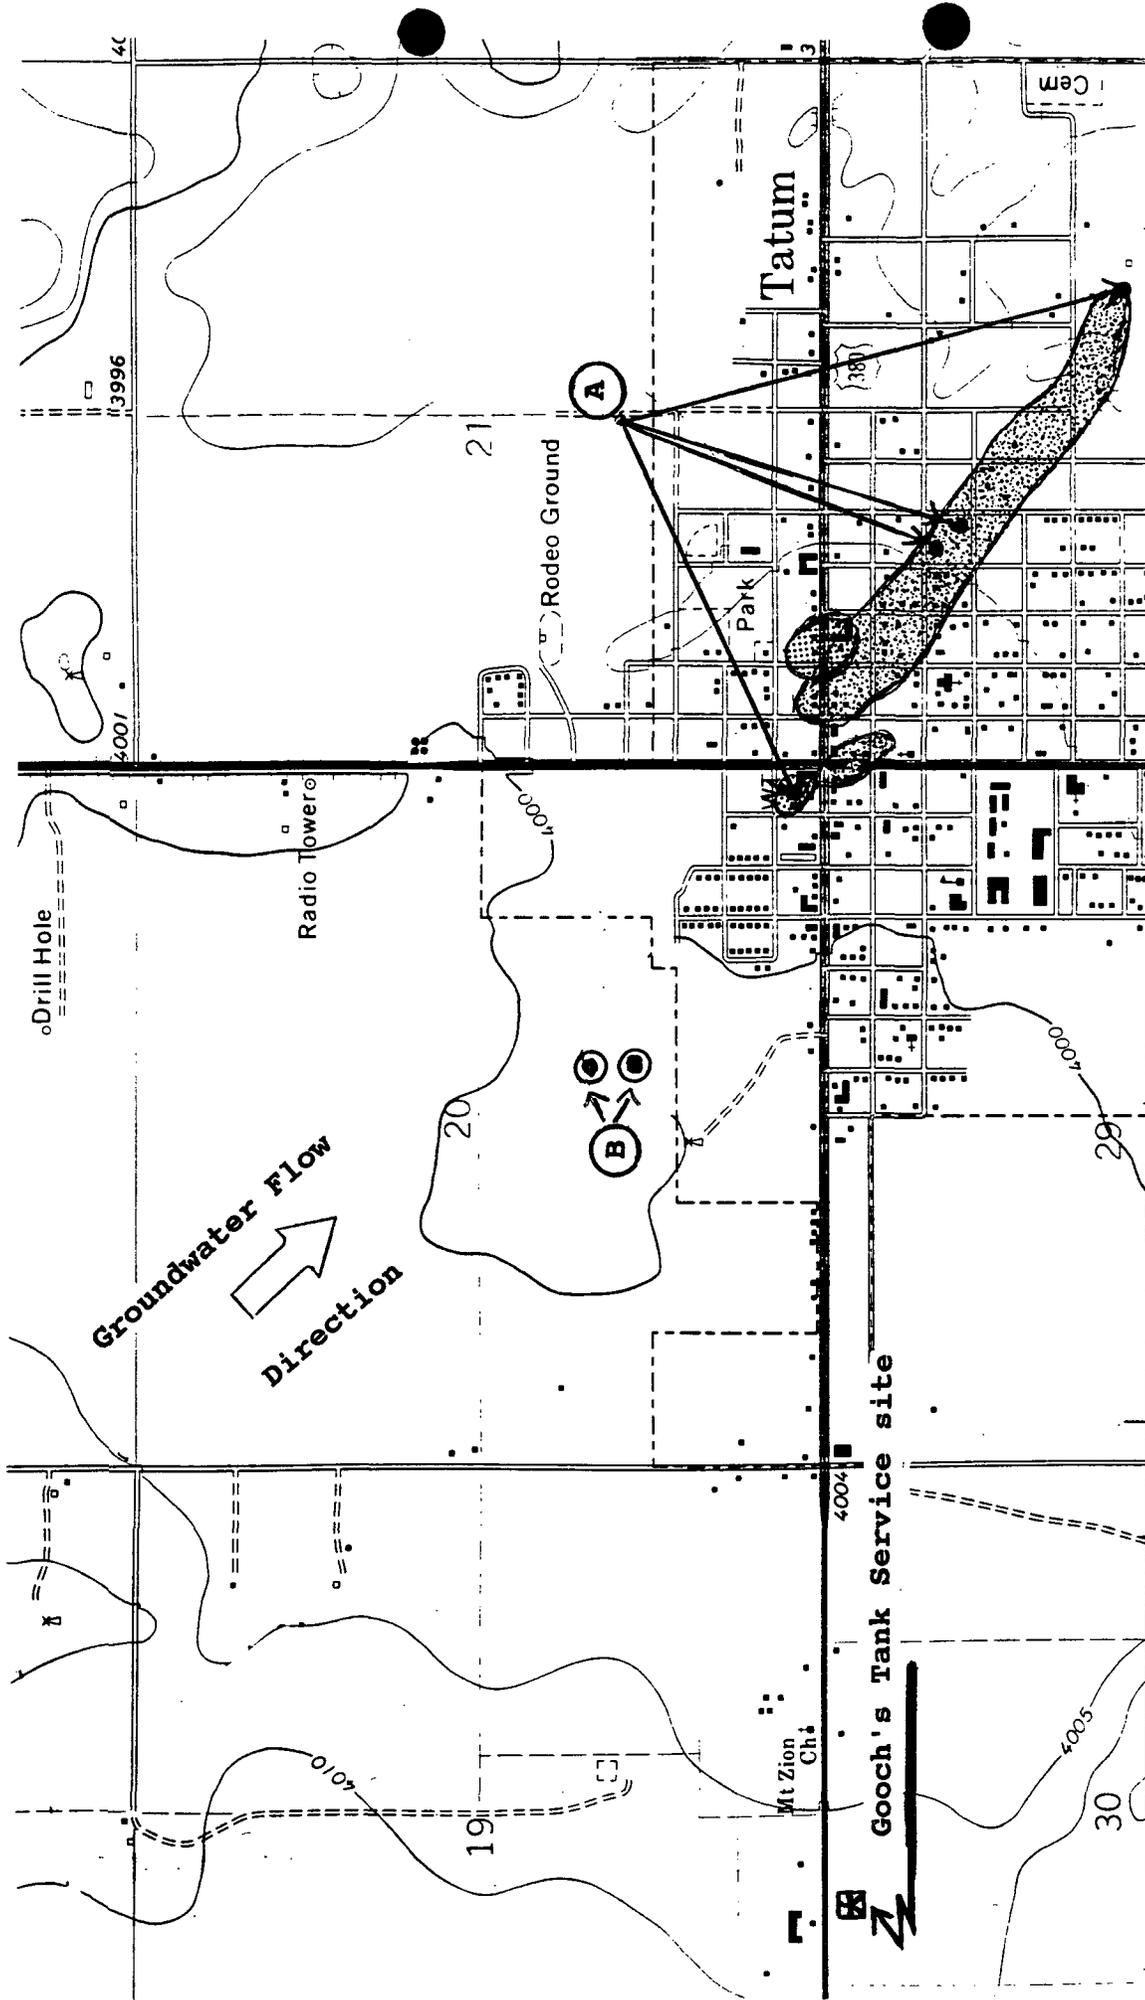
Figure 5. Four groundwater plumes emanating from leaking underground storage tank sites have contaminated four municipal wells (A) in Tatum. Gooch's Tank Service site is off gradient from the two, new municipal wells (B) that are serve the community.

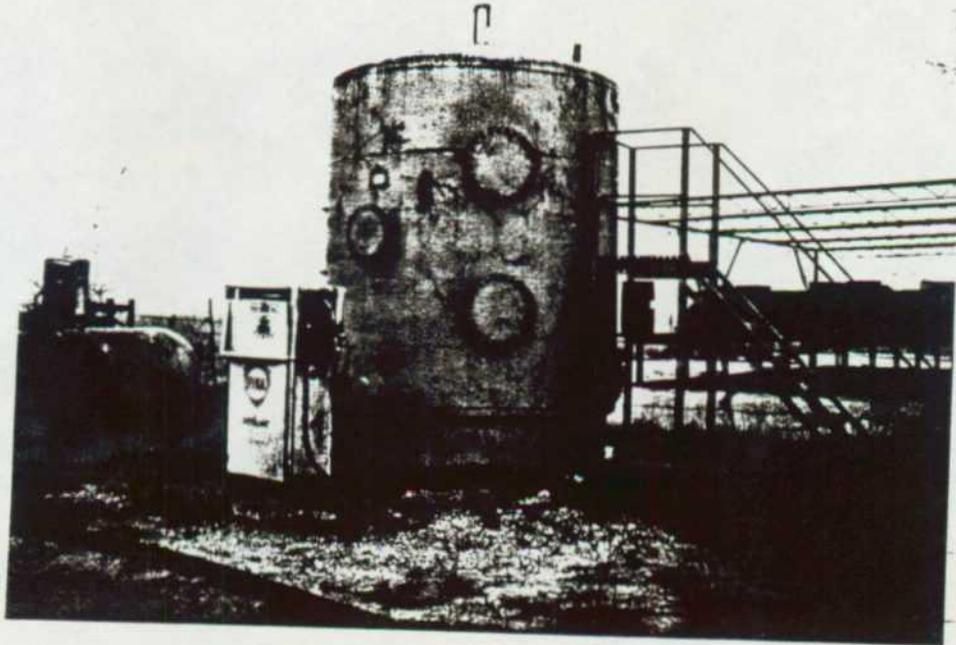
The site is a 10 acre parcel that has 3 buildings: a central office and two work sheds (Figure 3). The site is entered through the main office building or through a locked gate. Along the western property line there is an above ground gasoline storage tank and pump (Photograph 3). Numerous large, steel storage tanks line the front fence along Highway 380 and occupy the yard east of the main building (Figure 3). A cesspool is located on the western side of the office building and serves the restroom facilities on site. Ms. Meyers spoke with Mr. Gooch about the feasibility of connecting to the Tatum Sewer line and informed him that a cesspool was a violation of the New Mexico Liquid Waste Regulations.

Photograph 3. Located on the western edge of the property, an aboveground tank stores gasoline on site.
Photographer: Susan A. Morris, Date: 12/11/91

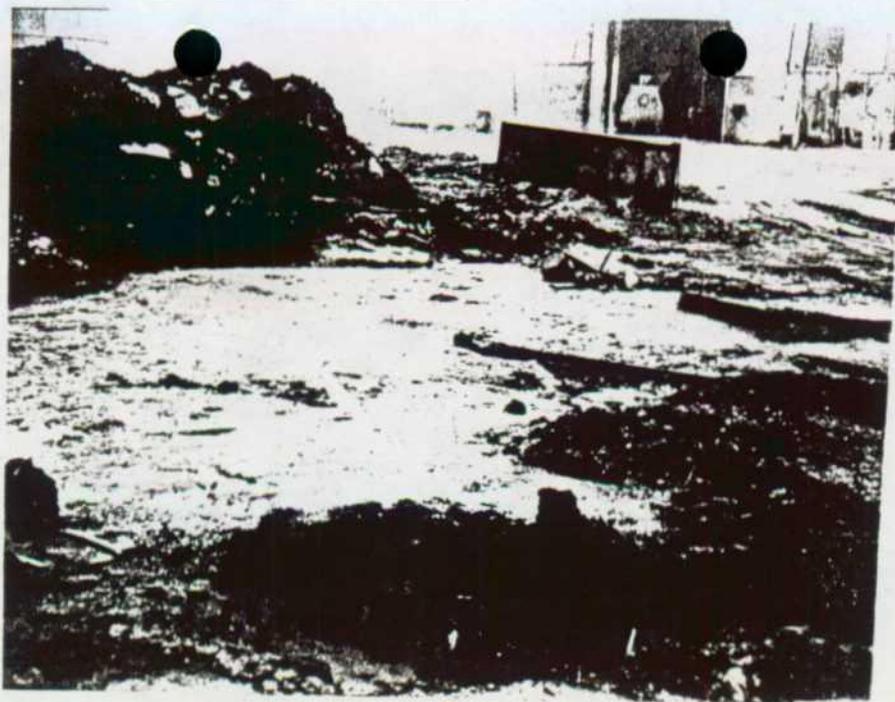
The onsite waste pile has never been sampled. The material consists of primarily blacken blasting sand, and appears oily. Potential contaminants of concern are semi-volatile organic compounds and heavy metals. In some areas, the traffic of heavy machinery has mixed the waste materials into to the soil (Photograph 5). Within the piles are pieces of rusting metal debris and construction materials (Photograph 6).

Photograph 5. Oily waste has been mixed into the surface soil by heavy machinery traffic. Photographer: Susan A. Morris, Date: 12/11/91

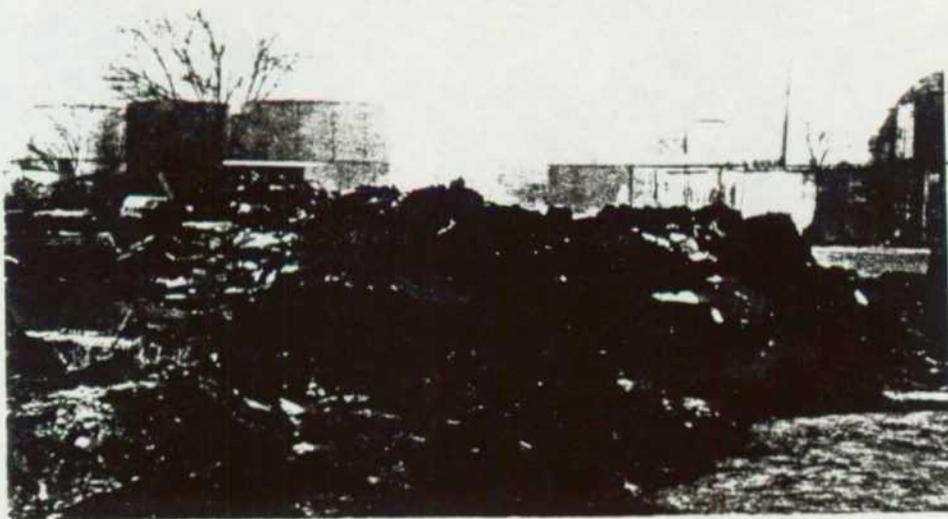
Photograph 6. Large metal scraps are mixed in the waste pile. Photographer: Susan A. Morris, Date: 12/11/91
