Re: Monument Community Water Supply Contamination

LEAK ASSESSMENT REPORT

TEXAS-NEW MEXICO PIPE LINE COMPANY CRUDE OIL PIPE LINE LEAK - MONUMENT, NEW MEXICO

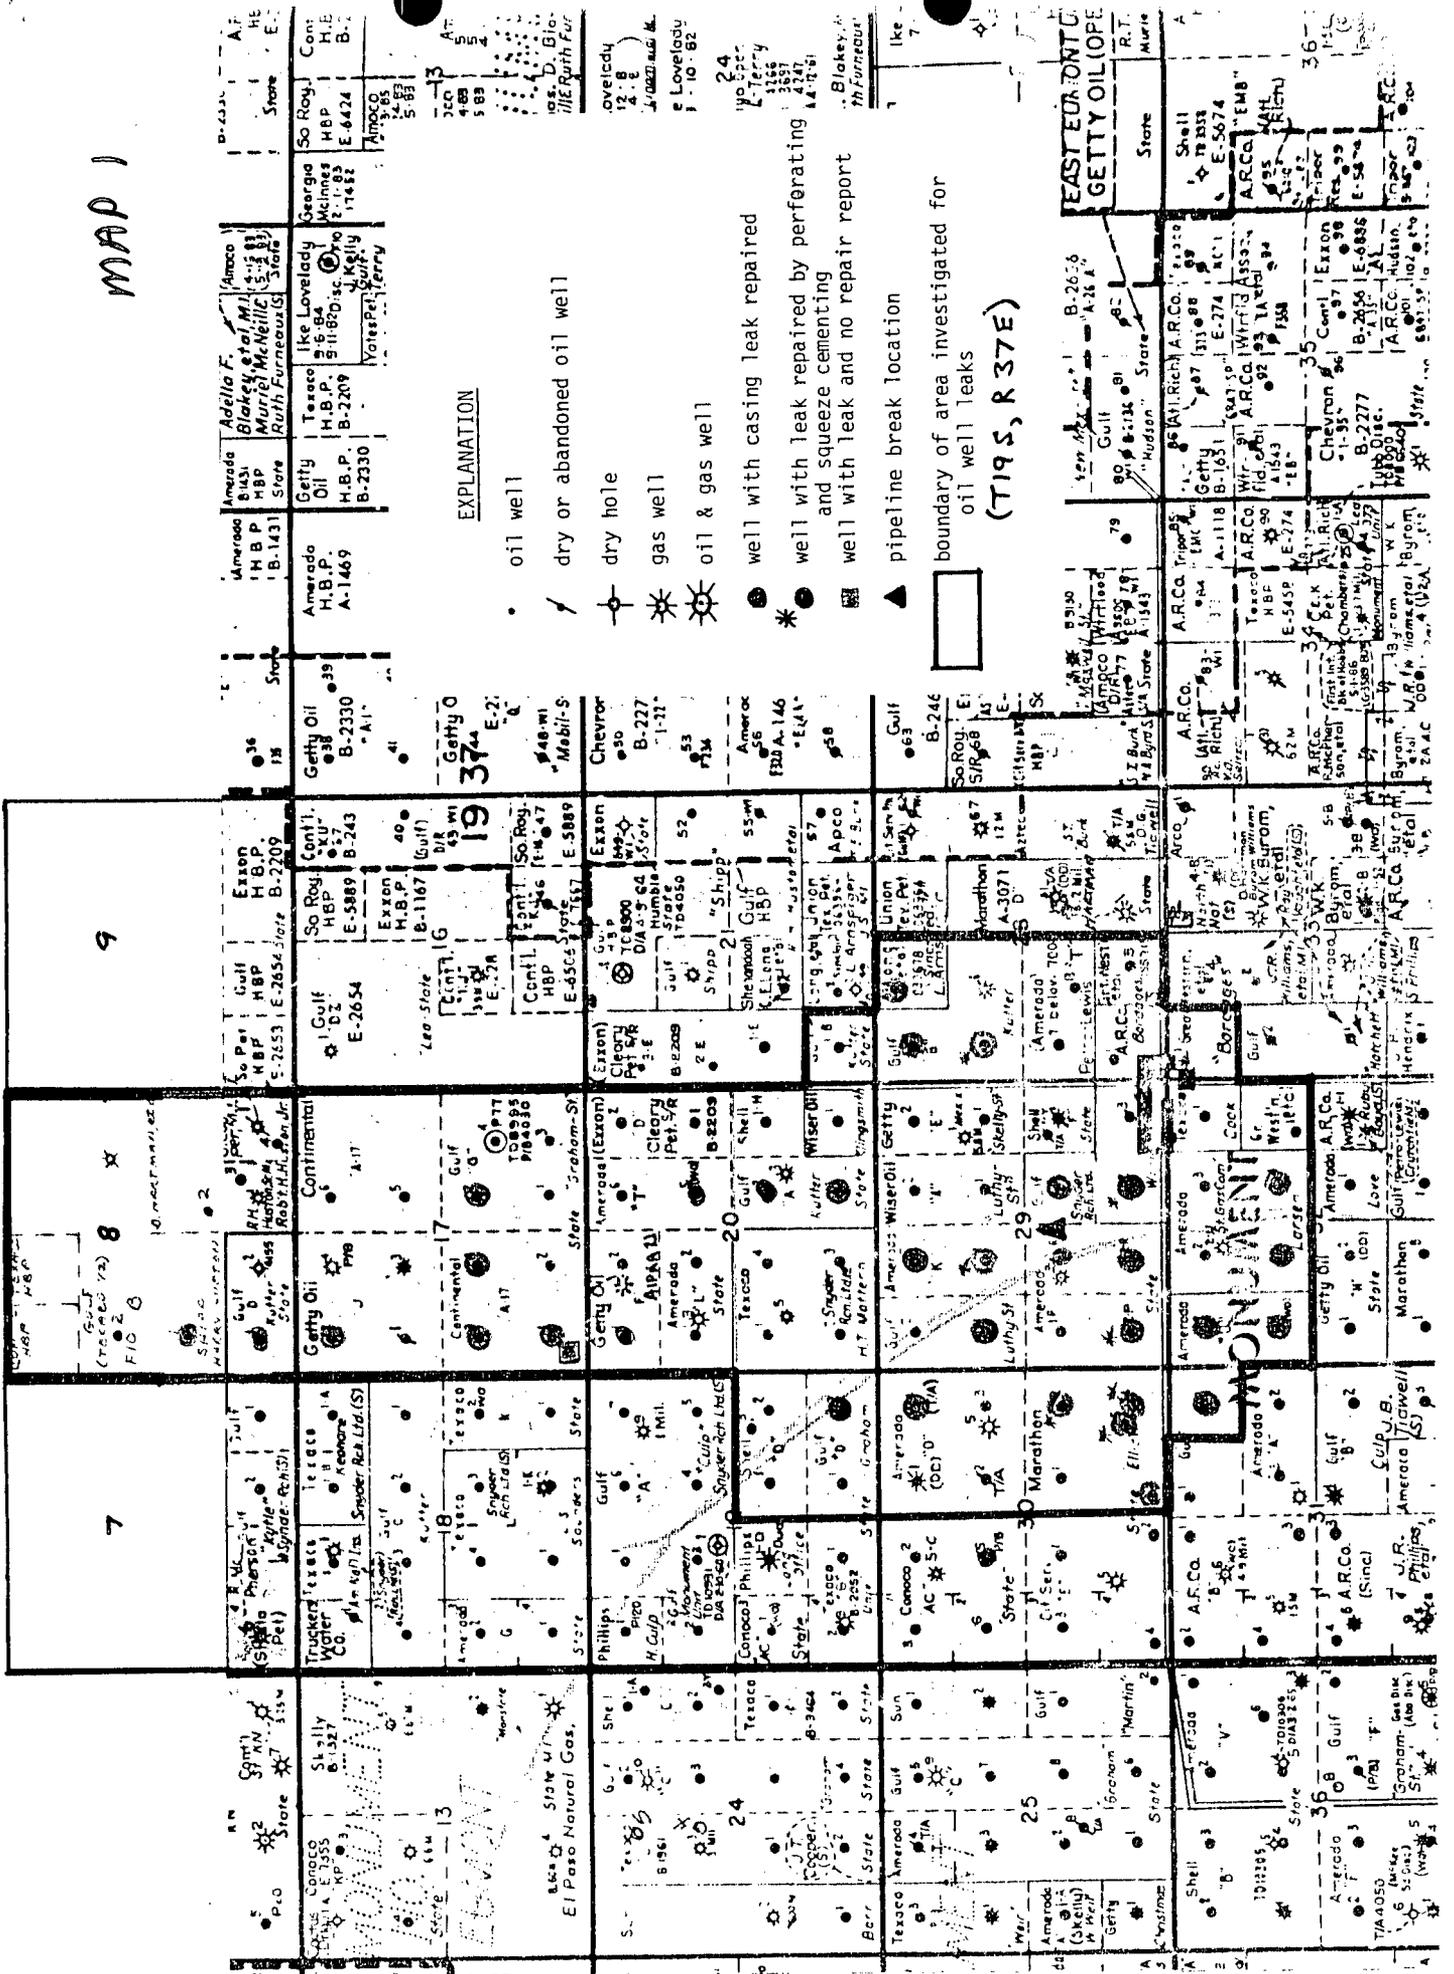
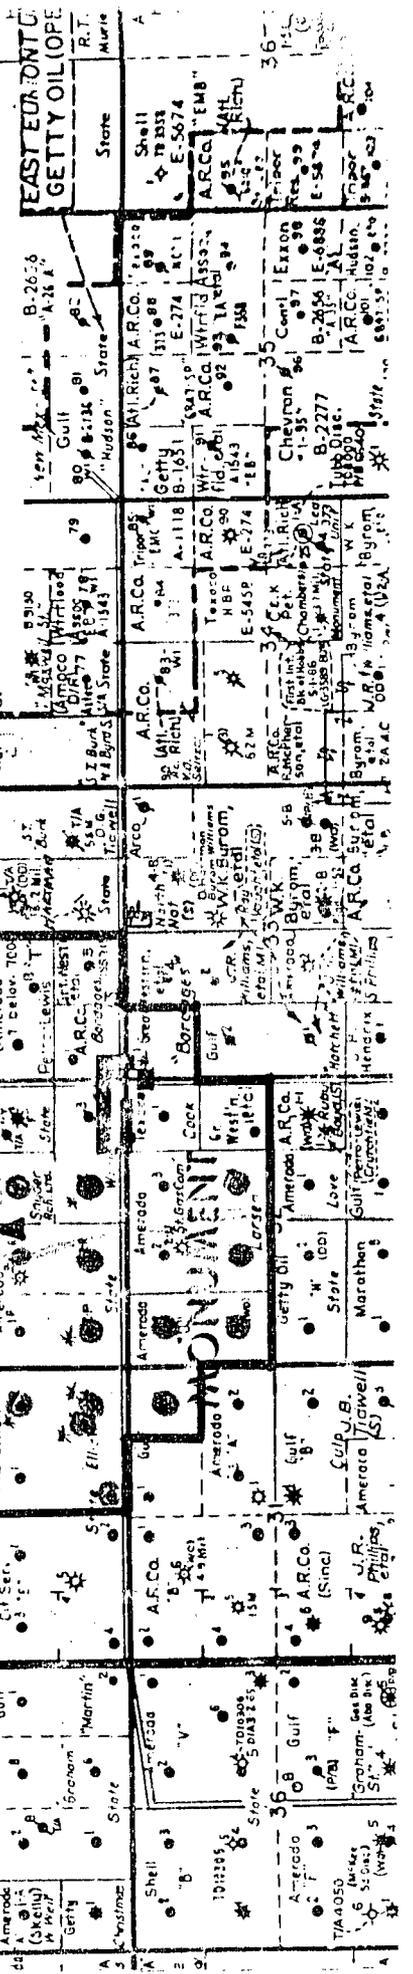
MAP 1

5. Any oil pipeline break(s) and/or leak(s) in the area and their proximity to the well: In addition to this pipeline break, this Division has records of eight oil well casing leaks within the same section of land as the contaminated well. Some of these occurred greater than 30 years ago at wells operated by several different producers.

The enclosed maps show locations of previously reported oil well casing leaks in the Monument area and in Sections 8, 17 and 20 (T19S, R37E) to the north (Map 1); and contaminated groundwater monitor wells and product thickness as of November, 1984 (Map 2). Since groundwater movement in the area is slow (less than 1.5 feet per day) the contamination found in monitoring wells away from the immediate vicinity of the pipeline break is thought to be from some other source or sources.

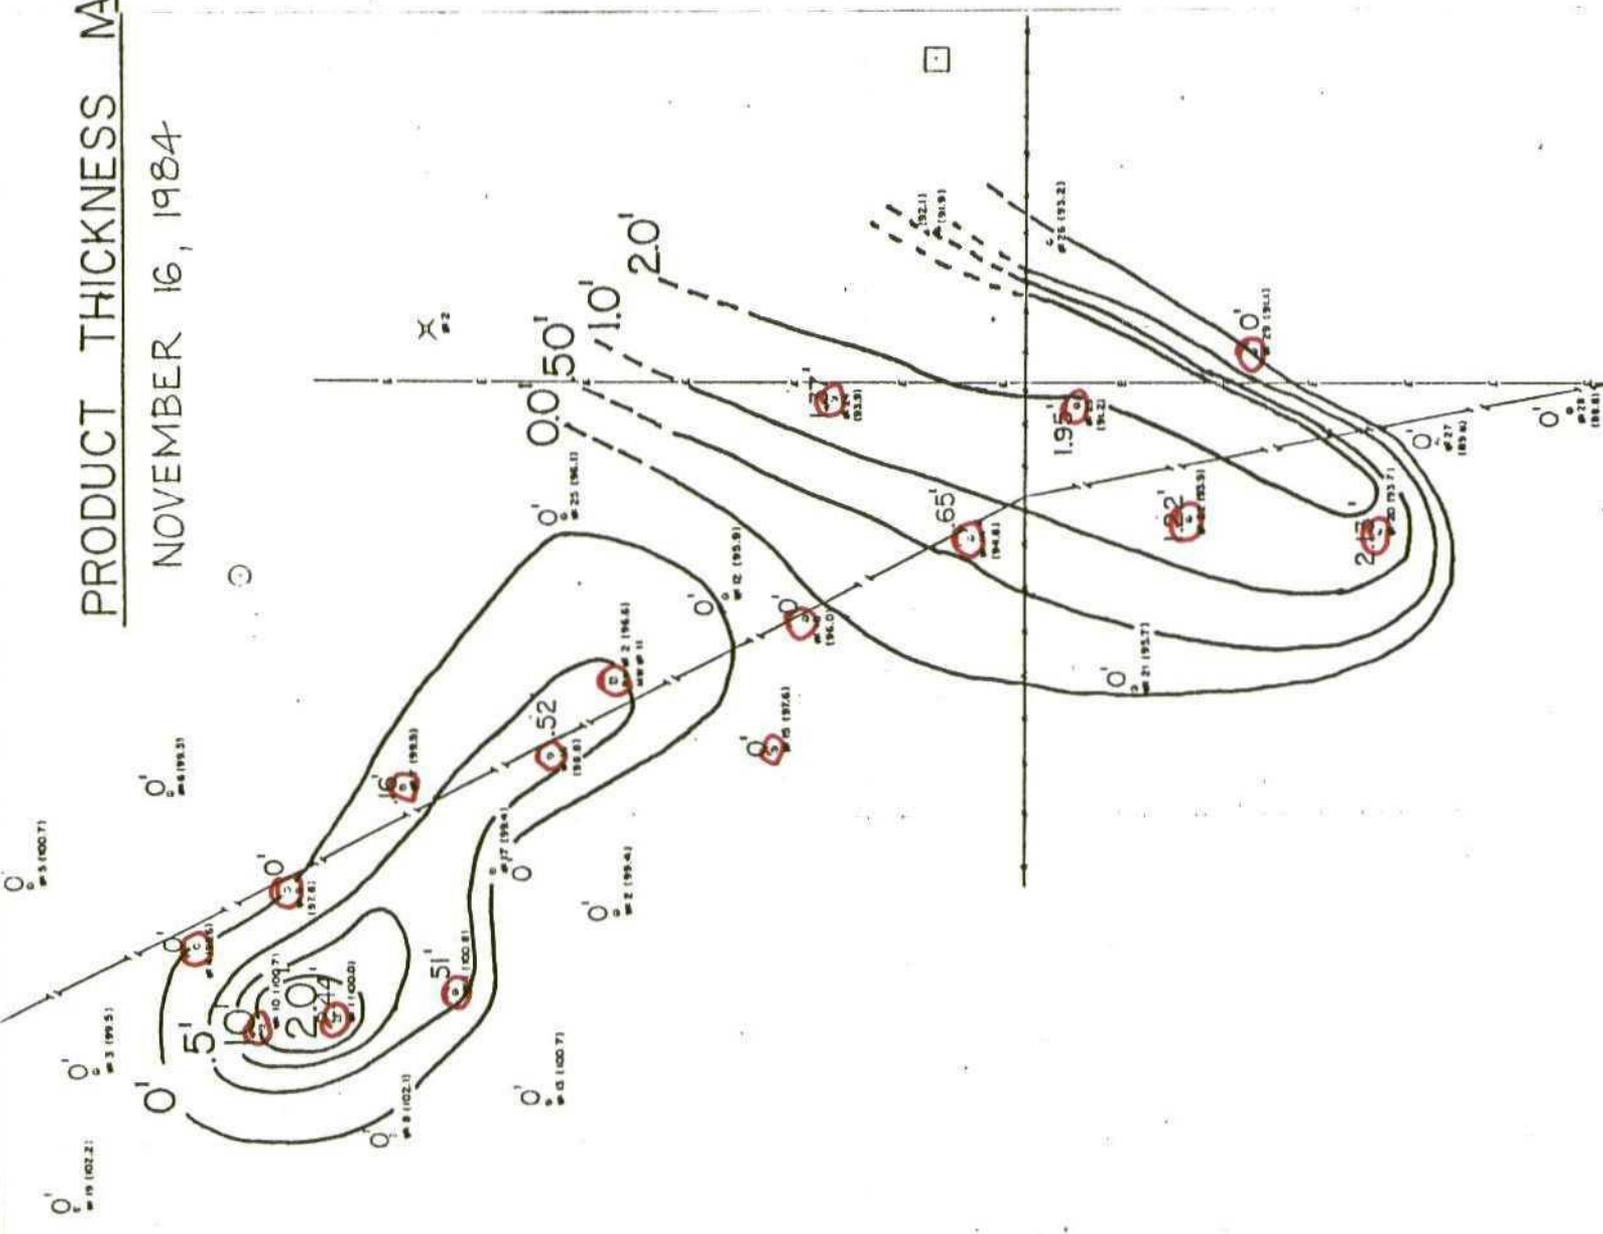
MAP 2

2. Extent of contamination: Lateral migration appears to be about 700 feet by 250 feet in a southeasterly direction from the pipeline break. Oil has been detected in monitor wells drilled within this area.

PRODUCT THICKNESS MAP NOVEMBER 16, 1984

1. Install monitoring wells (probably 4 to 10) to determine the areal extent of the leak and to determine the thickness of the oil on the surface of the water table. These wells will also be used to determine the direction of groundwater flow and be used in a pump test to determine the aquifer properties.
