1R - 187

**UMC Carlisle State Com # 1
Pit Remediation Project
Closure Report
Volume II**

**Whole Earth Environmental
19606 San Gabriel
Houston, Tx. 77084**

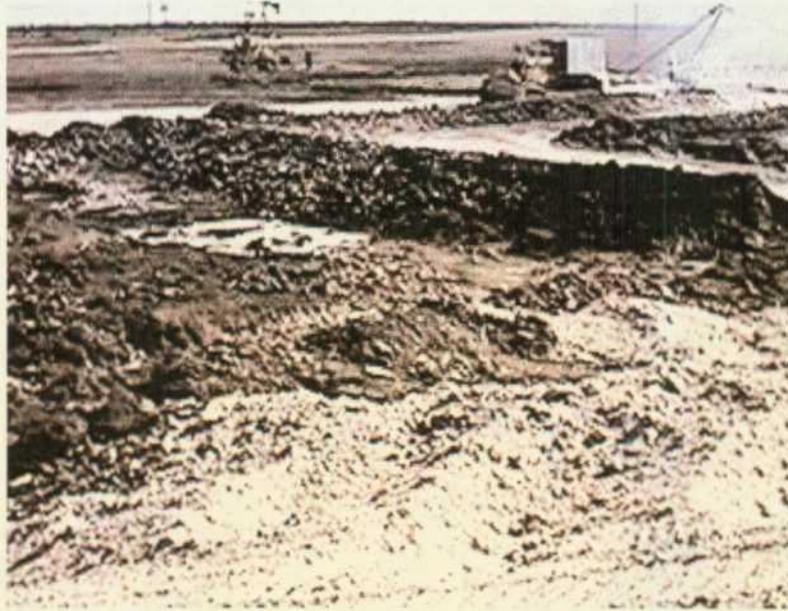
A-1 West Reserve Pit during event

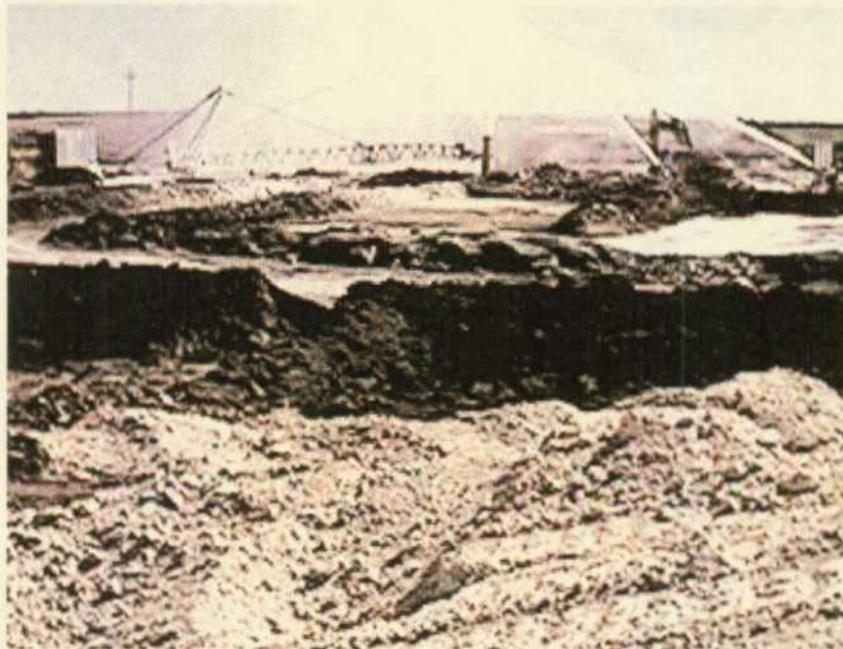
A-2 West Reserve Pit During Event

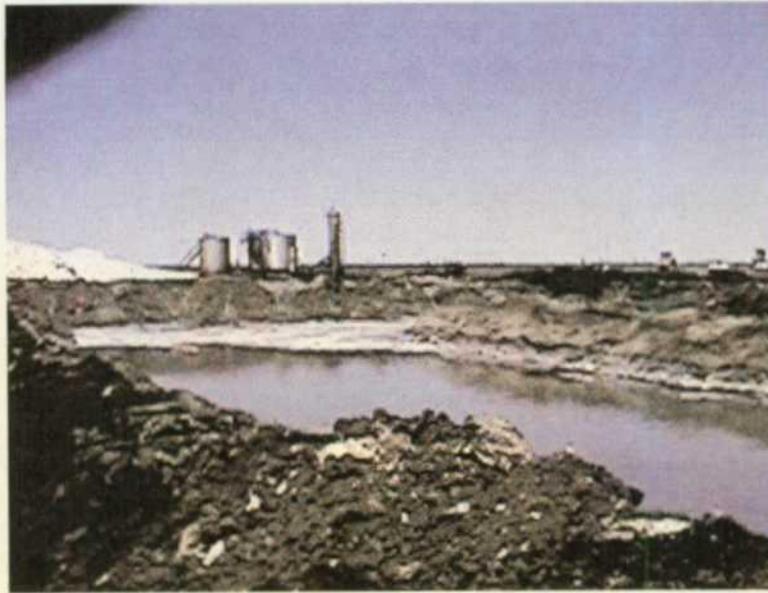
A-3 West Reserve Pit during event

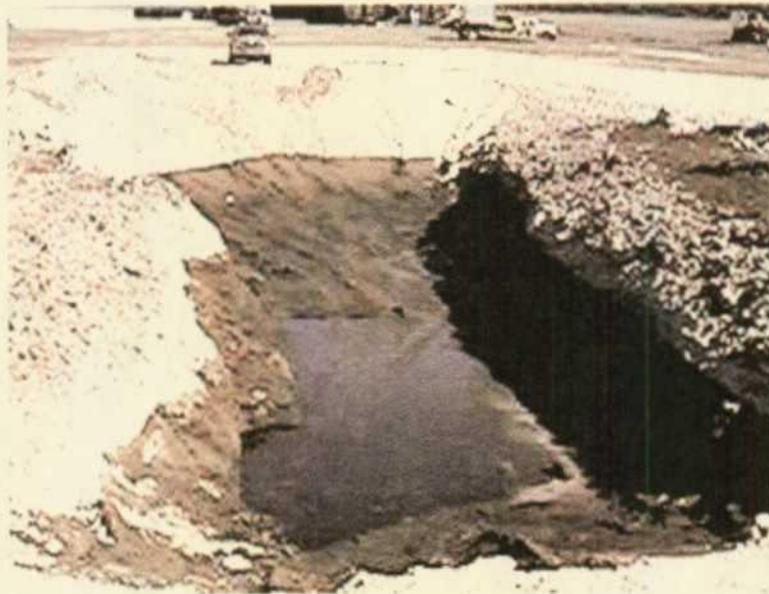
A-4 West Emergency Pit during event

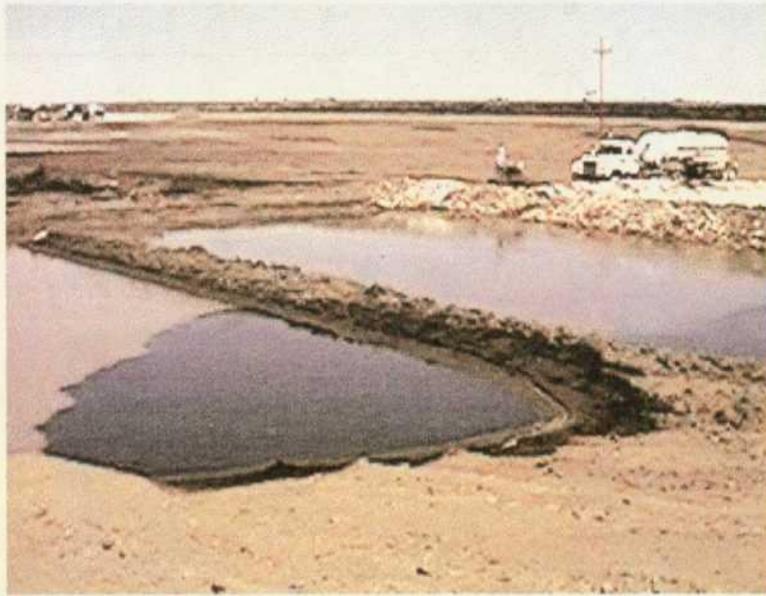
A-5 East Emergency Pit during event

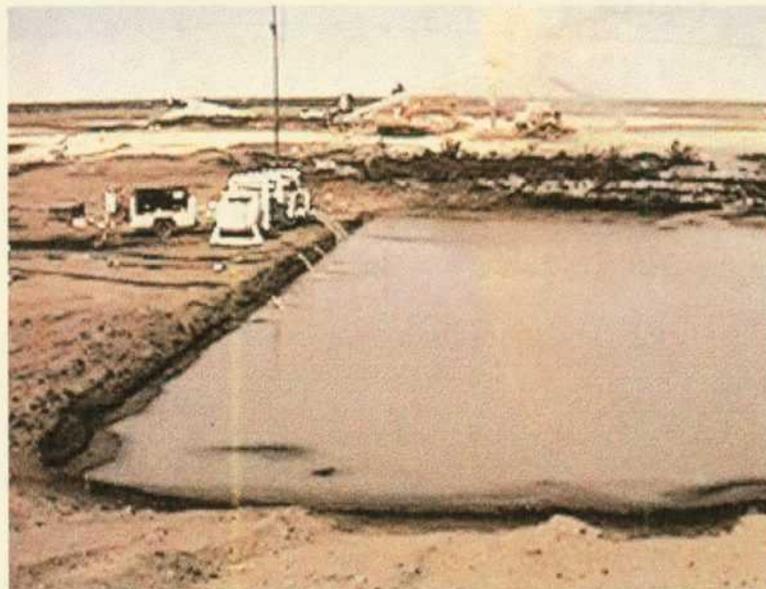
A-6 East Emergency Pit during event

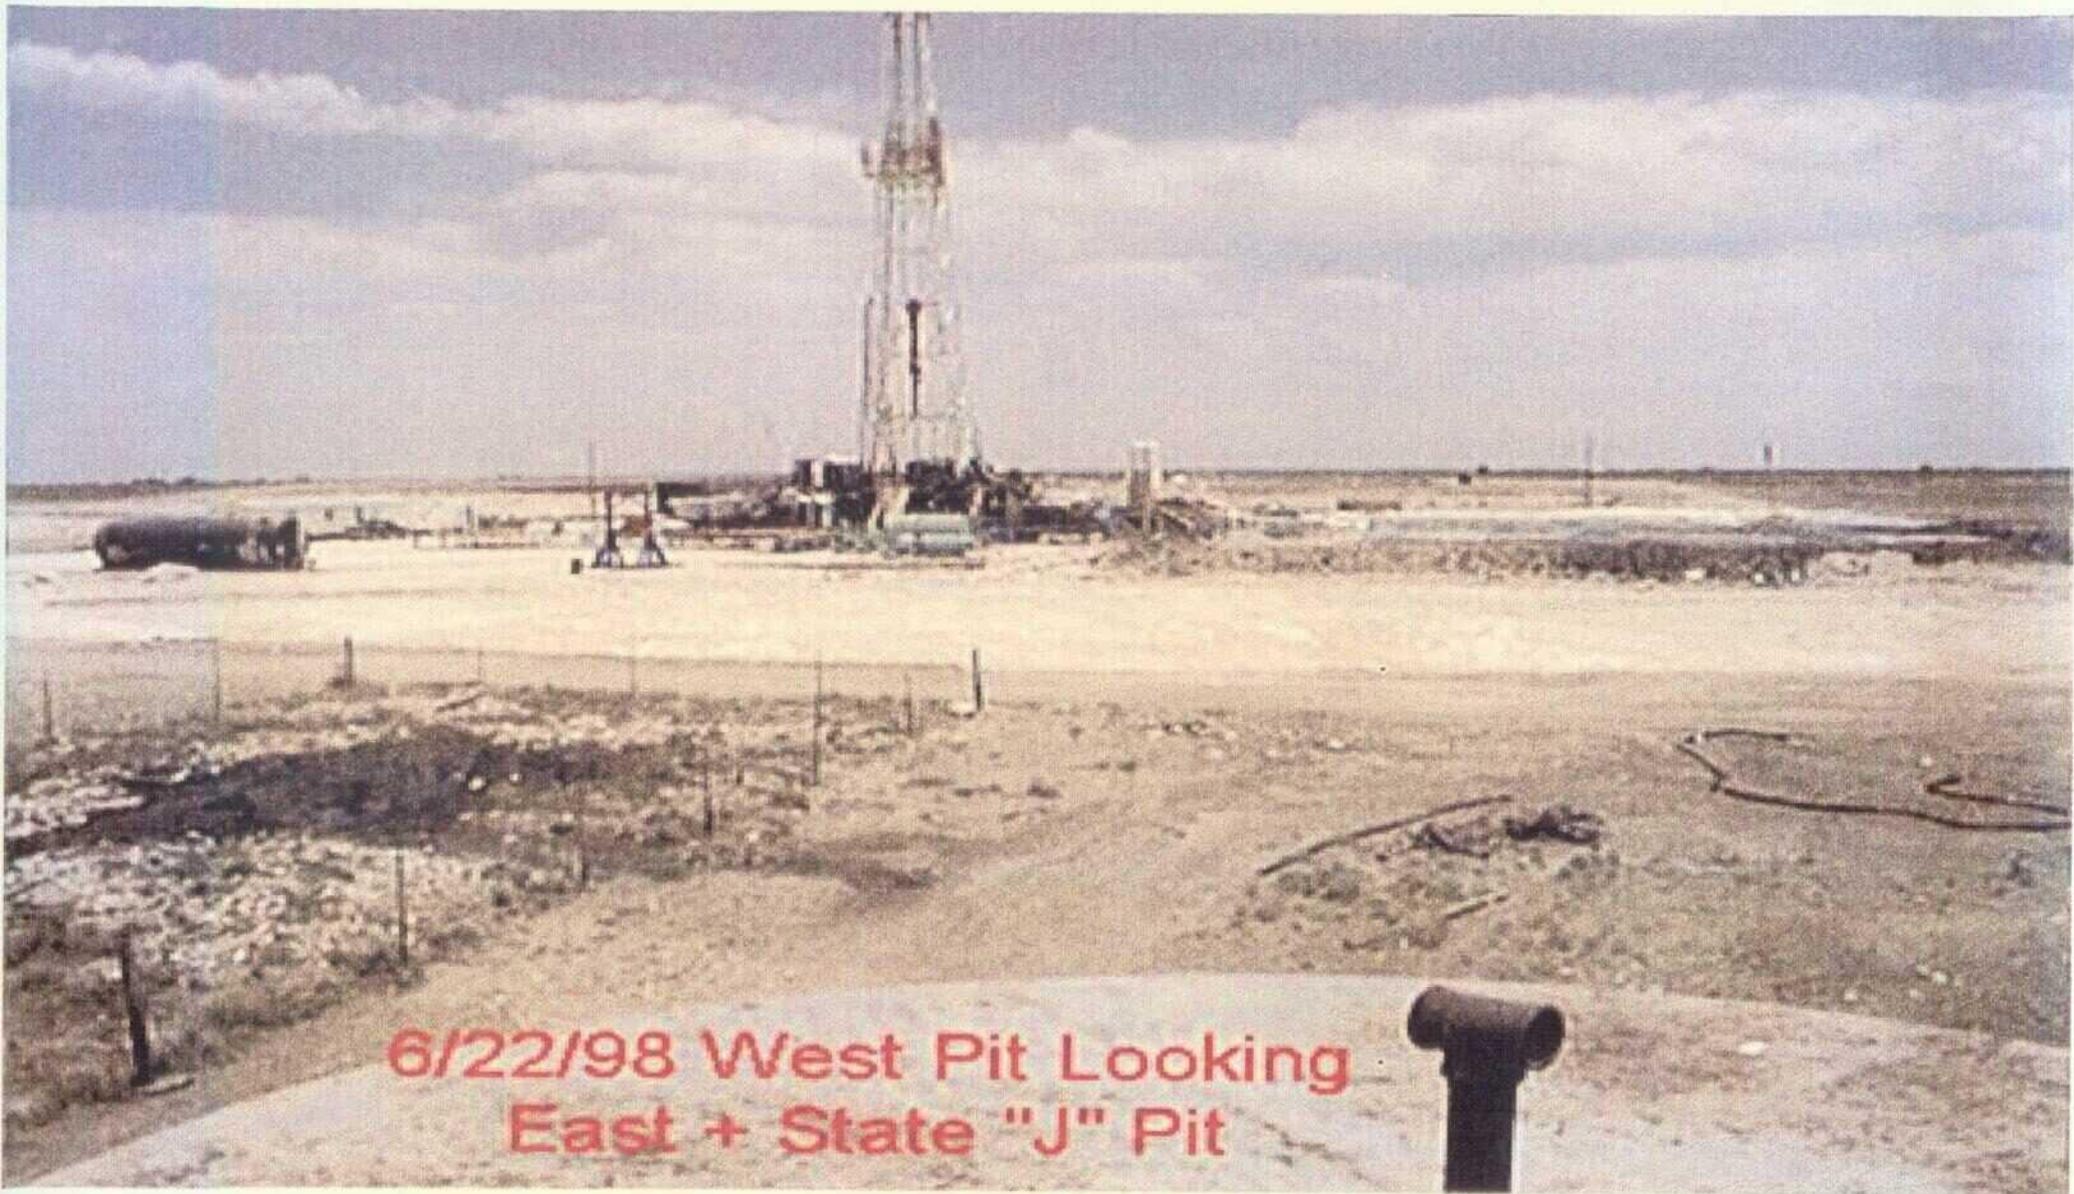
C-1

6/22/98 West Pit Looking
East + State "J" Pit

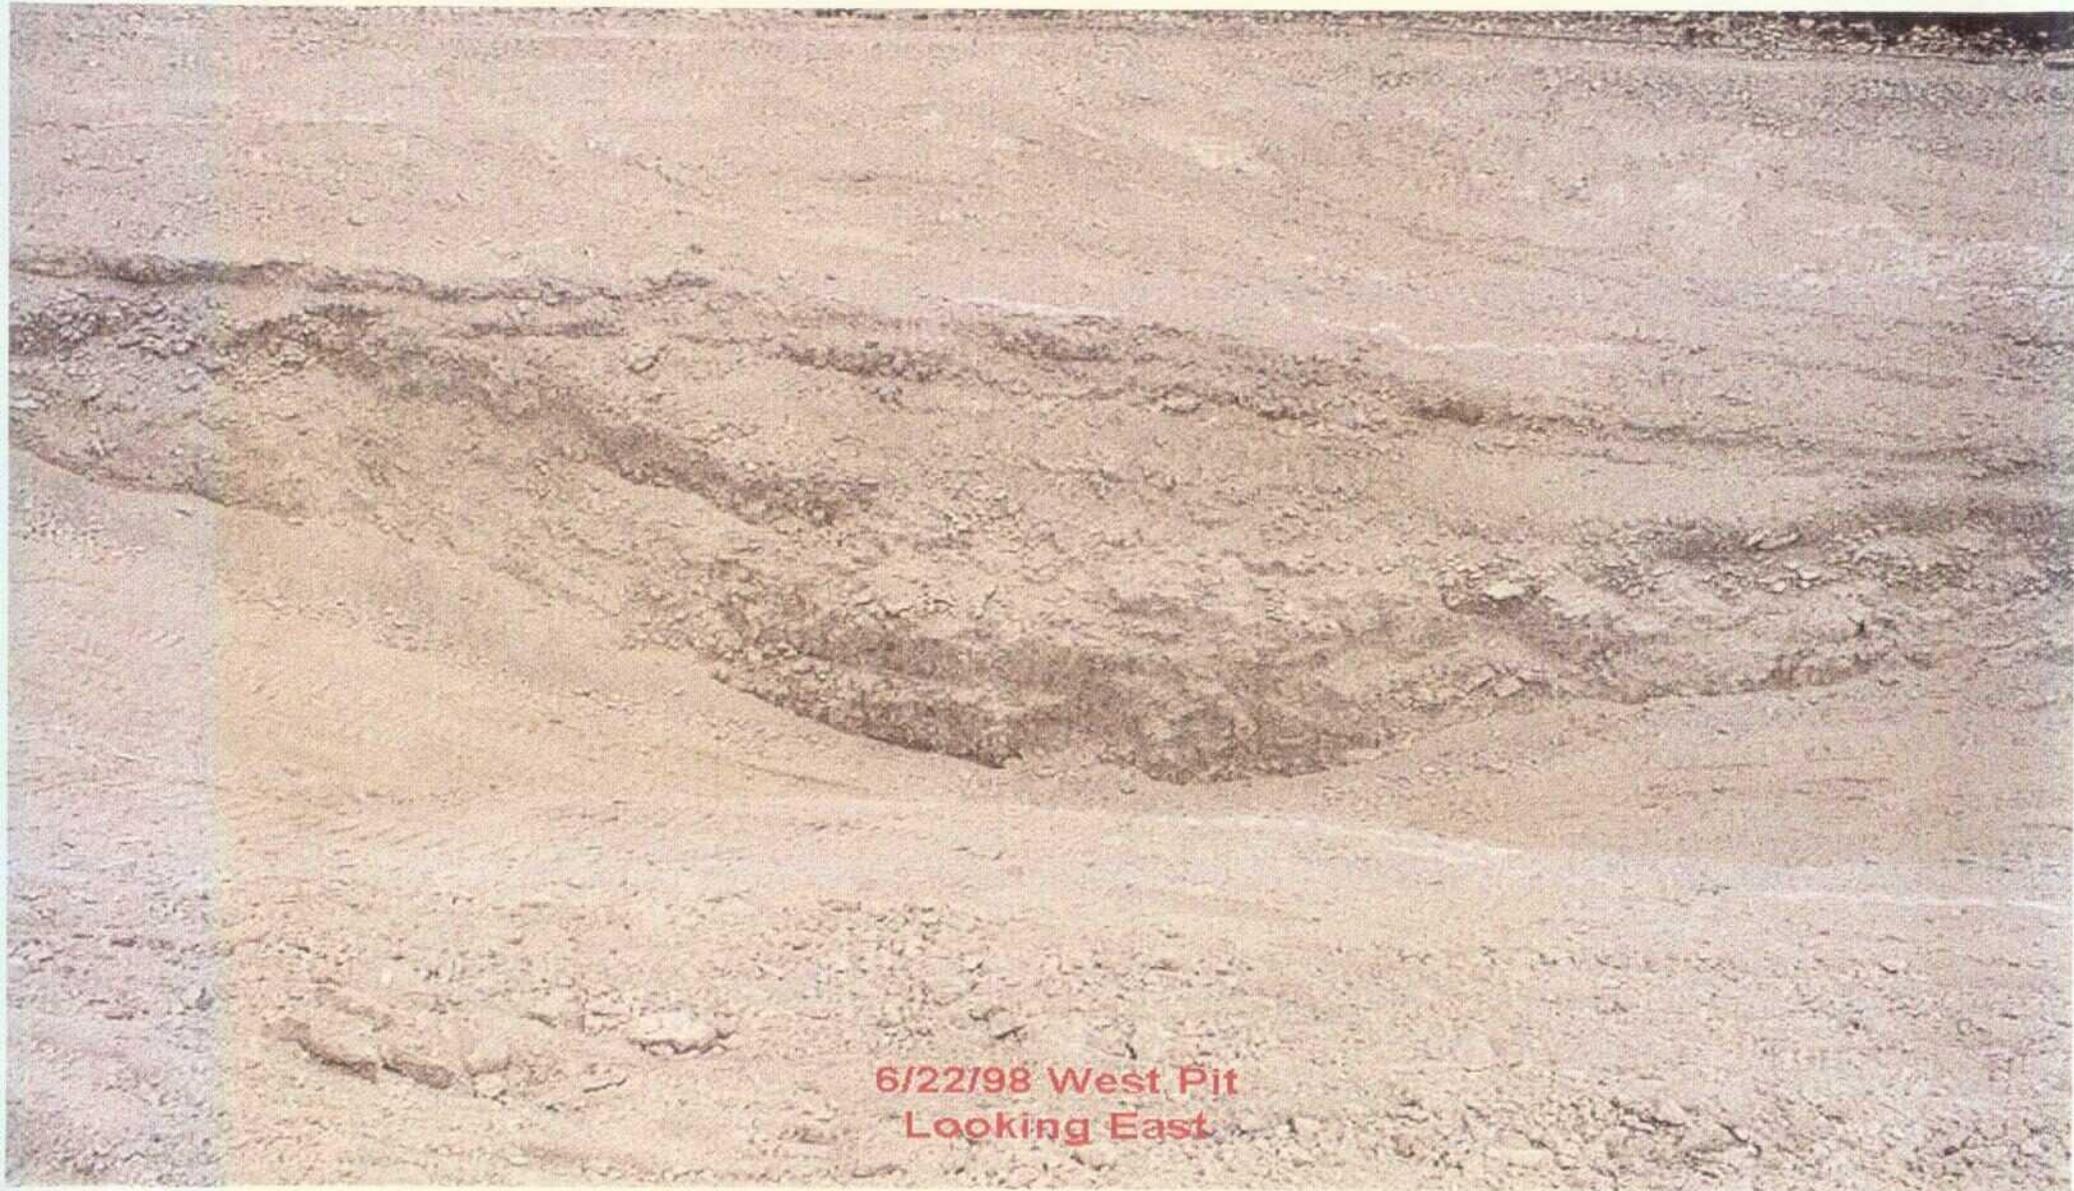
C-2

6/22/98 West Pit
Looking East

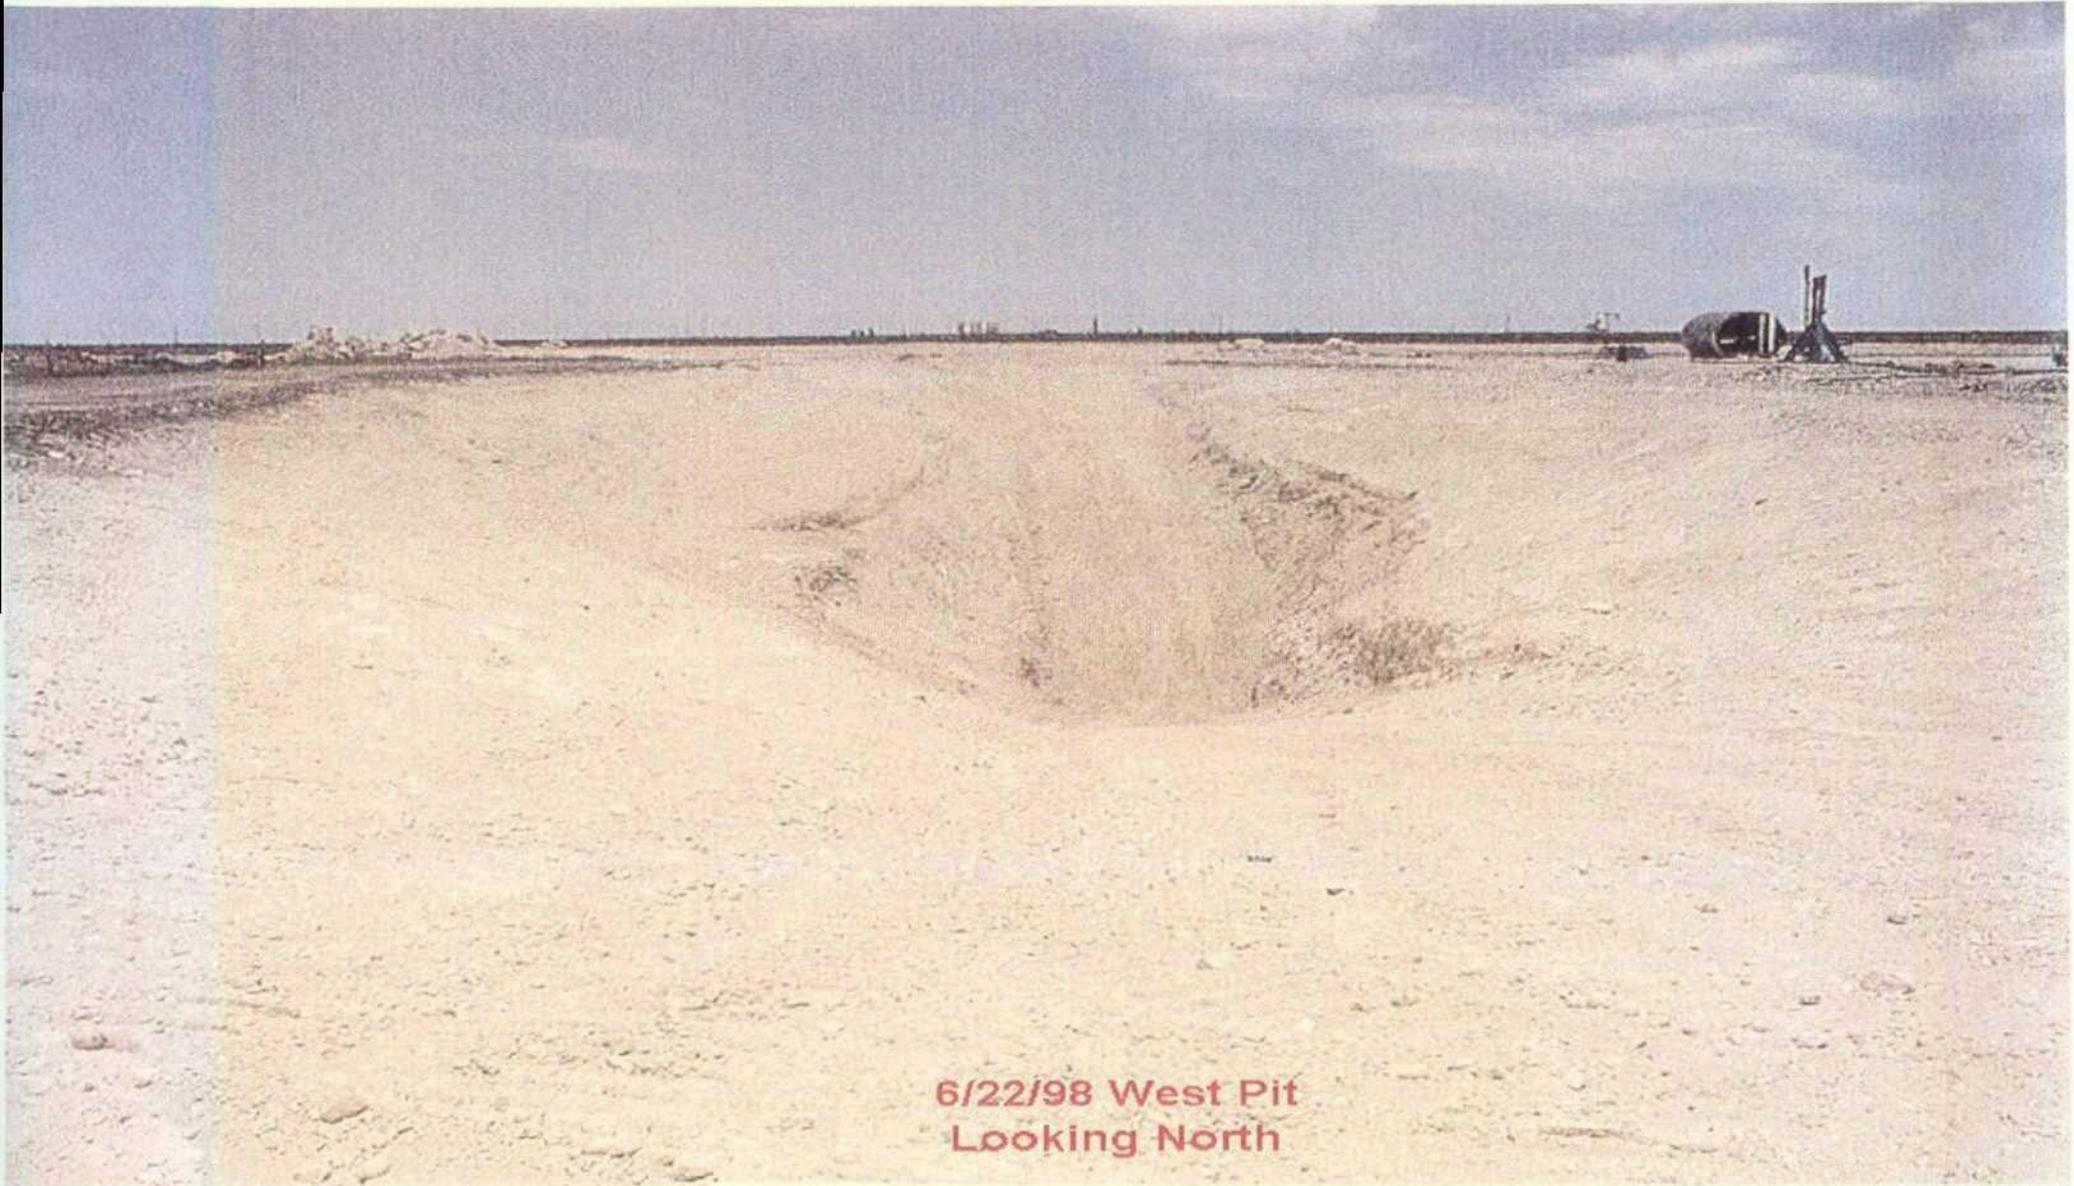
C-3

6/22/98 West Pit
Looking North

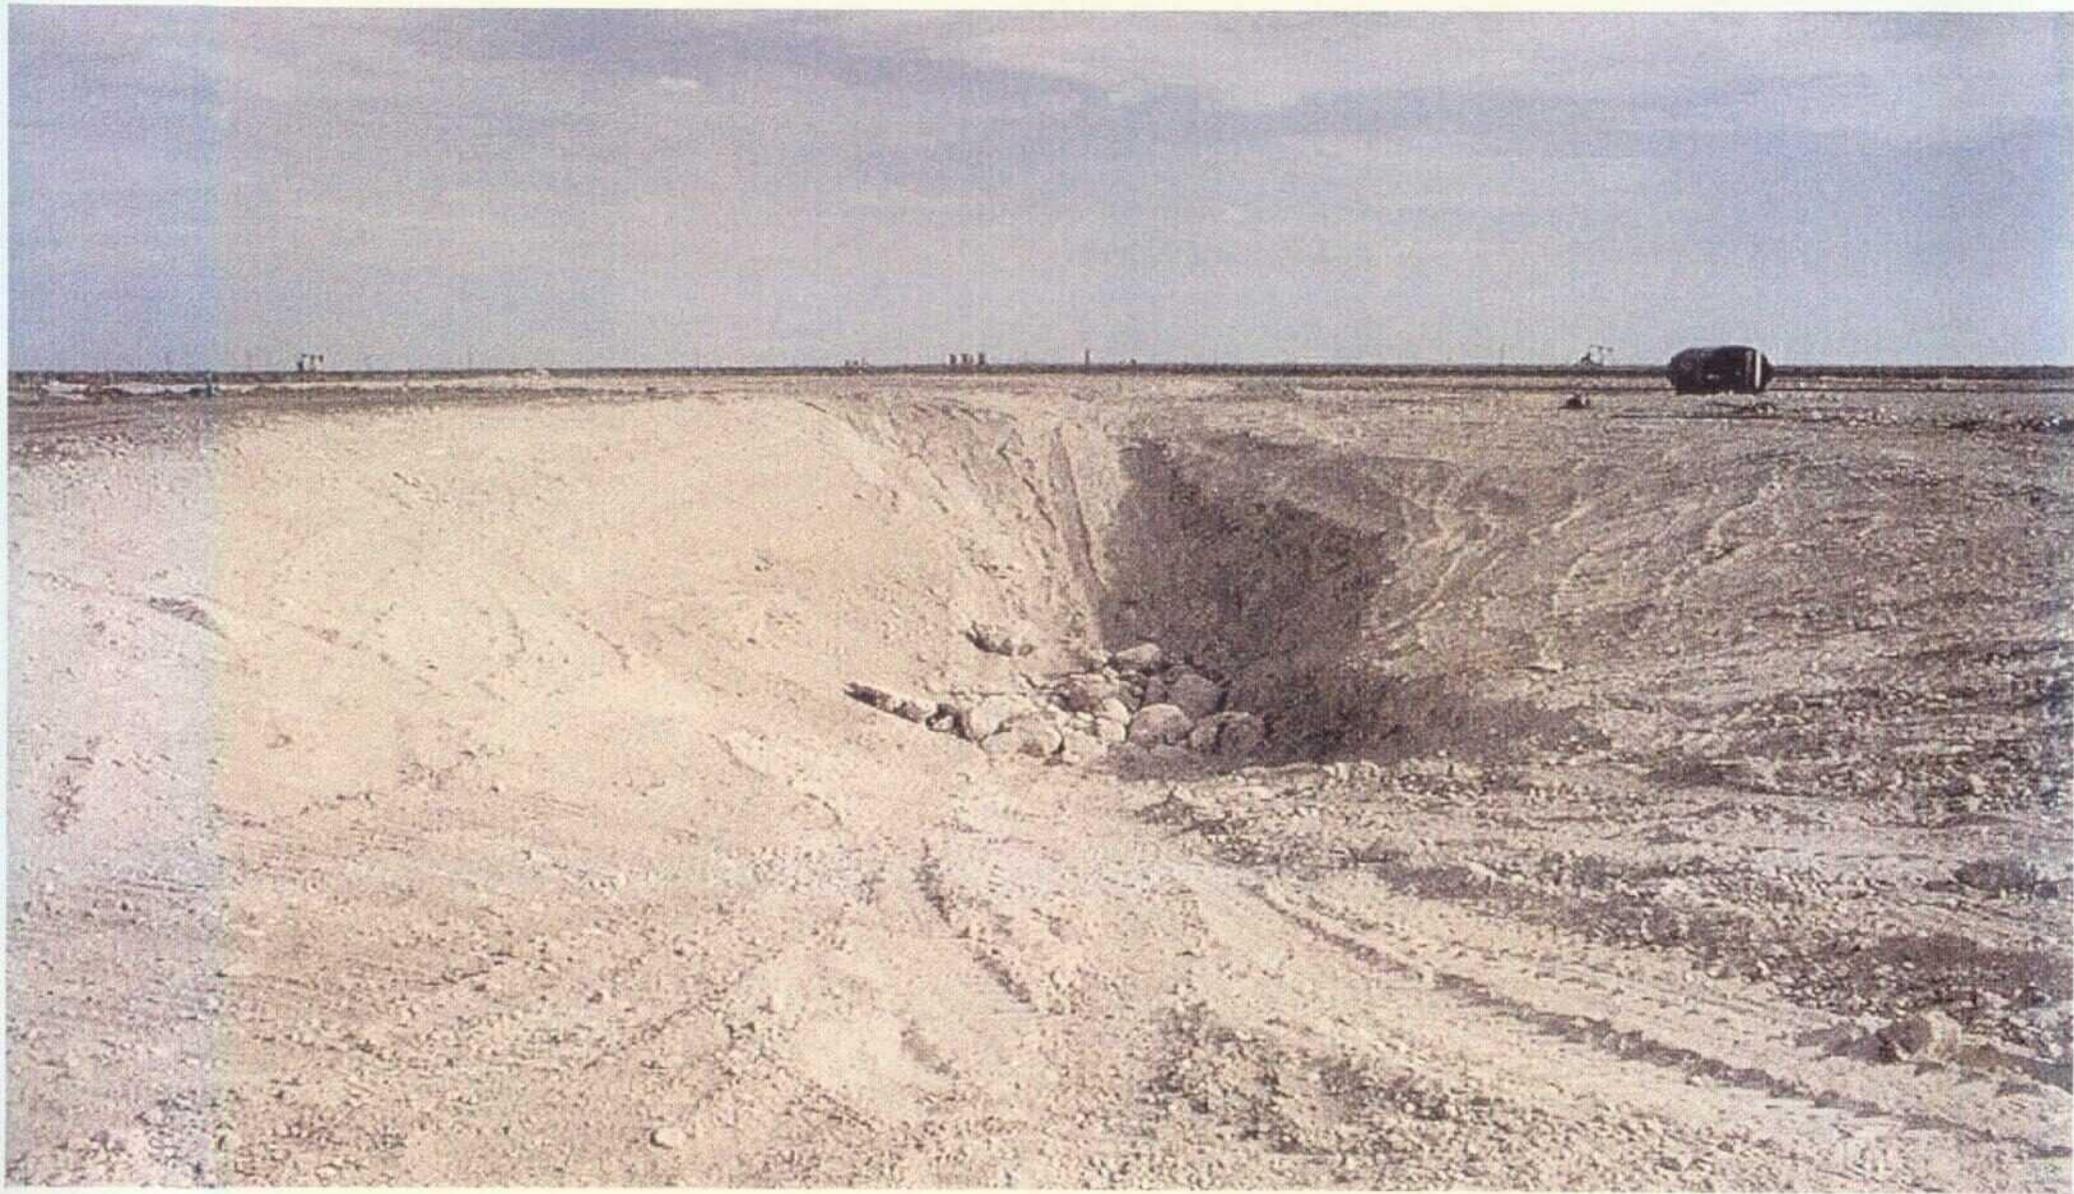
C-10

- C-1** View from "J" Battery overlooking West Emergency Pit
View to E
- C-2** West Emergency Pit prior to remediation
View to E
- C-3** West Emergency Pit prior to remediation
View to N
- C-4** Detail of drilling West Emergency Pit monitoring well
View to N
- C-5** West Emergency Pit liner installation detail
View to NE
- C-6** West Emergency Pit liner installation detail
View to ENE
- C-7** West Emergency Pit liner installation detail
View to N
- C-8** West Emergency Pit liner installation detail
View to S
- C-9** West Emergency Pit liner installation detail
View to S
- C-10** Detail of boulders placed into pit after 10' backfill
View to N
- C-11** West Emergency Pit backfill detail
View to NE

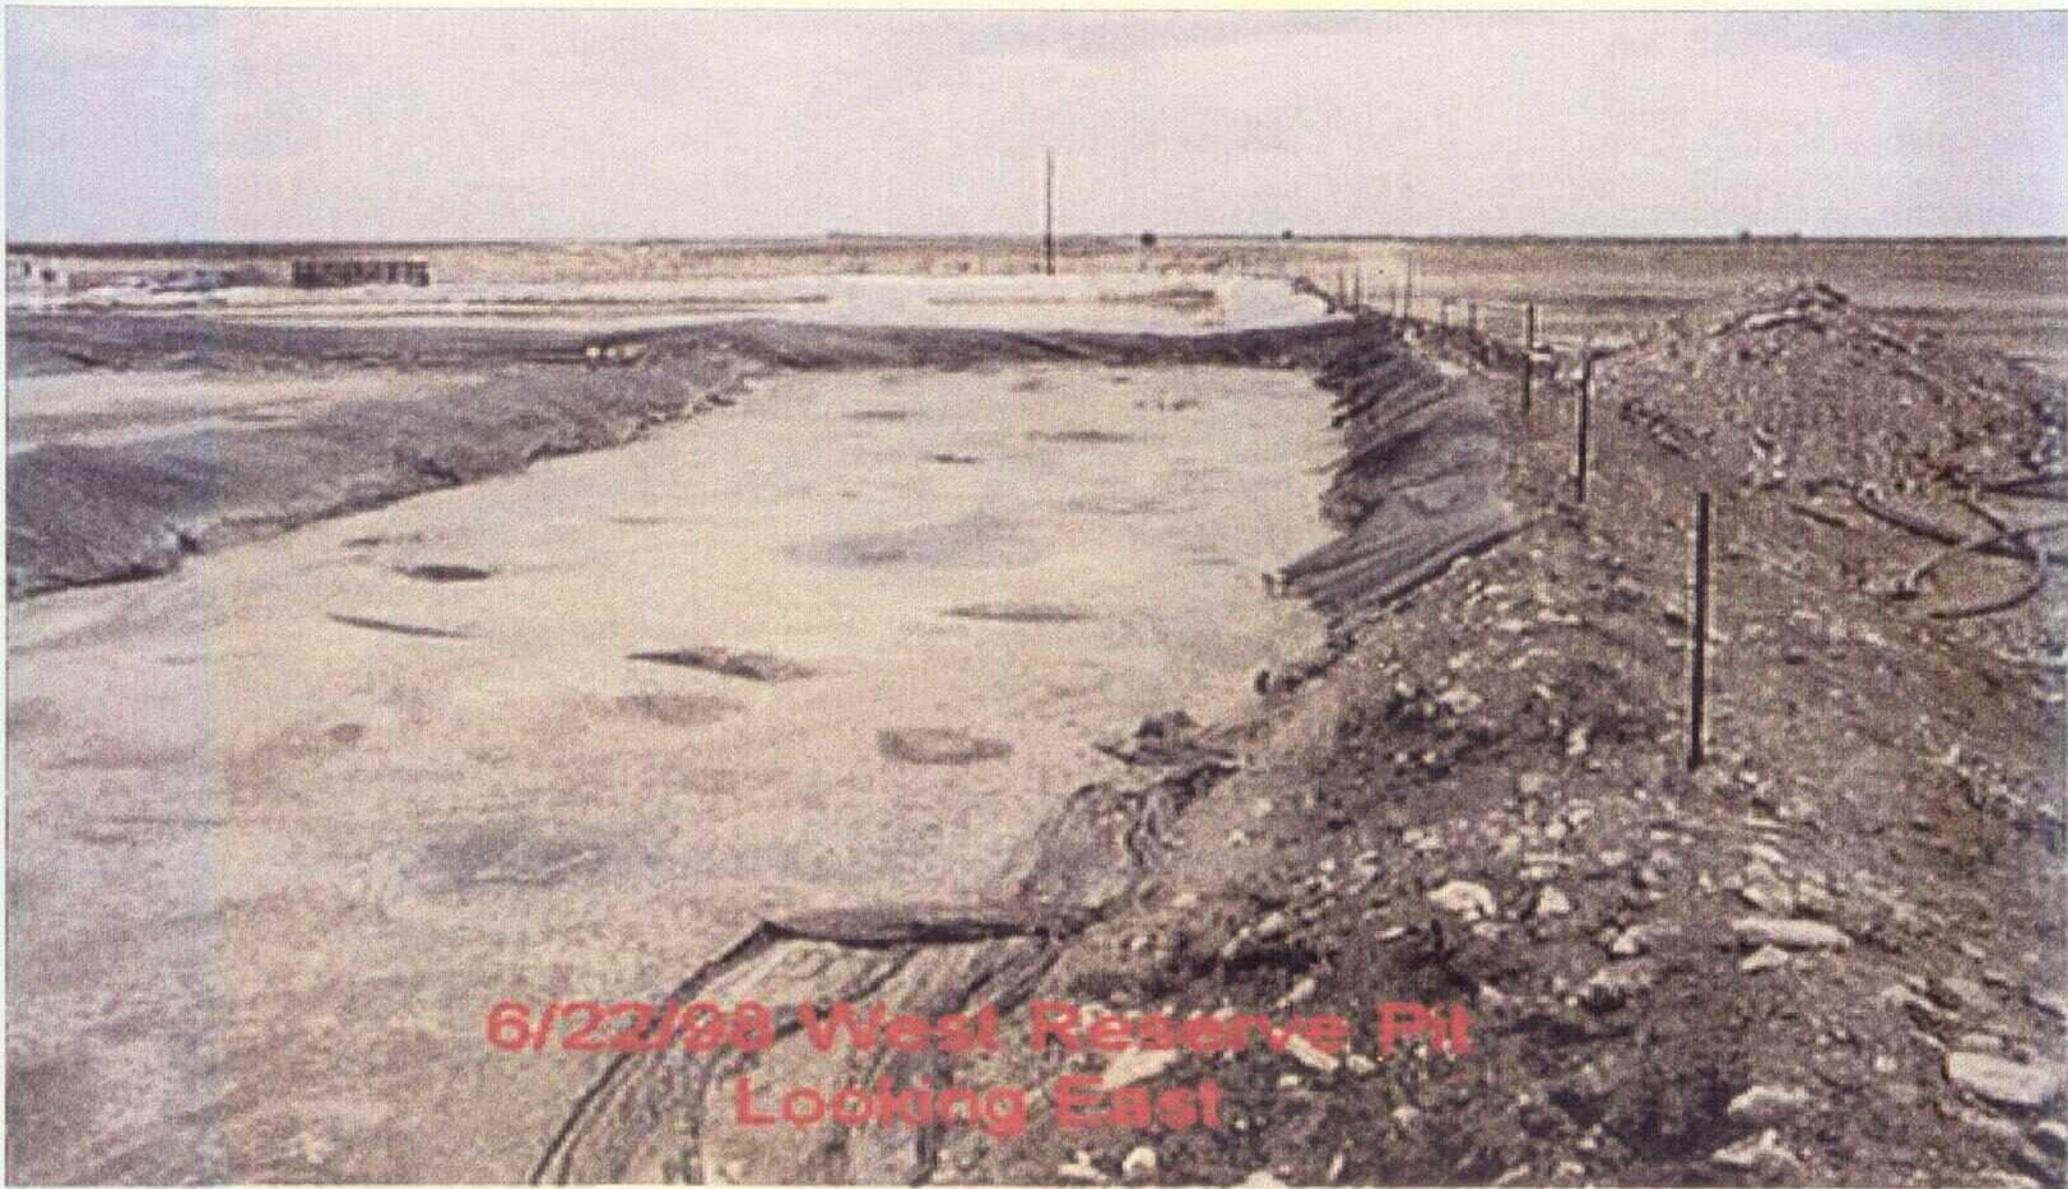
D-1

6/22/98 West Reserve Pit
Looking East

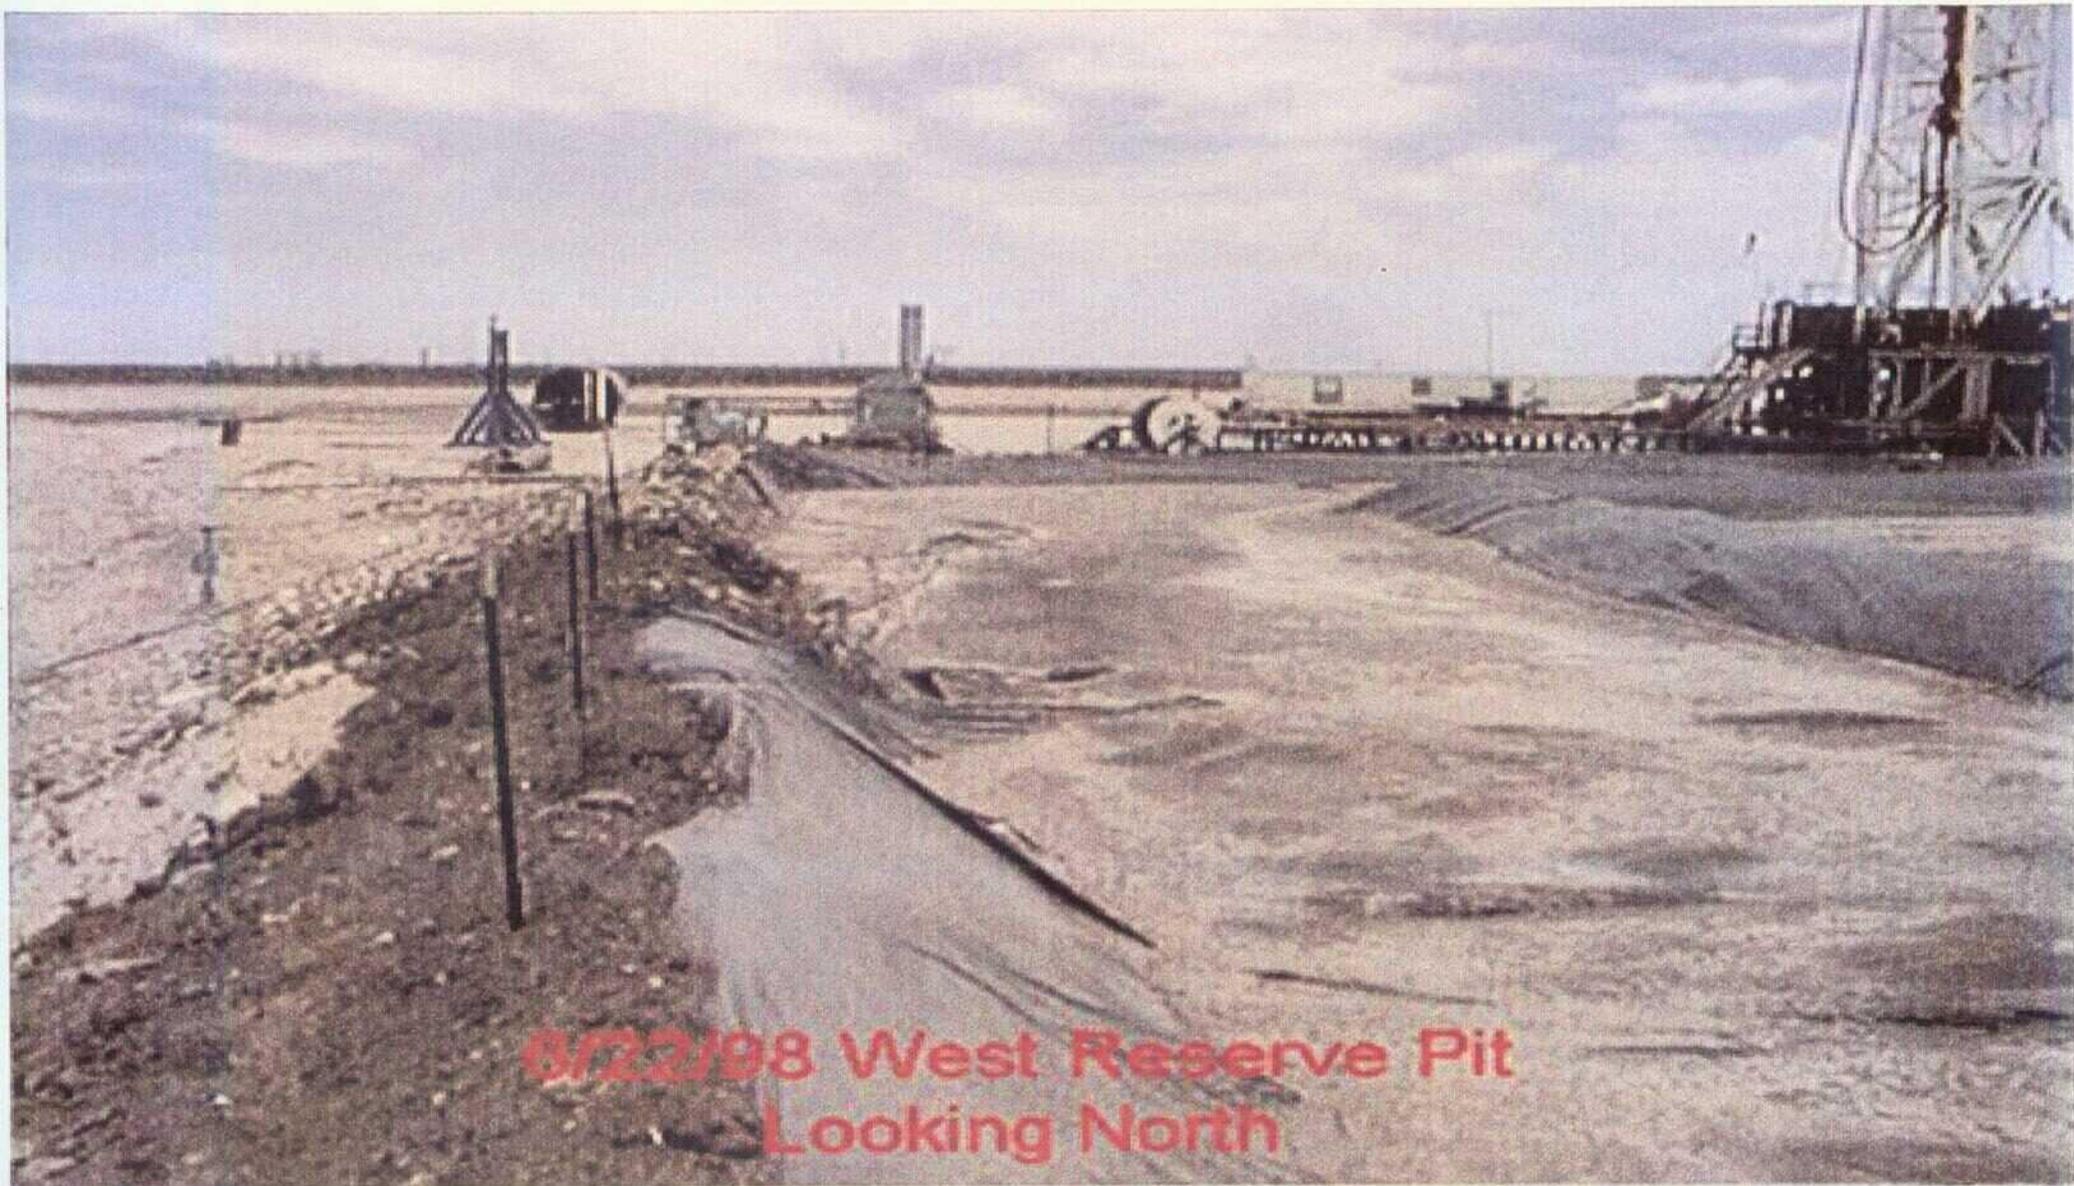
6/22/98 West Reserve Pit
Looking North

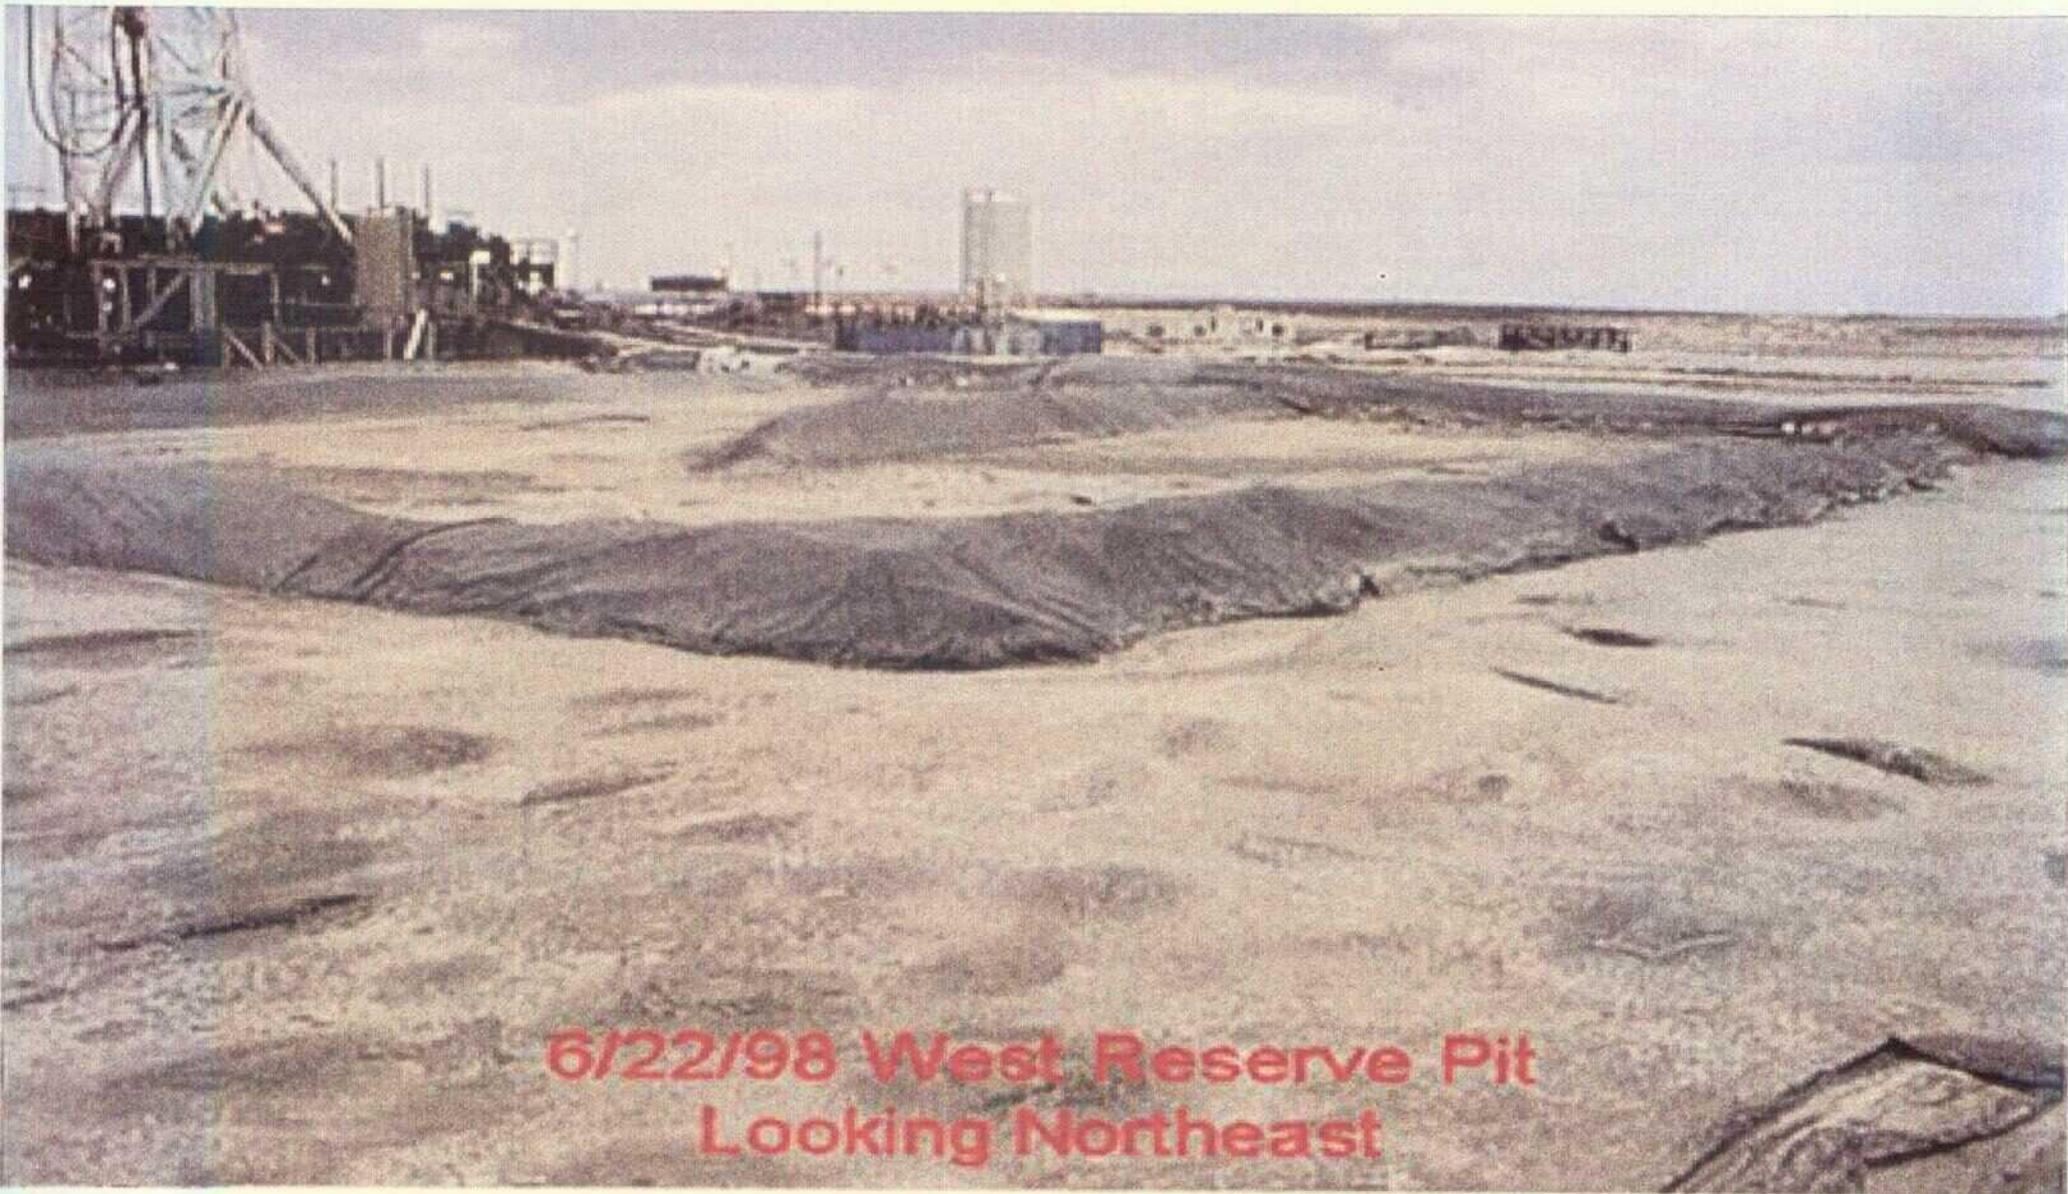
6/22/98 West Reserve Pit
Looking Northeast

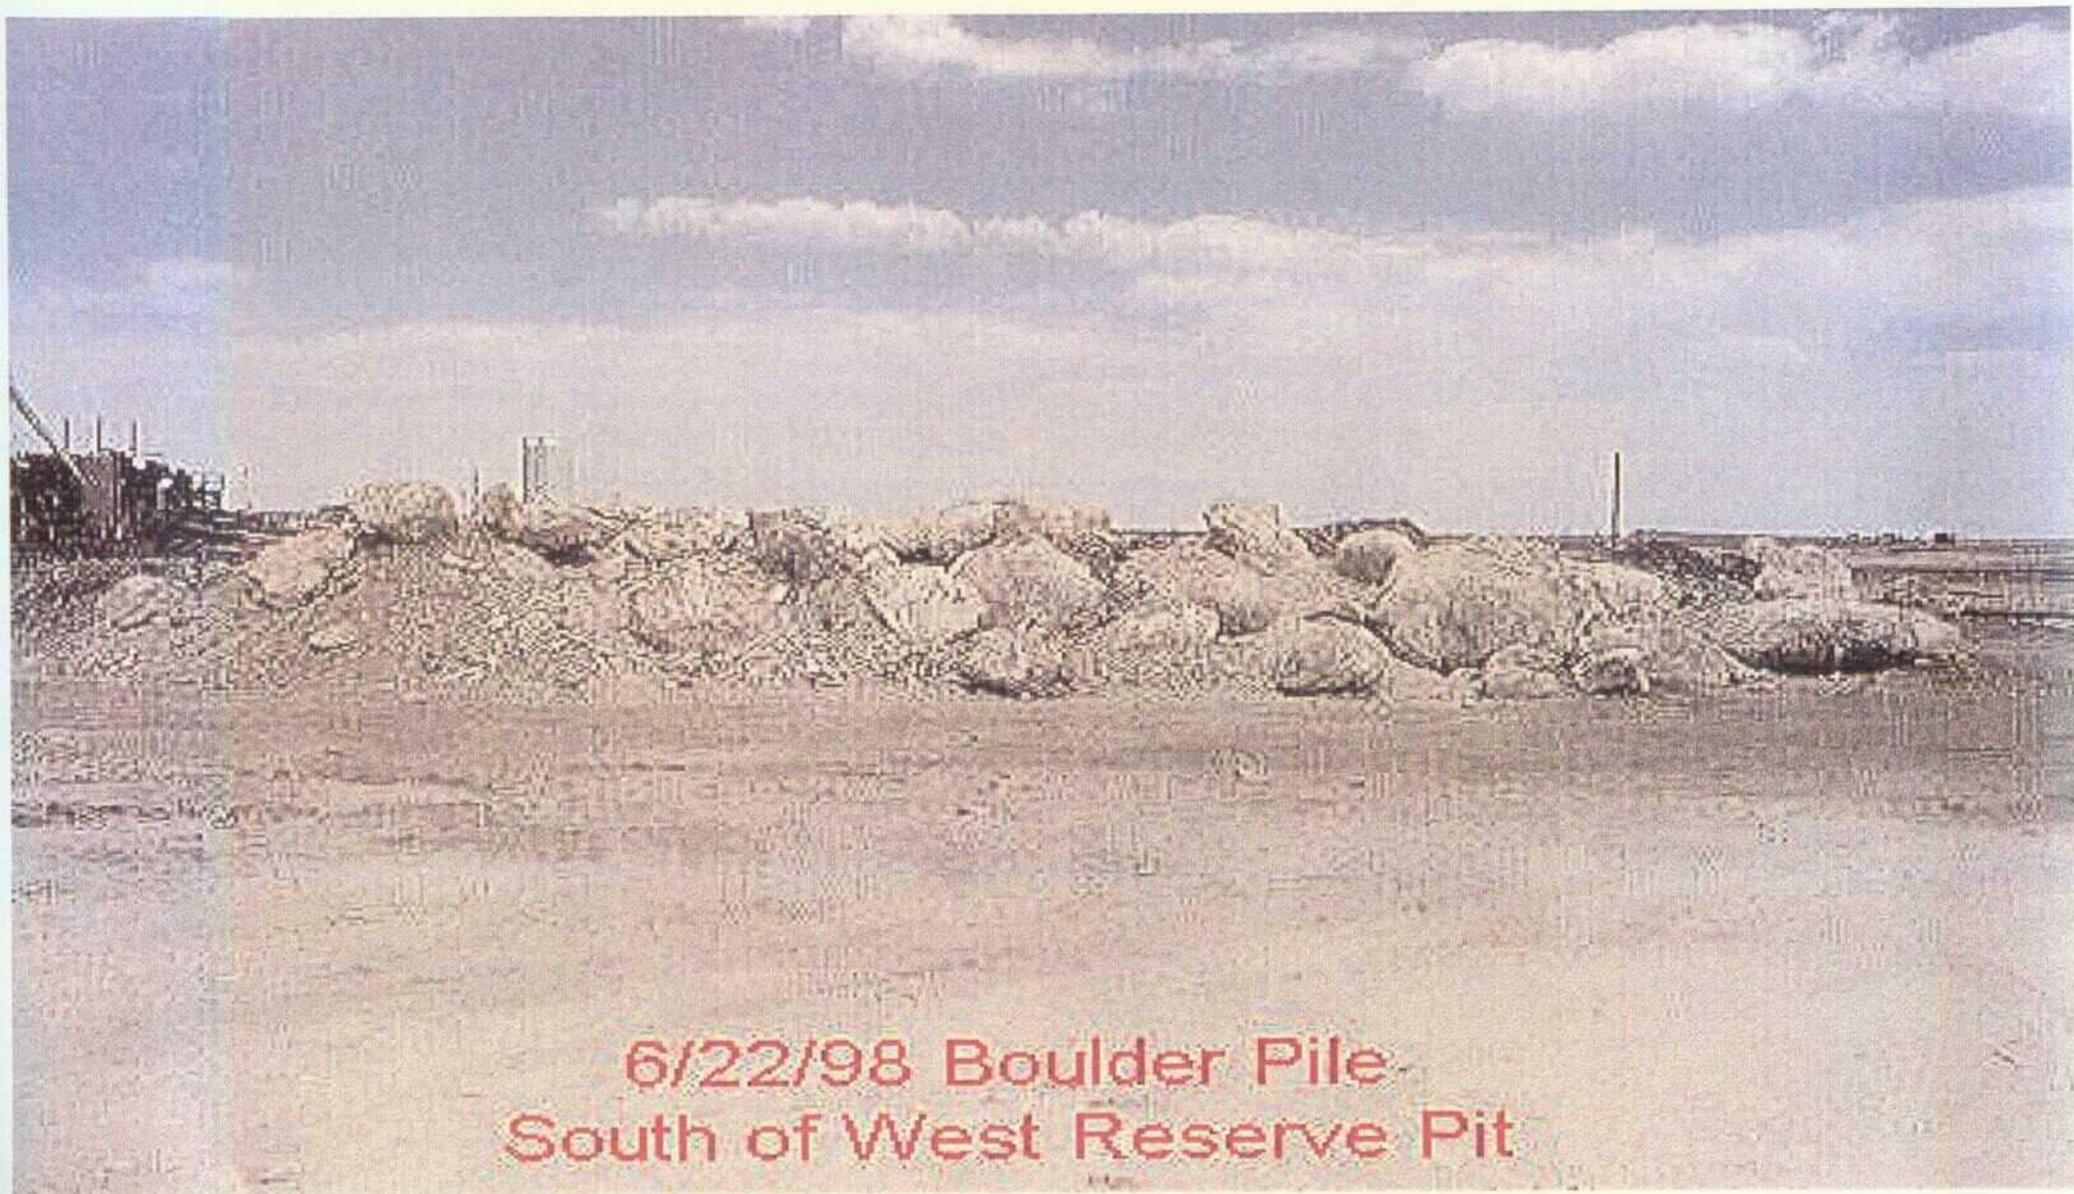
D-5

- D-1** West Reserve Pit prior to remediation
- D-2** West Reserve Pit prior to remediation
- D-3** West Reserve Pit prior to remediation
- D-4** West Reserve Pit prior to remediation
- D-5** Boulder pile at West Reserve Pit prior to remediation (see C-10)
View to NE
- D-6** Detail of mixing West Reserve Pit
View to SW

6/22/98 Boulder Pile
South of West Reserve Pit
