1R - 187

**UMC Carlisle State Com # 1
Pit Remediation Project
Closure Report
Volume II**

**Whole Earth Environmental
19606 San Gabriel
Houston, Tx. 77084**

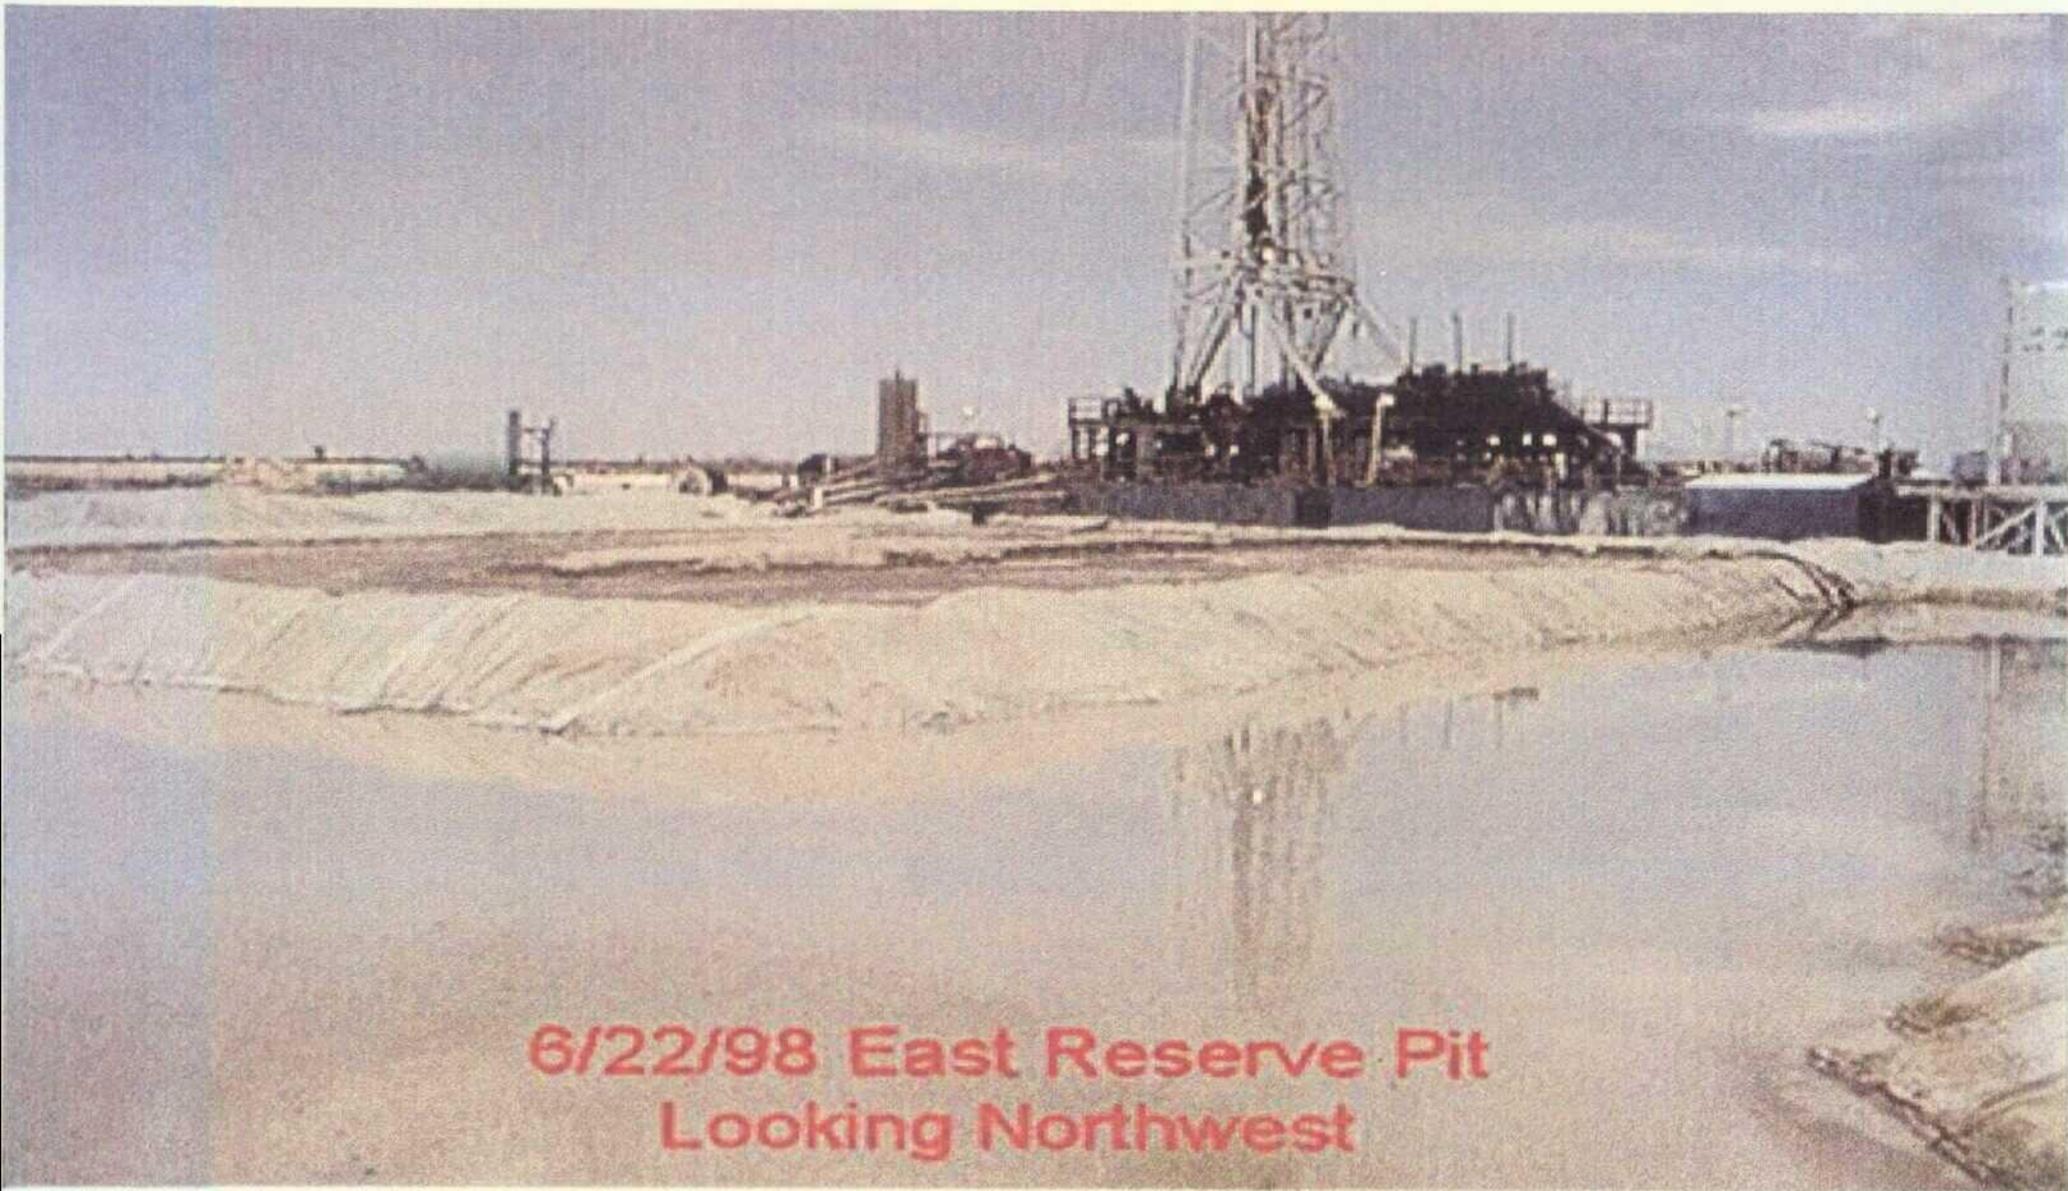
E-2

6/22/98 East Reserve Pit
Looking Northwest

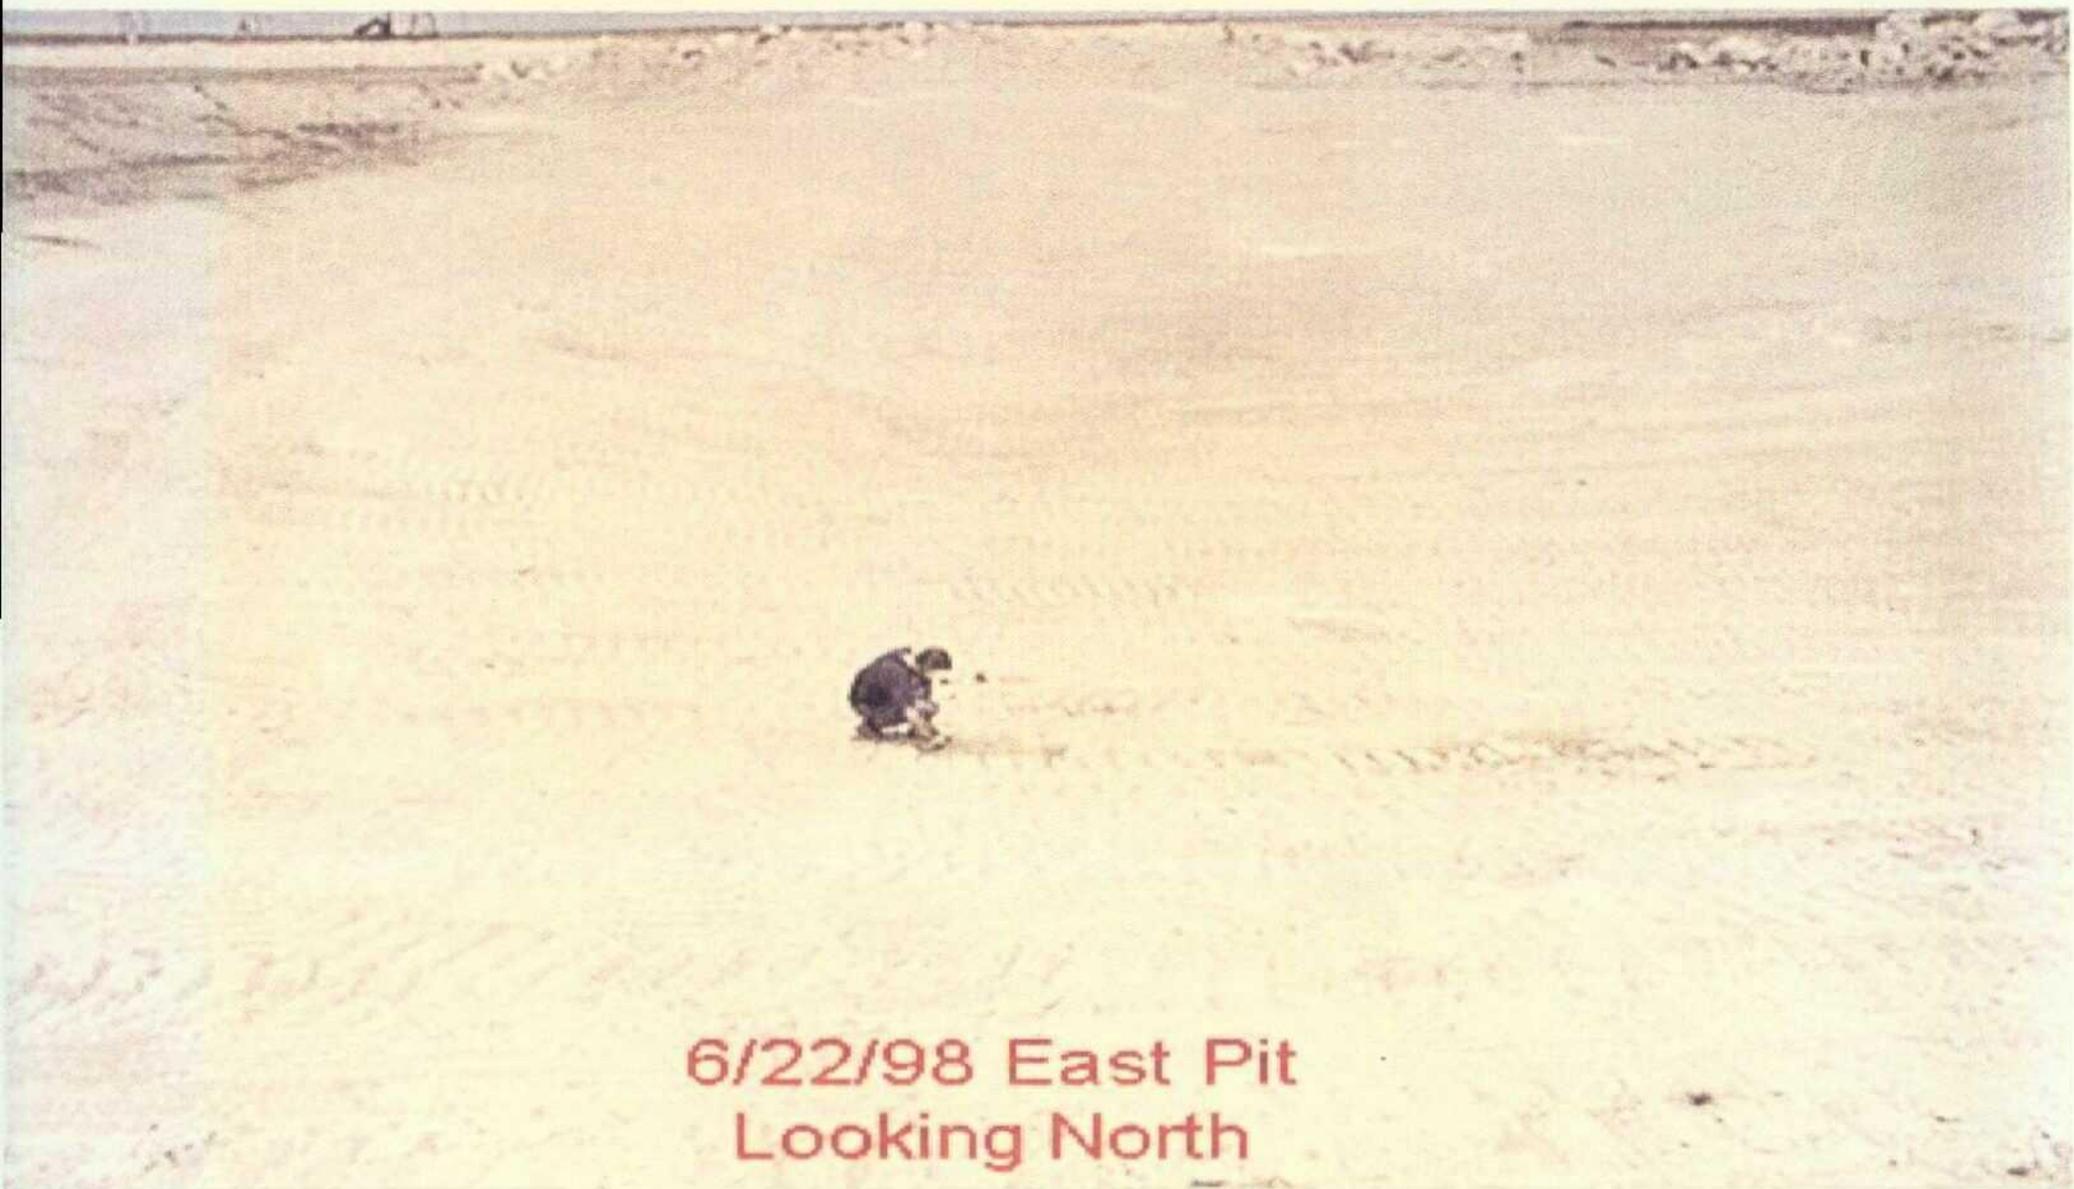
6/22/98 East Pit
Looking North

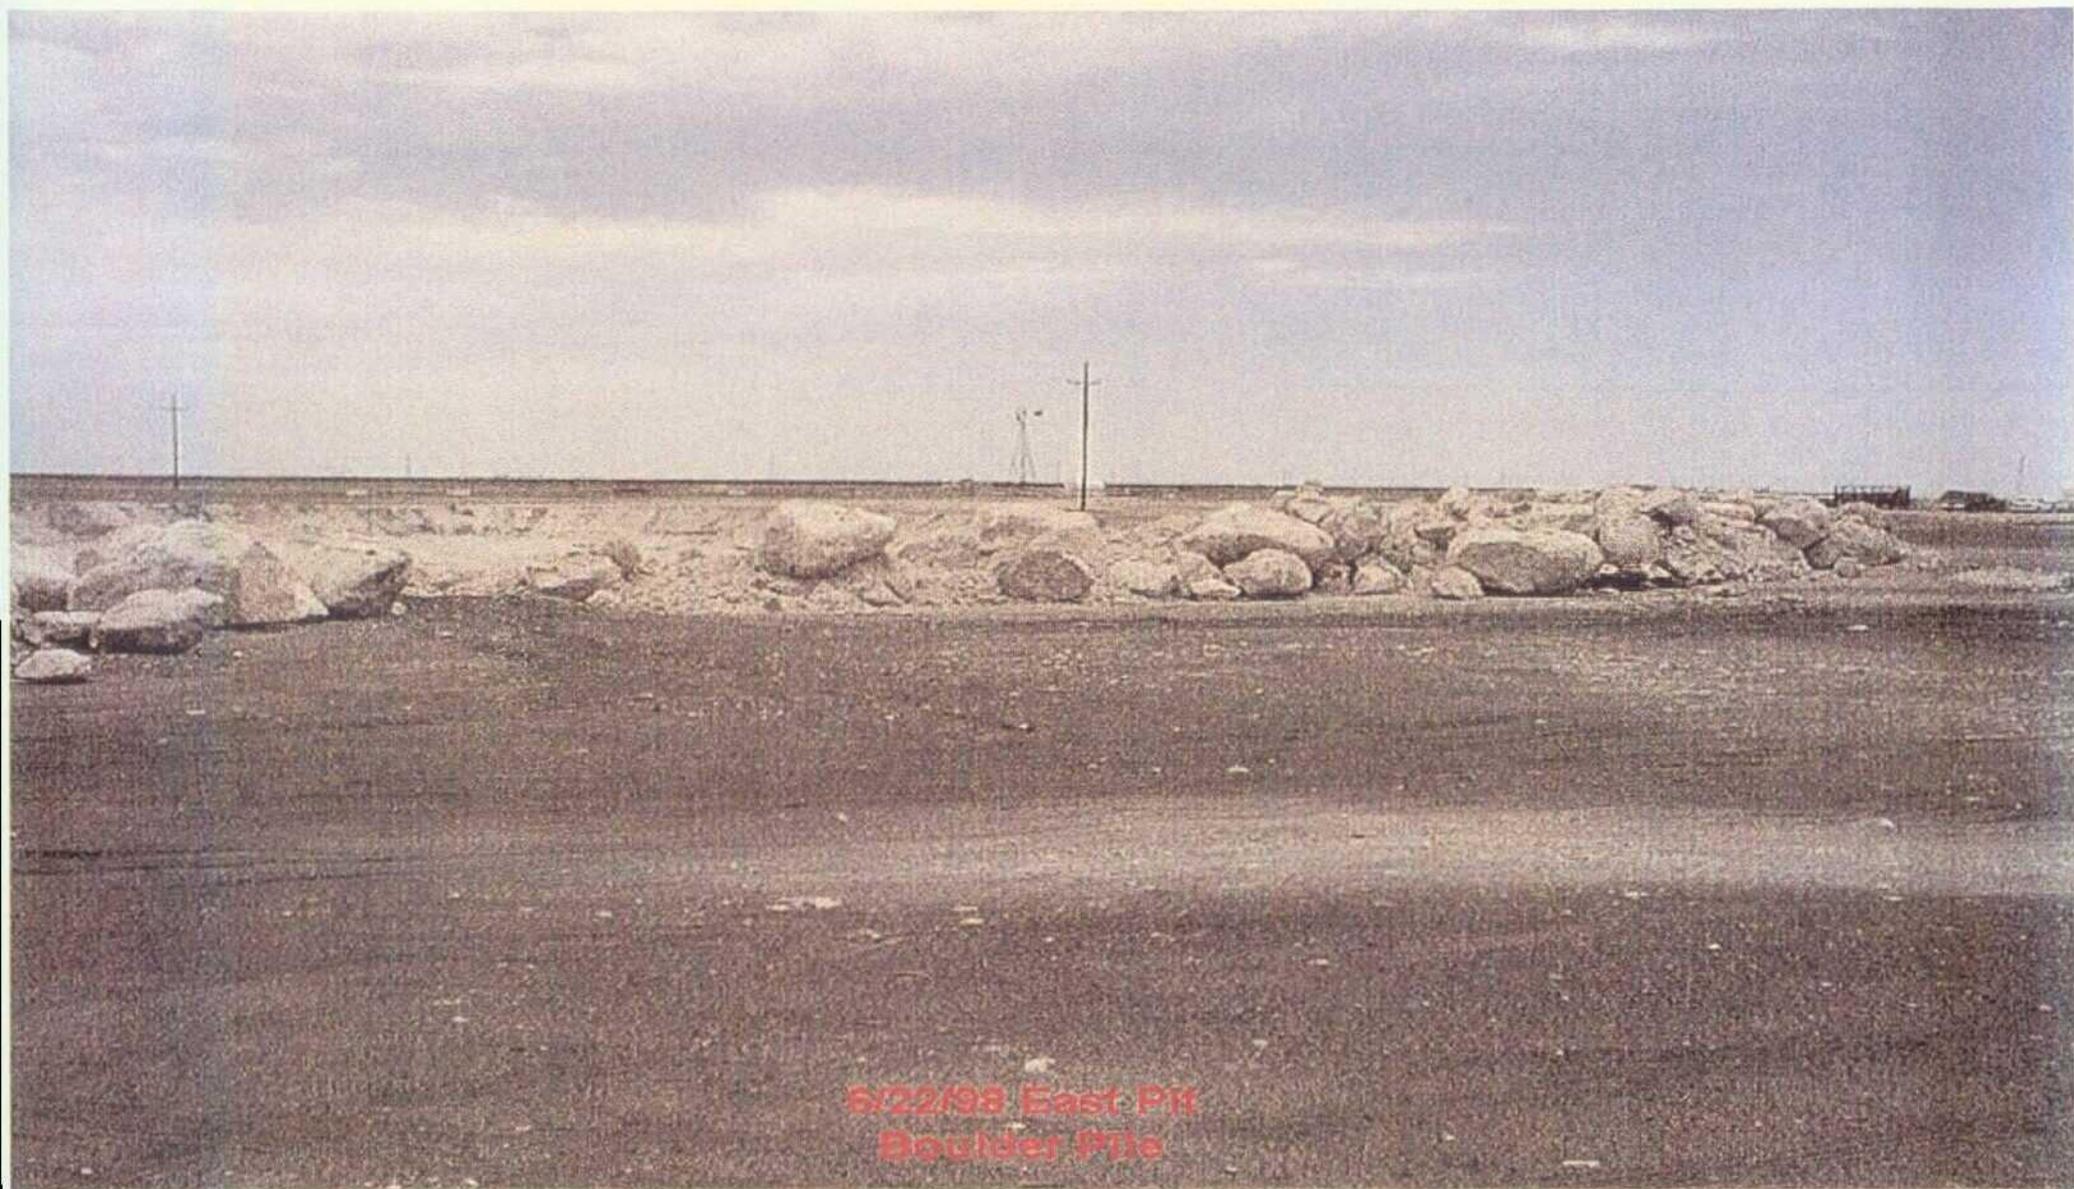
F-5

- F-1** Detail of E. Emergency Pit prior to remediation
- F-2** Detail of E. Emergency Pit prior to remediation
- F-3** Detail of the drilling of the test pit monitor well
View to NW
- F-4** Detail of coring the pit center to determine vertical extent
View to N
- F-5** Detail of boulder pile at northern edge of the pit
View to S
- F-6** View of back-filling
View to N
- F-7** View of back-filling
View to NW

6/22/98 East Pit
Boulder Pile
