## Final Remedial Action Report - ADDENDUM

UMC/Ocean Energy: Carlisle State Com #1  
"East Flare Pit"  
N.M.P.M. S15 T16S R35E  
990' FNL & 2310' FWL  
Lea County New Mexico

ADDENDUM submitted October 22, 1998

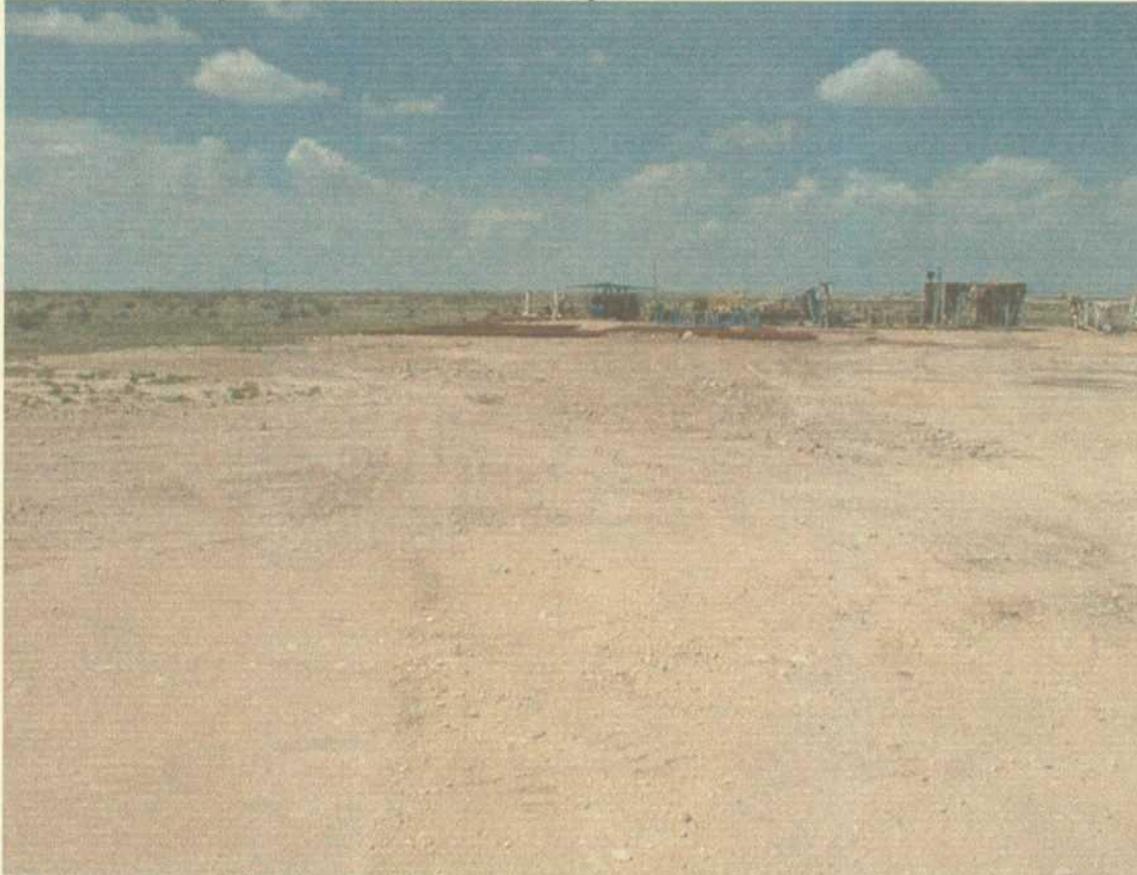
East Flare Pit after Final Backfilling and Contouring  
 August 27, 1998
