Subject: Remediation Completion Report
Lockhart A-27 Battery, OCD File: IR-0345
Eunice, New Mexico
Maxim Project No. 3690056

REMEDATION CONSTRUCTION COMPLETION REPORT
LOCKHART A-27 BATTERY
EUNICE, NEW MEXICO

REMEDIATION CONSTRUCTION COMPLETION REPORT LOCKHART A-27 BATTERY EUNICE, NEW MEXICO

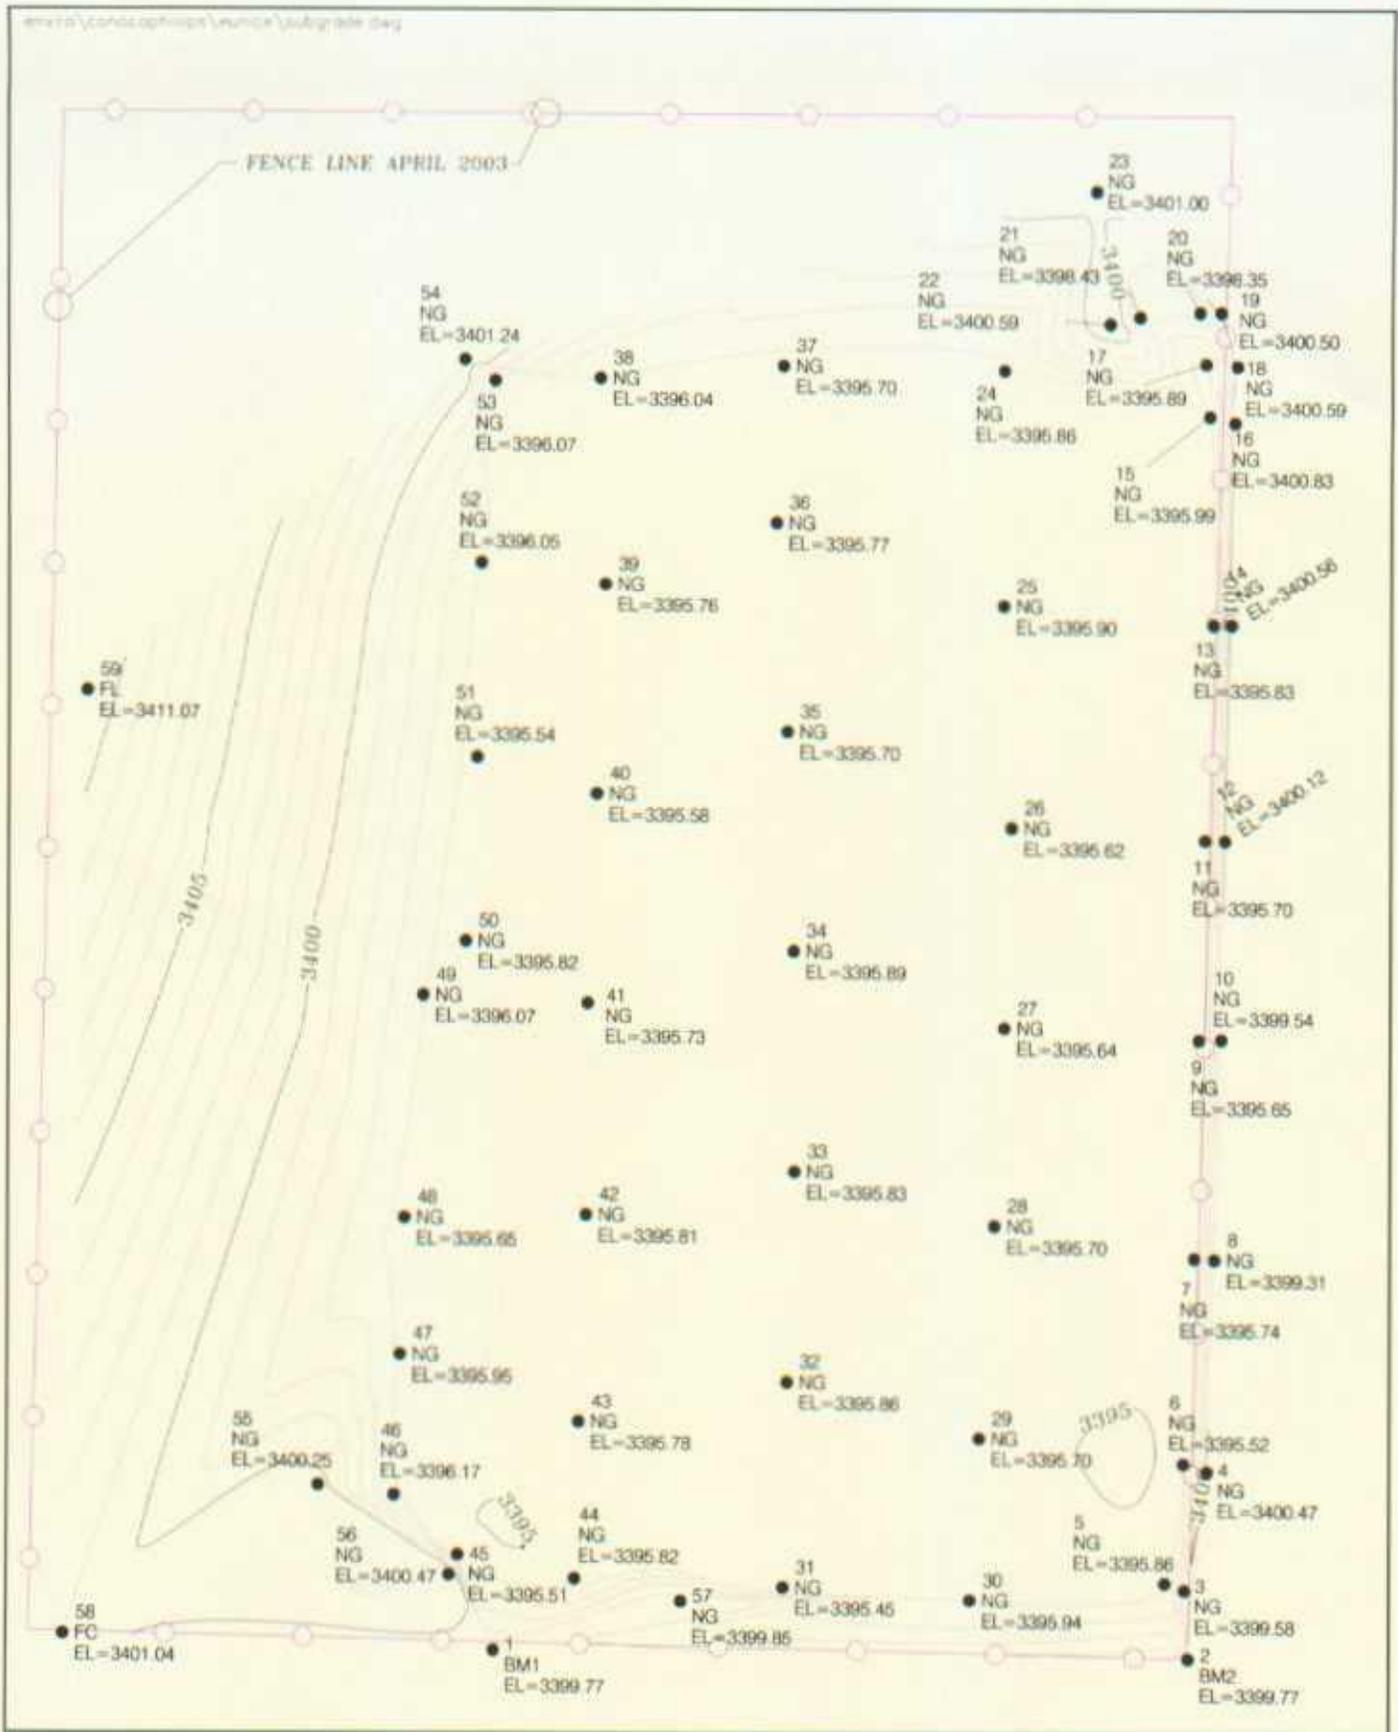
FIGURE 2

The previously fenced area (approximately 1.55 acres) that was above the minus 4-foot grade elevation were excavated, and the soil stockpiled on the western portion of the construction area (Photos 5 and 6). With the backfilling of the two pits, removal of stockpiled impacted soils, and excavation of site clean soils, the entire site footprint was brought to an elevation 4 feet below the benchmark elevation (Photos 7 and 8). This was the base elevation for the placement of the clay layer. The site area was surveyed to ensure that the surface elevation and area to be covered complied with NMOCD requirements (Figure 2) to cover the original (May 2002) fenced area with an engineered clay cover. Thirty-eight points surveyed in the bottom of the excavation had an average elevation of 3395.78 feet, which is 4 feet below the benchmark elevation.

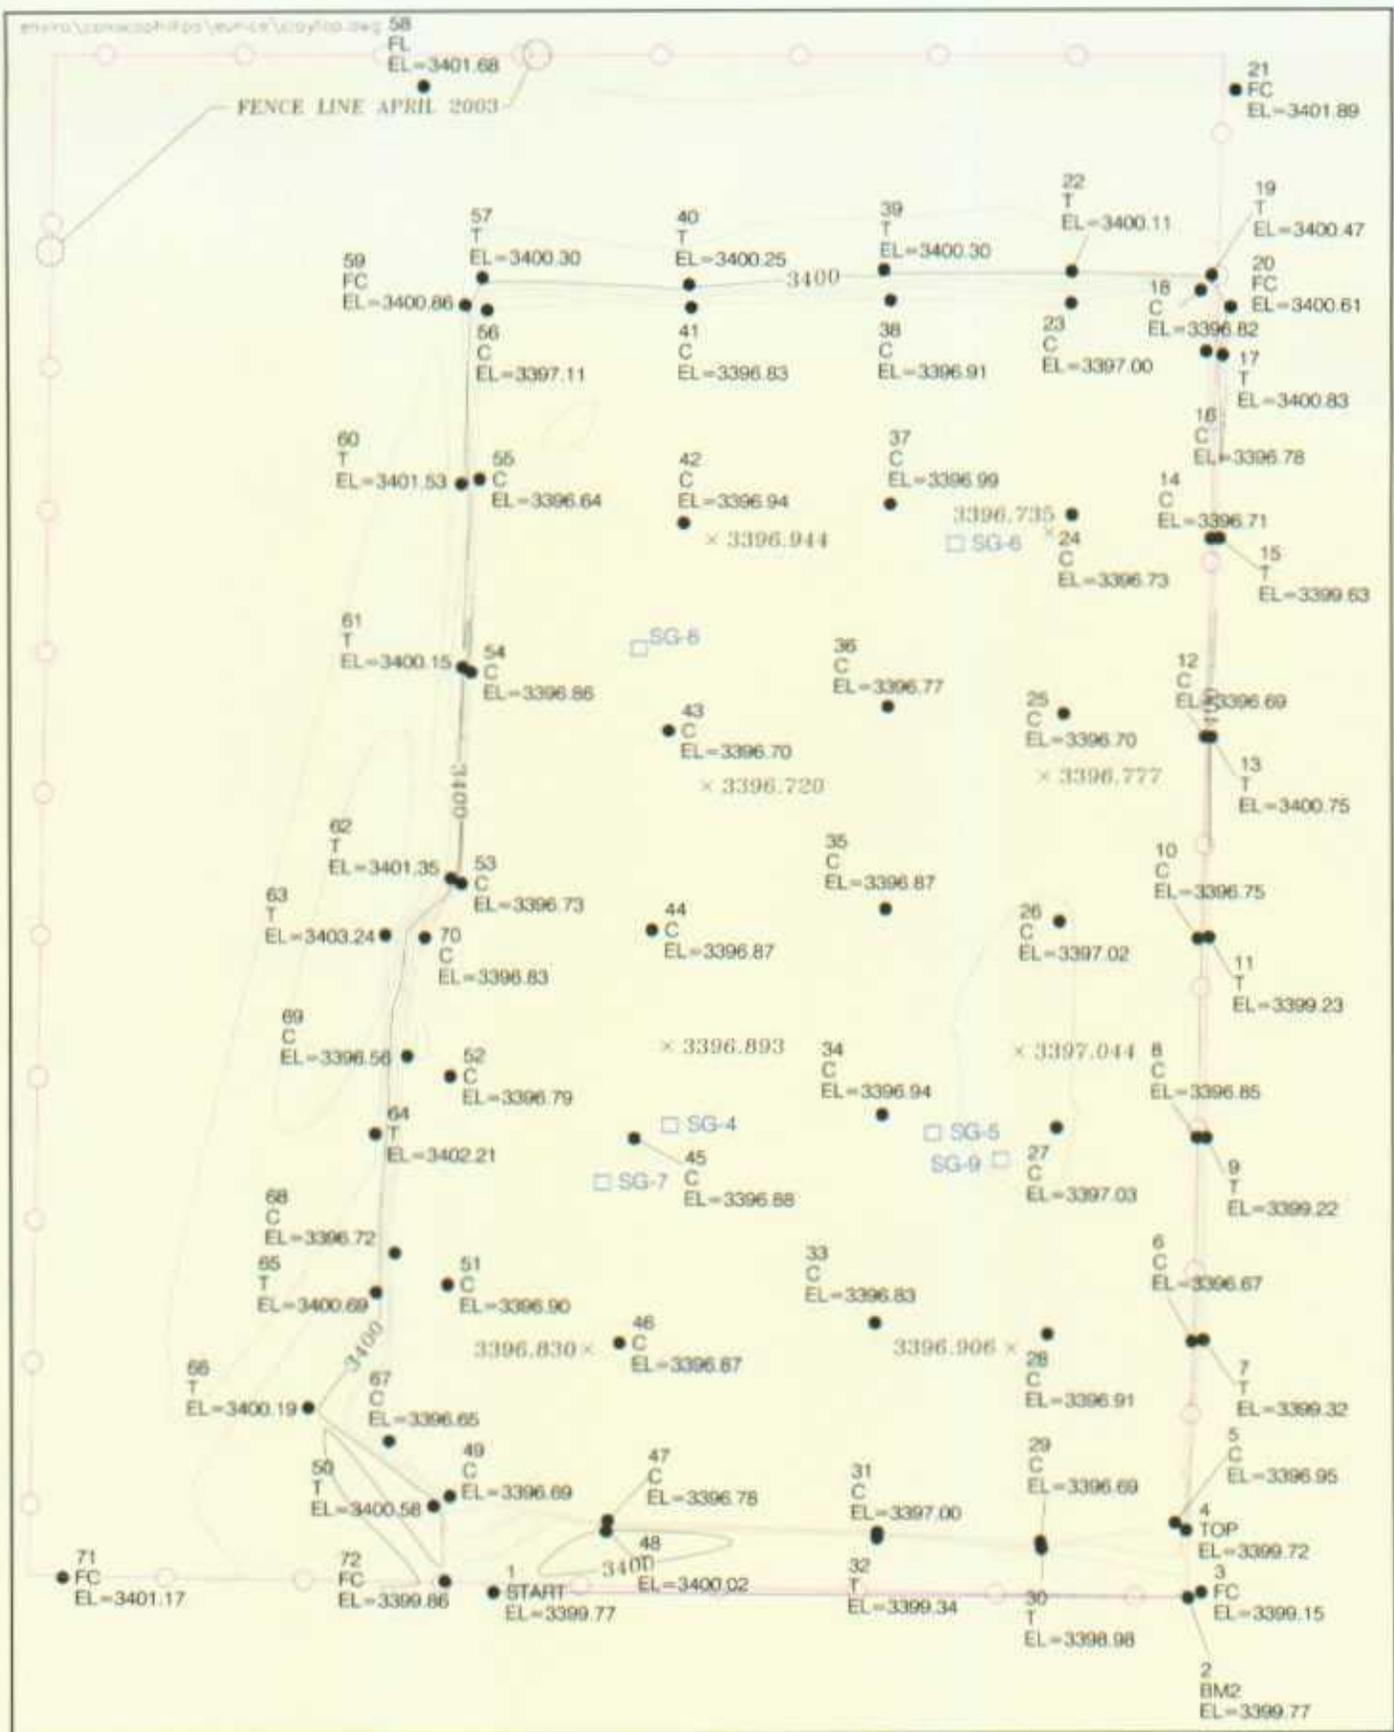
Following construction and testing of the clay layer, a registered land surveying firm surveyed the site (Figure 3). The average elevation of 40 points surveyed on top of the clay layer averaged 3396.82 feet MSL, which is slightly more than one foot higher in elevation than the clay subgrade elevation. These data confirmed that a minimum one-foot thickness of clay was constructed over the site footprint. The clay layer was crowned slightly (approximately 2 to 3 inches) to prevent infiltrating water ponding on the surface of the clay, and to induce drainage off the cover to the east and west. A total of 4,276 tons of clay were purchased and hauled from Wallach Concrete to construct the clay layer (Photos 10 and 11). With an in-place dry density of approximately 100 pounds per cubic foot (see Appendix C, Laboratory Test Results), this amount of clay would be approximately 3,100 cubic yards in place.

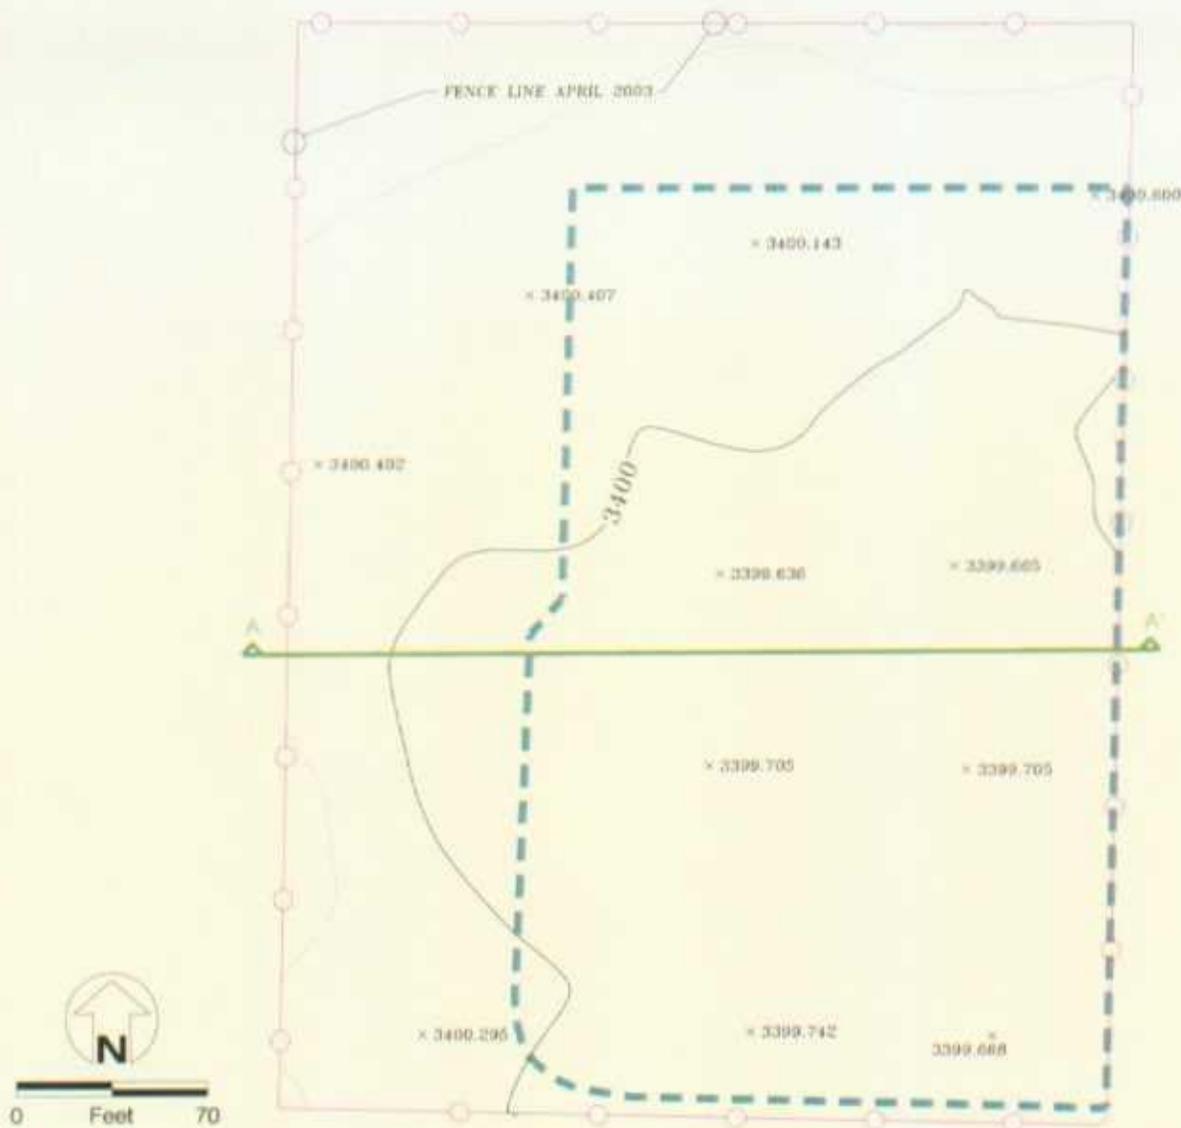
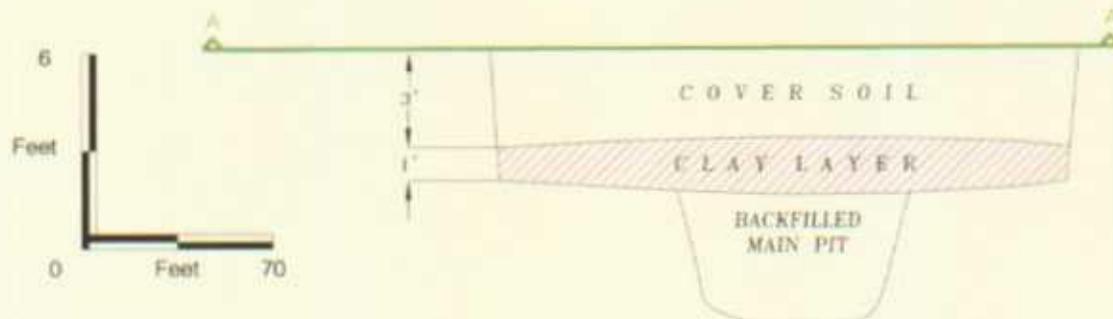
FIGURE 4

Placement and compaction of the cover soils from the stockpiled on-site soils continued until they had been used as backfill over the clay cover. Then soils from a borrow area approximately 600 feet north of the site were hauled to the site and placed as the upper layer of cover soils. The upper one-foot of soils were not compacted to encourage root growth and re-vegetation of the site. Soils were placed over the site footprint to replicate the original ground surface and have approximately 3 feet of cover over the clay layer (Photos 13 and 14). Final ground surface elevations ranged from 3399.6 feet MSL in the southeastern part of the site to slightly over 3400 feet MSL on the northern and western portion of the site (Figure 4). This figure also shows the areal extent of the clay cover and a general cross-section of the site at the end of construction.

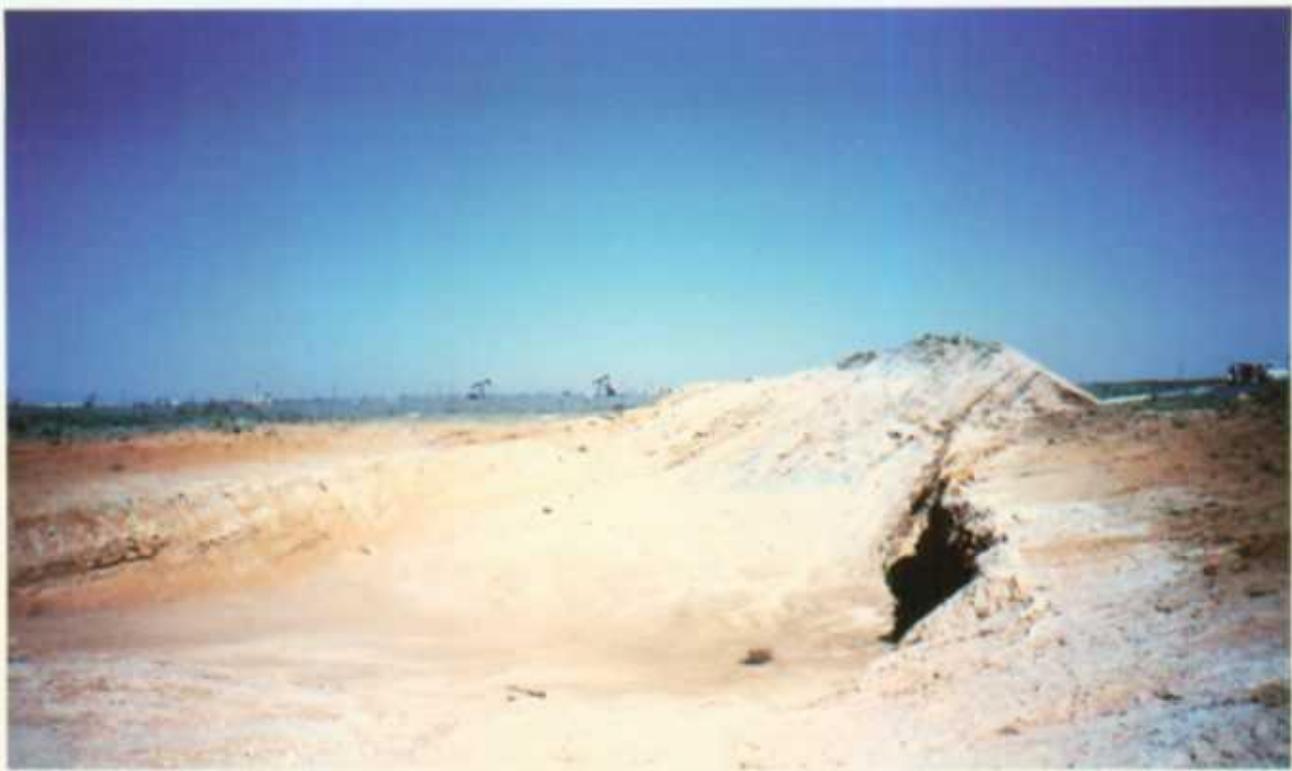
Overall, approximately 7,500 cubic yards of impacted soil were removed from the site during the May 2002 efforts, resulting in two excavations. The first, small excavation is located in the southeast corner of the site, and the second, larger excavation is roughly in the center of the fenced area (Preconstruction Site Survey, Appendix B). The larger excavation was about 17 feet deep at the deepest point. The excavation walls were near vertical on the east and west and the north and south walls were about 20° from the horizontal. Three soil piles existed at the site: the north pile, which contained hydrocarbon-impacted soil; and the southwest and east piles which consisted of unimpacted site soils. The site was fenced and the pits were dry. A caliche road had been constructed into the area (Photo 1).

Photo 1. Pre construction, view to the north (04/17/03).

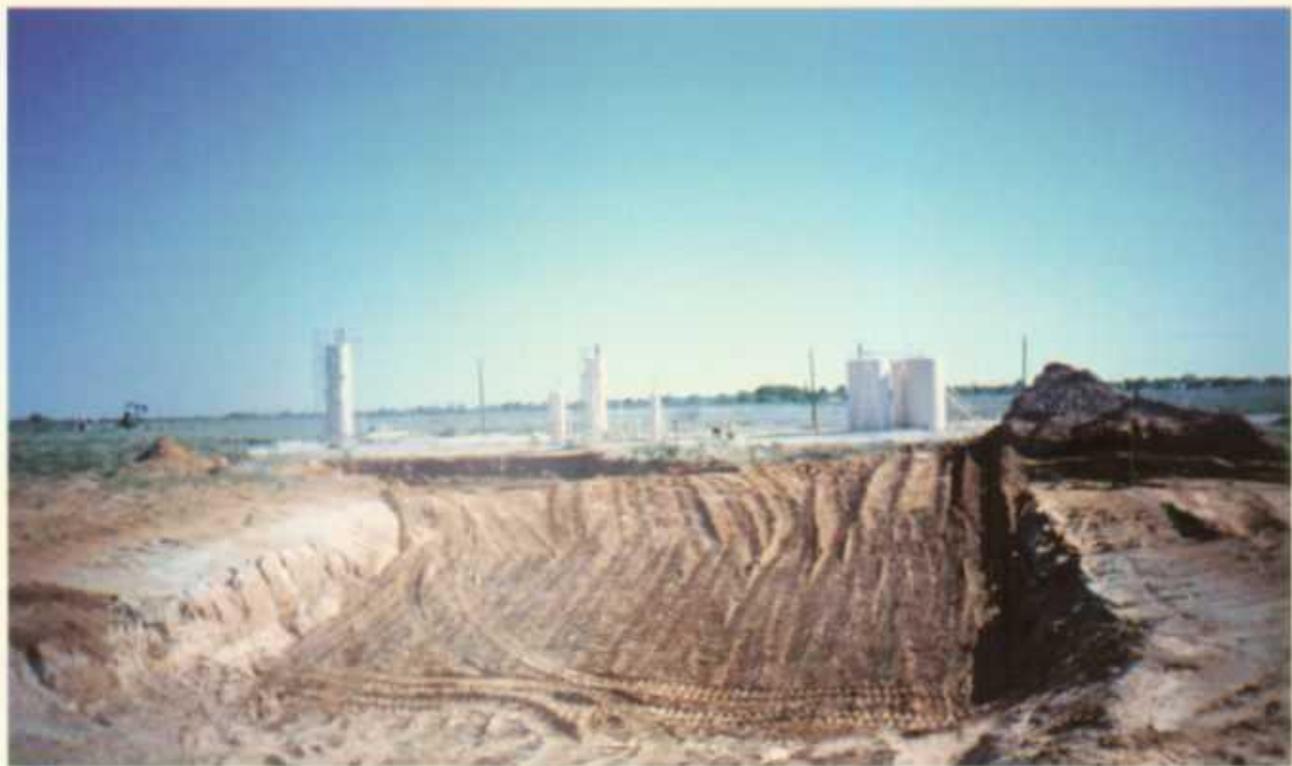
Initial earth moving activities at the site consisted of placement and compaction of soil in the large excavation in the center of the site from the pre-existing southwest soil stockpile (Photo 2). At this time the southeast pit was also filled with site soils that were above the 4-foot excavation grade level. To control the potential for run-on of surface water to the site, small earthen berms were constructed around the perimeter of the site on the northern and eastern sides. The soil stockpiled from the excavation to grade formed the run-on controls on the western side of the site and surface water flow would drain away from the site on the southern boundary.

Photo 2. Backfilling of pits; view to the south. Note: pre-existing southwest soil stockpile on right (04/08/03).

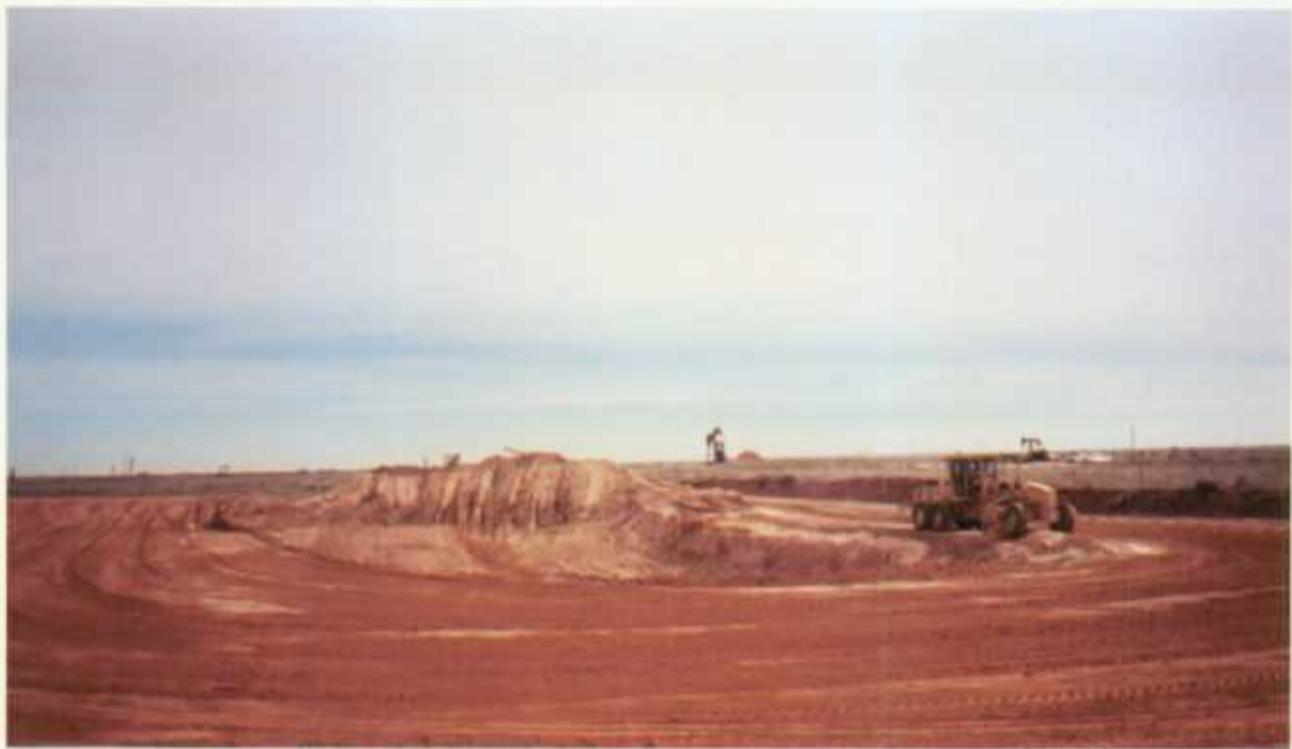
Concurrent with soil placement into the excavations, a front-end loader loaded trucks with soil from the north pile, which was hauled to the J&L Landfarm, southwest of Hobbs New Mexico. This facility is an NMOCD-approved landfarm. Any impacted material clinging to the truck beds was removed at the landfarm. Soil was loaded from the north pile above original ground surface elevation and hauled to the landfarm (a total of 1,060 cubic yards of soil was removed, see receipt, Appendix C). Soils surrounding and beneath the footprint of the north pile were placed into the eastern half of the central pit to bring it up to the minus 4 foot grade elevation (Photos 3 and 4).

Photo 3. Backfilling of main pit and site grading (04/10/03).

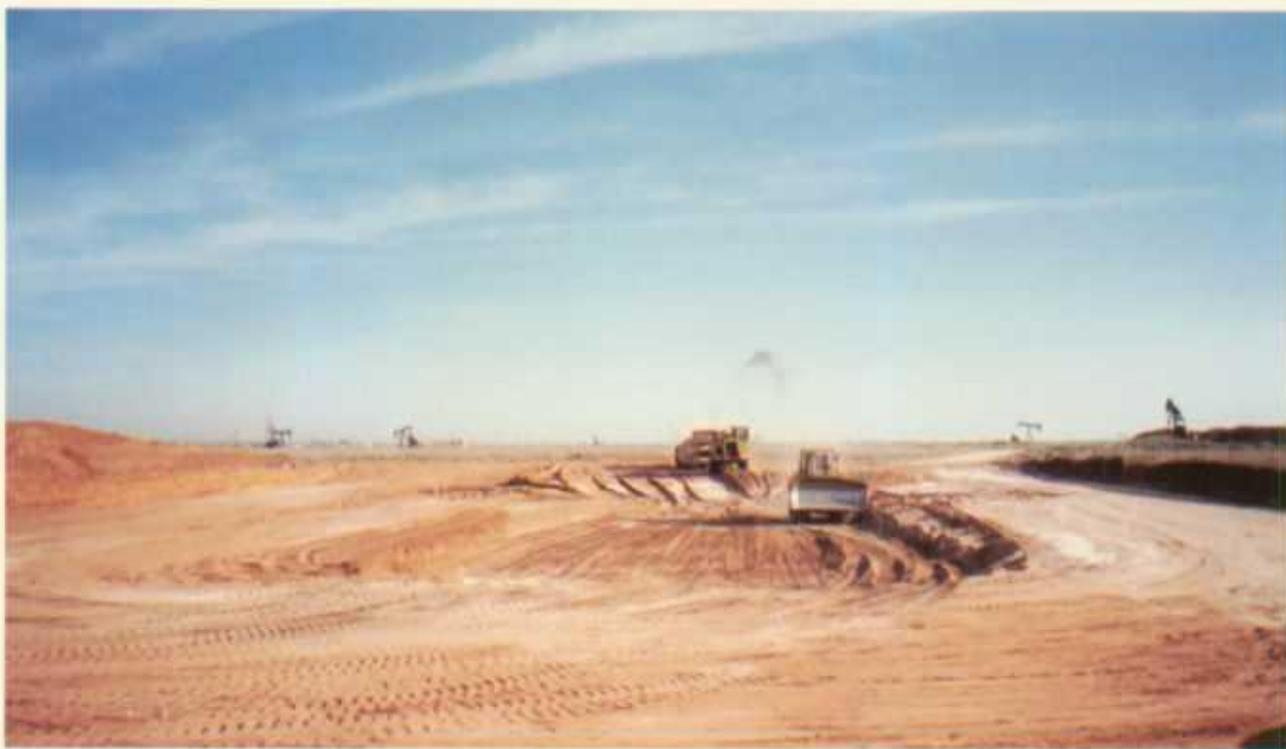
Photo 4. North pile removed; completion of backfill of main pit (04/11/03).

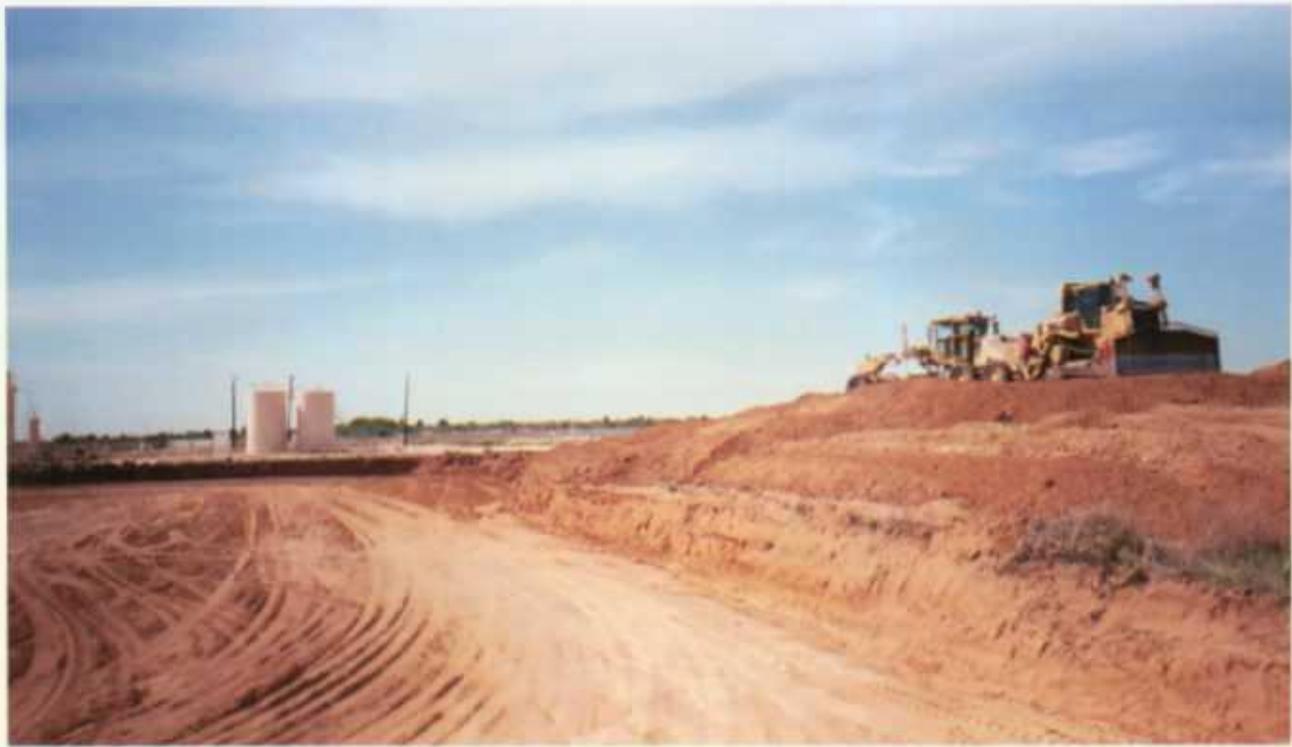
Photo 5. Site grading and stockpiling of cover soils (04/11/03).

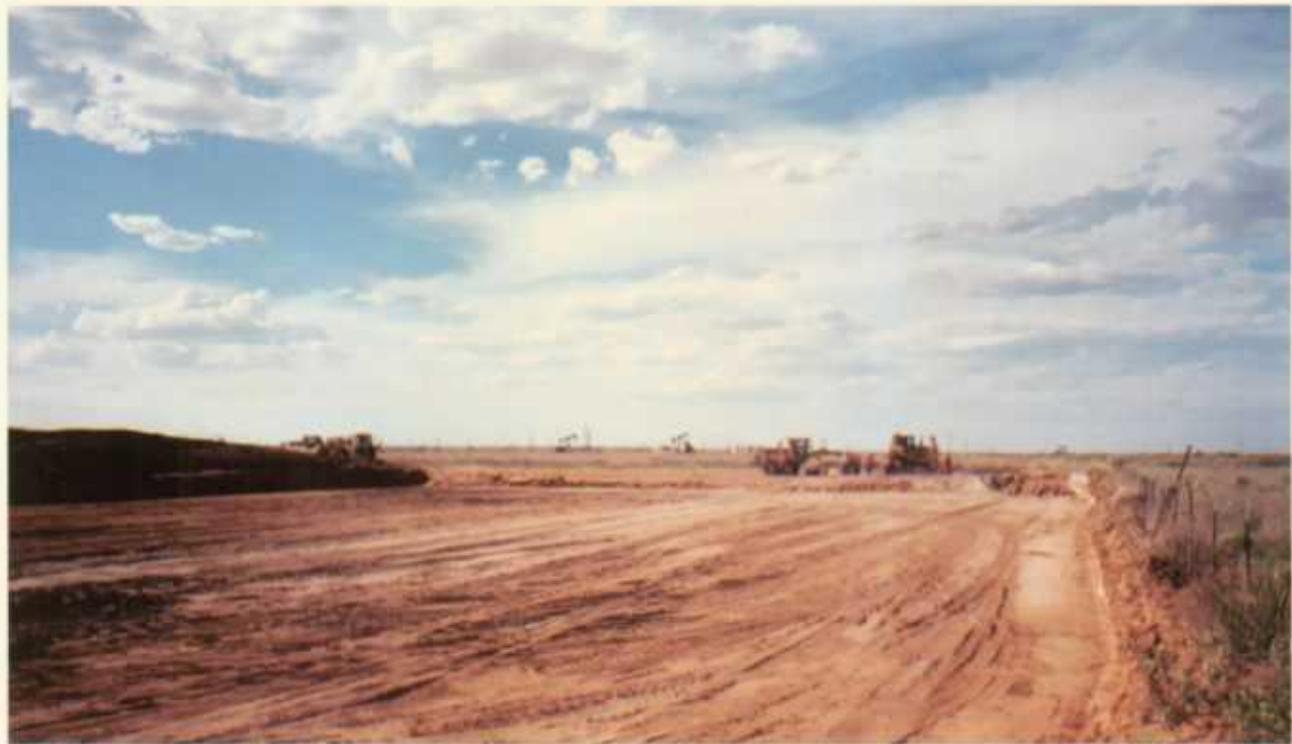
Photo 6. Site grading; view to the north (04/14/03).

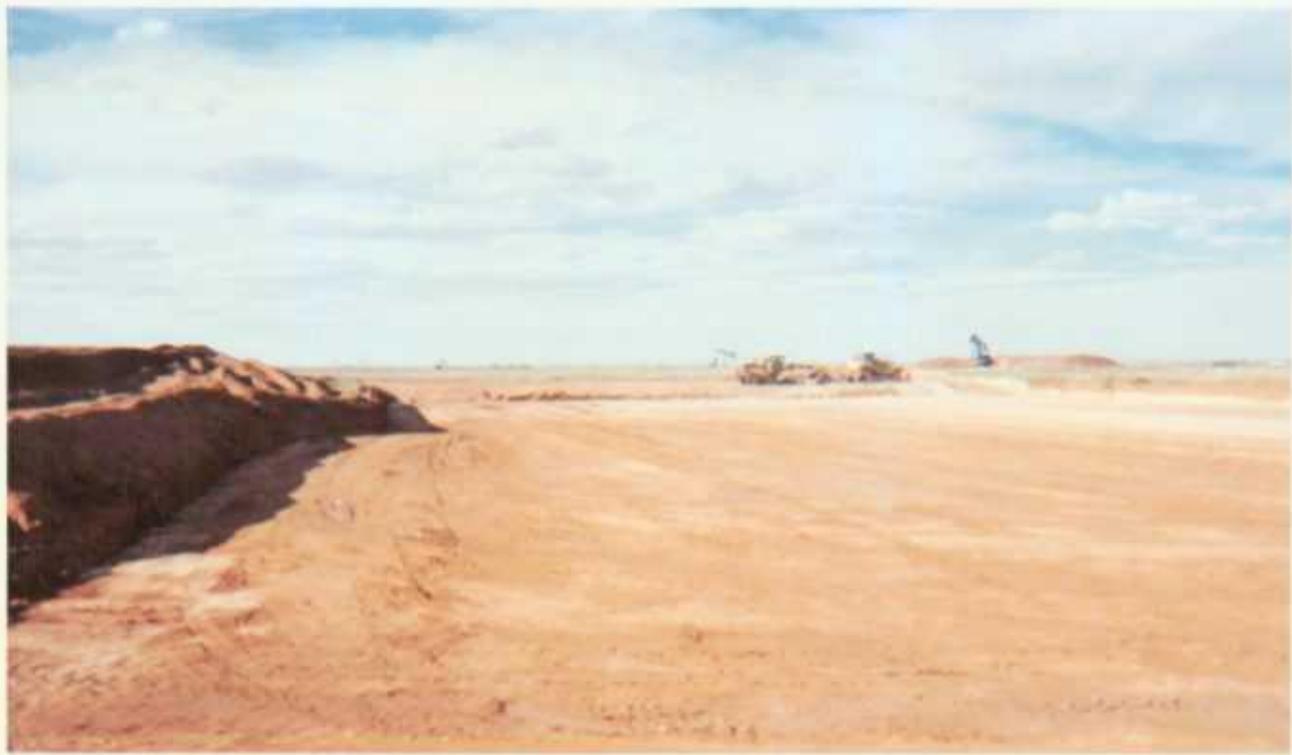
Photo 7. Sub grade elevation for clay layer; view to the north (04/14/03).

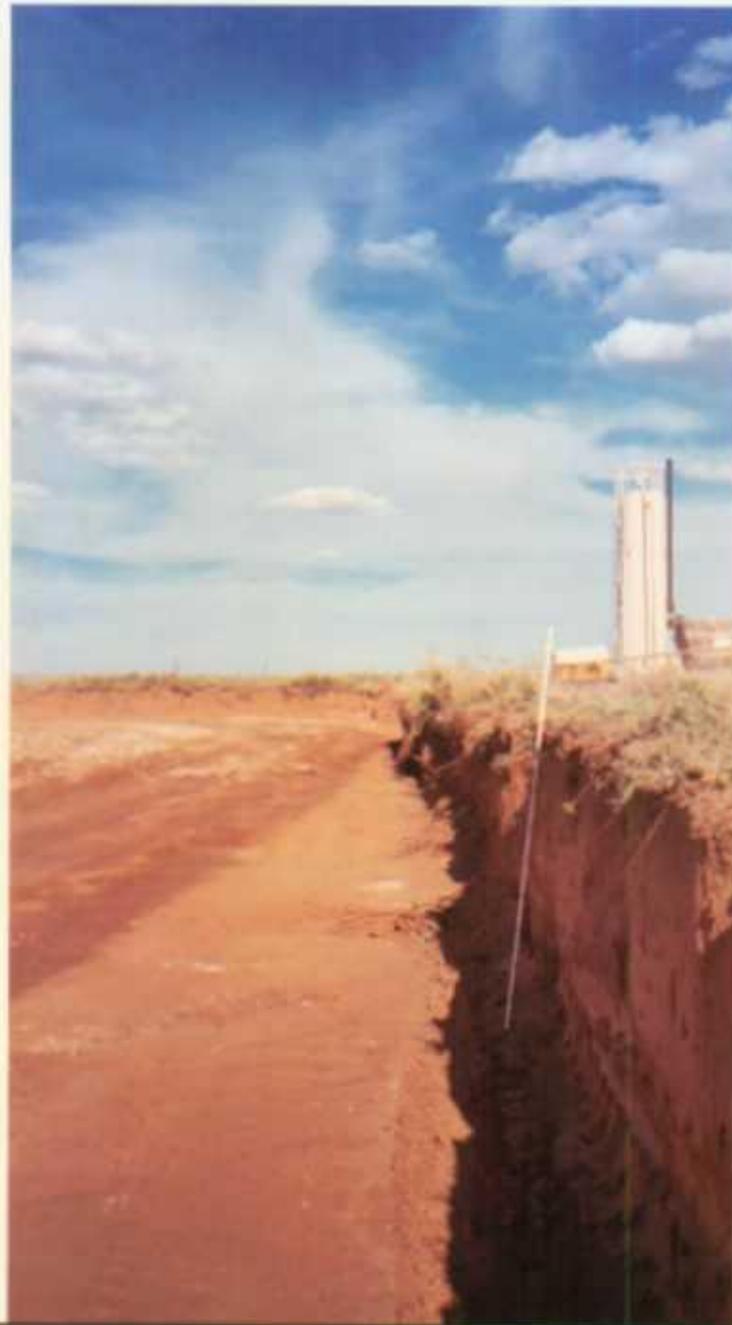
Photo 8. Sub grade elevation for clay layer (note six-foot rule) (04/14/03).

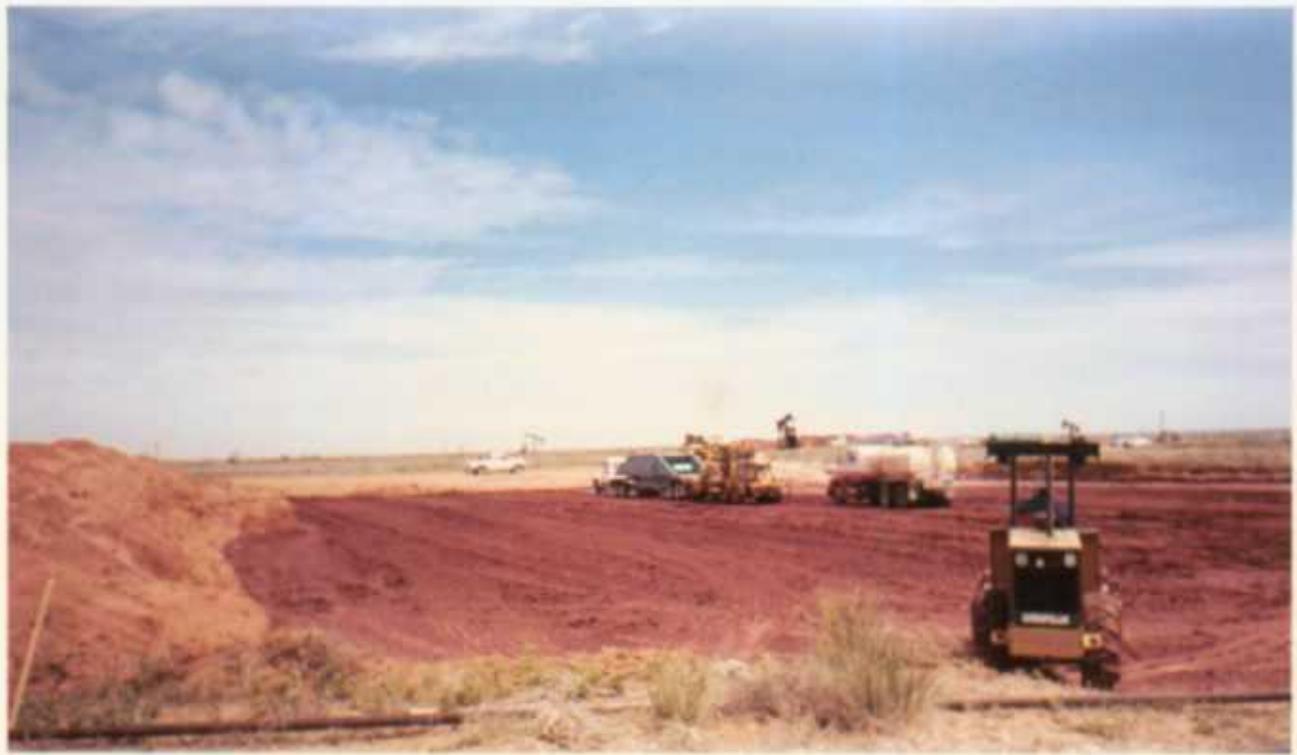
The area for placement of the clay had a previous application of water for moisture conditioning. Clay materials for the clay cover were hauled to the site footprint using “belly dump” trucks. After unloading, a road grader was used to spread the materials into thin, approximately 3 inch lifts. Water trucks then applied water to the materials and a “sheep’s-foot” compactor was used to break down the larger clay clods, to work the water through the entire lift of the clay, and compact it to a minimum 95 percent Standard Proctor dry density (Photo 9).

Photo 9. Construction of clay cover (04/18/03).

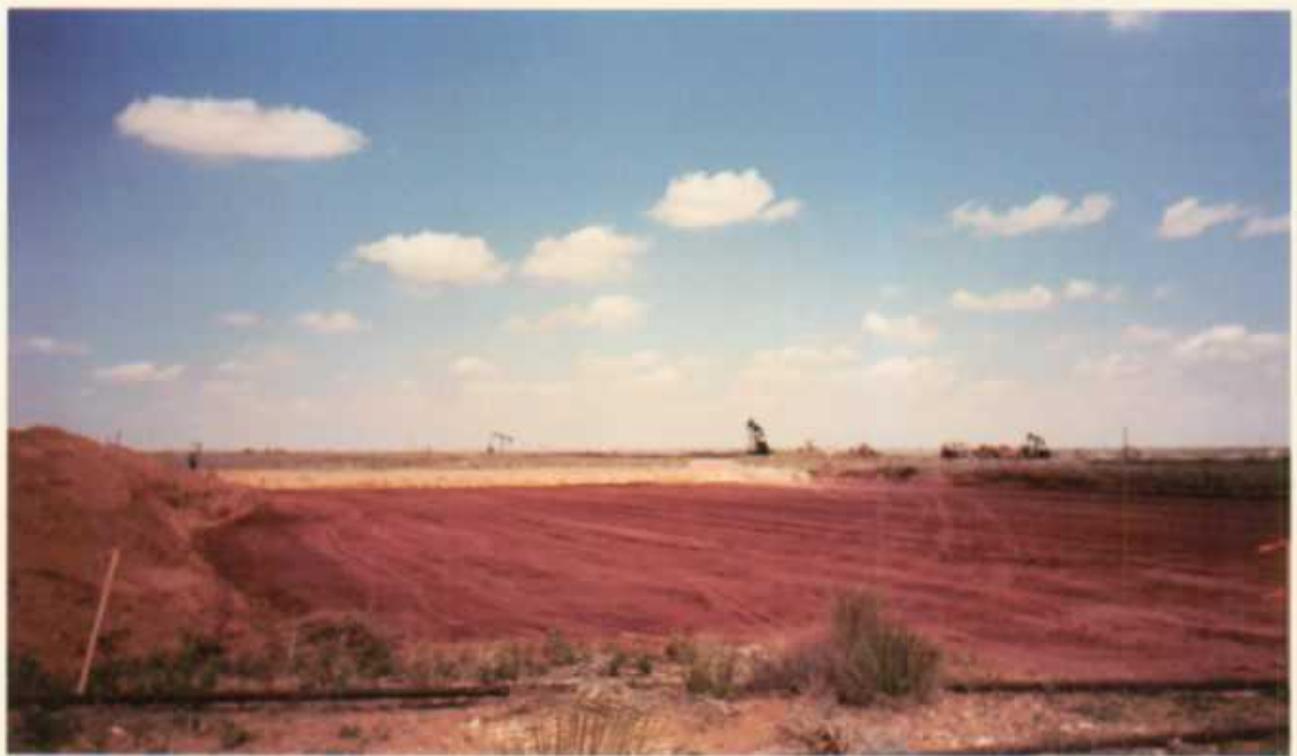
Photo 10. Top of clay cover, west side of site (04/22/03).

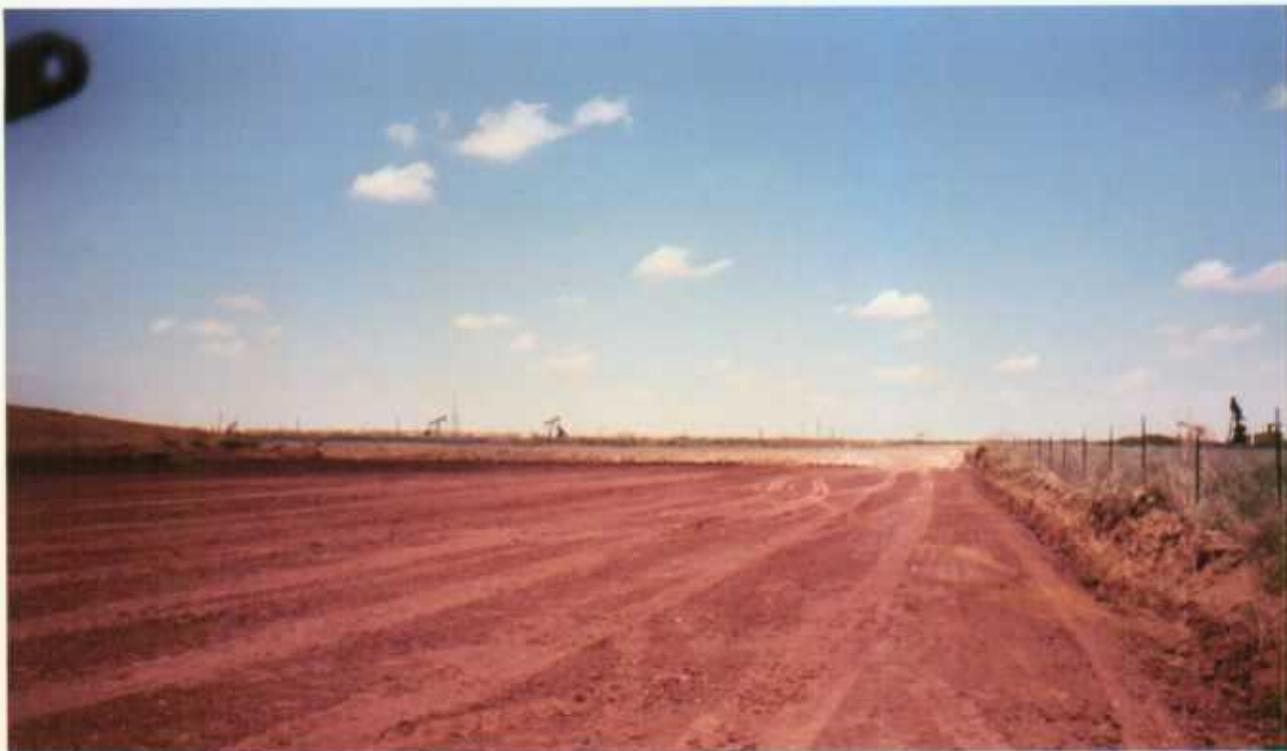
Photo 11. Top of clay cover, east side of site (04/22/03).

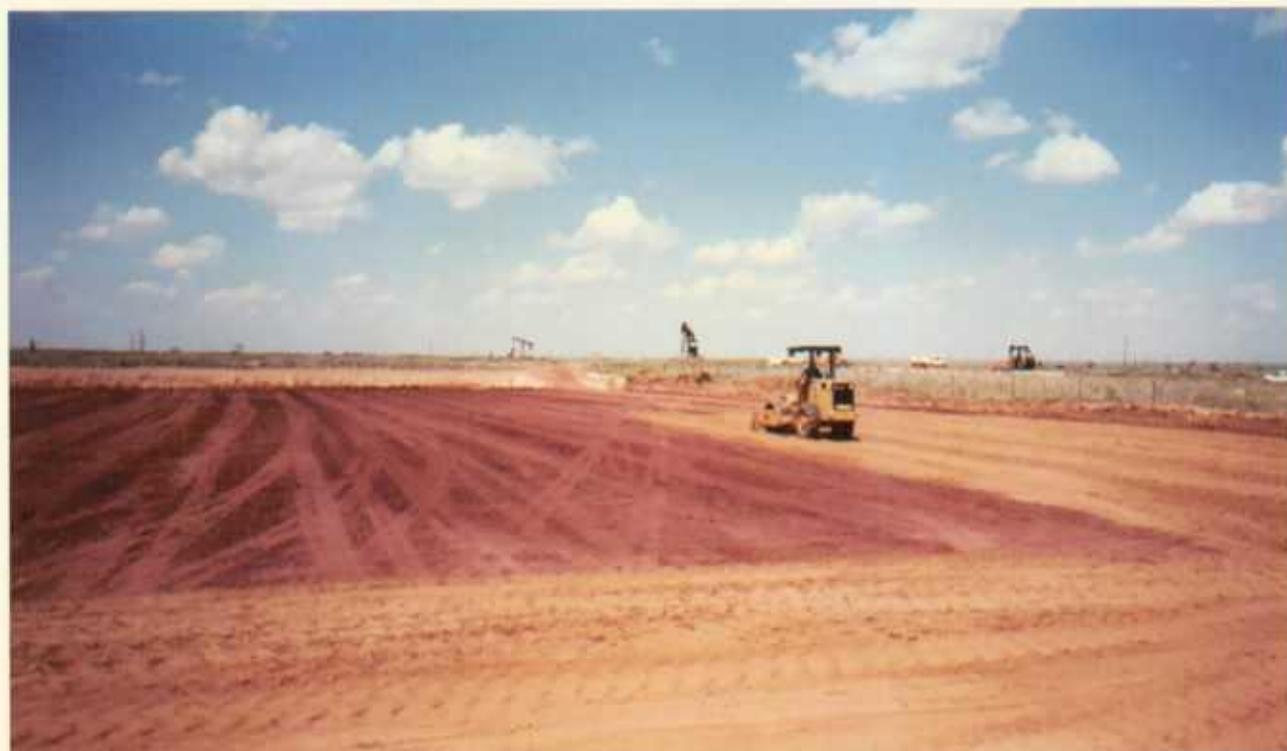
were placed within 4 hours of the final survey of the clay cover. The cover soils were placed in approximate 8- to 9-inch-thick lifts and nominally compacted to prevent settlement of the soils (Photo 12).

Photo 12. First lift of cover soil over clay layer (04/22/03).

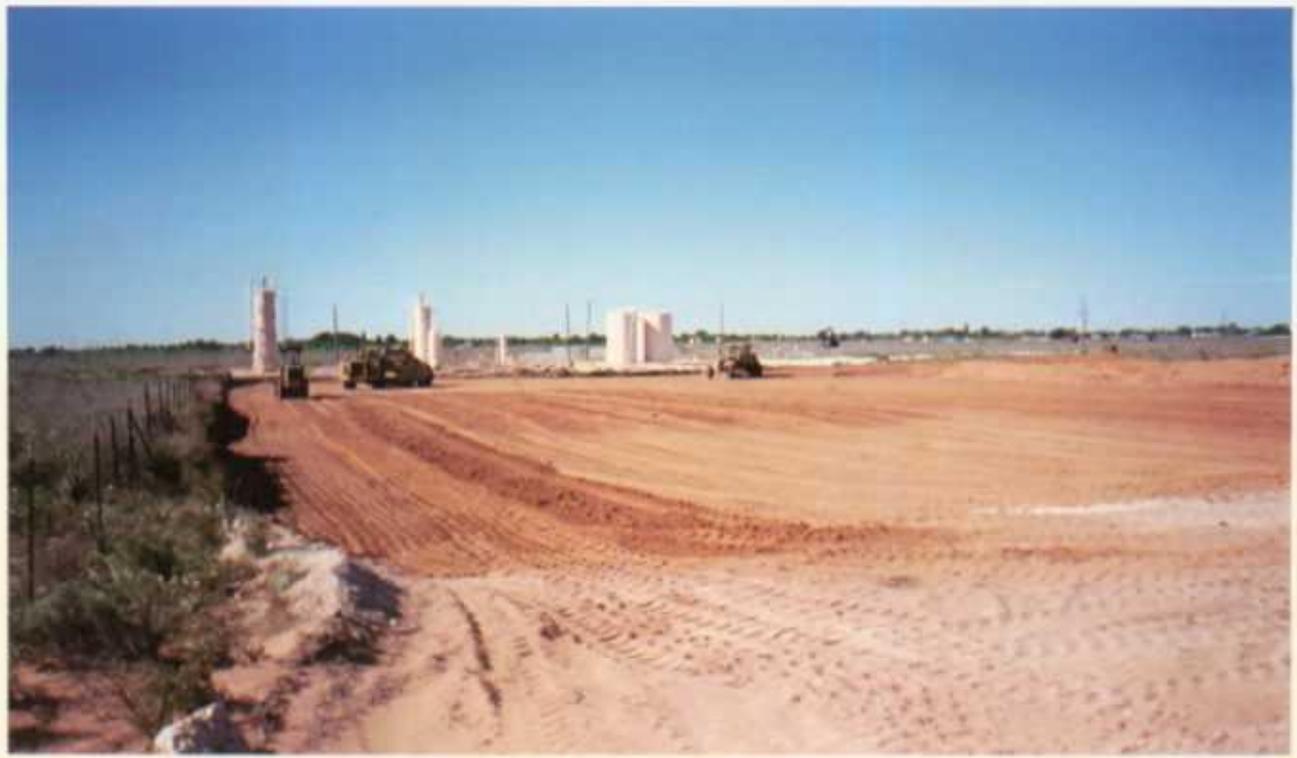
Photo 13. Placement of compaction of cover soils (04/24/03).

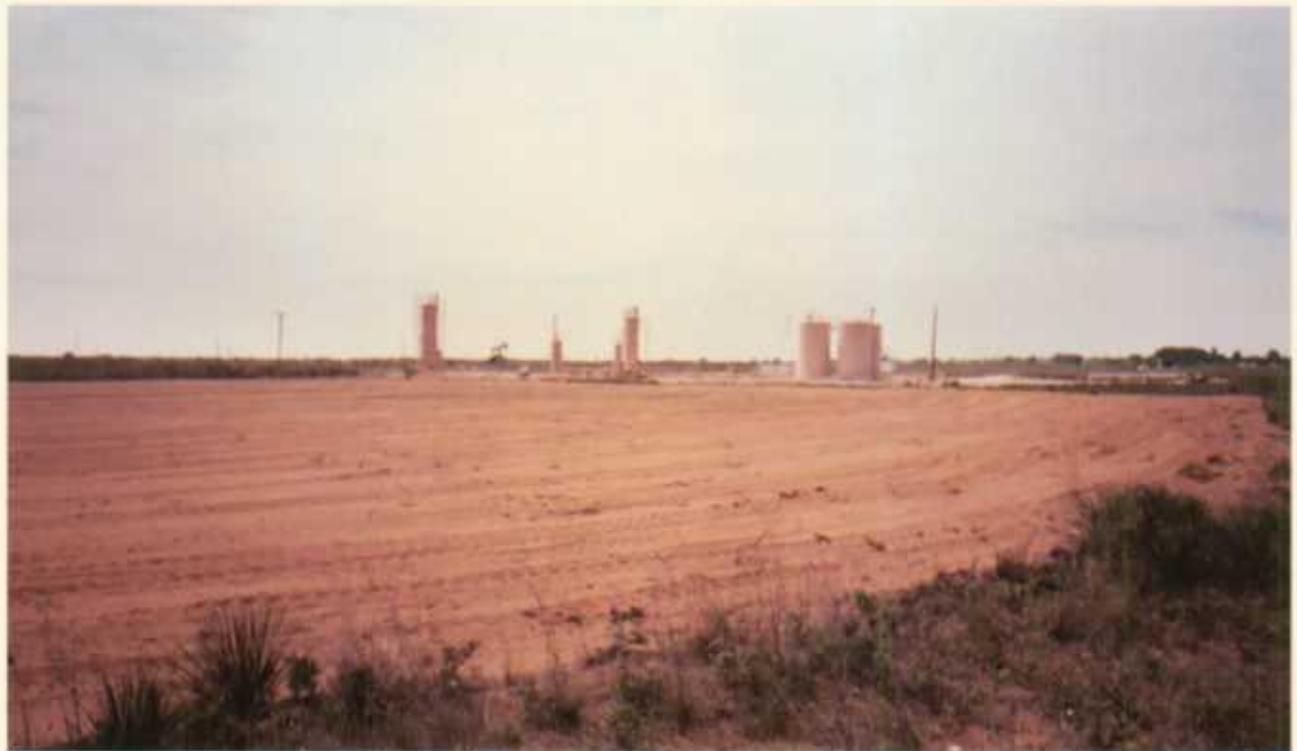
Photo 14. Completion of backfill and site grading (04/29/03).
