RE: Indian Basin Gas Plant
Pipeline Spill (Line #1) Remediation Report

**INDIAN BASIN GAS PLANT
PIPELINE (LINE #1) SPILL
REMEDICATION REPORT**

**Indian Basin Gas Plant
329 Marathon Road
Lakewood, New Mexico 88254
Eddy County**

**Submitted by
Marathon Oil Company
on behalf of the
Indian Basin Gas Plant Owners**

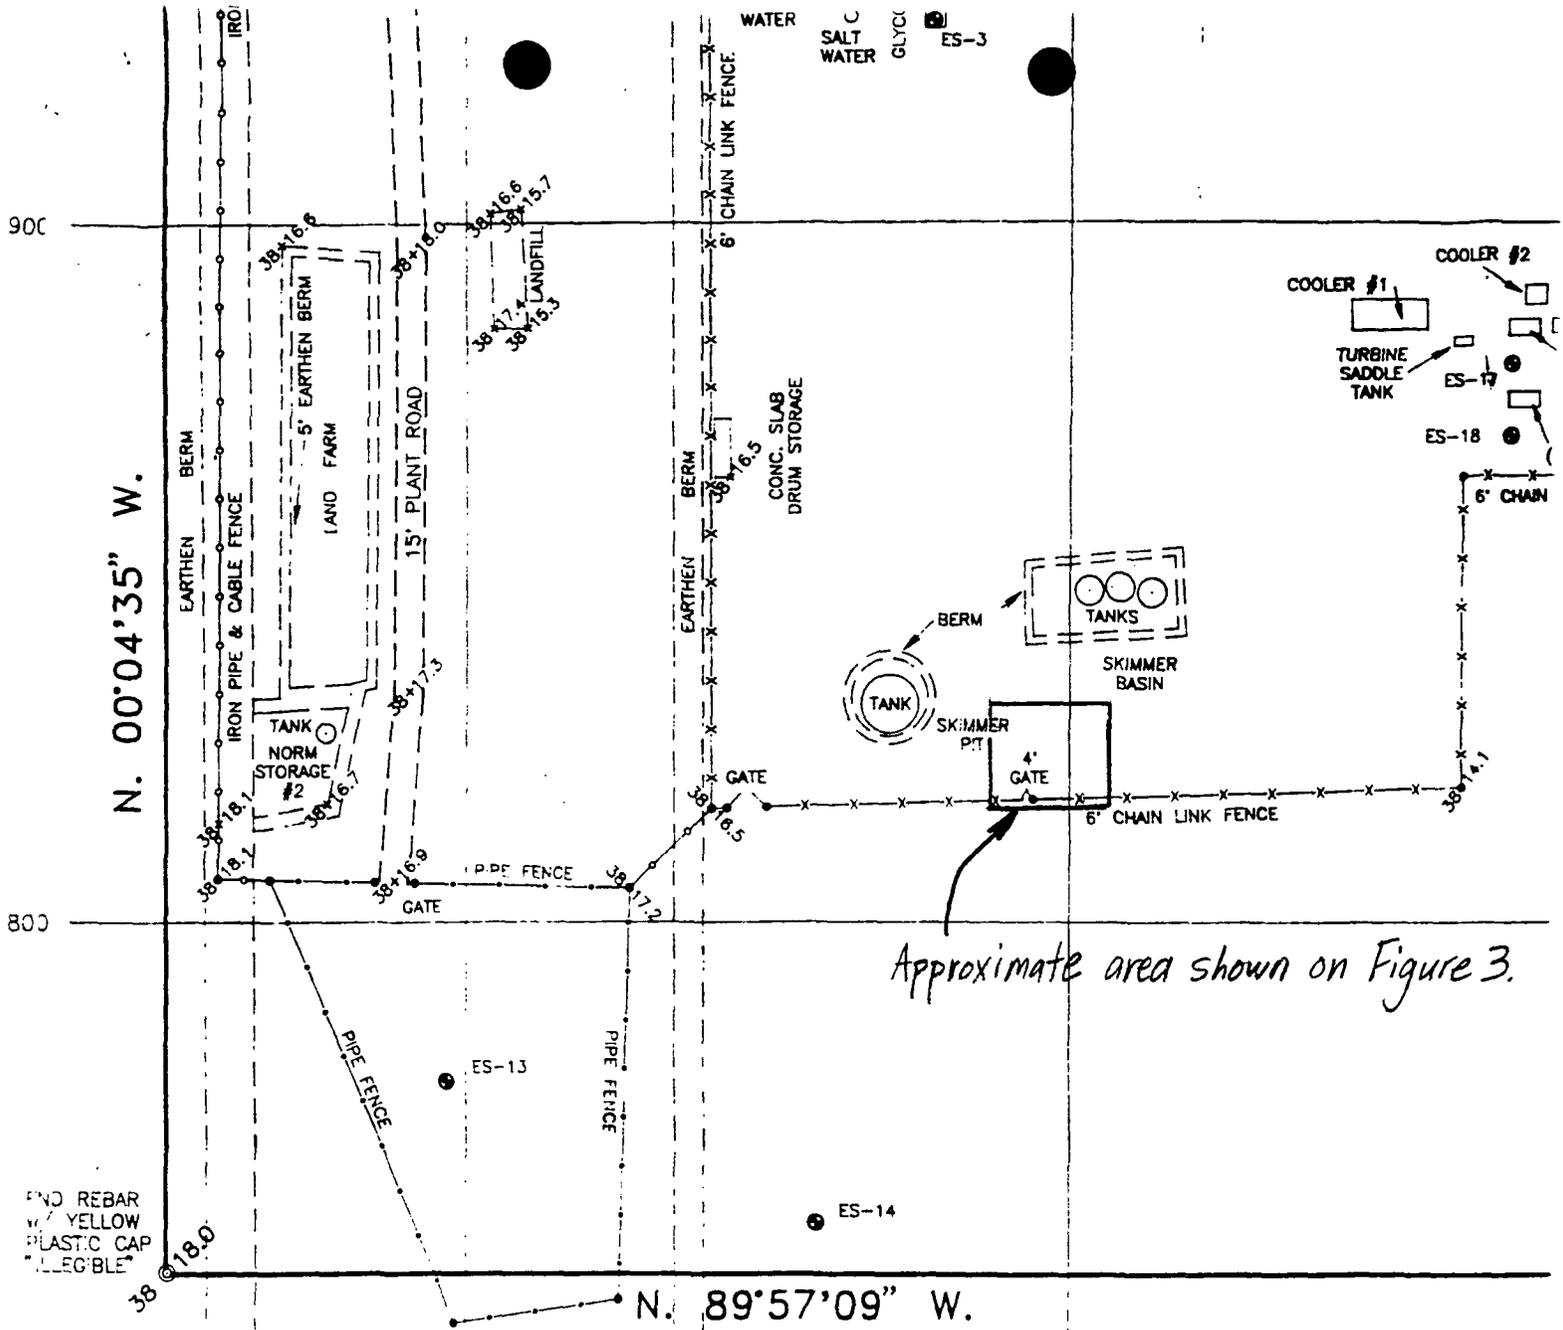
Figure 2
 Southwest part of Indian
 Basin Gas Plant
 1 inch = 100 feet

The Line #1 leak was discovered on the afternoon of July 13 by a plant operator on routine rounds. A wet area was observed above Line #1 at the southern plant area approximately 80 feet west of the inlet separators (Figure 2). Marathon immediately took steps to shut in and blow down Line #1. One high pressure dry gas pipeline is buried beneath Line #1 and presented a safety hazard during the excavation to repair Line #1. Marathon shut in and blew down this dry gas pipeline. Shovels and a backhoe were then used to excavate around the pipelines to expose the problem area. A corroded dresser coupling connecting two lengths of polyvinyl chloride (PVC) piping was leaking from one 1/8-inch hole. This faulty coupling was replaced with a section of poly pipe and the excavation was backfilled.

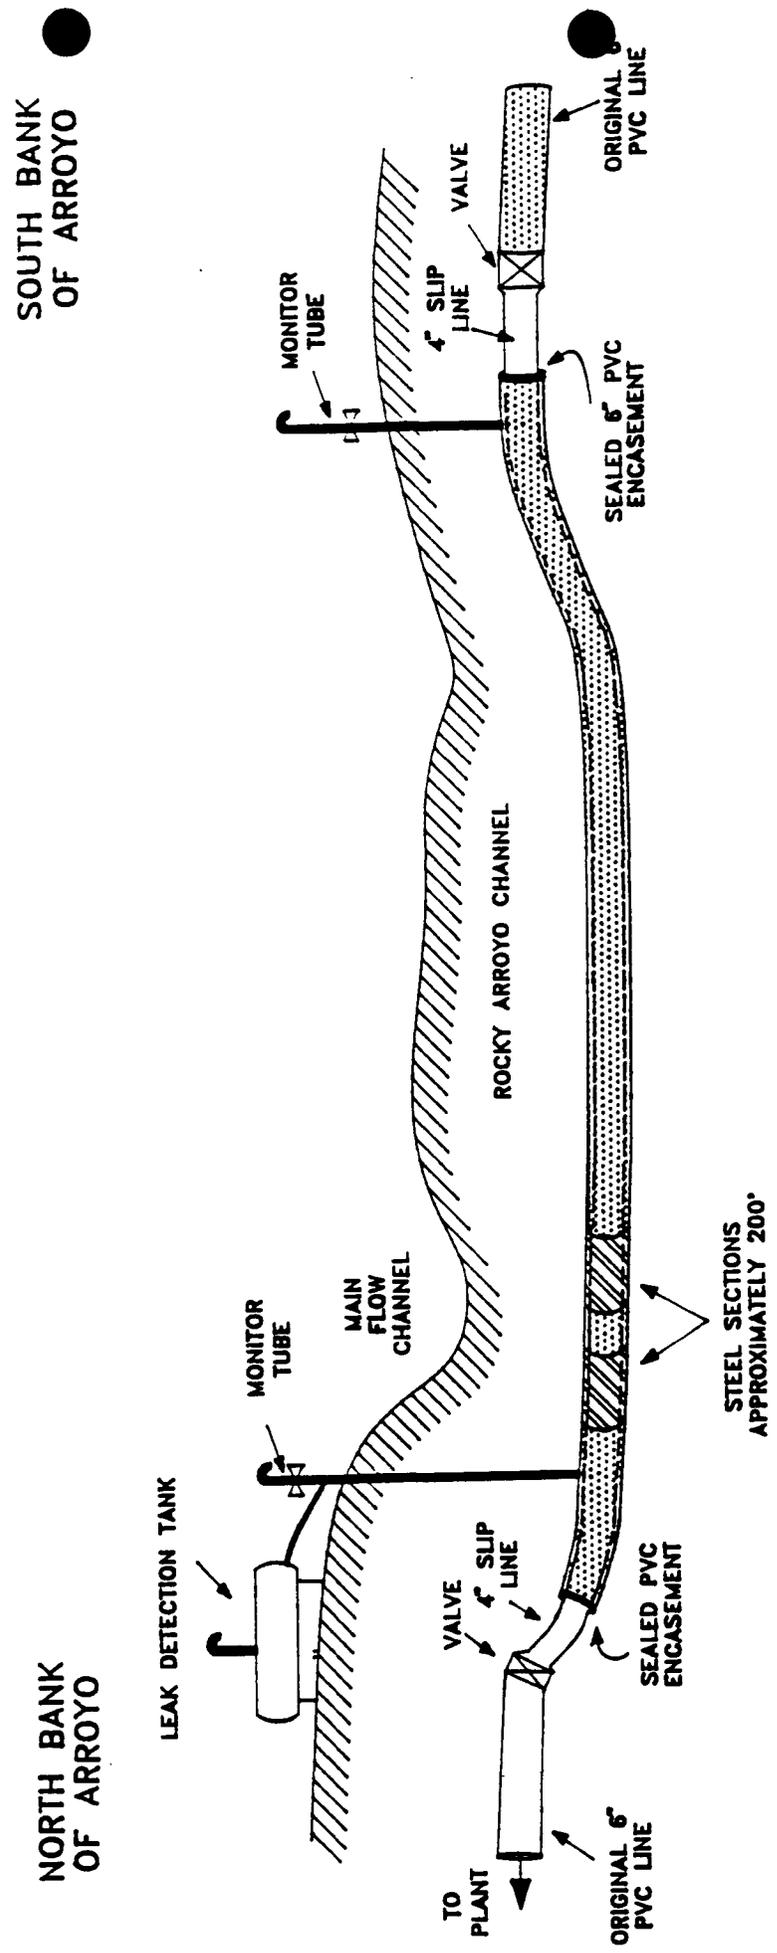
SCHEMATIC OF CONDENSATE LINE #4 MODIFICATION

NOTE: 4" PEP SLIP LINE GOES FROM NORTH BANK OF ARROYO TO SOUTH BANK (APPROXIMATELY 1700')

The existing 6" PVC and steel condensate line across Rocky Arroyo was removed from service and a 4" polyethylene pipe (PEP) was sliplined into the 6" line across the arroyo. In this manner the 6" line will act as a containment casing for the 4" PEP; the steel providing structural integrity while the fluids travel in the corrosion resistant plastic pipe. Valves were installed on each side of the arroyo to minimize drainage and thus reduce liquid volumes if a leak should occur. The pipe encasement was sealed using a double "Link Seal" and "Trenton Wax" combination at each end. A Link Seal was installed approximately 3' inside the pipe encasement on each end. Another Link Seal was installed at the edge of the pipe encasement on both ends. The void between the link seals was filled with Trenton Casing Filler. This ensures a liquid tight seal between the pipe encasement and the PEP slipline. Please refer to Exhibit #1.

To provide for early detection should a leak occur, a fiberglass tank with a 3/4" stainless steel line was installed to the 2" casing vent. This will allow gas plant personnel to determine if the 4" PEP slipline is leaking. The 6" encasement would capture any escaped condensate and evidence of condensate would appear in the fiberglass tank from the casing vent. Maintenance personnel will periodically check the tank for condensate liquid and/or fumes. The 6" encasement is constructed with 2" vent pipes to the surface at each end of the arroyo. This, too, will be monitored for any escaping condensate fumes.
