Ameco Abrams L#1  
Photos

**Amoco Production  
Company**

ABRAMS GAS COM L WELL NO. 1  
SW/4 SW/4MSEC. 26-T29N-R10W  
SAN JUAN COUNTY

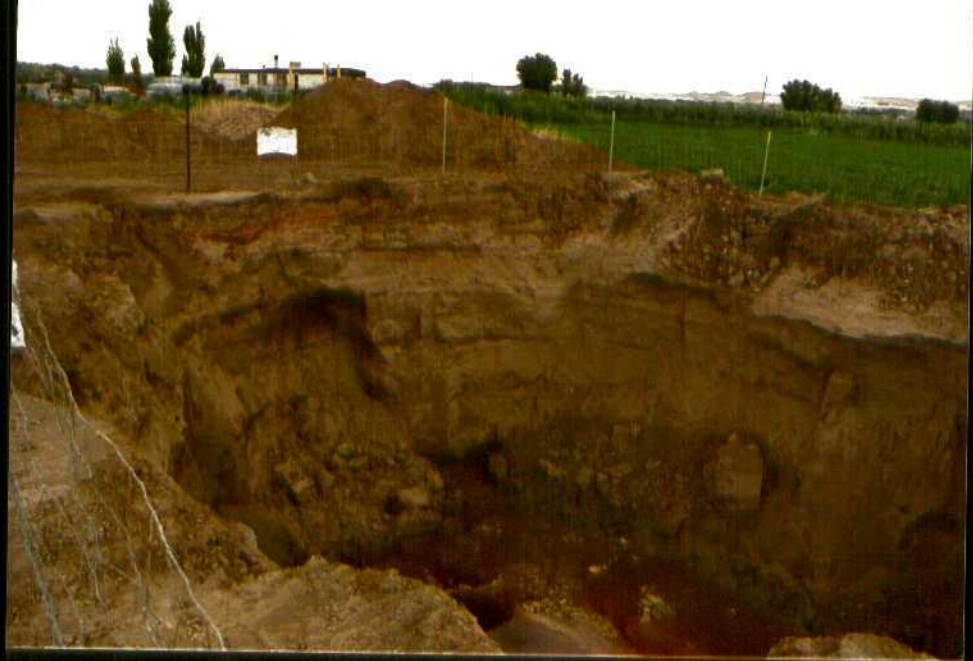
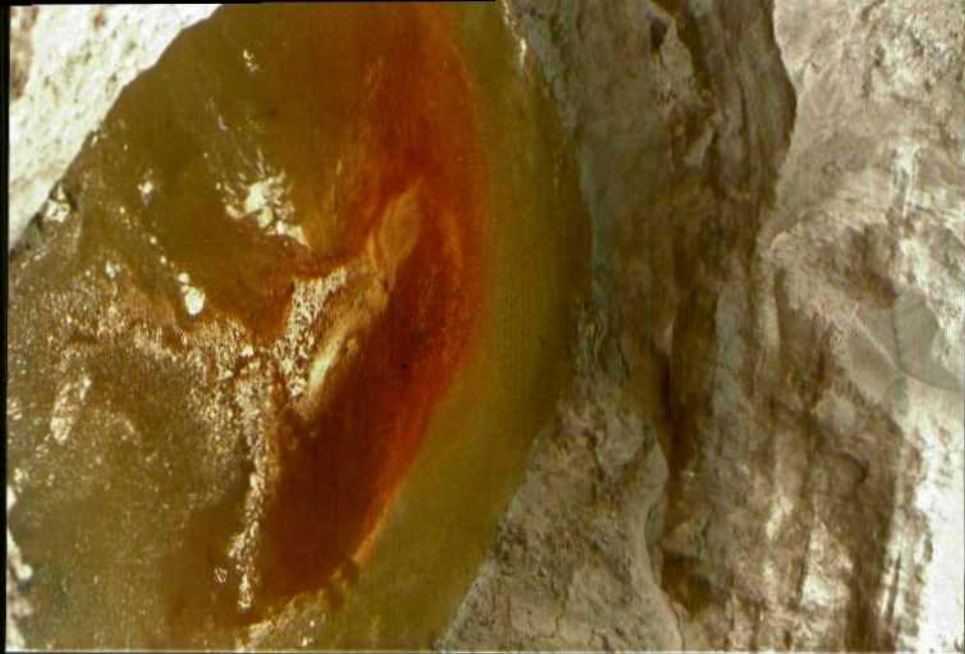
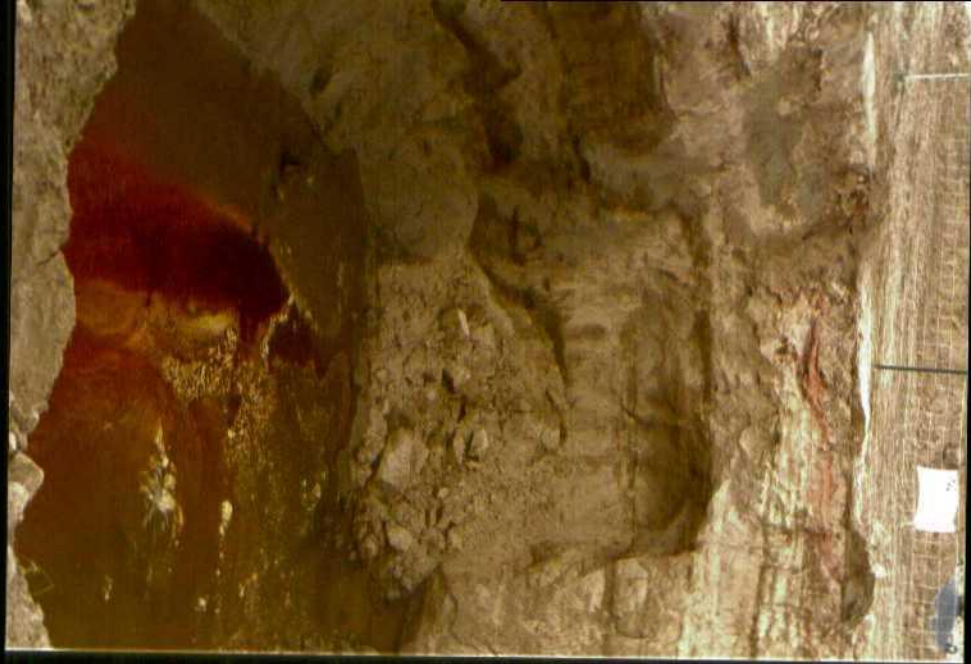
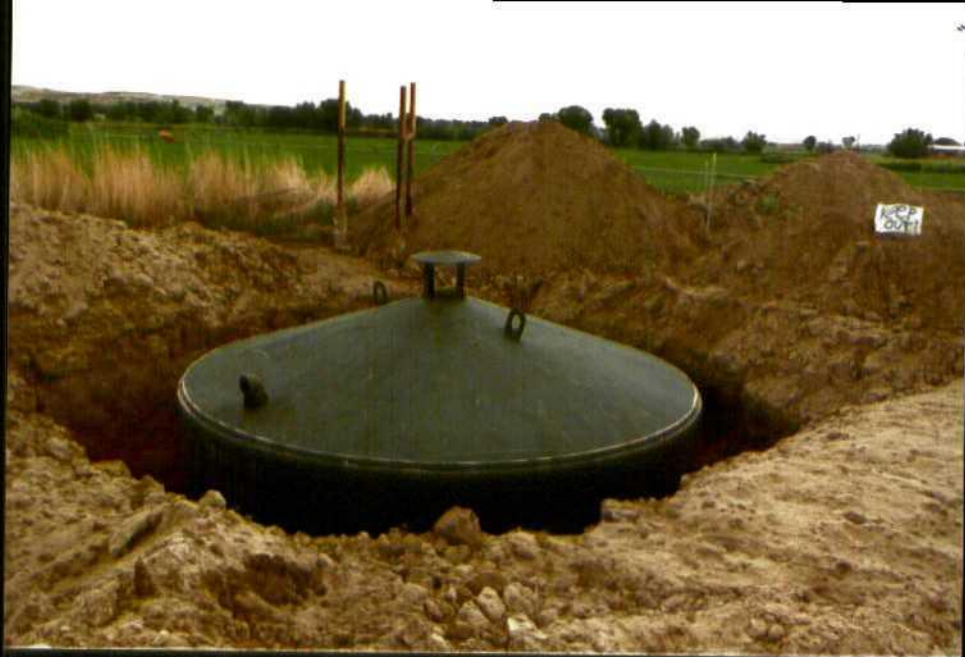
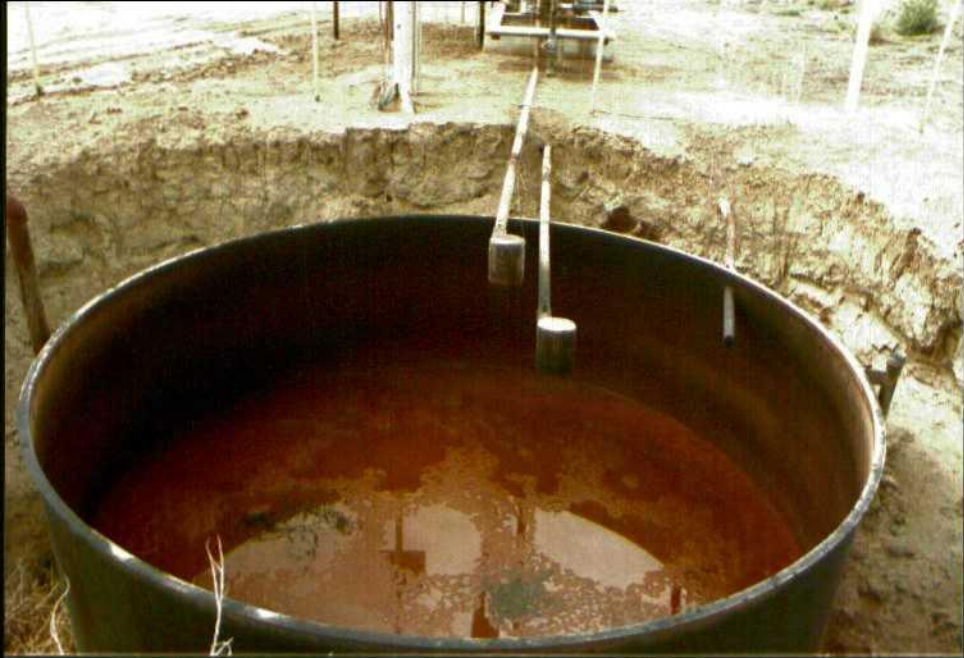
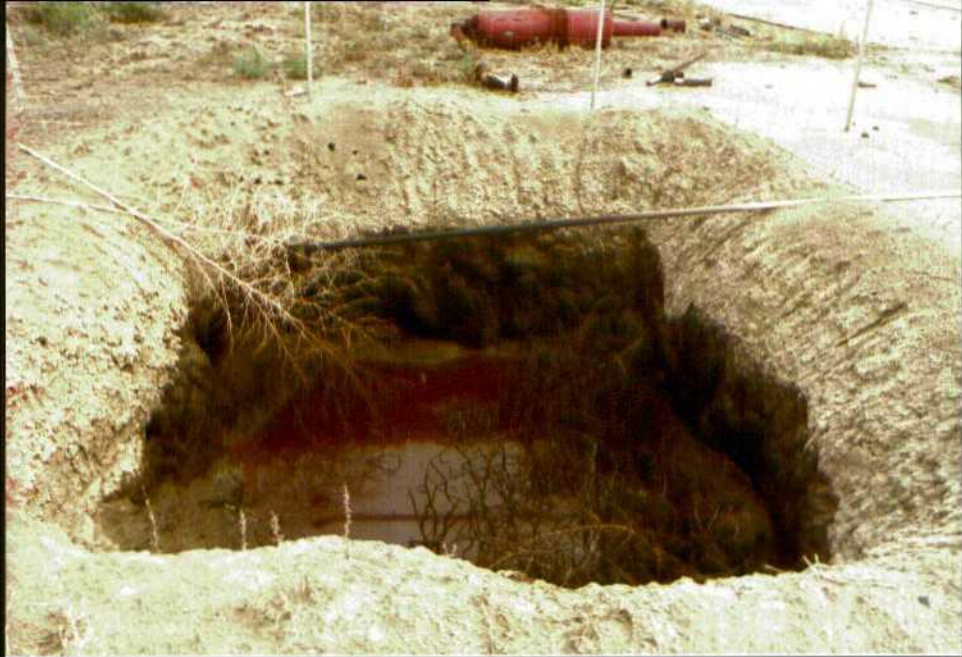
ABRAMS GC L#1 M-26-29-10 EAST OF  
~~WELL~~ OFFICE. NORTH SIDE OF ROAD  
TRYING TO RECLAIM PIT. DUG DOWN 18'.  
HIT H<sub>2</sub>O. FREE OIL ON H<sub>2</sub>O. INTEND  
TO FINISH DIGGING OUT. WILL DRILL 5  
INCHES DEEP. 1 NORTH TOWARD RIVER,  
1 NE, 1 W, 1 S + 1 E TOWARD HOMES. WILL  
GET SAMPLES FROM ALL WATER WALLS IN  
THE HOLE.

Leaking gate valve on tubing head - replace (??)  
difficult with pressure

Surface size of pit in question 25' X 30' approximately  
water covers bottom about 20' X 25'

NE<sup>1</sup>/<sub>4</sub> corner ~~empty~~ covered by yellow-brn paraffinic oil

Some oil globules floating on surface of the remainder  
of pit, globules are dispersed.

Dehydrator (?) pit example of the cause of  
problem. As about 2 bbls of fluid are in  
the earthen pit about 50% oil
