RE: 2002 Annual Groundwater Investigation and Remediation Reports
San Juan Basin, New Mexico

BURLINGTON RESOURCES 2002 ANNUAL GROUNDWATER REPORT

Maddox Com. 1A

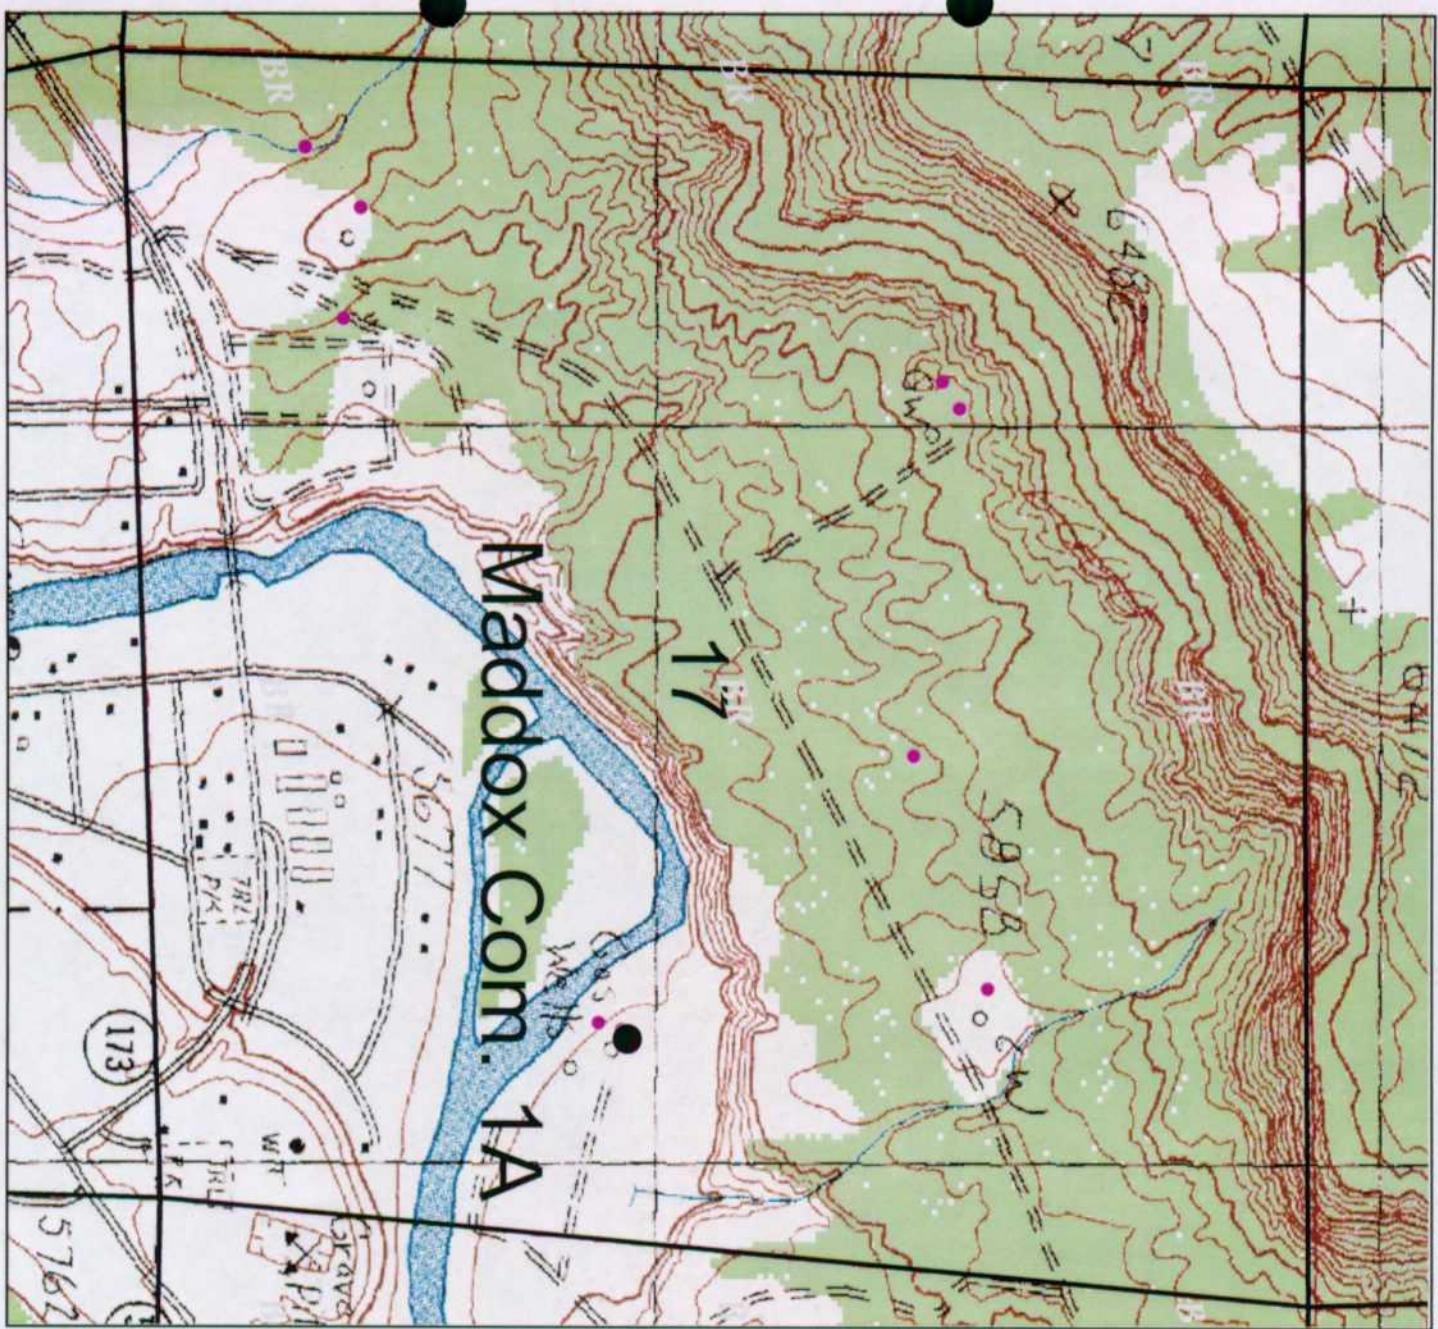
Attachments: Figure 1 - Site Map
Table 1 - Groundwater Sampling Results Summary
2001 Groundwater Analytical Results
Spill report, excavation log, and Drilling Log/Wellbore Diagrams

BR installed a source monitoring well (MW-1) in May 2000 within the area excavated and two downgradient wells MW-2 and MW-3 in January 2000. Groundwater data has been collected quarterly and is provided in Table 1 including laboratory reports. The source well was analyzed in the second quarter for a complete list of WCCC parameters incorrectly and a new analysis was performed in the forth quarter of 2000. A map of the site is included as Figure 1. A new laboratory, ACZ Laboratories in Steamboat, Colorado, was added for analysis of samples starting in the fourth quarter.

- Burlington Resources proposes to stop quarterly ground water monitoring at this site and submit the location for closure. A separate request for closure will be submitted.
