**STAGE 1 & 2
REPORTS**

Re: Pipeline Assessment Report, Dynegy Midstream Services, L.P., NW/4, SW/4, Section 21, Township 19 South, Range 37 East, Lea County, New Mexico

DYNEGY MIDSTREAM SERVICES, L.P.
MONUMENT PIPELINE ASSESSMENT REPORT
PHOTOGRAPHS

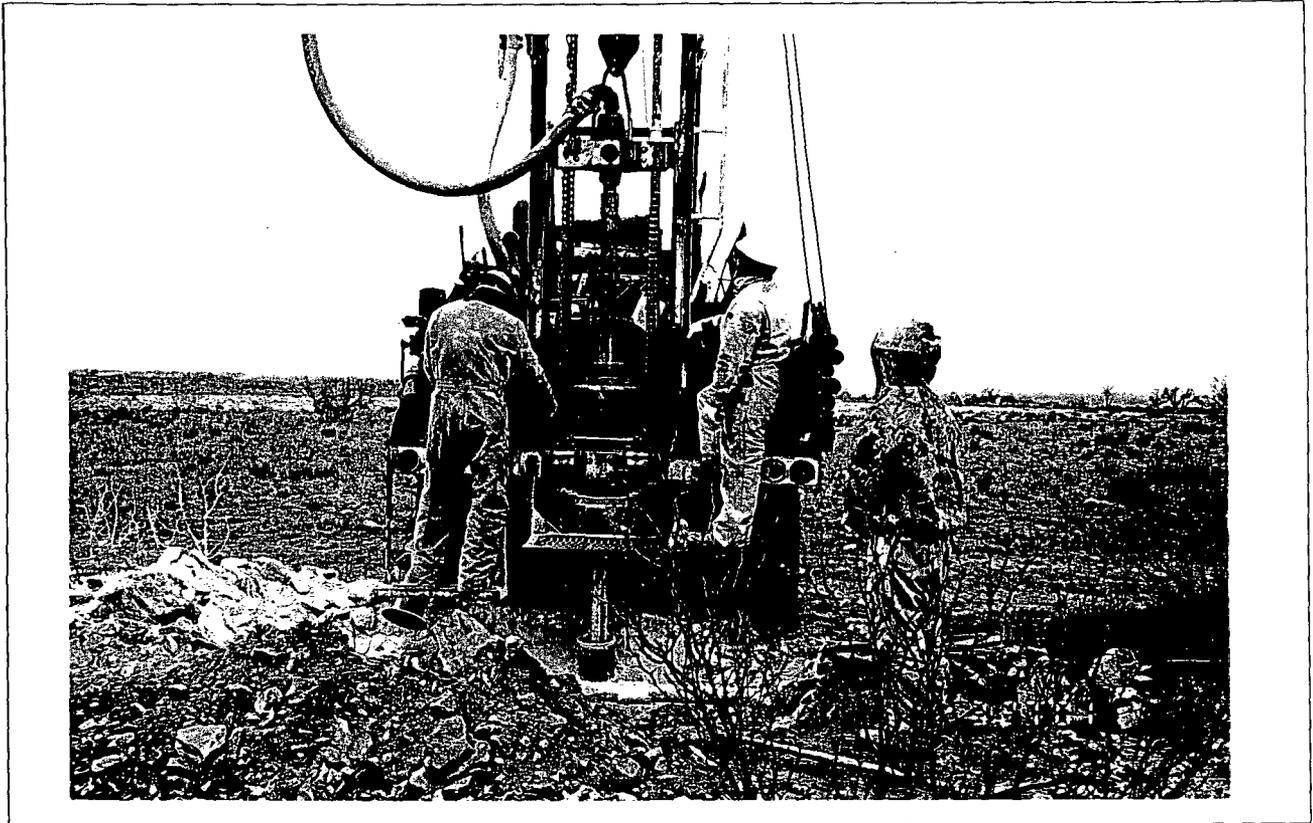
1. Boring BH-1

Nine (9) borings were drilled to assess potential leakage from approximately 1,300 linear-feet of pipeline on March 27, 2001. The borings were drilled by Scarborough Drilling, Inc., located in Lamesa, Texas. Boring BH-1 was drilled to approximately 21 feet BGS at the location of a non-reportable spill to assess the vertical

Referring to Table 1, benzene was not reported above the test method detection limit of 0.025 milligrams per kilogram (mg/kg) in samples 1 to 2 feet and 5 to 6 feet from boring BH-1. The concentration of total BTEX in the sample from boring BH-1, 1 to 2 feet BGS was 1.501 mg/kg. No BTEX compounds were detected in the sample from boring BH-1, 5 to 6 feet. The concentration of total BTEX was well below the RRAL (50 mg/kg). The only detectable concentration of TPH was in the sample from boring BH-1, 1 to 2 feet (555 mg/kg). The TPH concentration was well below the RRAL (1,000 mg/kg). No TPH was reported in the remaining samples.

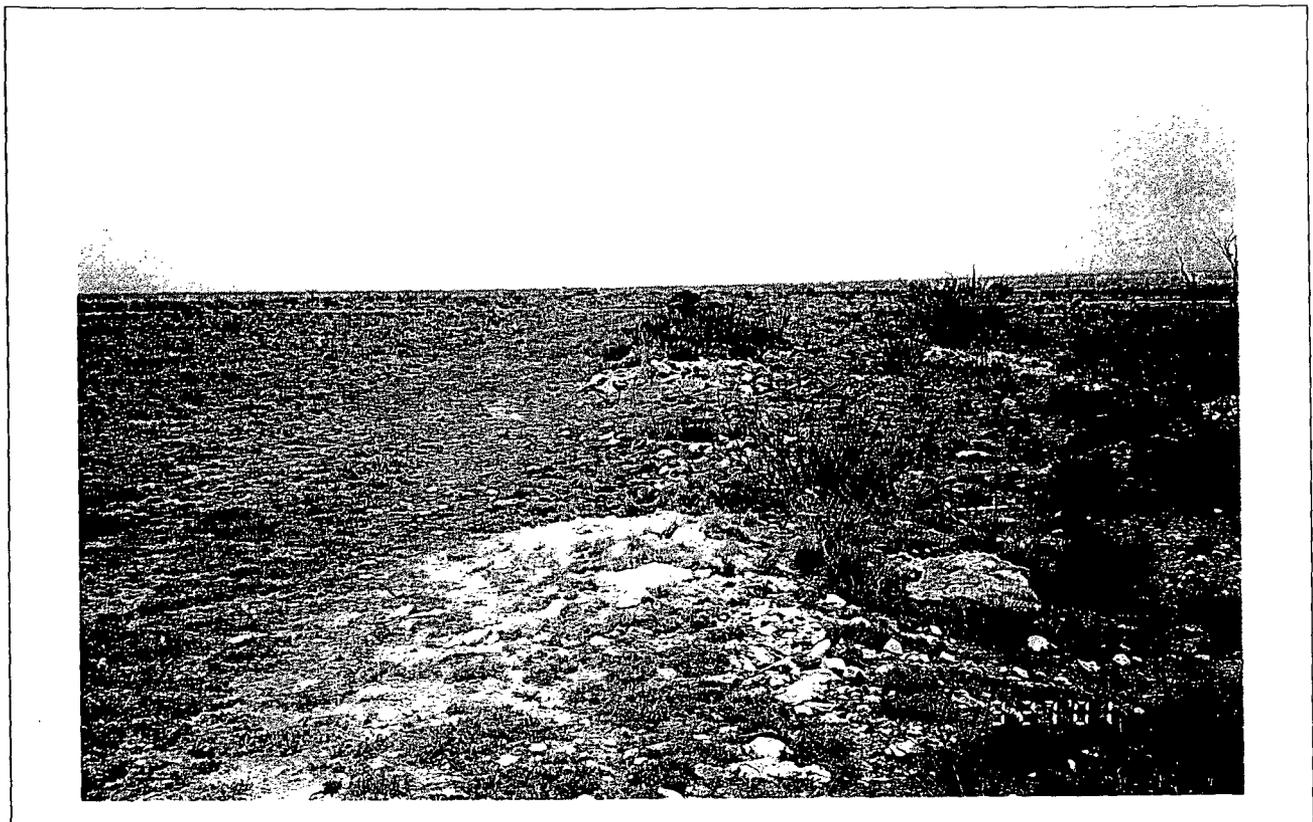
2. Pipeline Right-of-Way (Looking West from Boring BH-7)

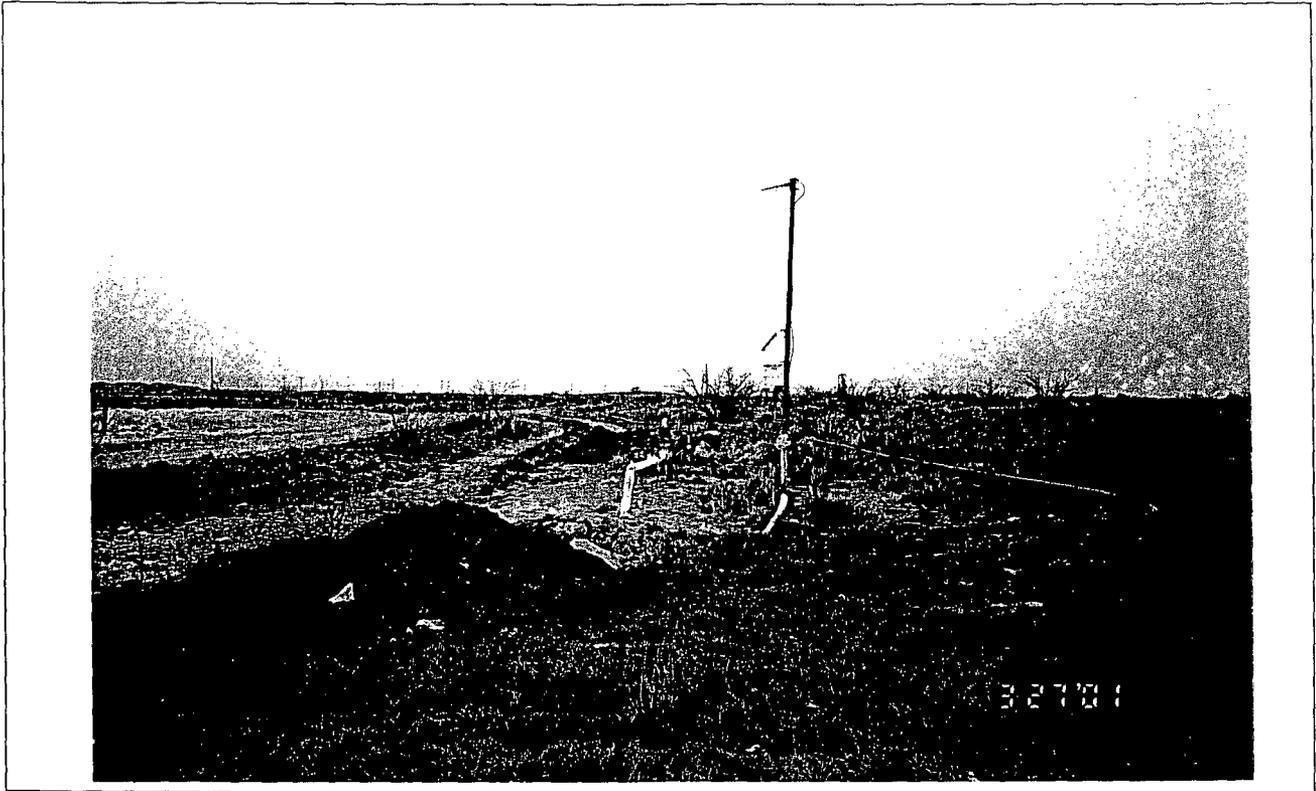
3. Borings BH-9 (Foreground) and BH-8 (Background)

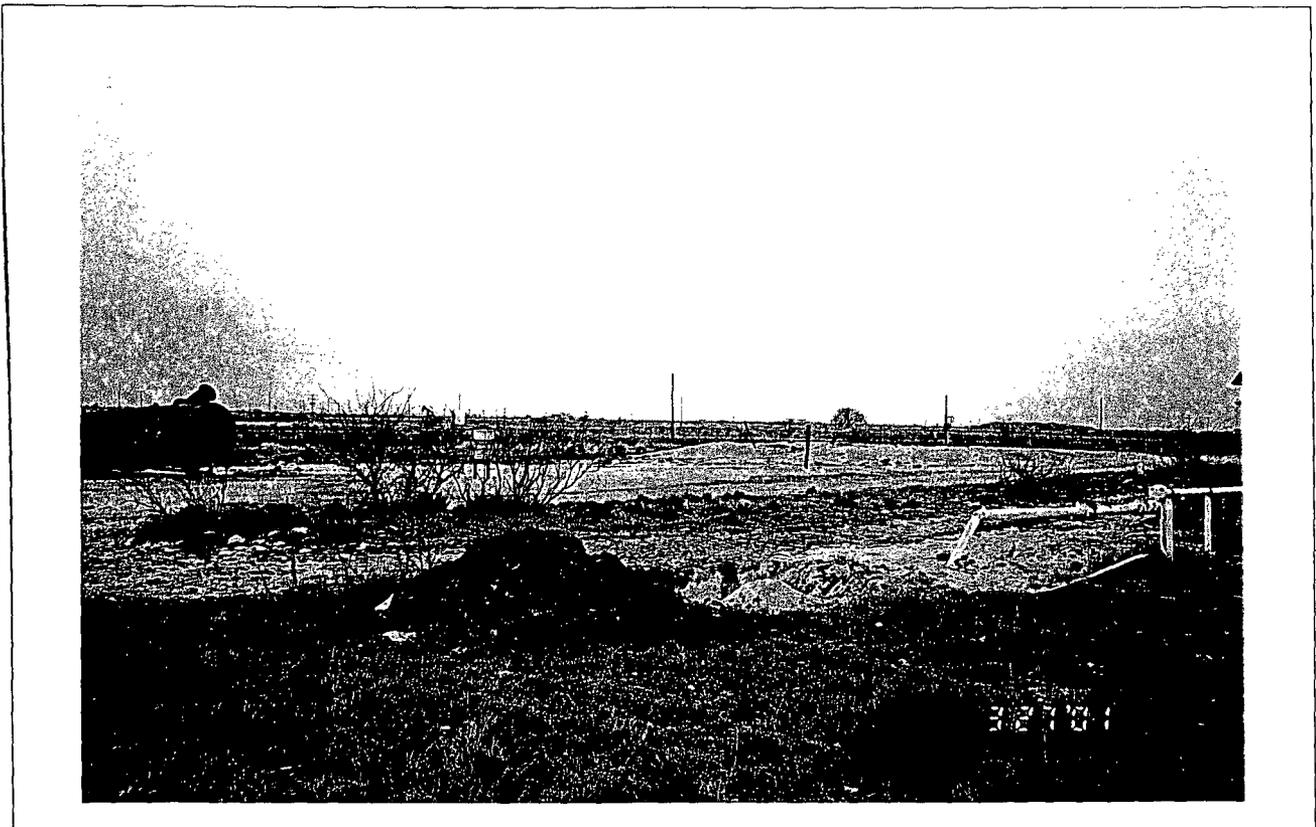
4. Boring BH-9 and Abandoned Tank Battery Location (Looking Southwest)
