Incident ID	NRM2008631179
District RP	
Facility ID	
Application ID

Release Notification

Site Name: PROXY WCA STATE COM 1H	Site Type: Oil Well
Date Release Discovered: 3/13/2020	API# (if applicable) 30-025-43922

Date: 3/12/2020 ~6:00 PM MDT
Location: Proxy WCA State Com No. 1H
Incident: Spill Inside Containment – Water (Est 150 bbl)

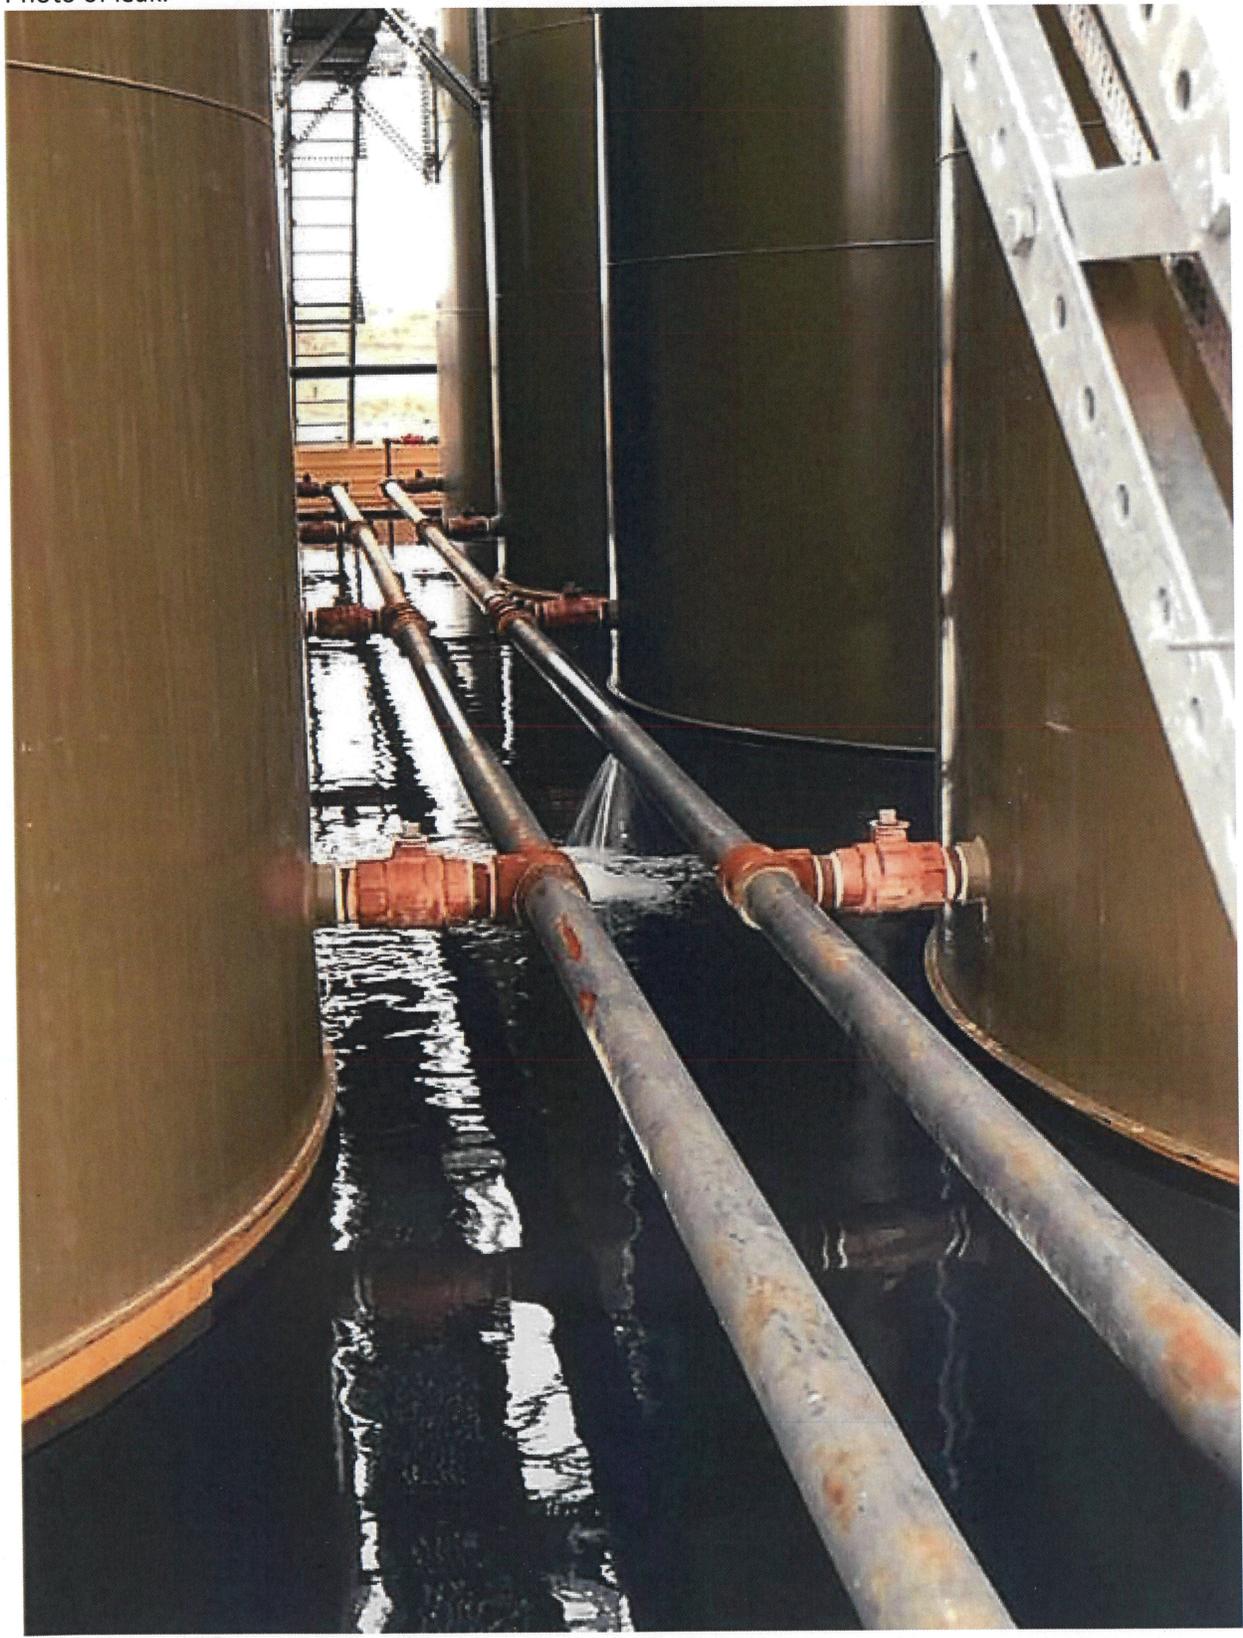
Photo of leak:

At 6:25 PM on 3/12/20, oil hauler Anthony Trantham (phone number 505-205-6276) with Sunoco notified Franklin Mountain Energy employee, Mark Hinaman, via text message of an observed and active water leak on the equalization and disposal line between water tanks 1 and 2. Trantham sent the below photo. Hinaman immediately forwarded the photo, Trantham's phone number, and notification of the leak to contract lease operator, Willie Dean. Dean contracted Trantham directly and requested Trantham safely close all four ball valves from each of the water tanks to the equalization and disposal line. Dean also requested he turn off the SWD pump. Hinaman followed up with Trantham after ball valves were closed and confirmed major flow had ceased. Based on dimensions of containment, tanks, and estimated height of water, it's estimated ~150 bbl of produced water was released into secondary containment. There was no impact to surface or groundwater, spill was fully contained within secondary containment.

Design flaw in process piping. Piping not internally coated and consequently corroded when exposed to corrosive liquids (produced water).

Line isolated from additional produced water until contract pumper can access location. Contract pumper to remediate hole with hose clamp for short term solution (<7 days). Long term solution will be to replace process piping with internally coated pipe to prevent additional leaks.
