NM1 - 30

**RE: Surface Waste Management Facility Inspection Report: Permit NM-01-0030
Artesia Aeration L.L.C.
N/2 of Section 7, Township 17 South, Range 32 East, NMPM,
Lea County, New Mexico**

ATTACHMENT 1
INSPECTION REPORT
PERMIT NM-01-0030
ARTESIA AERATION L.L.C
N/2 of Section 7, Township 17 South, Range 32 East, NMPM
Lea County, New Mexico
(December 11, 2002)

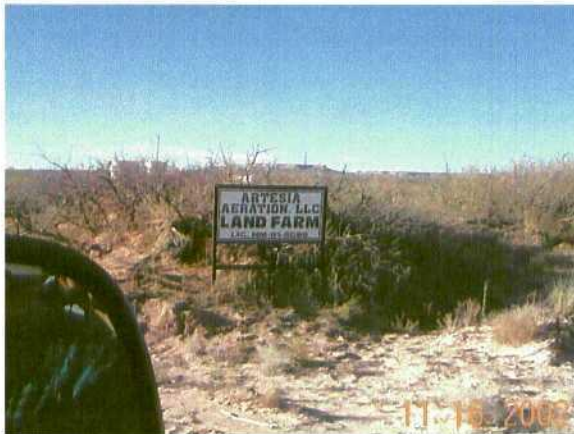
Facility is secured with fence and locking gate. The sign contains the name of the facility and NMOC D permit number. However, the sign does not contain the legal location and an emergency phone number (see Photo 1).

Photo 1. Sign at entrance with name and permit number but missing legal description and emergency phone number.

Artesia Aeration shall provide OCD with a detailed description of how the corrections will be made and a timetable of when each of the corrections will be completed. Artesia Aeration must respond to the permit deficiencies by January 21, 2003. The current financial assurance held by the OCD is in the amount of \$71,710.

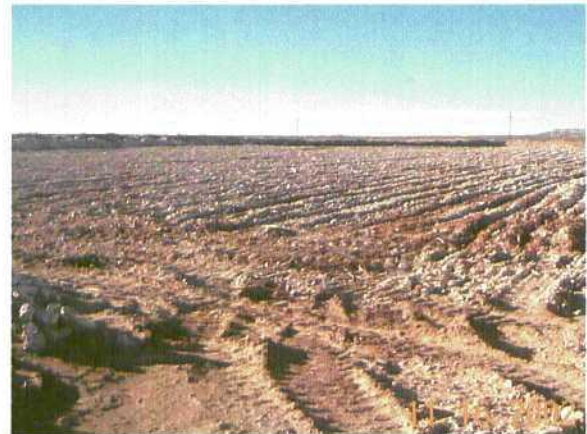
The soils have been disked and records were reviewed regarding maintenance and inspections (see photo 2, 3, and 4).

Photo 4. Cell tilled.

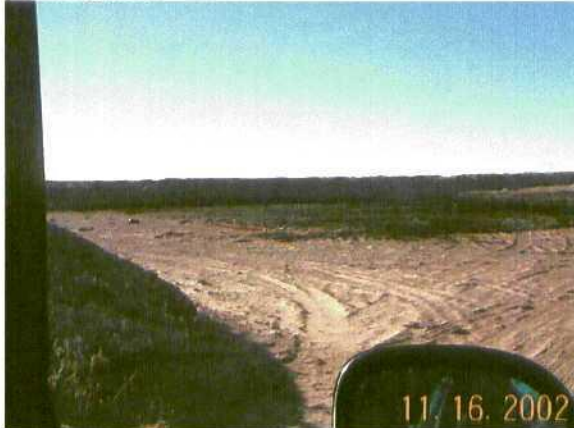
The facility was free of all plastic, however, there was one smashed container in Cell 1 (see photo 2).

Photo 2. Cell 1 contaminated soils are tilled. Cell has one piece of trash (squashed container).

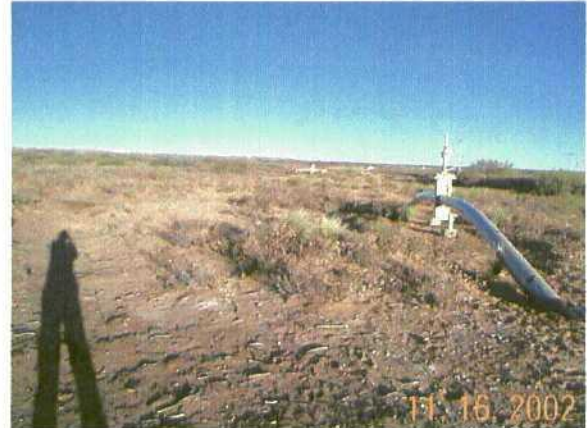
According to the facility survey map for the site there are pipelines bordering the facility on three sides. During this inspection the OCD facility personnel walked out a leak or spill of unknown volume along the south boundary of the facility. The spill was originally found by Artesia Aeration personnel during the fencing of the facility. The spill extends from the currently owned Navajo Pipeline to the north and south extending onto the landfarm property. The spill also in some places wraps up on top of the dunes some 2 to 2.5 feet above the base of the dunes where the flow tracked. According to the topographic map the gradient is to the south-southwest with a slope of approximately 50 feet to the mile (1'/105') (see photos 5, 6, 7, 8, 9, 10, 11 and 12)

Photo 5. Pipeline ride-of-way west of the landfarm facility. Contaminated soil found in the pipeline ride-of-way.

The portion of the landfarm containing the contaminated soil is currently not constructed. When the cells are to be constructed in this portion of the landfarm the facility must have at a minimum a 20-foot set back from the existing contaminated soil. If any additional contaminated soil is found during the construction of cells Artesia Aeration must notify the OCD Santa Fe and Hobbs District office in writing.

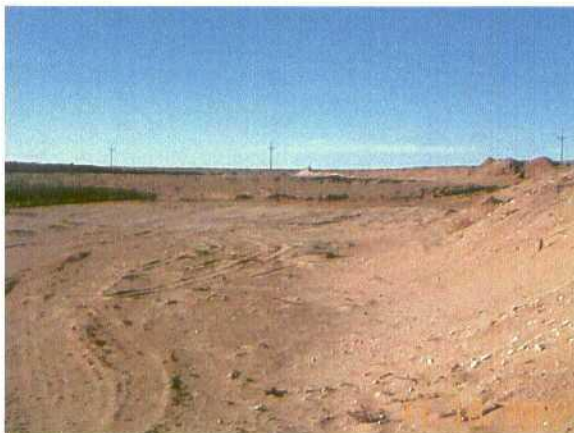
Photo 3. Cell construction. Pile in the back right corner is clean fill.

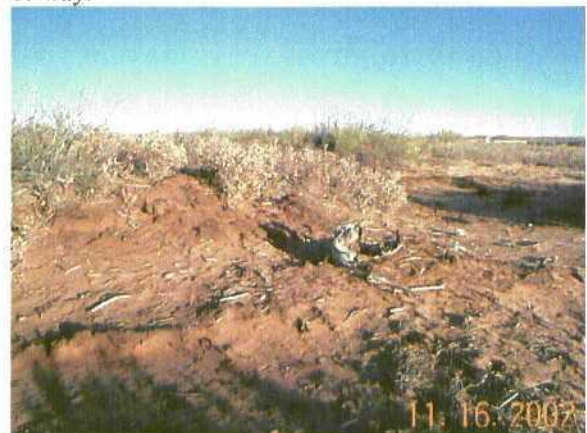
Photo 6. Contaminated soil near the pipeline ride-of-way was in the bottom of the dune field and on the sides of the sand dunes.

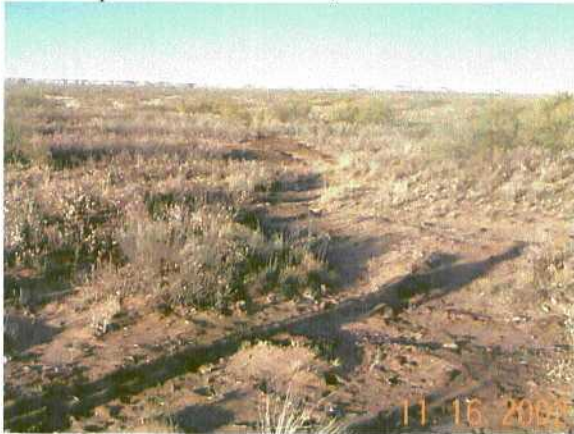
Photo 7. Contaminated soil follows pathway through the dunes.

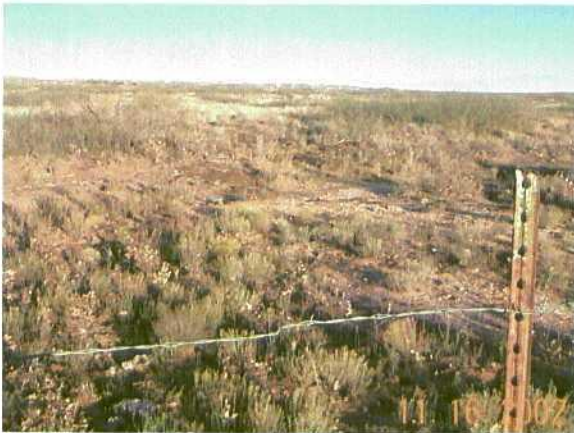
Photo 8. Contaminated soil tracked on the surface from the pipeline right-of-way across the Artesia Aeration fence line.

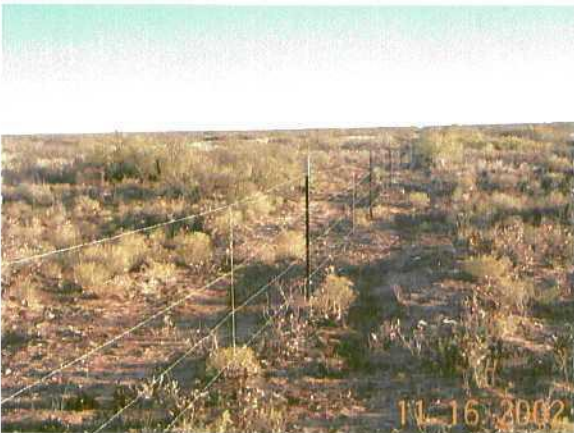
Photo 9. Hydrocarbon contaminated soils extend from the pipeline area to the Artesia Aeration south fence line approximately 300+ feet. Photo was taken from outside the Artesia Aeration fence line.

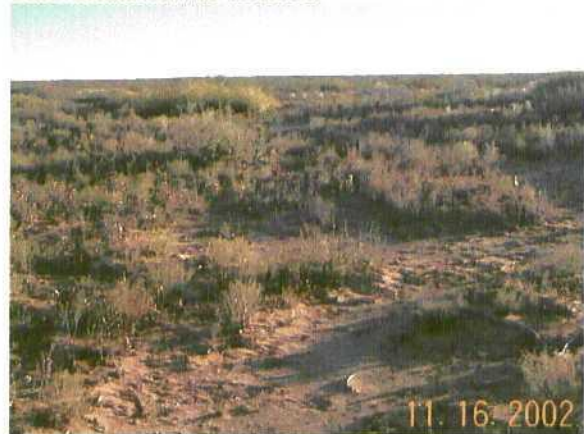
Photo 10. Release of hydrocarbons followed a depression between the dunes 40 to 50 feet west of the pipeline.

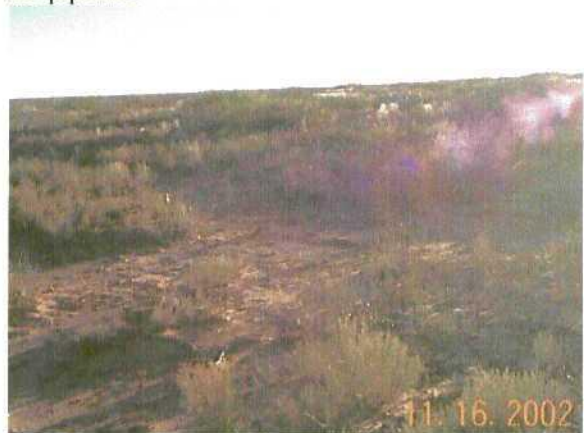
Photo 11. Hydrocarbon contaminated soils tracked to the east. Photo taken to the southwest.

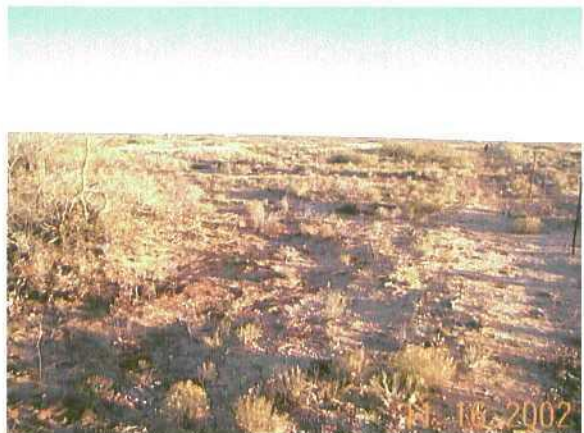
Photo 12. Hydrocarbon contaminated soils extend from the pipeline to the Artesia Aeration south fence line. Photo was taken from inside Artesia Aeration fence line.

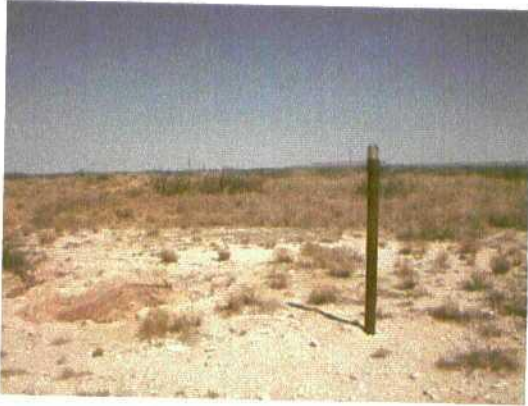
Photo 1 04-14-00
Looking North at test well.

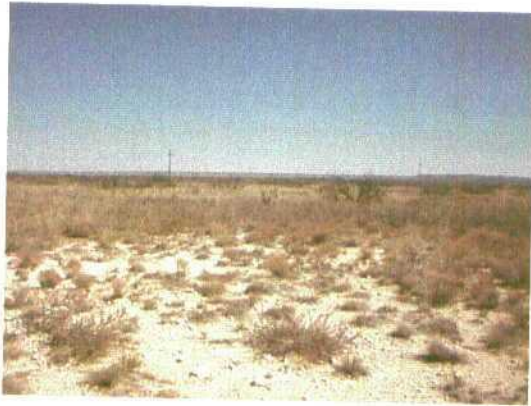
Photo 2 04-14-00
Looking Northeast at test well.

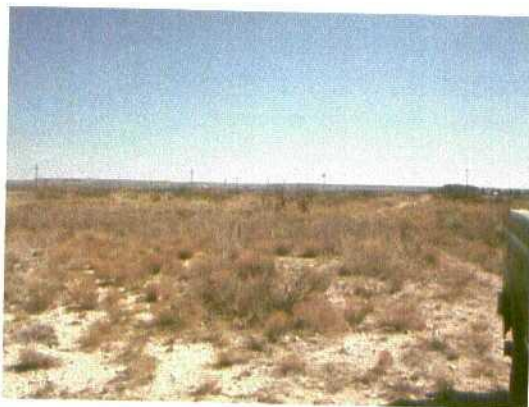
Photo 3 04-14-00
Looking East at test well.
