HUNGRY HORSE, LLC
ENVIRONMENTAL SERVICES

To: Mike Bratcher, NM OCD Dist II
Reference: Remediation Work Plan
Operator: Alamo Permian Resources, LLC
Location: West Area Grayburg Unit Battery
API: 30-015-02649 (WAGU #12)
Legals: SW1/4, Sec. 8, T18S, R28E
GPS: N32.7590 W-104.2011

Release Notification and Corrective Action

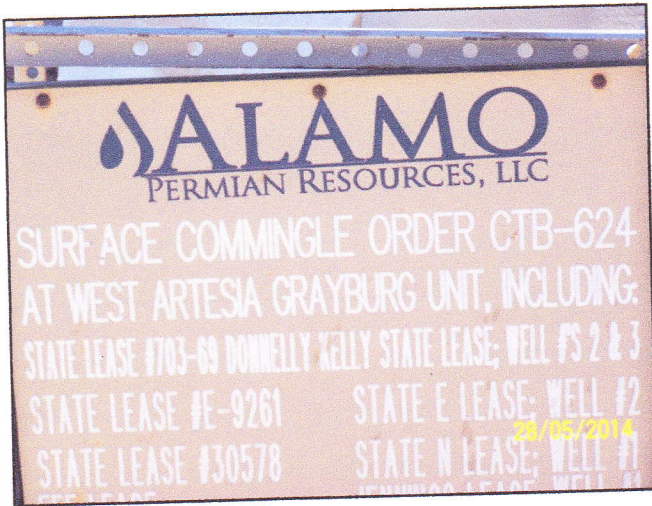
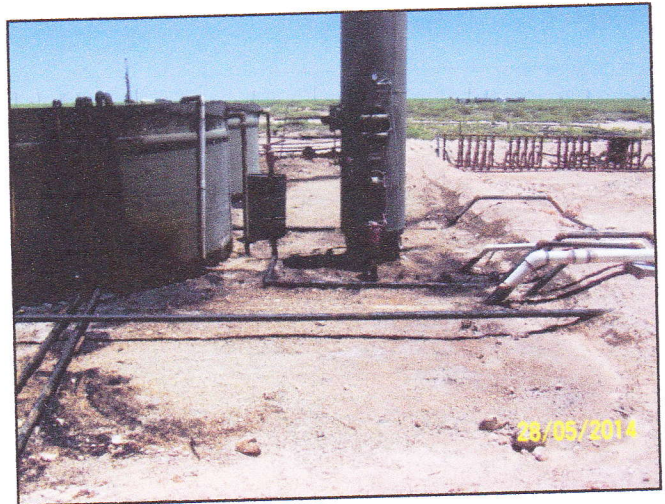
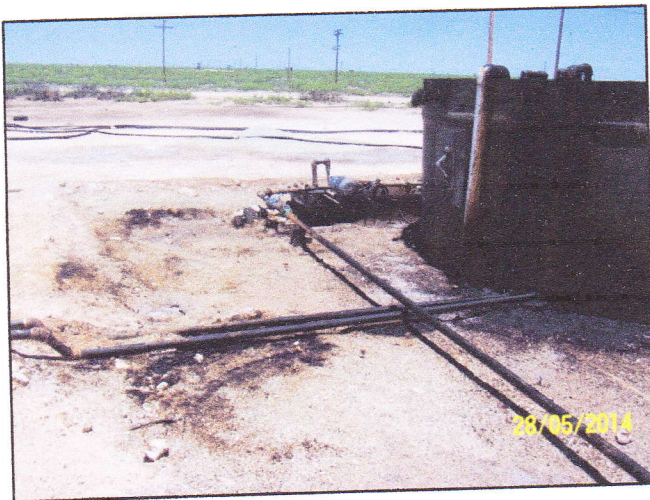
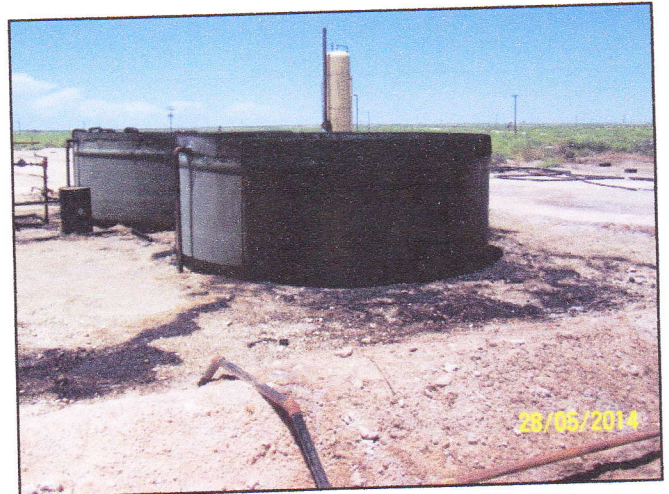
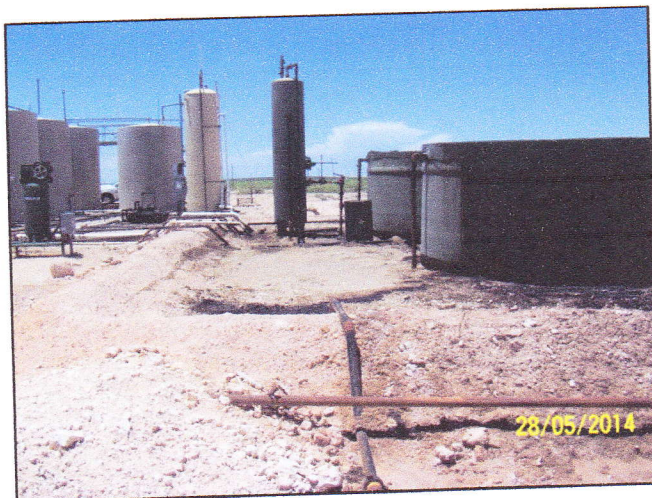
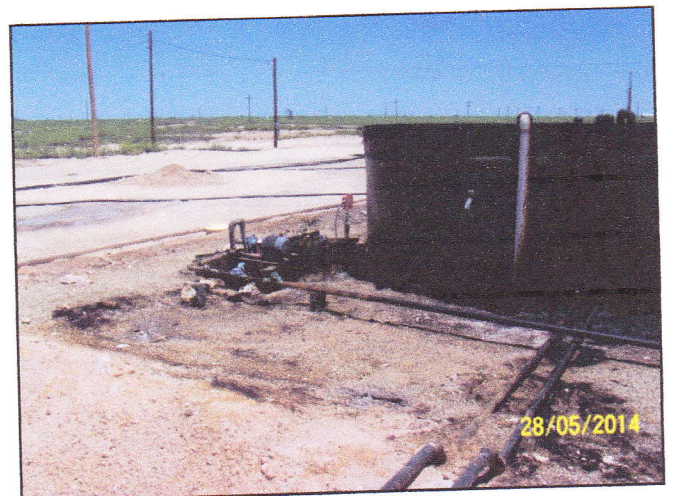
Alamo Permian Resources- WAGU

The impacted area is part of a surface commingle system. There are various tanks, vessels, and piping systems located throughout the system. The impacted area is a bermed tank containment that contains two open top tanks with associated pump and piping. This is a working site and the tanks are still in service.

Upon discovery of the release, a vacuum truck was dispatched and recovered all free standing liquid. The release was contained inside the fire walls except for a small amount that ran off the north wall. A small amount of caliche was spread on top of the release inside the walls to aid in absorption of the saturated soil.

The impacted area inside the fire walls is a congested area consisting the two open top tanks, a pump, valves, and piping on all four sides (see attached photos). Due to the congestion and a possible safety hazard of conducting extensive excavation in and around the tanks/equipment, I propose to hand excavate and remove 1' of material from inside the firewalls and replace the material with fresh soil with the stipulation that a full and complete remediation be conducted when this system is removed from service. Soil samples from each of the four corners will be collected upon removal of the 1' of material and lab analysis conducted for TPH, BTEX, and Chlorides. Lab results will be submitted as matter of record with the closing documents.
