Max Friess #1 (2RP-960)

Corrective Action Plan

Release Date: November 15th, 2011

**RE: Corrective Action Plan
Linn Energy – Linn Max Friess #1 (2RP-960)
UL/B sec. 30 T17S R31E
API No. 3001505459**

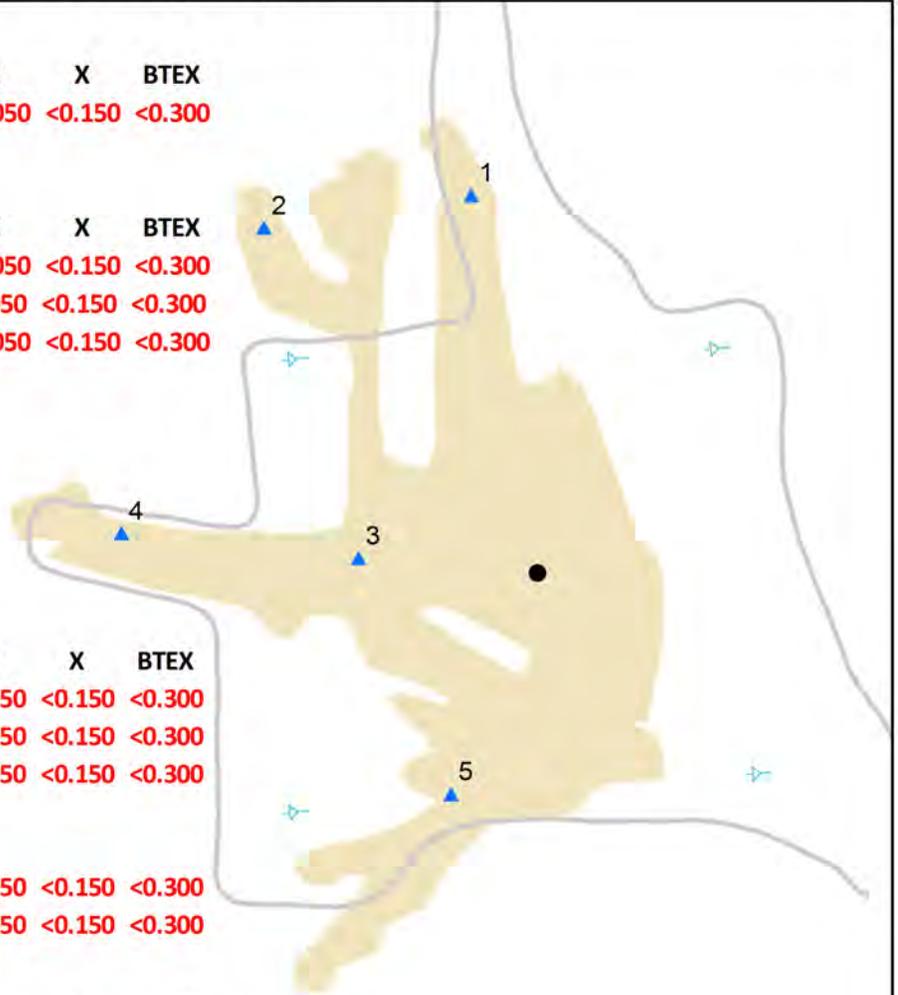
Figure 1

Initial Sampling Data

Point 1									
	Cl-	PID	GRO	DRO	B	T	E	X	BTEX
SS	384	1.6	<10	<10	<0.050	<0.050	<0.050	<0.150	<0.300

Point 2									
	Cl-	PID	GRO	DRO	B	T	E	X	BTEX
SS	208	3.5	<10	<10	<0.050	<0.050	<0.050	<0.150	<0.300
6"	144	4.4	<10	<10	<0.050	<0.050	<0.050	<0.150	<0.300
1'	880	29.1	<10	<10	<0.050	<0.050	<0.050	<0.150	<0.300

Point 3									
	Cl-	PID	GRO	DRO	B	T	E	X	BTEX
SS	3440	39.4	<10	<10	<0.050	<0.050	<0.050	<0.150	<0.300
6"	3000	31.6	<10	27.5	<0.050	<0.050	<0.050	<0.150	<0.300
1'	1880	77	<10	32.8	<0.050	<0.050	<0.050	<0.150	<0.300
1.5'	845	0.6							
2'	526	0.6							
2.5'	320	0.6	<10	<10	<0.050	<0.050	<0.050	<0.150	<0.300
3'	272	0.3	<10	57	<0.050	<0.050	<0.050	<0.150	<0.300

Point 4									
	Cl-	PID	GRO	DRO	B	T	E	X	BTEX
SS	256	0.2	<10	<10	<0.050	<0.050	<0.050	<0.150	<0.300
6"	96	0.1	<10	35.6	<0.050	<0.050	<0.050	<0.150	<0.300

Point 5									
	Cl-	PID	GRO	DRO	B	T	E	X	BTEX
SS	256	28.3	<10	<10	<0.050	<0.050	<0.050	<0.150	<0.300
6"	428	23.9							
1'	912	60.7	<10	<10	<0.050	<0.050	<0.050	<0.150	<0.300
1.5'	874	6.3							
2'	176	2.7	<10	<10	<0.050	<0.050	<0.050	<0.150	<0.300
