## Report Type: Work Plan

| Site: | Salada Vista 36 State #2 | | | | | |
| Company: | COG Operating LLC | | | | | |

**Re: Work Plan for the COG Operating LLC., Salada Vista 36 State #2, Unit D, Section 31, Township 19 South, Range 31 East, Eddy County, New Mexico.**

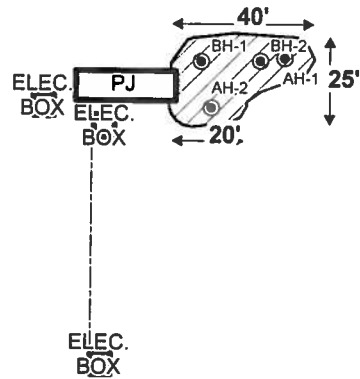
Figure 3

On January 21, 2014, Tetra Tech personnel inspected and sampled the spill area. Three (3) auger holes (AH-1, AH-2 and AH-3) were installed using a stainless steel hand auger to assess the impacted soils. Selected samples were analyzed for TPH analysis by EPA method 8015 modified, BTEX by EPA Method 8021B and chloride by EPA method 300.0. Copies of laboratory analysis and chain-of-custody documentation are included in Appendix C. The results of the sampling are summarized in Table 1. The auger hole locations are shown on Figure 3.

Referring to Table 1, none of the samples exceeded the TPH or BTEX RRAL's. Elevated chloride concentrations were detected in all auger holes (AH-1, AH-2 and AH-3), with chloride highs of 3,400 mg/kg at 9'-9.5', 2,540 mg/kg at 5'-5.5', and 1,140 mg/kg at 8'-8.5' below surface, respectively. The chloride impact in the area of AH-2 declined with depth at 7'-7.5' below surface and was vertically defined. The areas of auger holes (AH-1 and AH-3) were not vertically defined, with bottom auger holes samples at 9-9.5' of 3,400 mg/kg and 1,040 mg/kg, respectively. The area of AH-3 did not show a significant impact to subsurface soils from 0 to 4.0' below surface, but spiked in the deeper samples at 8-8.5' (1,140 mg/kg) and 9-9.5' (1,040 mg/kg).

PASTURE

OVERSPRAY  
(COG  
MICROBLAZED)

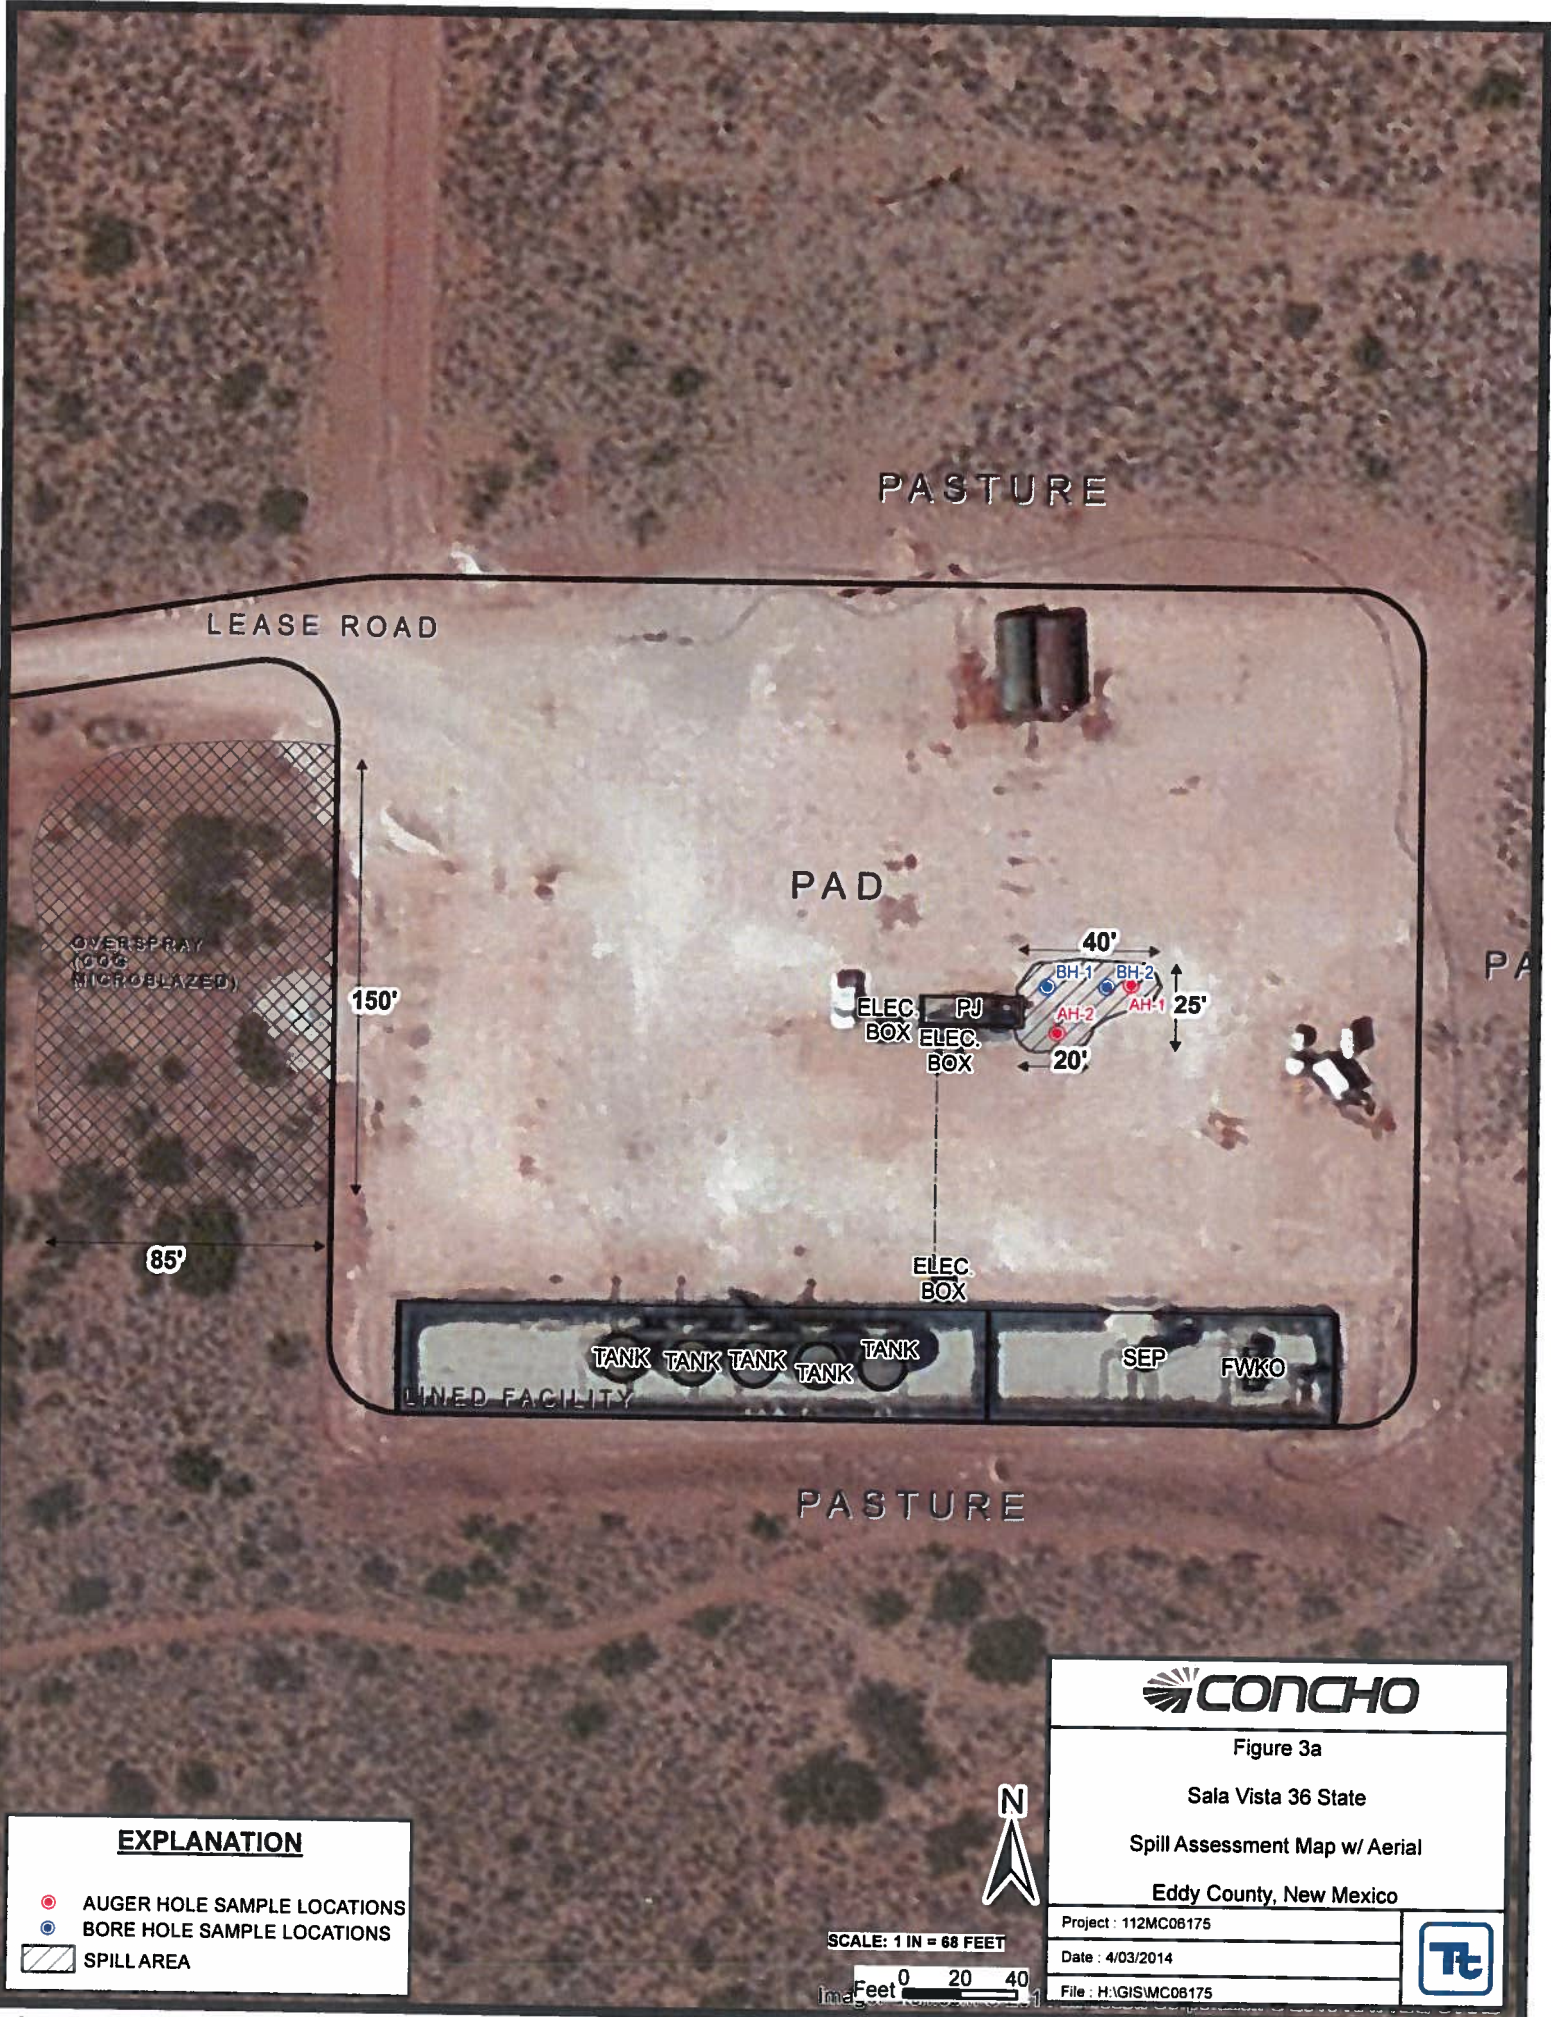
Figure 3a

On March 3, 2014, Tetra Tech personnel installed two (2) boreholes (BH-1 and BH-2) using a drilling rig to vertically define the chloride impact. The borehole locations are shown on Figure 3. The sampling results are summarized in Table 1. Copies of laboratory analysis and chain-of-custody documentation are included in Appendix C.

Boreholes BH-1 (AH-3) and BH-2 (AH-1) did show declining chloride concentrations with depth. BH-1 detected a chloride high of 2,470 mg/kg at 2'-3', which declined with depth 4-5' of 48 mg/kg, spiked at 6-7' to 1,080 mg/kg and declined to 671 mg/kg at 9-10' below surface. The BH-1 sampling data did not correlate with the sampling data encountered in area of AH-3. Borehole (BH-2) also showed declining chlorides with depth of 1,700 mg/kg at 9-10 and 160 mg/kg at 14-15' below surface.

COG proposes to remove impacted material as highlighted (green) in Table 1 and shown on Figure 4. The assessment data showed inconsistent chloride concentrations in the subsurface soil and appears to be from well activities performed on the well. The area of AH-3 (BH-1) did not show significant chloride impact to the soils and no excavation will be performed in this area.

Due to the proximity of the producing well, limited excavation will be performed in the areas of AH-1 (BH-2) and AH-2. The area will be excavated to approximately 3.0' to 4.0' below surface to remove majority of the chlorides, if accessible. In addition, these areas will be capped with a 40 mil liner or clay at 3.0' to 4.0' excavation bottom. Once excavated to the appropriate depths, the excavation will be backfilled with clean soil.

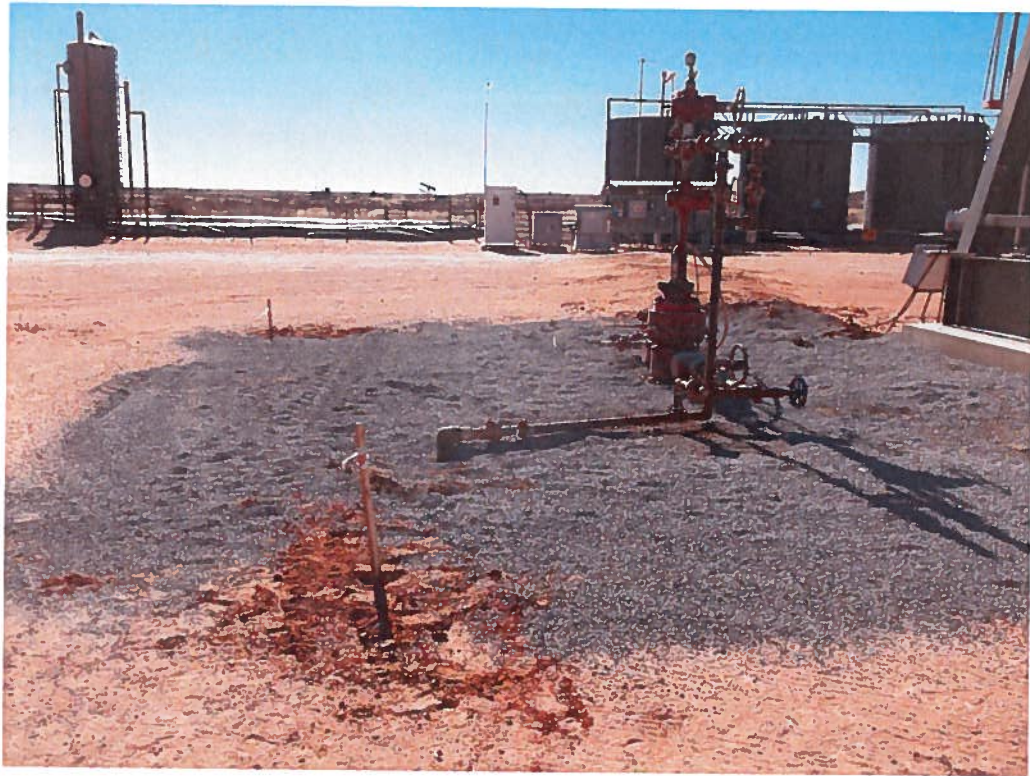
View South – Area of AH-1 and AH-2

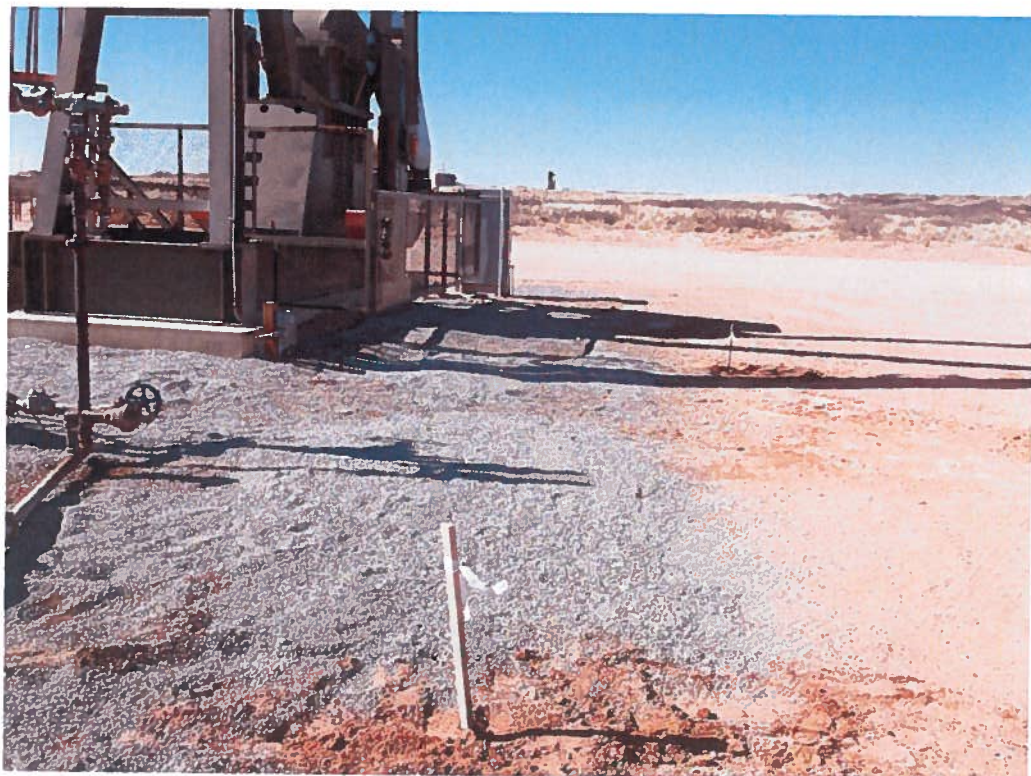
View West – Area of AH-1 and AH-3

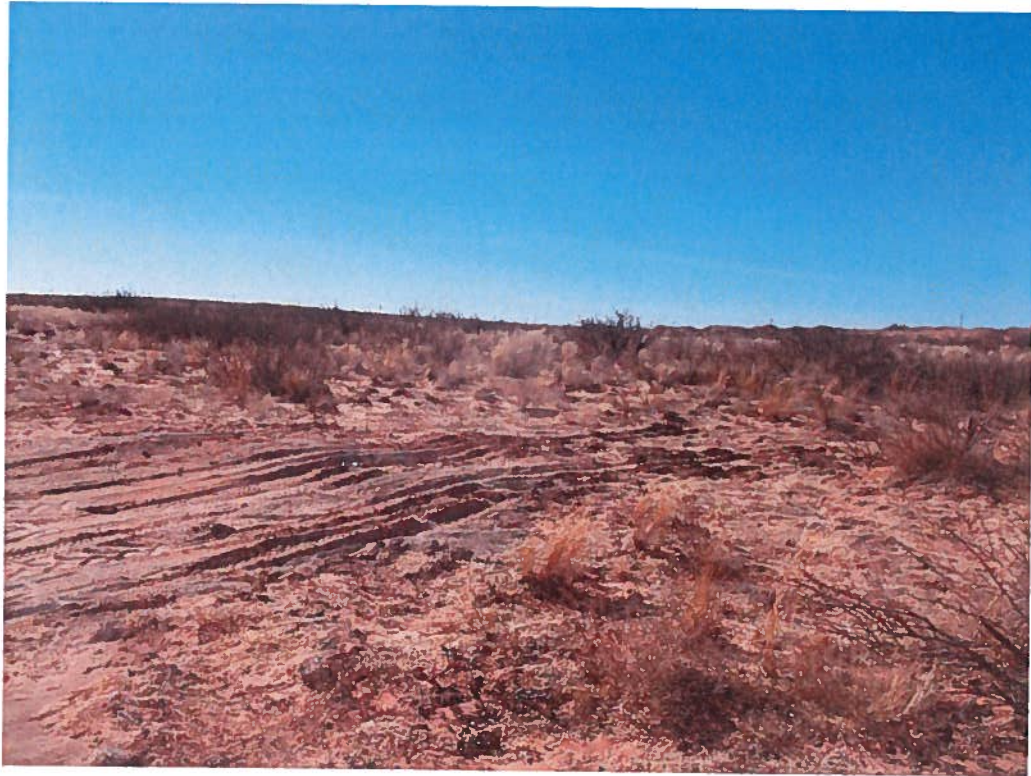
View West – Area affected by overspray
