Subject: **Remediation and Closure Report**
Judah Oil, LLC
Oxy T-Bone Federal #1 SWD
API # 30-015-32122

Judah Oil, LLC had contracted Talon/LPE (Talon) to perform soil assessment and remediation services for the Oxy T-Bone Federal #1 SWD. The results of our soil assessment, completed remediation activities and closure request are submitted herein.

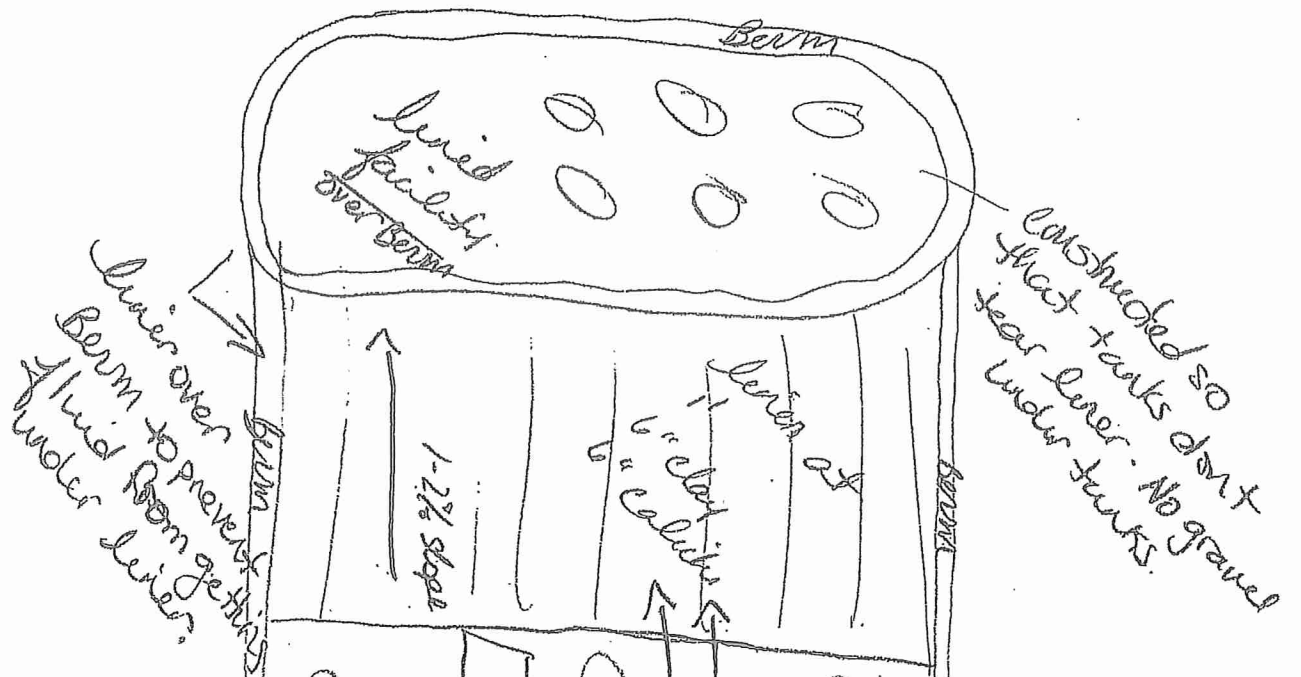
Constructed so that tanks don't tear liner. No gravel under tanks.

Liner over berm to prevent fluid from getting under liner.

check dam to hold leachate
leachate collection system
Top
Bottom

leachate collection system
gravel area

All surrounding should include in lined area
be in secondary containment
No pits

This is going to be an extensive cleanup, so I would like to add a couple of steps to prevent this event in the future. I have attached a hand drawn sketch. The step is not going to cost much more, but will save from the cost of this clean up from happening again. If bottom samples come back less than 2500 at 8' with cls not increasing below that point, I do not see the point of placing a liner. I will require a liner at surface for the facility. I will also require the liner be protected from puncture from beneath or on top. The tanks will need to be placed on something other than gravel to protect the liner. I will also require the pumps and other leak potential equipment to be inside the lined secondary containment.
