# SITE INFORMATION

## Report Type: Closure Report

| Site: | Burch Keely Unit #205 | | | | | |

**Re: Closure Report for the COG Operating LLC., Burch Keely Unit #205, Unit O, Section 26, Township 17 South, Range 97 East, Eddy County, New Mexico.**

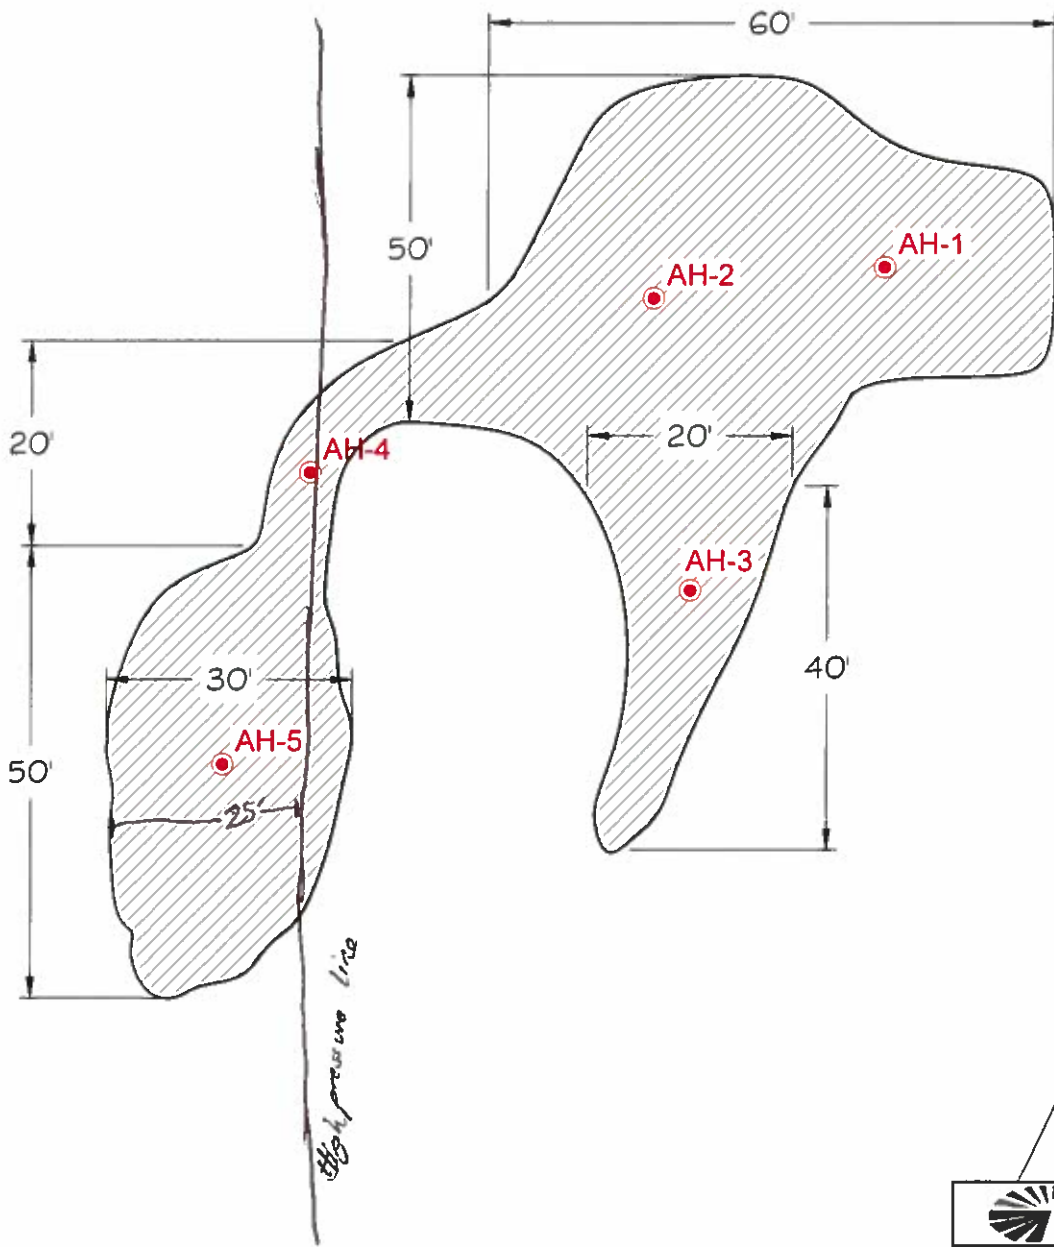
Figure 3

On September 3, 2013, Tetra Tech personnel inspected and sampled the spill area. Five (5) auger holes (AH-1 through AH-5) were installed using a stainless steel hand auger to assess the impacted soils. Selected samples were analyzed for TPH analysis by EPA method 8015 modified, BTEX by EPA Method 8021B and chloride by EPA method 300.0. Copies of laboratory analysis and chain-of-custody documentation are included in Appendix C. The sampling results are summarized in Table 1. The auger hole locations are shown on Figure 3.

Referring to Table 1, none of the samples showed BTEX or TPH concentrations above the RRAL. Auger holes (AH-1 and AH-2) showed elevated chloride concentrations down to 9.5' below surface with chloride highs of 20,400 mg/kg and 22,100 mg/kg at 2.5' below surface, respectively. The areas of auger holes (AH-1 and AH2) were not vertically defined.

The areas of auger holes (AH-3, AH-4 and AH-5) all showed elevated chloride concentrations with chloride highs of 17,800 mg/kg at 2.5', 20,400 mg/kg at 4.5', and 20,800 mg/kg at 1.5' below surface, respectively. Auger holes (AH-3, AH-4, and AH-5) showed a decline in chloride concentrations with depth with chloride concentrations of 445 mg/kg at 6.5', 327 mg/kg at 8.5' and 299 mg/kg at 7.5' below surface, respectively. However, in the areas of auger holes (AH-4 and AH-5) the chloride concentrations increase or spiked to 3,120 mg/kg at 9.5' and 1,770 mg/kg at 5.5' below depth, respectively; possibly due to cross contamination.

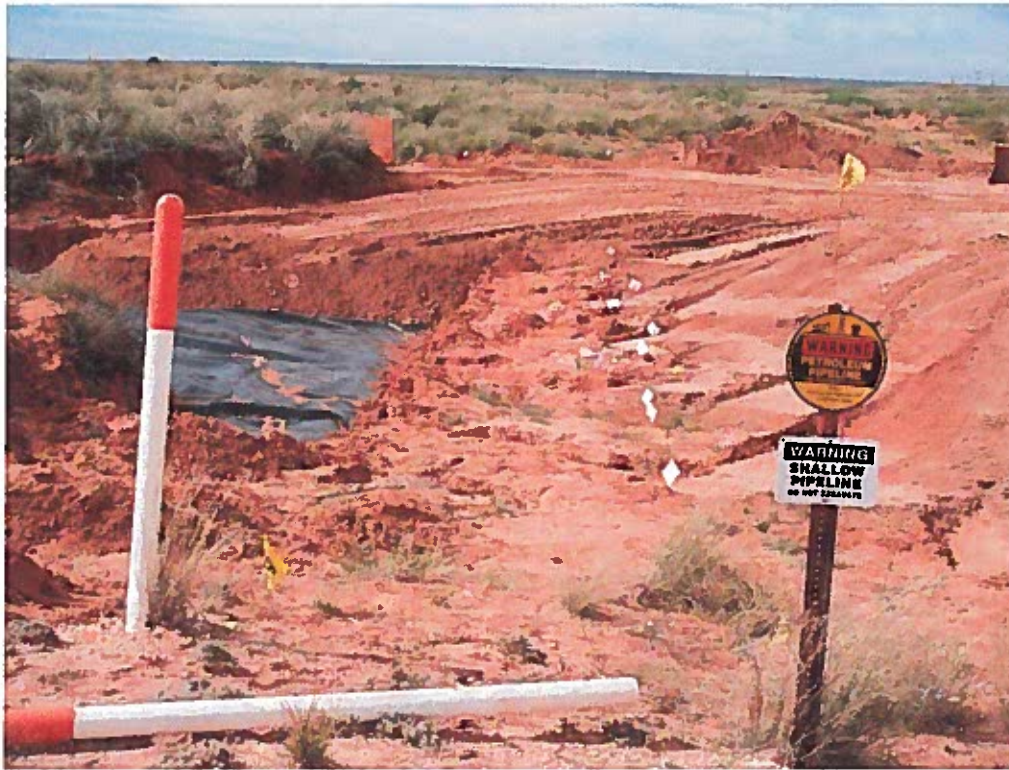
View West – Area of AH-1 and AH-2 backfilled on North side of pipeline

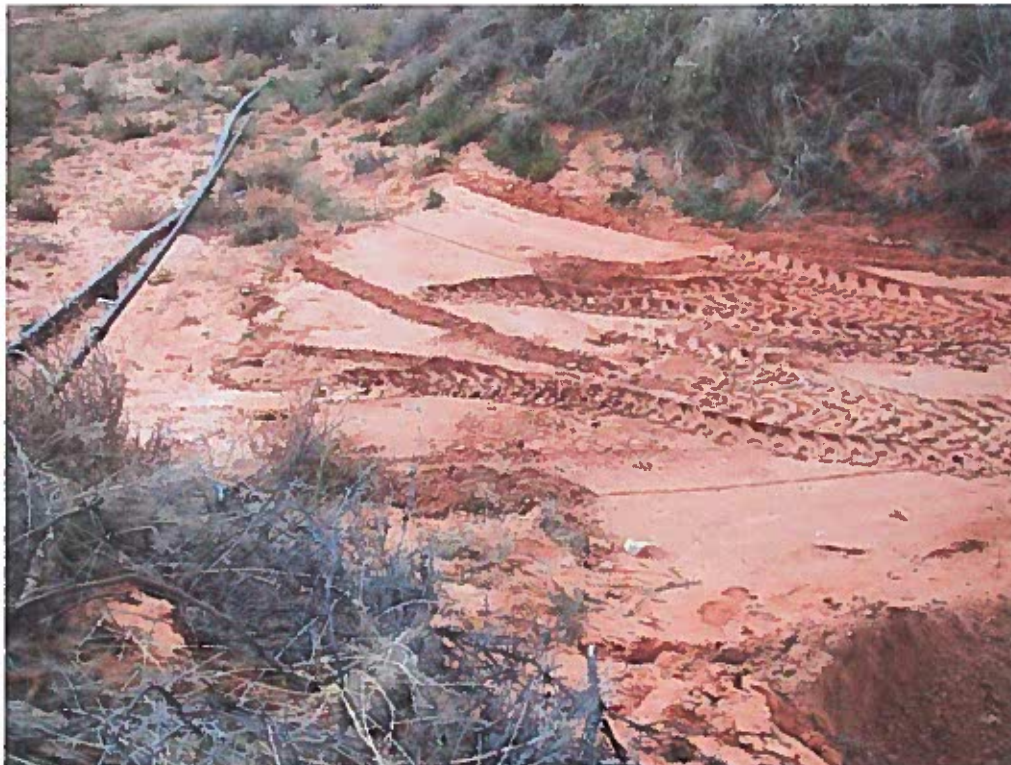
View South – Areas of AH-3 backfilled

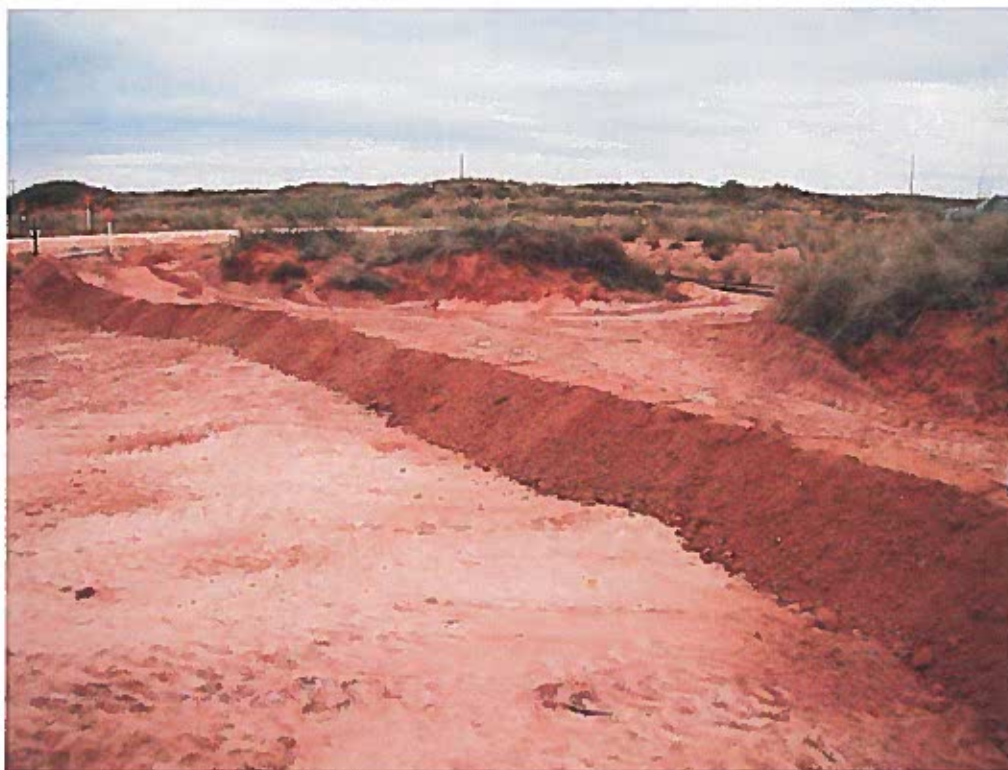
View East – Area of AH 1-AH 3 backfilled with DCP shallow line outlined in berm.

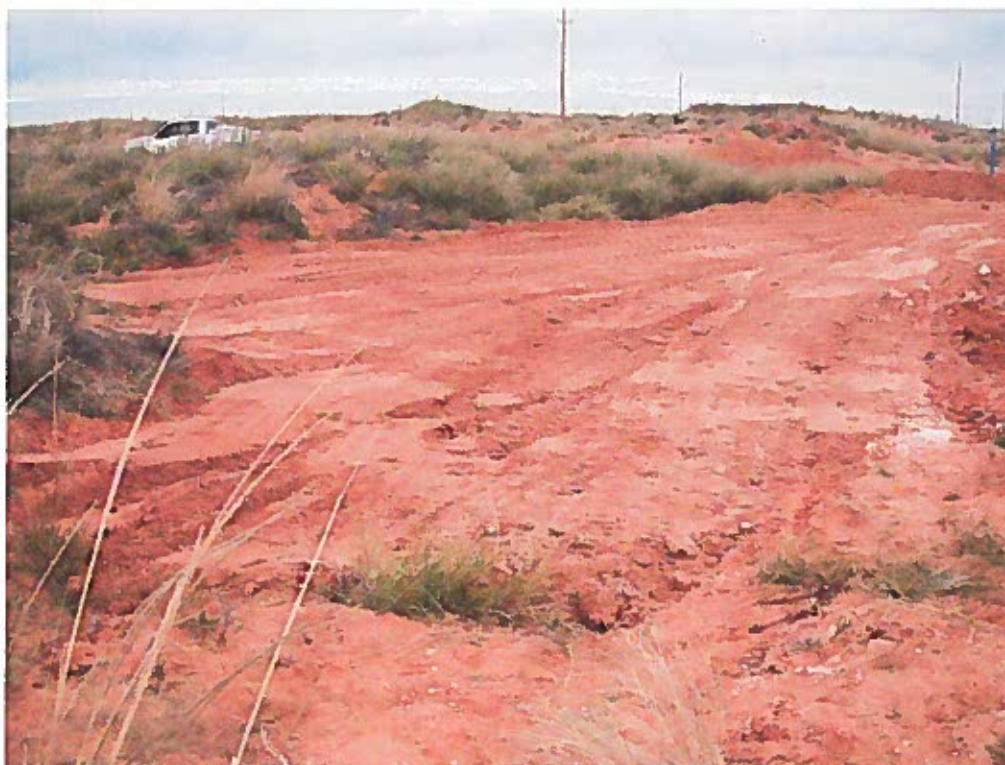
View North – Area of AH 4 and AH 5 backfilled
