Khody Land & Minerals Co. NMSLO Lease #X006470405

Section 32, T18S-R28E. Eddy County, NM

New Mexico State Land Office Carlsbad District: Ian Dolly District Resource Specialist
6/18/2015

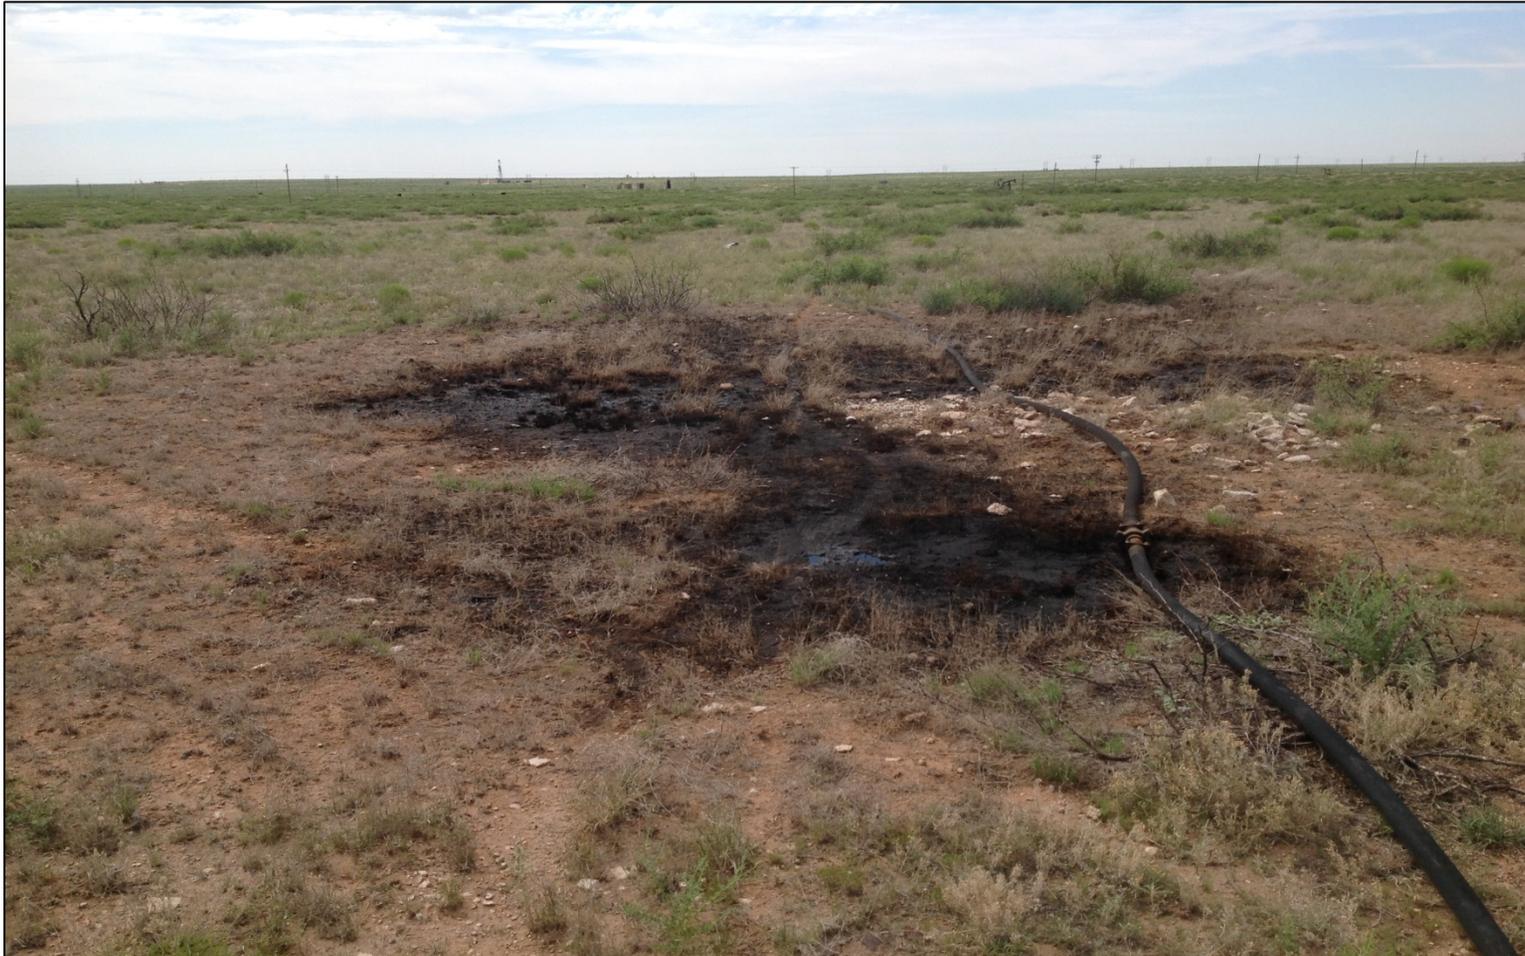
Photo Point 1: View of Spill Site #1 Lat: 32.710757° Lon: -104.201069°

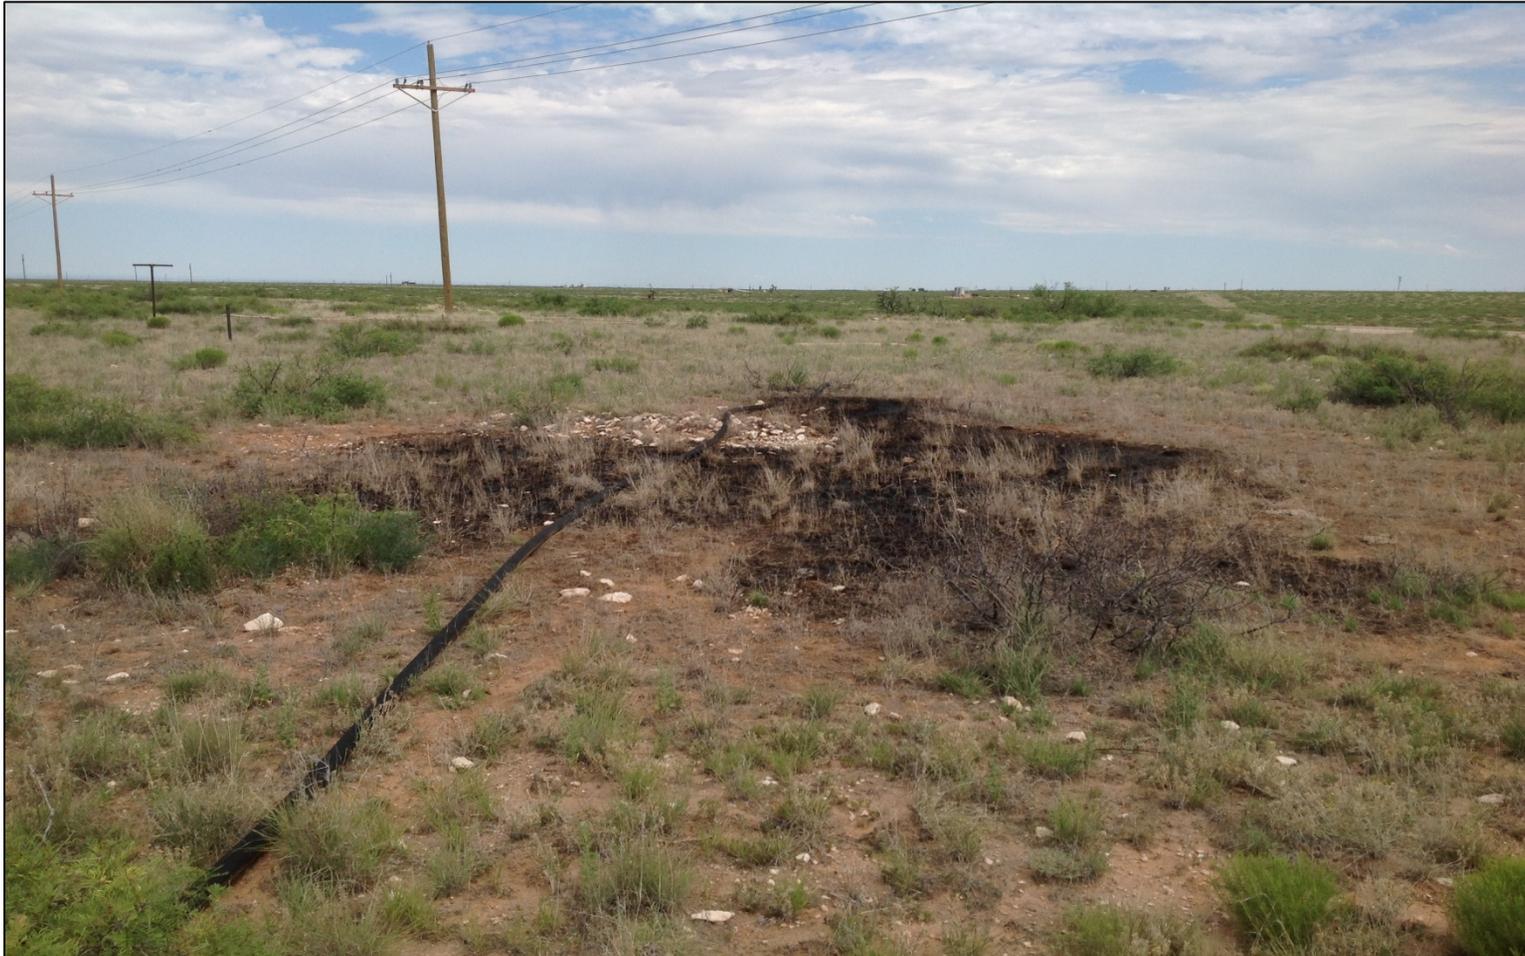
Photo Point 2: View of Spill Site #1

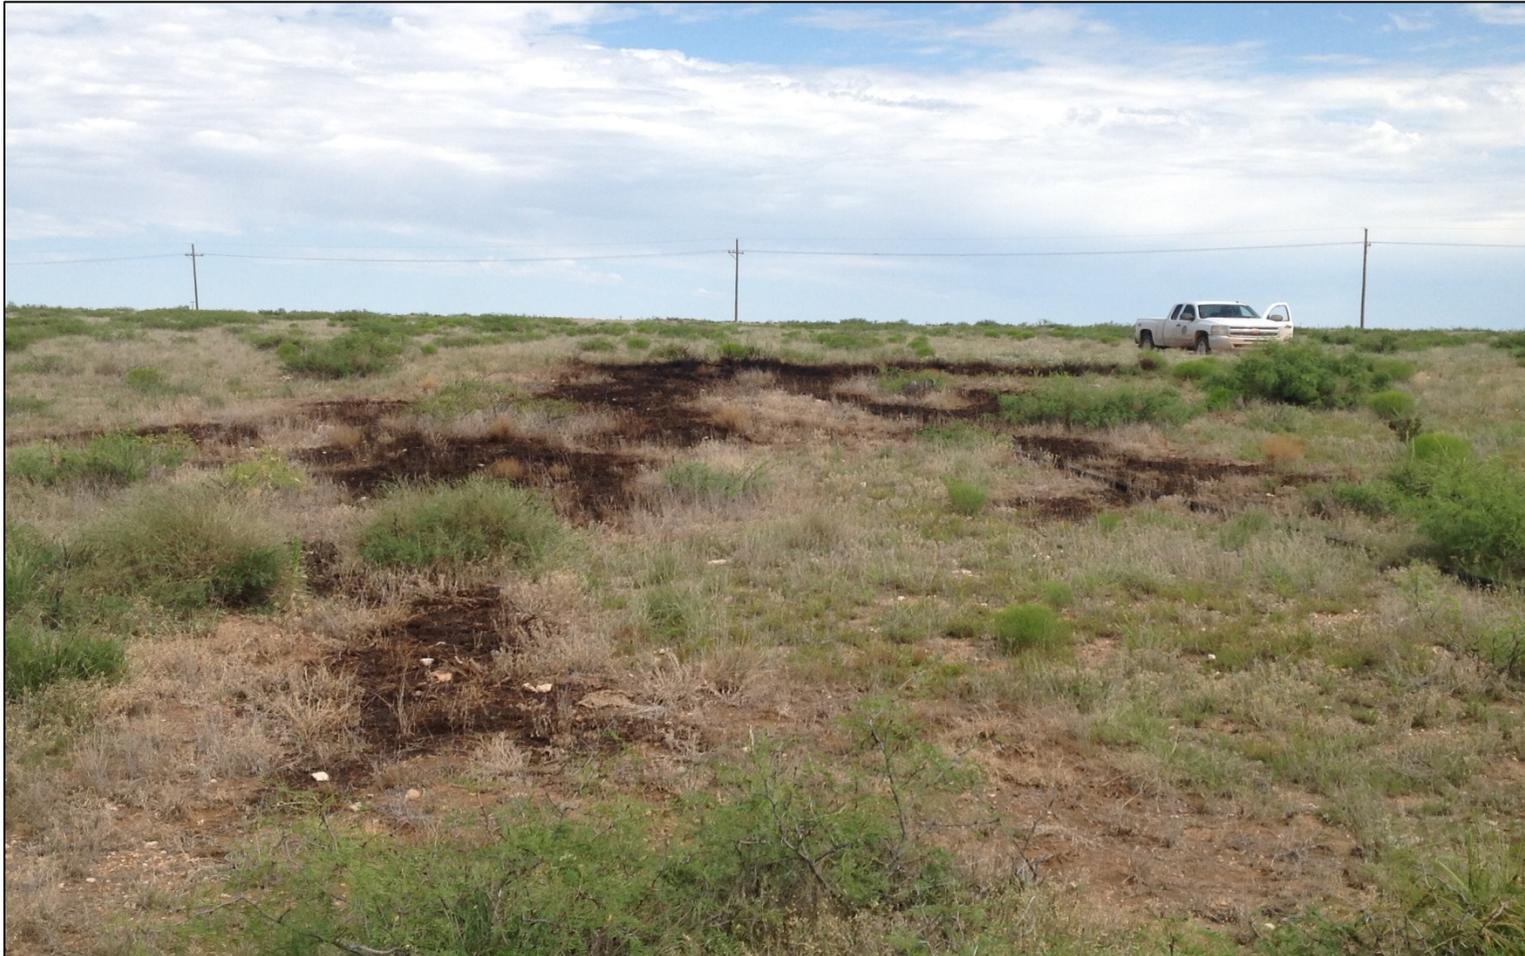
Photo Point 3: View of Spill Site #2 Lat: 32.709307° Lon: -104.199400°

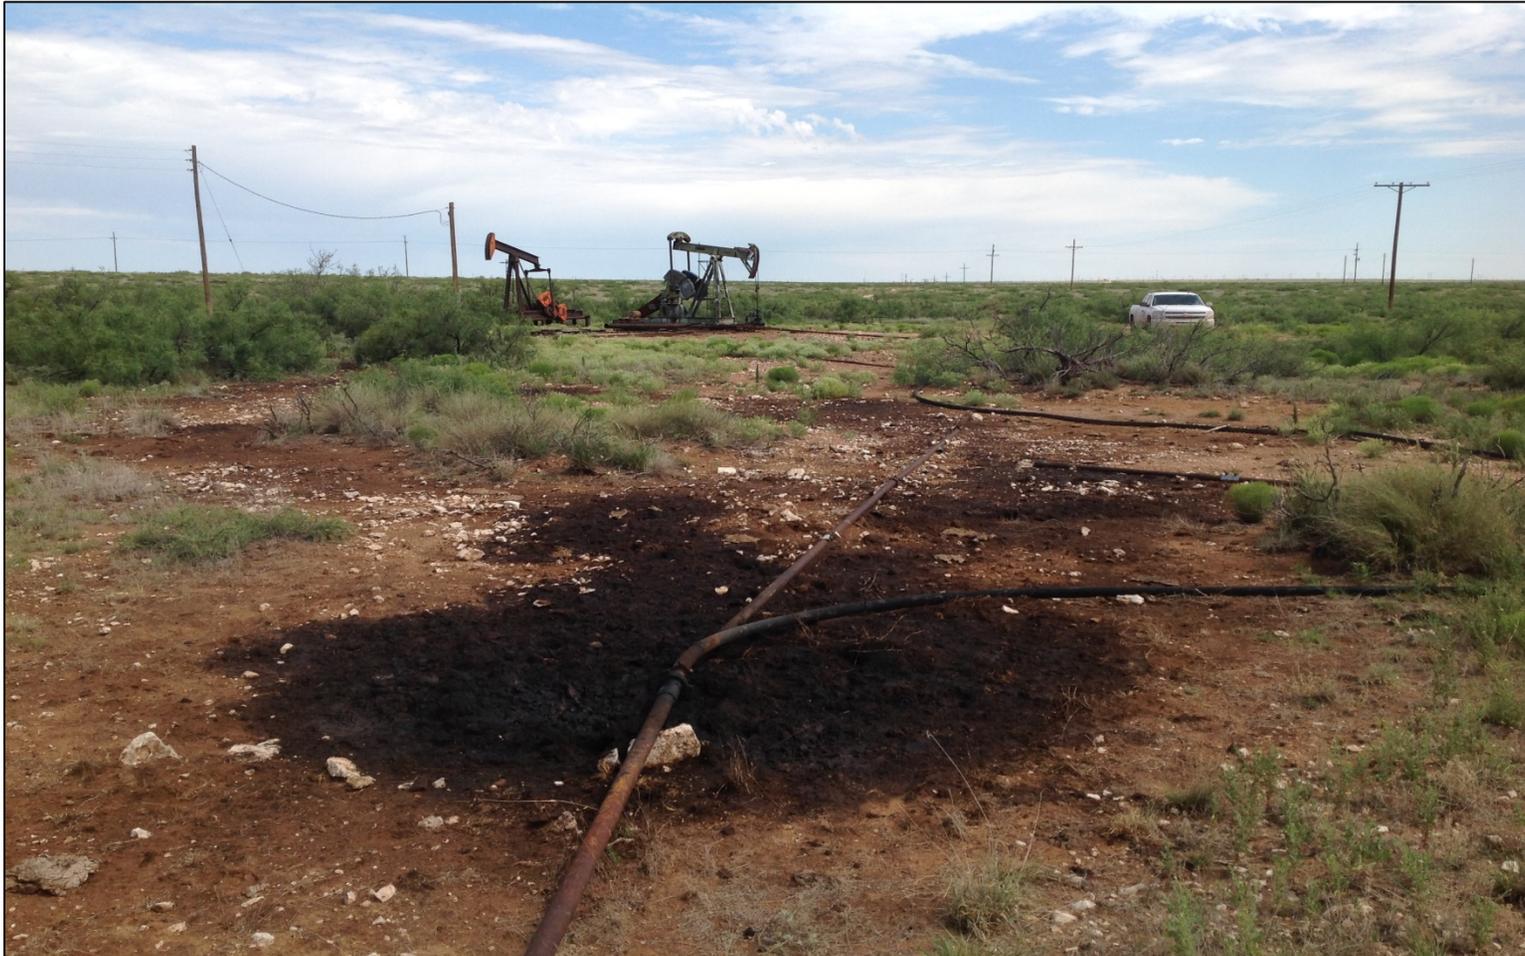
Photo Point 4: View of spill site #3 Lat: 32.708042° Lon: -104.198542°

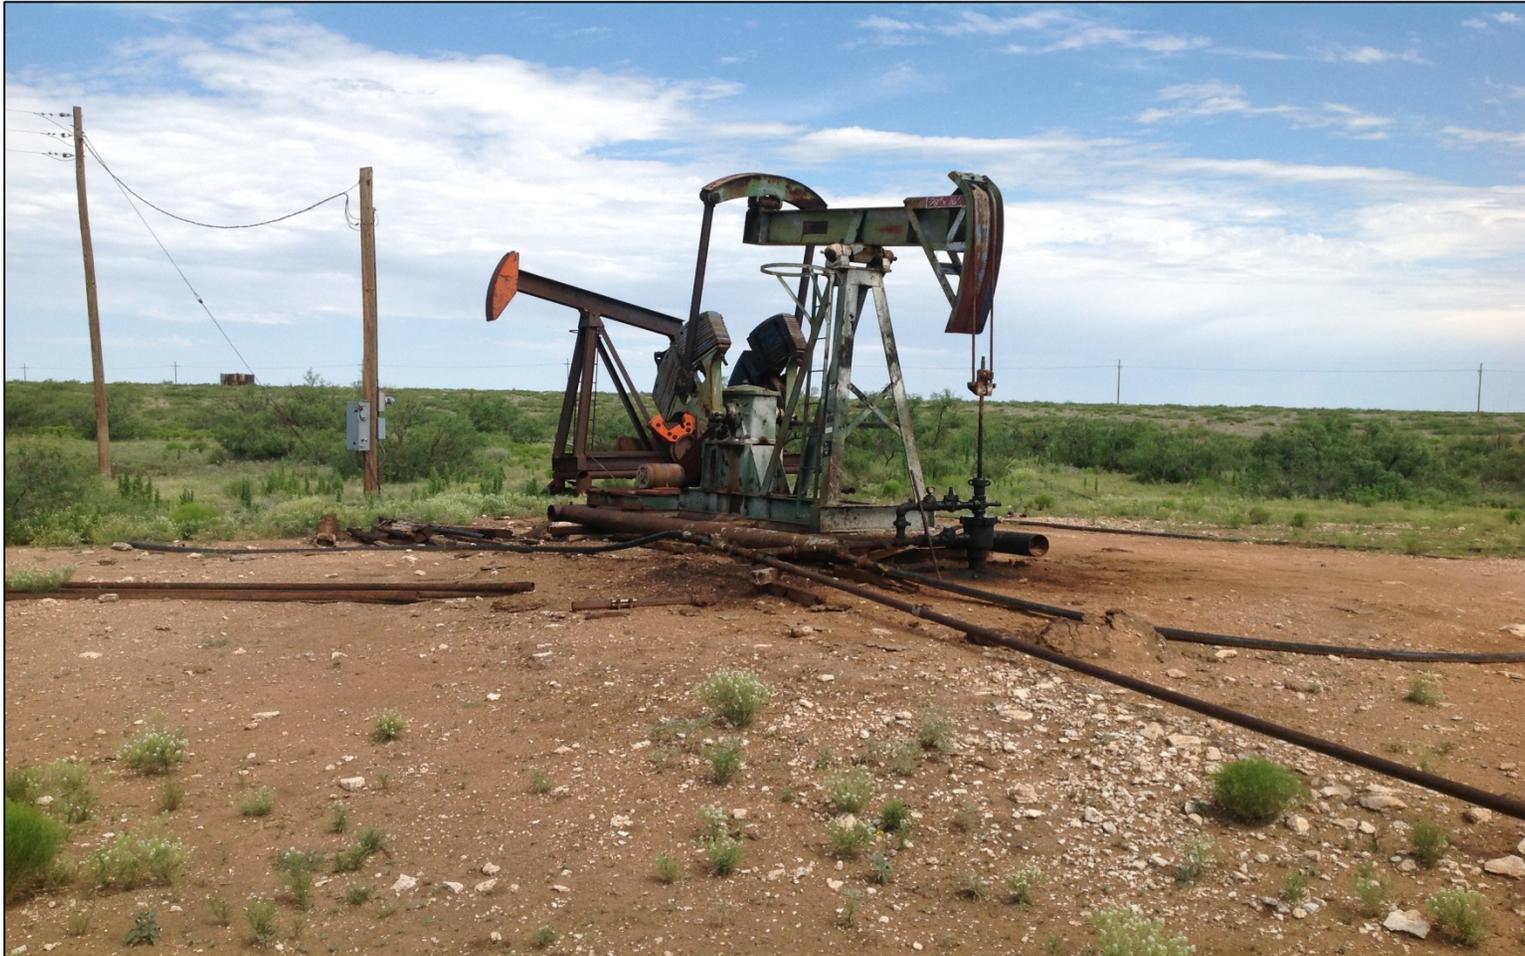
Photo point 5: View of Pump Jack

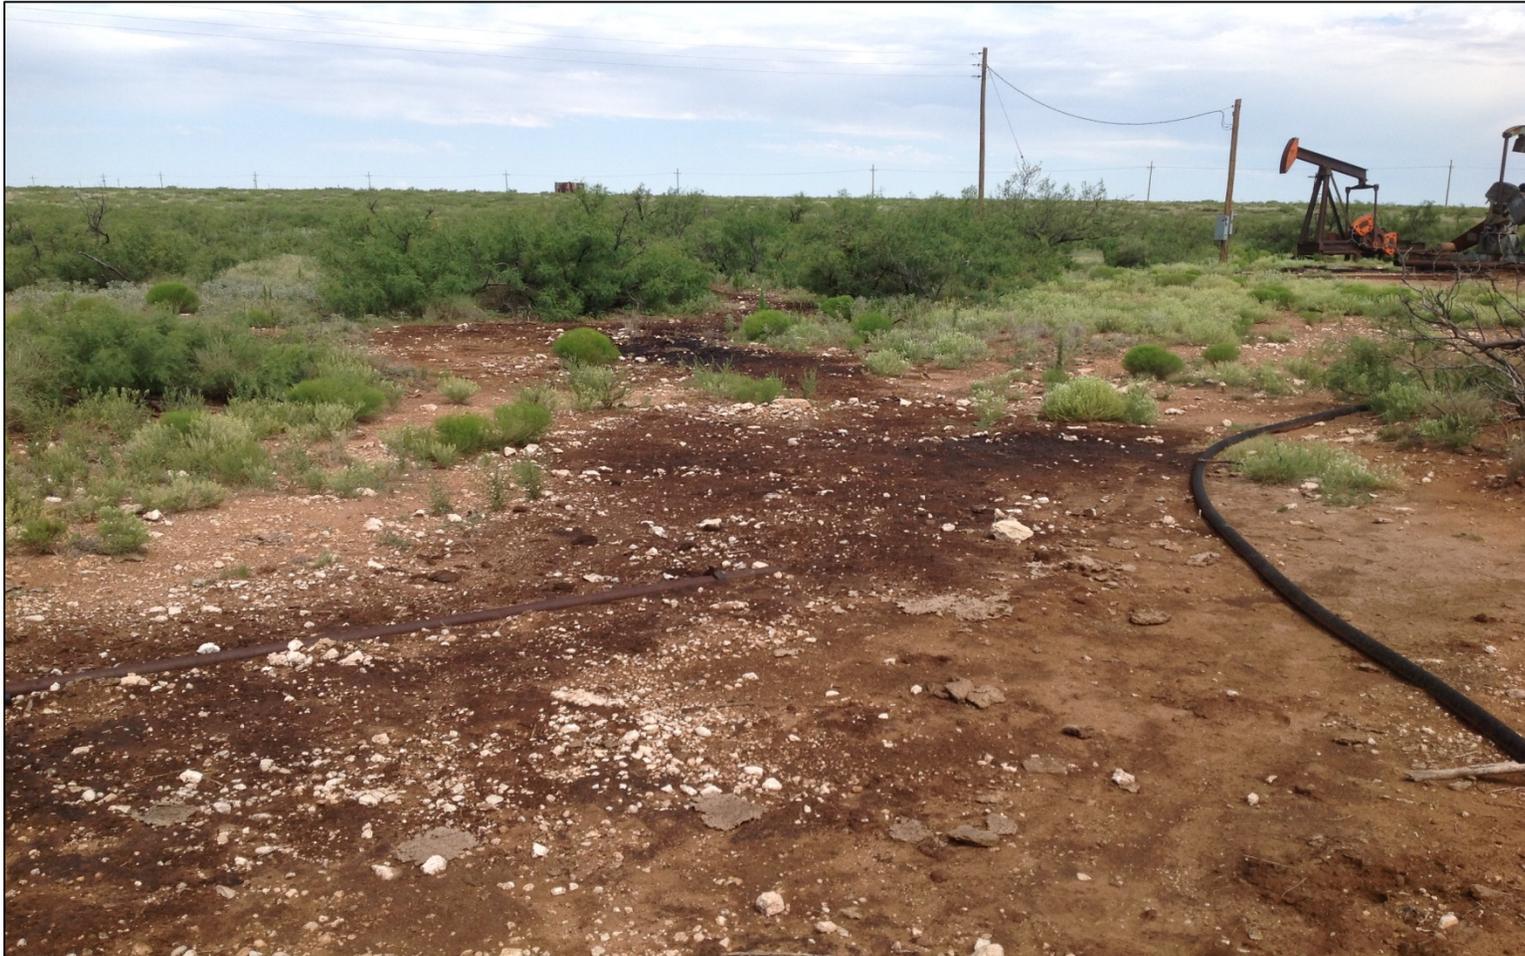
Photo point 6: View of Spill site #3

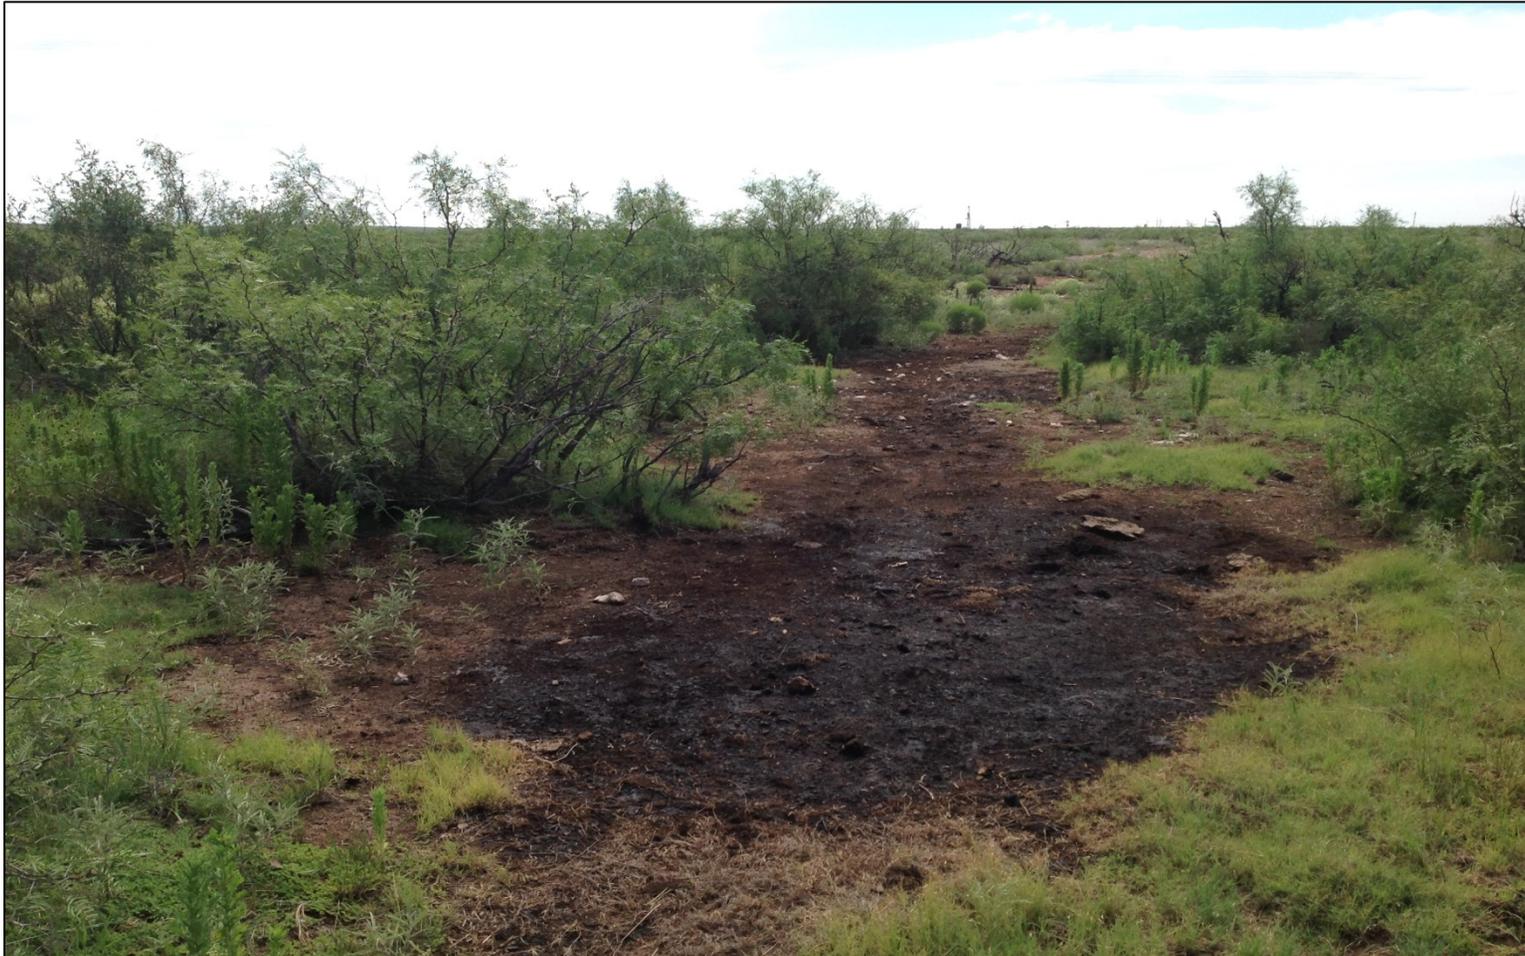
Photo point 7: View of Spill site #3

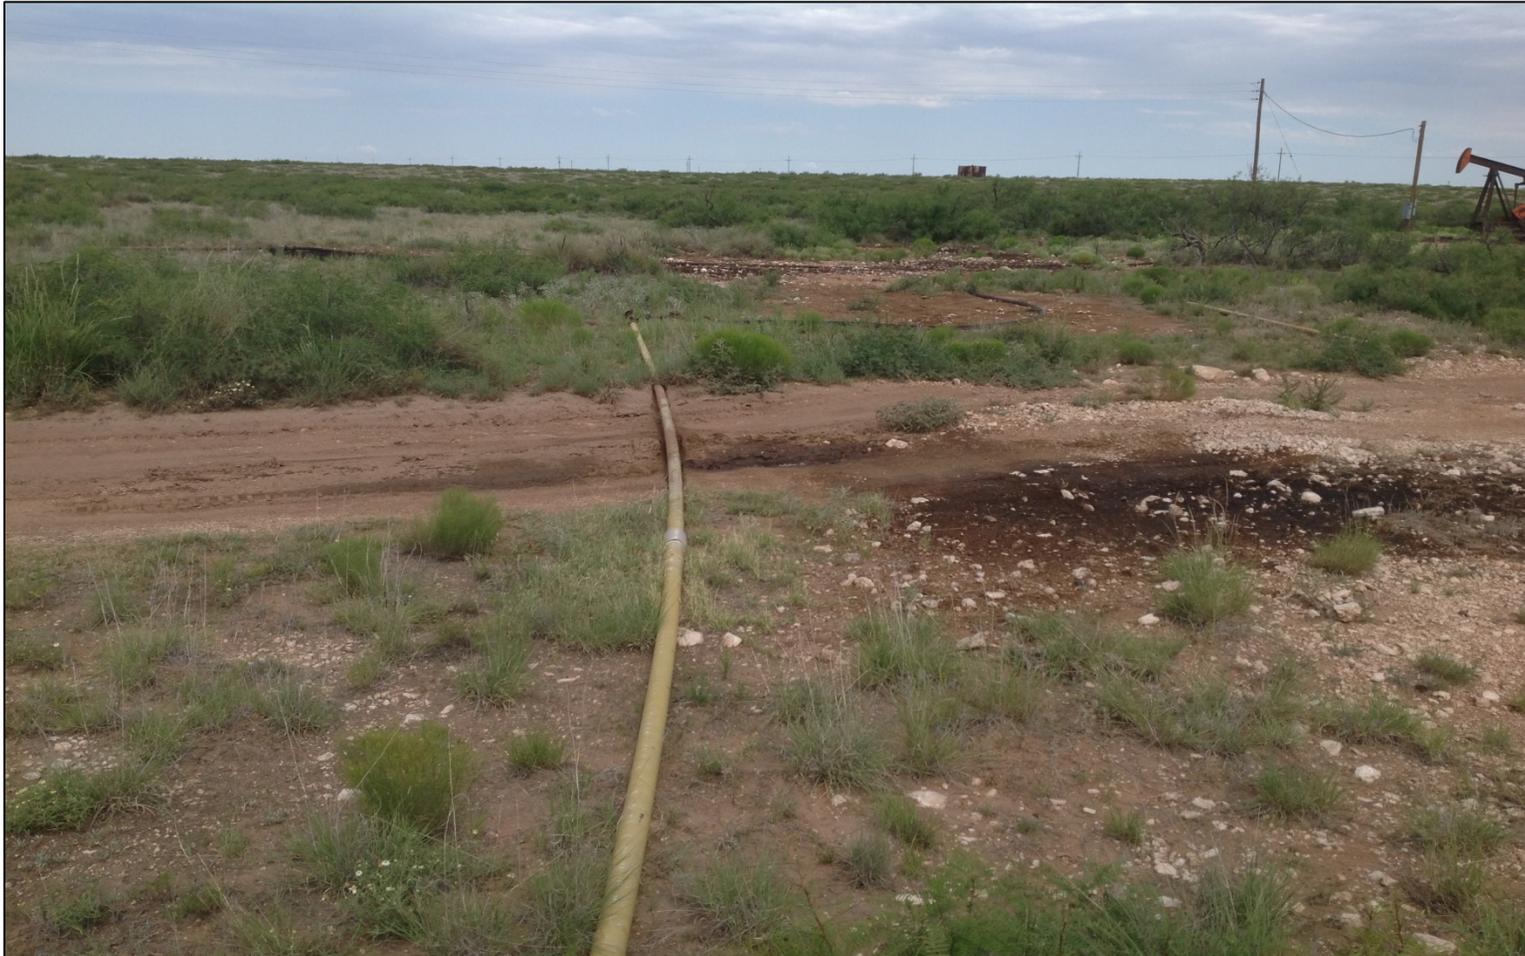
Photo point 8: View of Spill site #5 and Fiber Glass Line Crossing Two-Track Road
