August 28, 2015

Subject: **Soil Assessment and Remediation Work Plan**
Devon Energy
Hackberry 16 SWD No. 1
API # 30-015-41783, 2RP-3145 & 2RP-3146

Hackberry 16 SWD #1
Devon Energy Corporation
Eddy County, New Mexico
Figure 1 - Site Plan

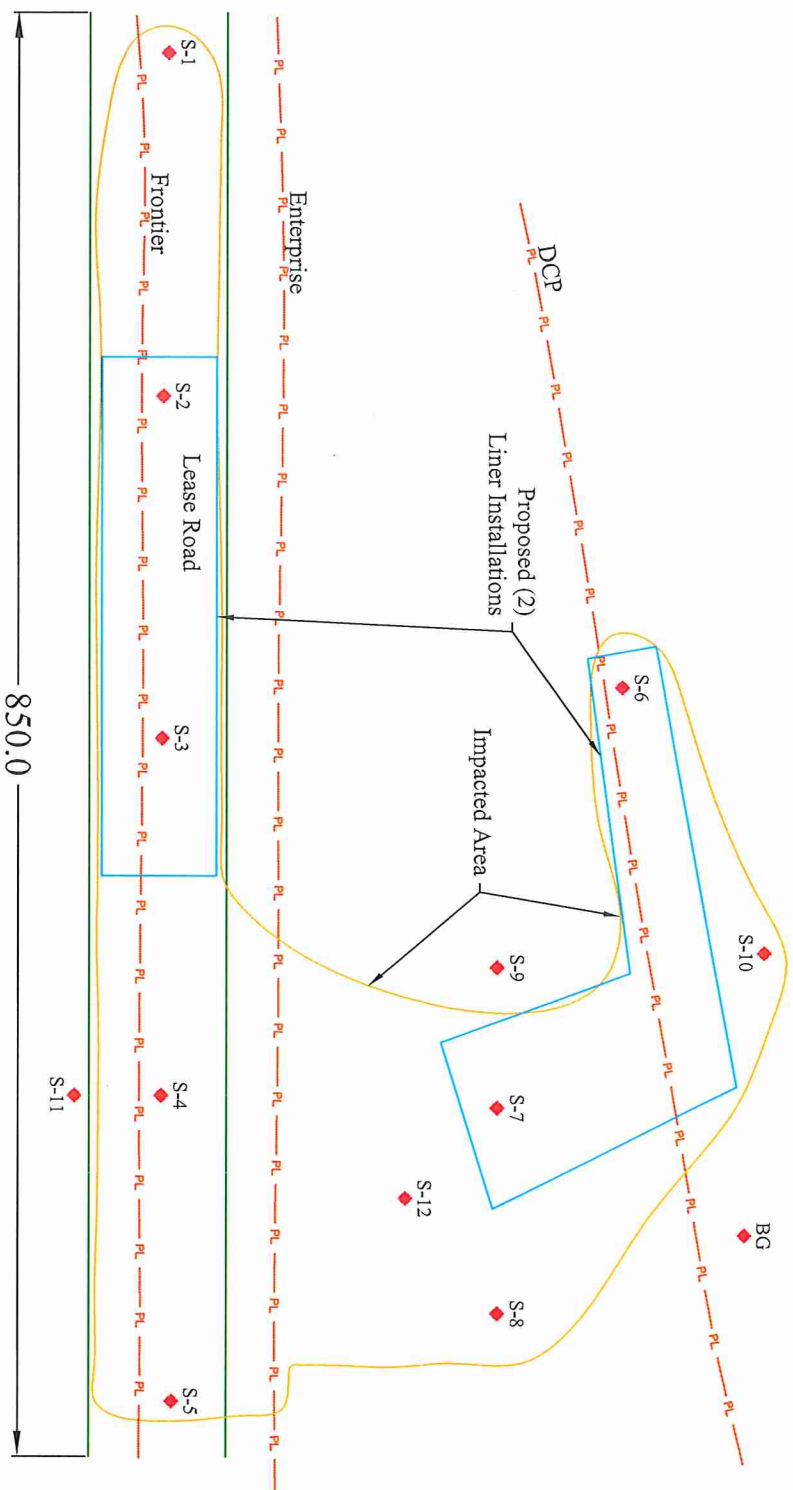
- The impacted area in the vicinity of sample locations S-1, S-5 and S-8 will be excavated to a depth of 2-feet deep.
- The impacted area in the vicinity of S-10 will be excavated to a depth of 1-feet deep.

- The impacted soil in the area of S-4 will be removed to a 2.5-feet depth and the impacted soil in the vicinity of S-12 will be excavated to a depth of 3.5-feet deep.

- The remaining impacted areas will be removed to a depth of 4-feet below land surface, which include S-2 and S-3 along the lease road and between S-6 and S-7 in the pasture.

- A 20 mil liner will be installed where proposed on the site plan in the 4-foot deep excavation areas.
- The impacted soil around the pipelines will be hand-excavated until the liner can be safely installed below the DCP and Frontier lines.

- All excavated material will be hauled to an NMOCD approved solid waste disposal facility.
- The excavation will be backfilled with clean top soil obtained from a local borrow pit, re-contoured to match the surrounding terrain and seeded with the recommended BLM seed mixture for the area.
