**REMEDATION SUMMARY
&
SITE CLOSURE REQUEST**

**BOPCO, L.P.
POKER LAKE UNIT #213 (SWD)
(Spill dated 5/28/12)
API-30-015-33859
Eddy County, New Mexico
UL-P, Section 18, Twns. 24 South, Range 30 East
Latitude N 32.212505° Longitude W 103.914199°
NMOCD Spill reference #2RP-1202**

September 2015

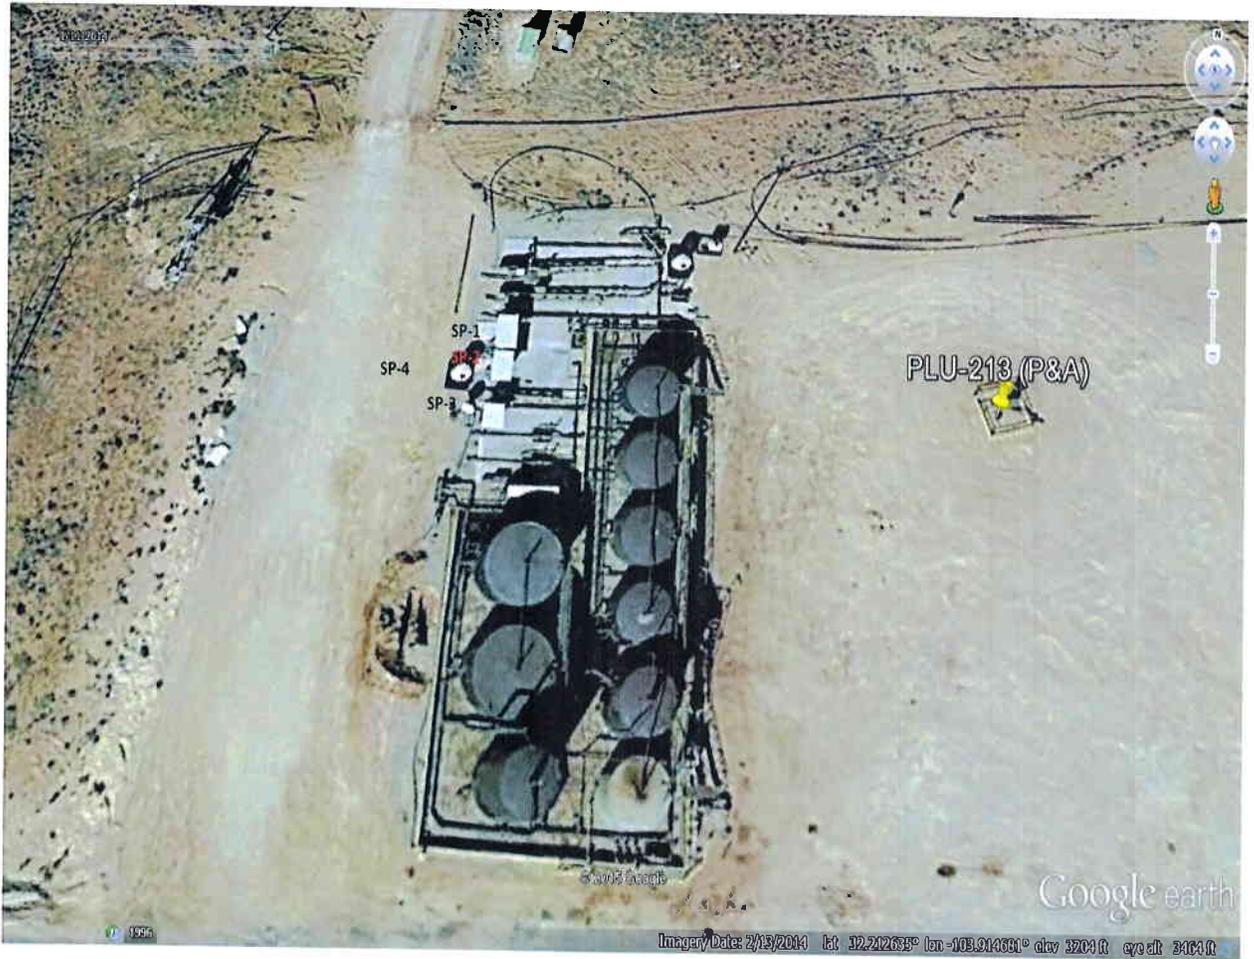
Sample location map with Lab Analysis

The sample analysis indicated that everything was below the remediation action level for TPH, BTEX, and Chlorides.

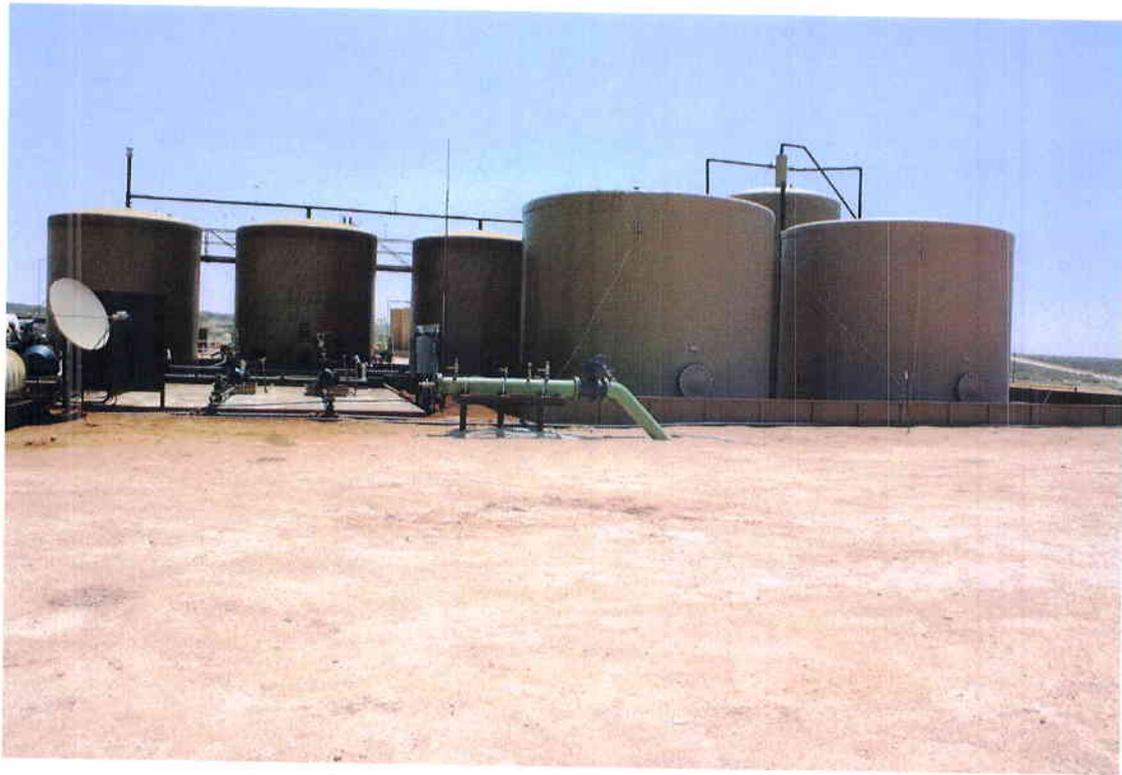
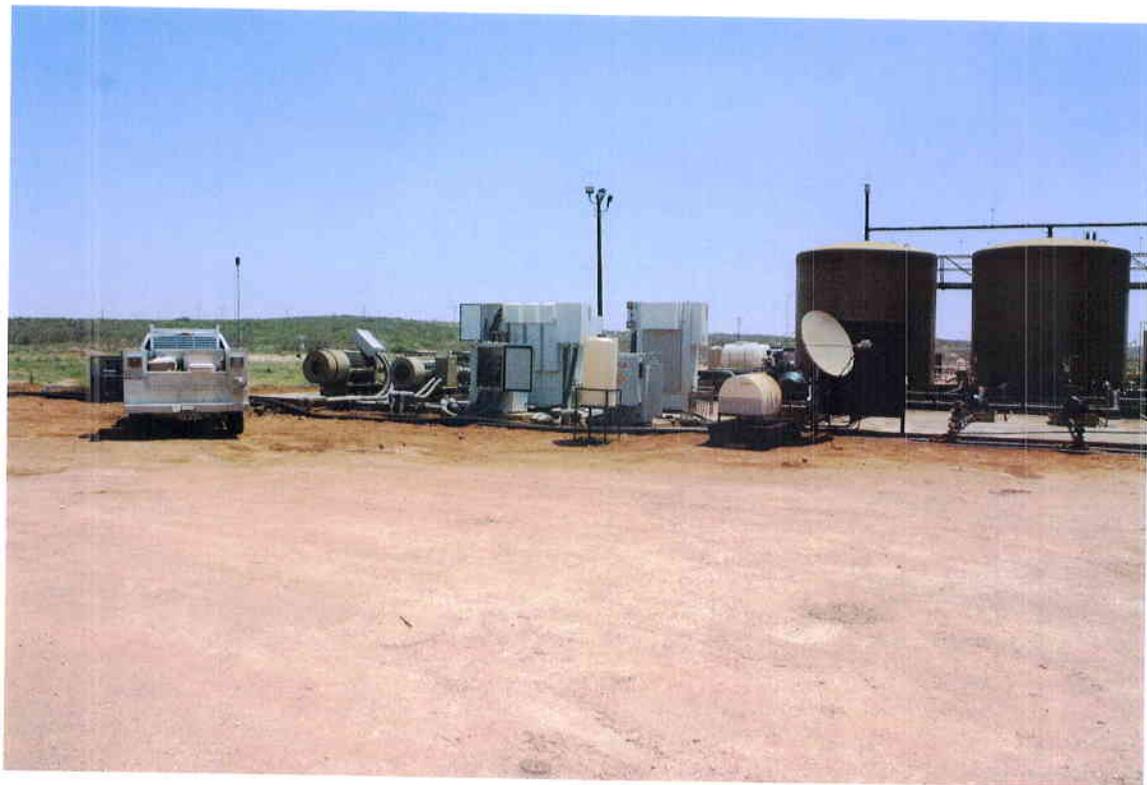
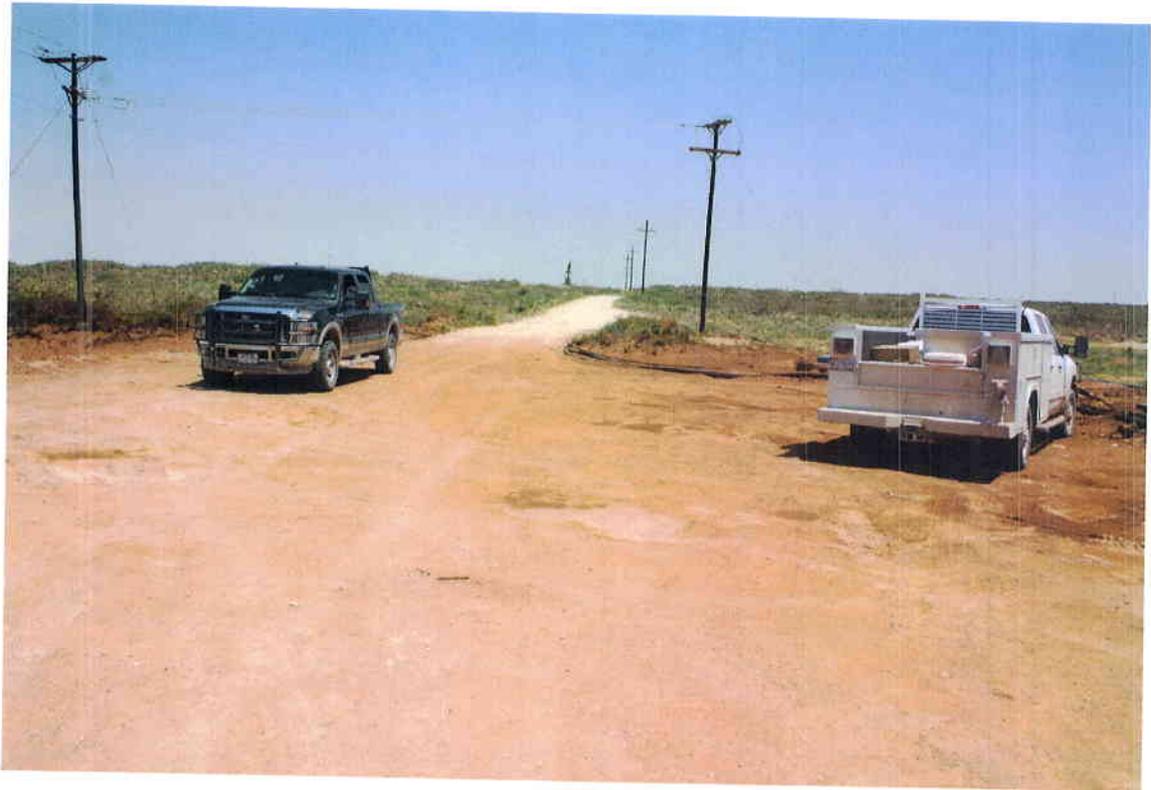
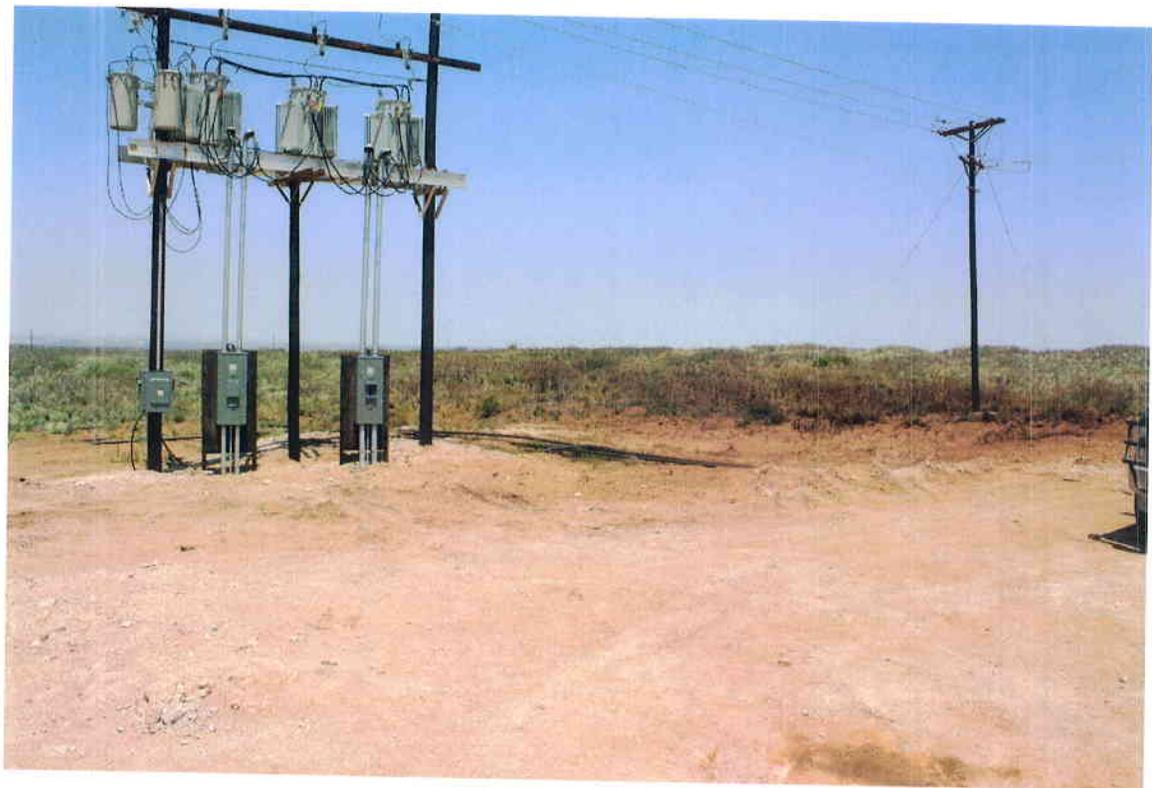
Initial Photographs 5/29/12

On the 5/28/12 the pumper at the PLU discovered that due to a power failure at the SWD facility the PW tanks overflowed. The facility did have a 0 Perm containment around the tanks but due to the high winds at the time of the release approximately 5 bbls of crude oil and 5 bbls of produced water misted about 23,400 sq.ft. of pasture area. The oil and PW did puddle up at the edge of the concrete slab around the transfer pump and electric control panels. A C-141 spill report was submitted to the NMOCD on 6/26/12 and issued the spill report #2RP-1202.

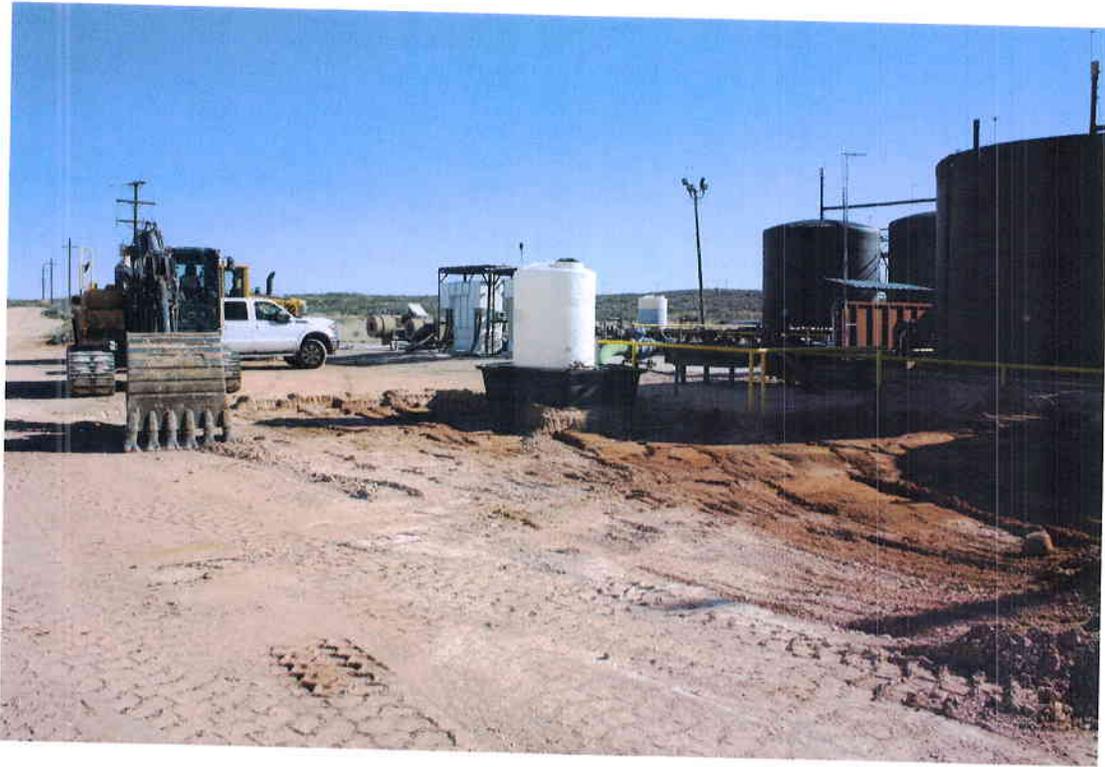
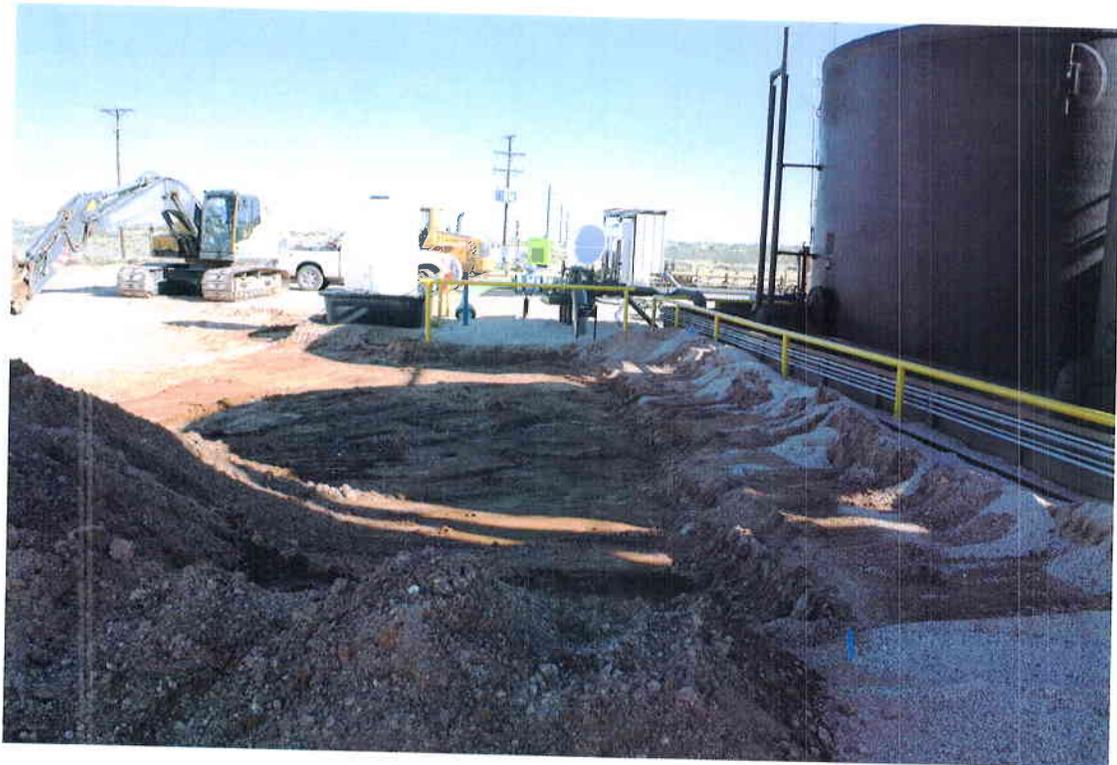
During Remediation Activities 3/24/15

During a period shortly after the spill until a sampling event on 2/6/15 conducted by Basin Environmental there had be a considerable amount of construction activity around the edges of the concrete pad and electric control panel.

It was discussed with the NMOCD to conduct a sampling event of the impacted area around the edges of the concrete pad and road.
